Heritage Advisory Committee
JUN 19 2012

Heritage Impact Statement

**1570 Stavebank Road
Mississauga ON L5G 2V7**

Heritage Impact Assessment
St. Apostle Andrew Romanian Church
4030 Dixie Rd., Mississauga, Ont.

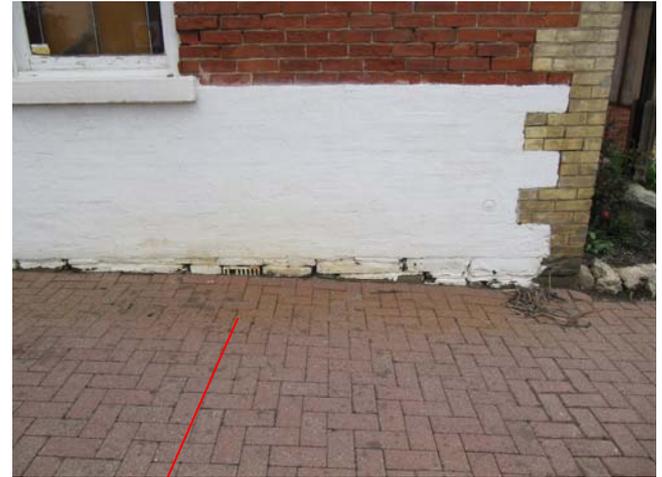
- Spalling brick on the south side in a band extending from the foundation up to approximately 5 ft. (1.5m) above grade. (Photo page 4.) The lower part of this area has been painted with what appears to be a breathable paint which showed no signs of failure but which may conceal earlier repairs. An area of spalling brick extends roughly 2 ft. above the top of this dado. Removing the paint may allow the wall to breathe in the lower part. The possibility is also that the brick in the lower part of the wall behind the paint has been replaced using a dense mortar and if the brick and mortar was poorly matched, that explains why the wall was painted and why the brick dado appears undamaged. That would also be a likely cause of the spalling brick above. If that is the case, removing the paint won't help. Our recommendation is to allow the paint to remain and replacement of only the most severely spalled brick, leaving quite a lot of brick with shallow surface spalling. The stone foundation has large open joints suggesting some mortar loss which should be repointed with a stronger mortar.

7. South side showing erosion of brick below dotted line.

7. Painted brick. Open joints in stone foundation.

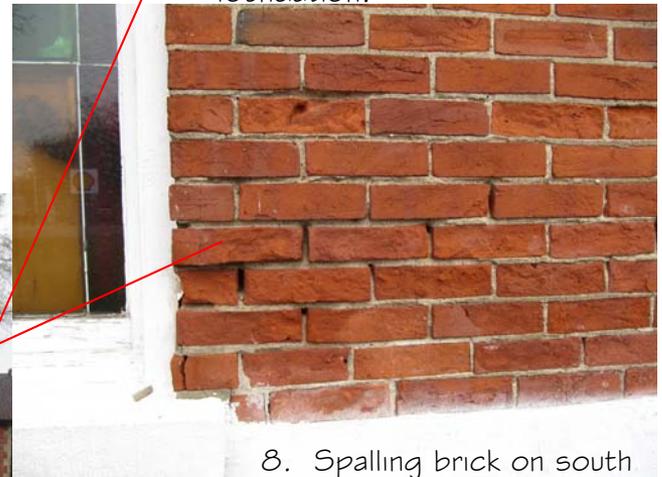
8. Spalling brick on south side

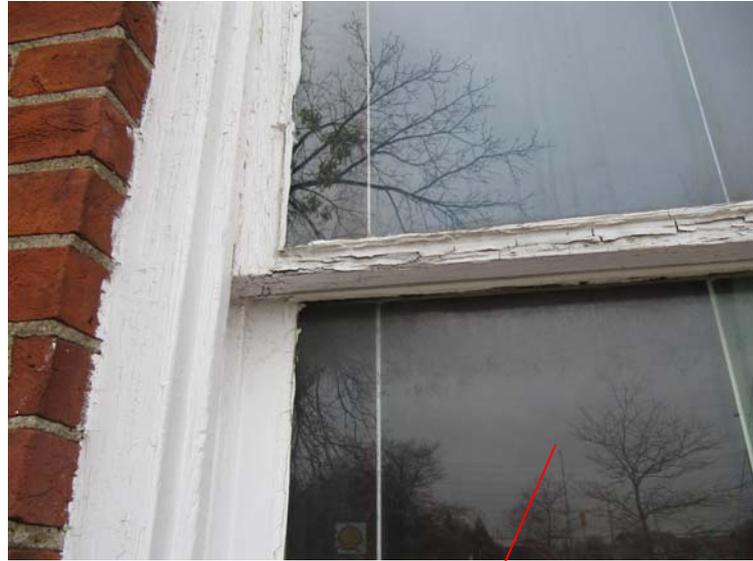
- The mid and bottom rails of each window generally appear to be in fair condition. Paint is peeling in all locations and may conceal some deterioration. One window mid rail has been reinforced with small hardware angles. (Photos 10, 21). In the long run, weak and damaged rails should be properly repaired.

10. Window detail showing face glazed storm & condition of mid rail (peeling paint).

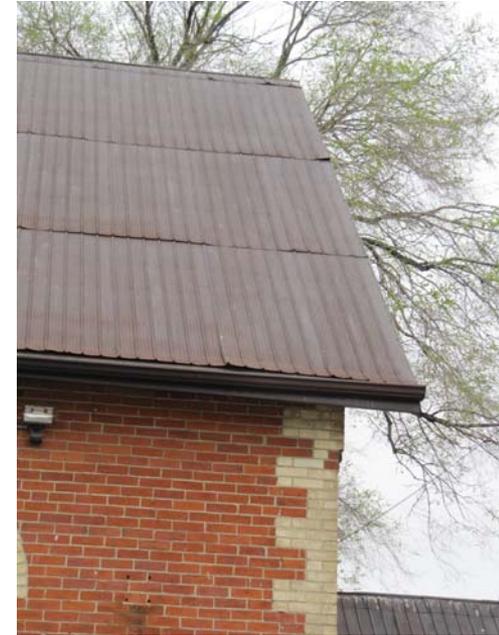
The roof is sheet metal, of a simple profile with surface fasteners, quite old and rusty with edges curling or loose. (Photos 7, 11, 14). Replacement is recommended with an appropriate profile prefinished metal roofing.

11. View showing sheets of rusty metal roof with edges curling.

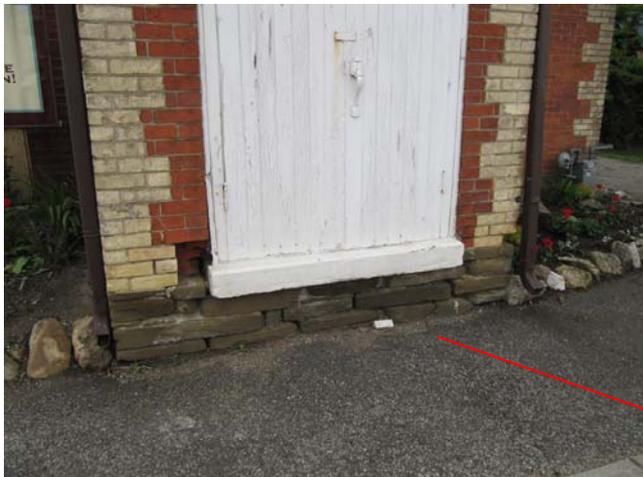
- At the front vestibule foundation there is significant mortar loss and above that there is brick loss and other masonry deterioration. Replacement and repointing is recommended for this area.

13. Unused front door. Open joints in foundation stone. Missing brick.

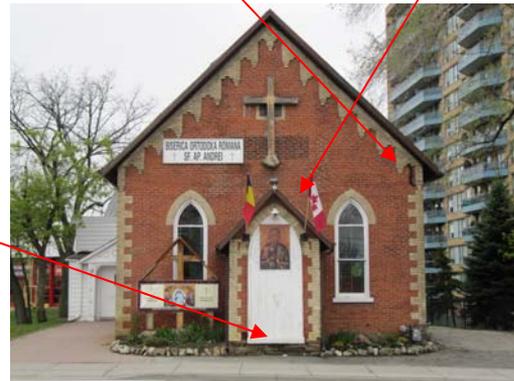
15. General view. The cross is in poor condition with open metal joints.

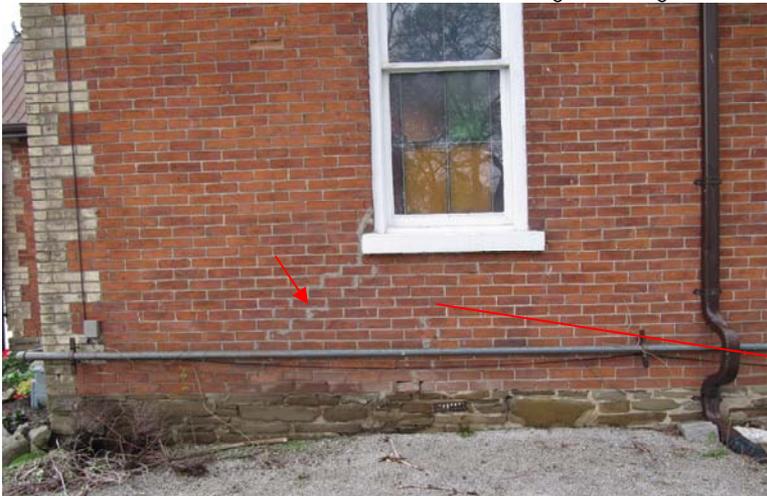
18. Condition of foundation stone is fair.

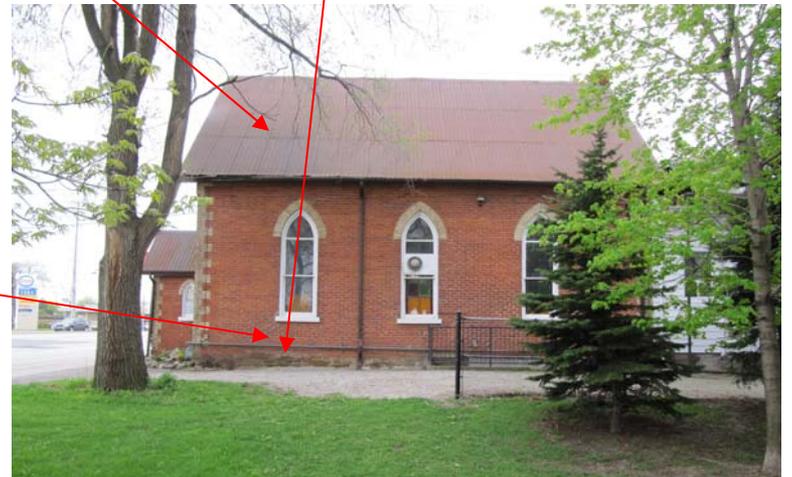
- On the north side there has been some repointing of diagonal cracks with a harder mortar which appears to be holding well. The foundation also shows some mortar loss, mainly towards the east end. Repointing of mortar loss only is recommended this area.

17. Some open joints in foundation. Brick generally good. Some earlier repairs at diagonal cracks.

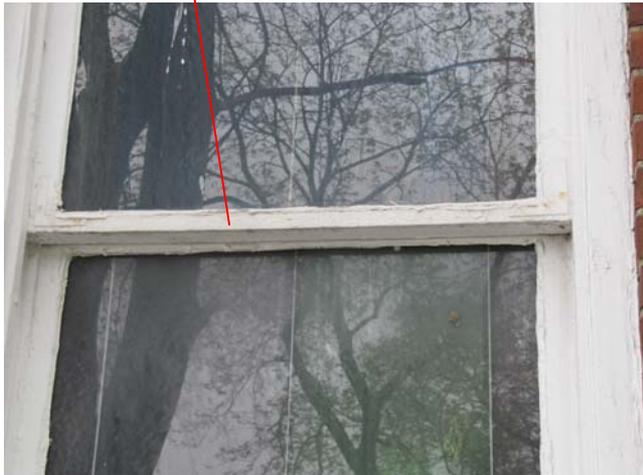
21. Window detail showing face glazed storm glass and condition of mid rail reinforced with hardware angles.

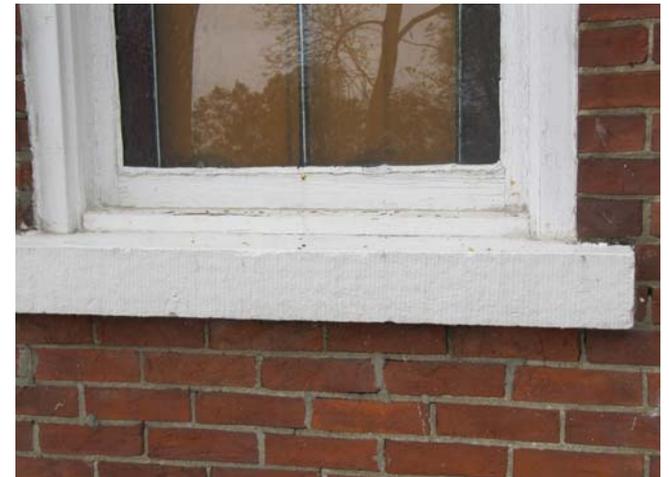
22. Typical window sill. Generally in good condition.
