Serson Creek Geomorphic Assessment and Rehabilitation Design Lakeview Village City of Mississauga

Lakeview Community Partners Limited

Beacon Environmental Limited

December 2020 217424

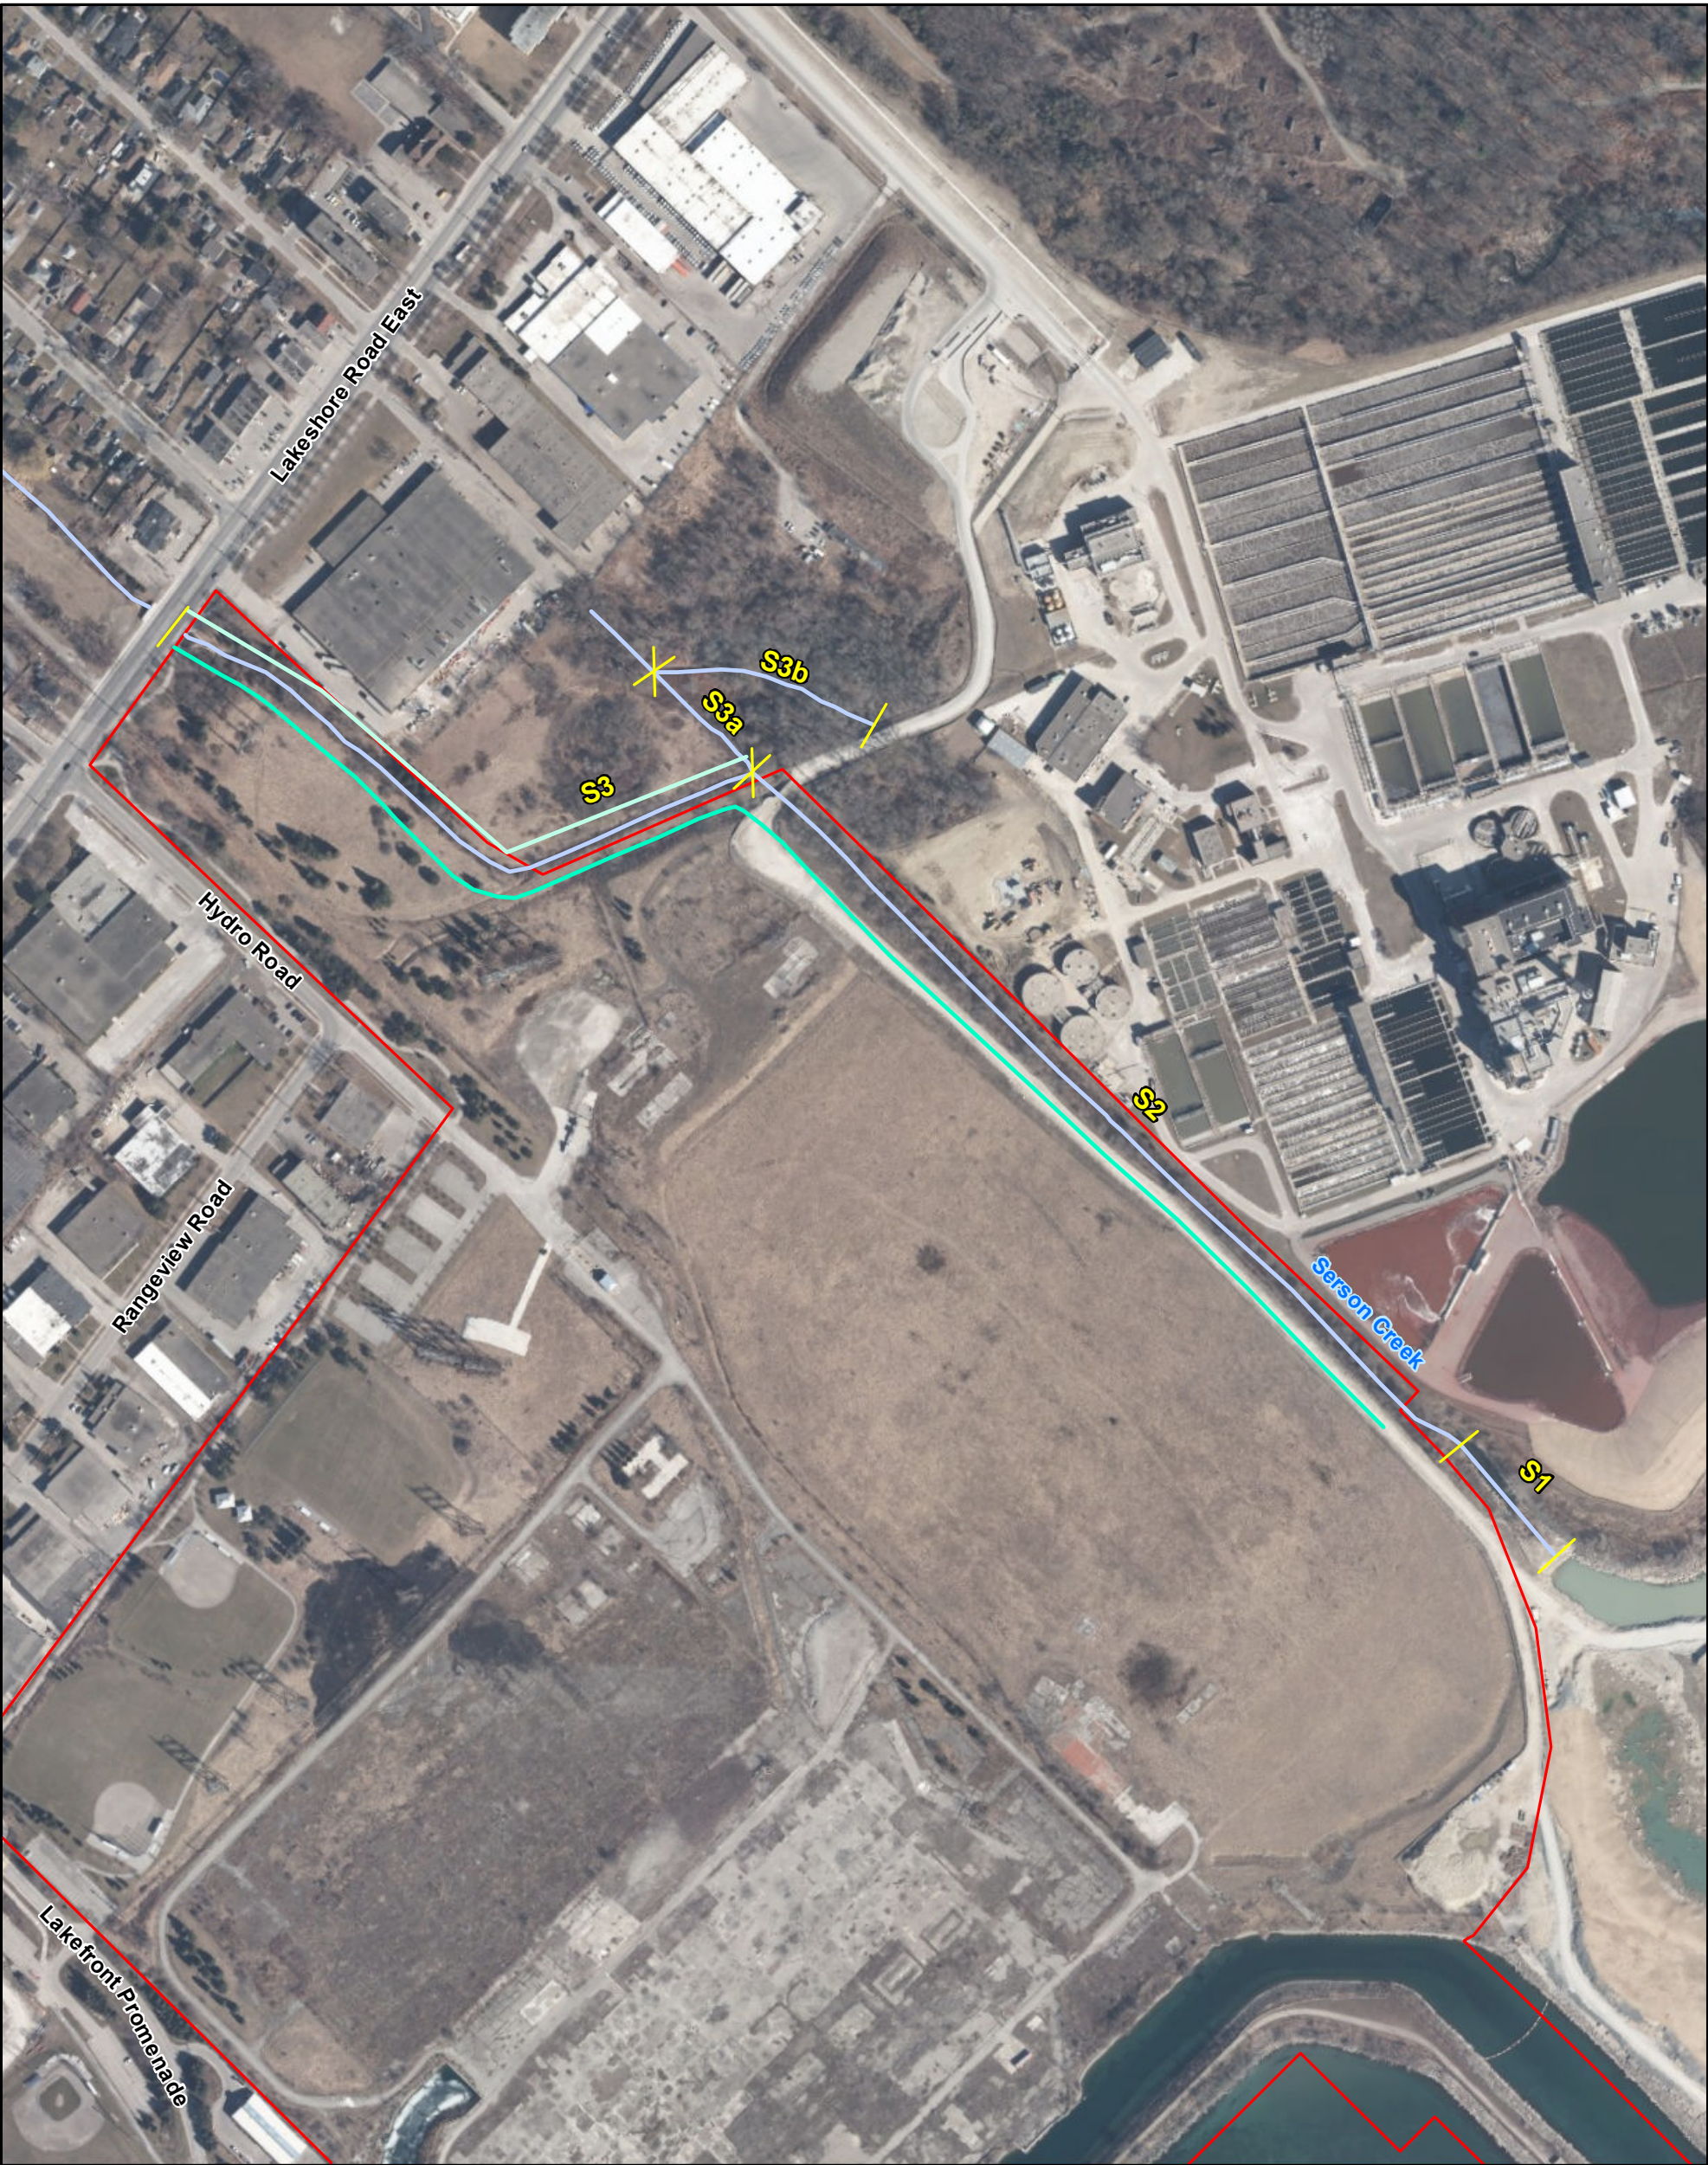
The results of the empirical analysis are summarized in **Table 5**. An illustration of the recommended meander belt limit for Reach S3 as shown on **Figure 3**. Note that the meander belt limit along the confined (right bank) of the valley slope was adjusted to illustrate the long-term stable top of slope as discussed in **Section 6.2**.

meander belt limit for Reach S3 of Serson Creek was adjusted to reflect the recommended long-term stable top of slope along the right bank of the valley slope. The recommended watercourse erosion hazard components (meander belt limit and long-term stable top of slope), are illustrated in **Figure 3**.

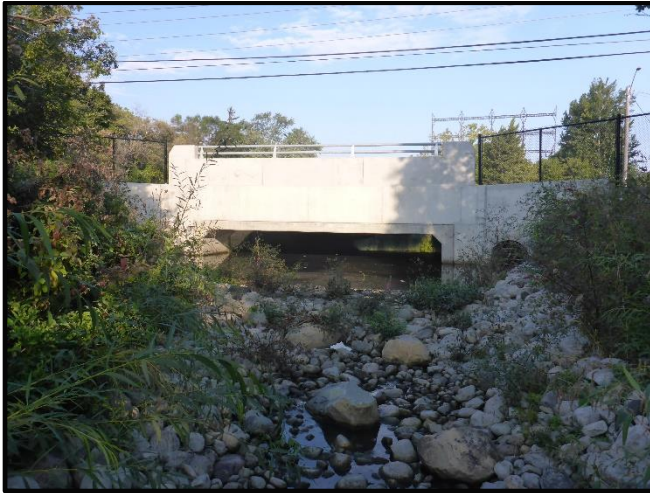
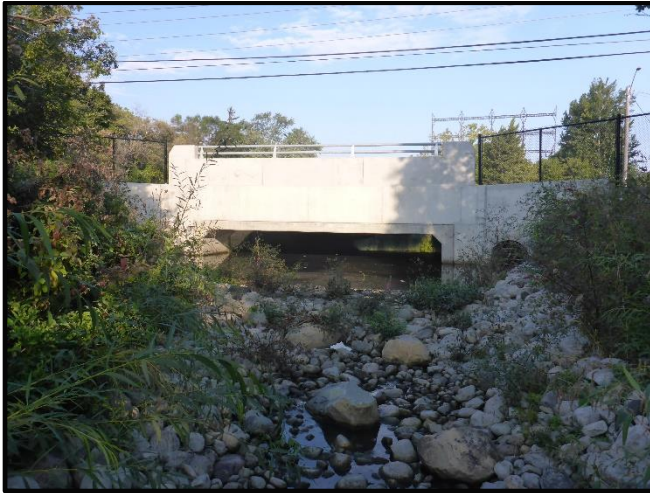
Photo 1. Location 1.
Reach S3. Upstream view of designed cobble lined channel and Lakeshore Road E culvert. September 21, 2018.

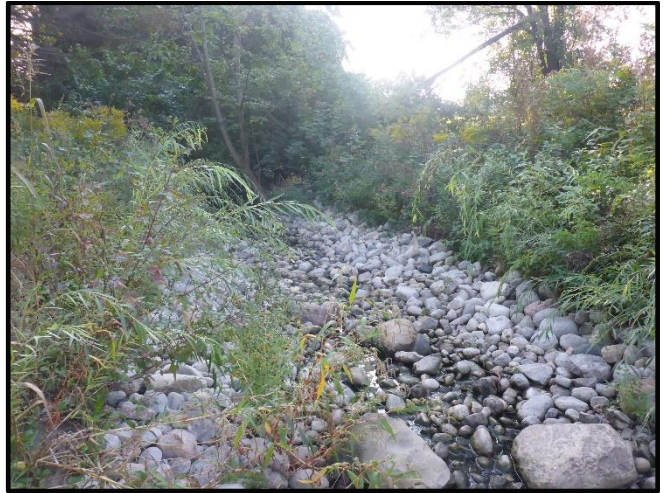
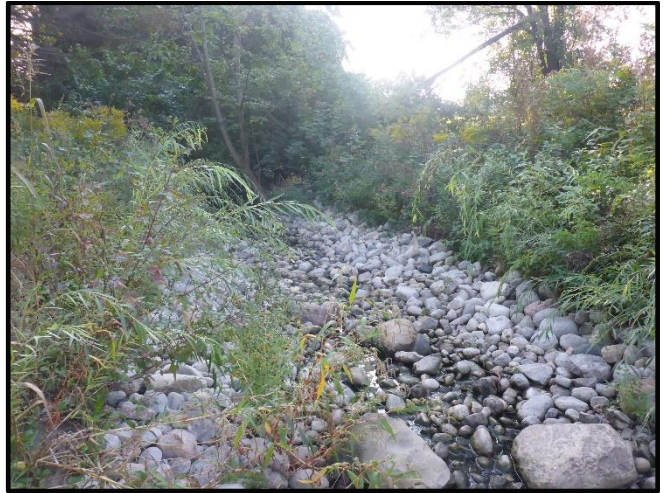
Photo 2. Location 1.
Reach S3. Downstream view of designed cobble lined channel. September 21, 2018.

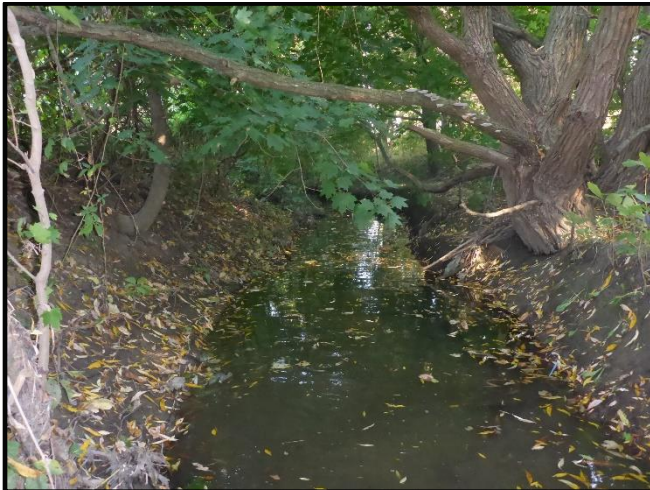
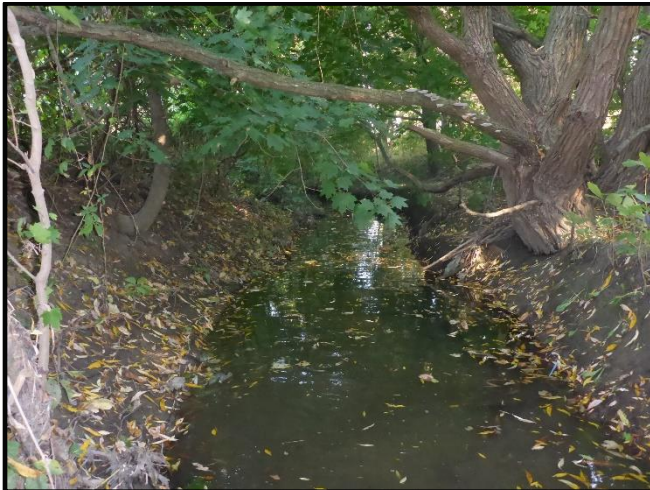
Photo 3. Location 2.
Upstream view of Reach S3 general conditions. September 21, 2018.

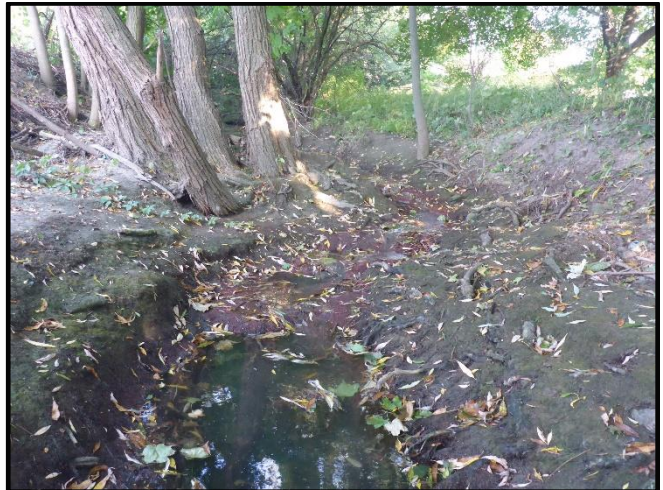
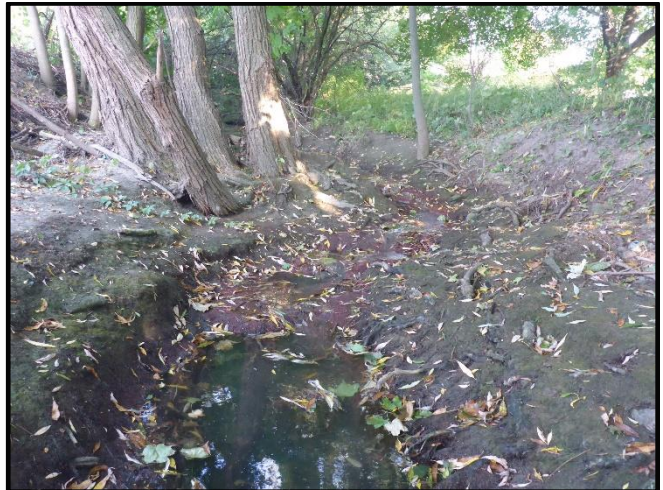
Photo 4. Location 3.
Reach S3. Upstream view of rooted knickpoint leading into pool. September 21, 2018.

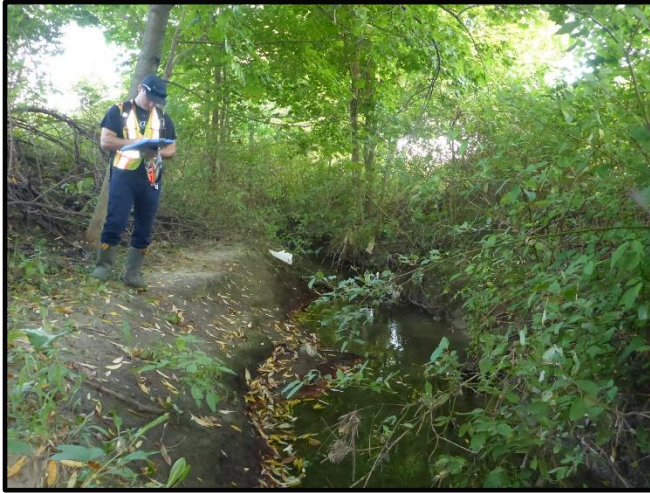
Photo 5. Location 4.
Reach S3. Upstream view of pool with terracing on right bank. September 21, 2018.

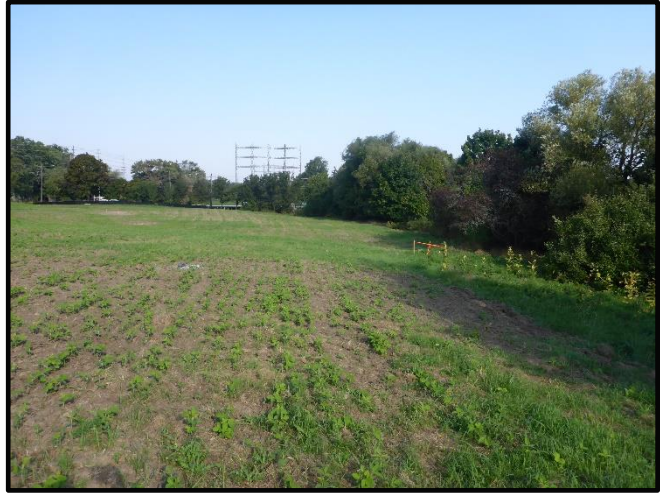
Photo 6. Location 5.
Reach S3. Floodplain along top of right bank, view towards Lakeshore Road E. September 21, 2018.

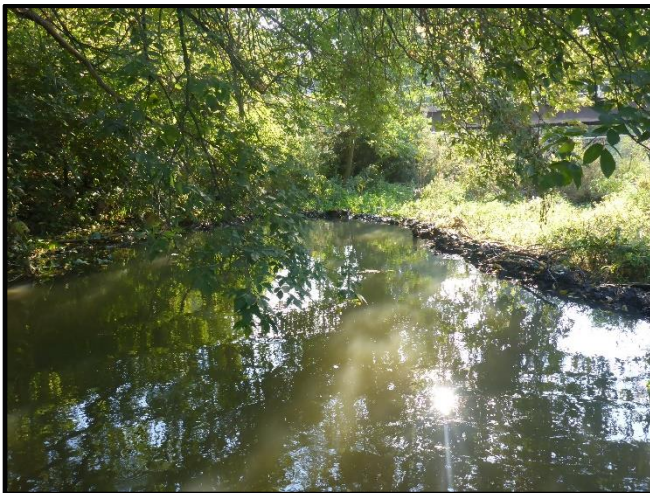
Photo 7. Location 6.
Reach S3. Downstream view of backwatering from beaver activity at channel confluence. September 21, 2018.

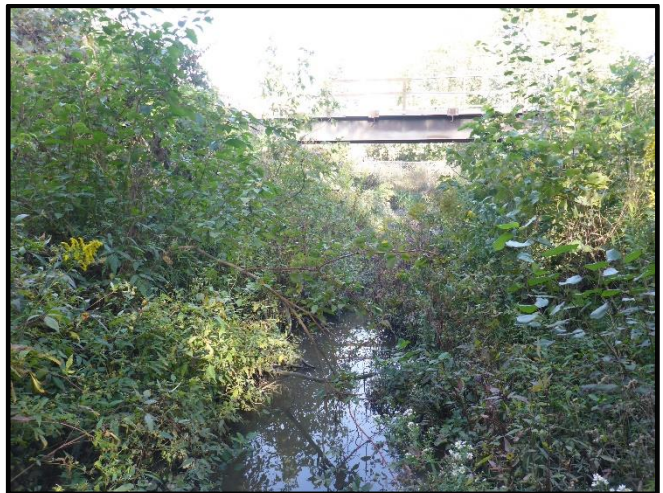
Photo 8. Location 7.
Reach S2. Upstream view towards property line at top end of reach. September 28, 2018.

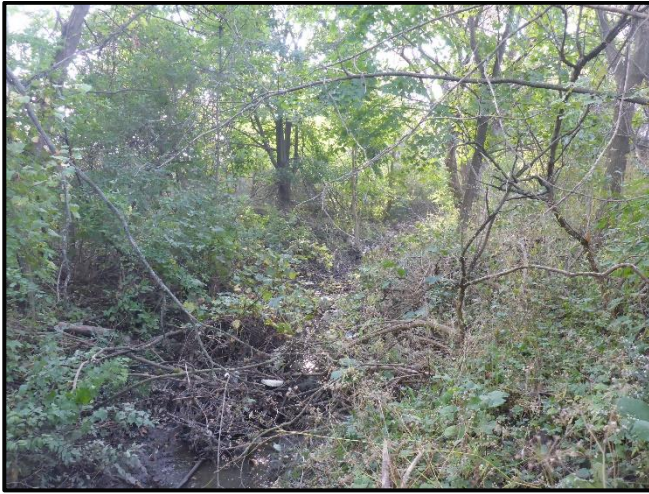
**Photo 9. Location 8.
Reach S2. Downstream view of woody debris jam.
September 28, 2018.**

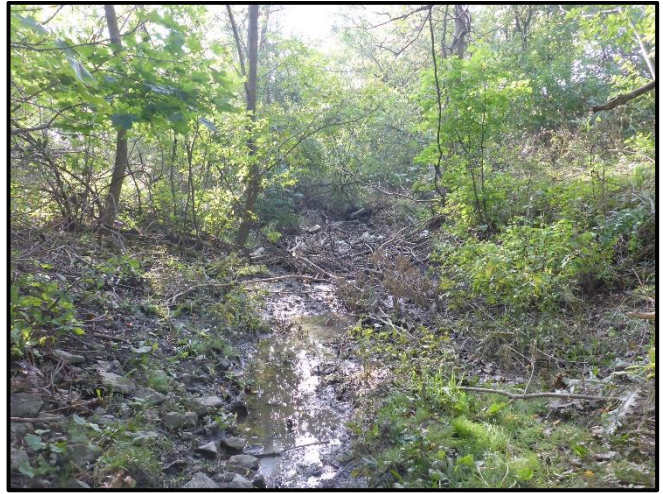
**Photo 10. Location 9.
Reach S2. Downstream view of typical valley
section: confined slope on right bank. September
28, 2018.**

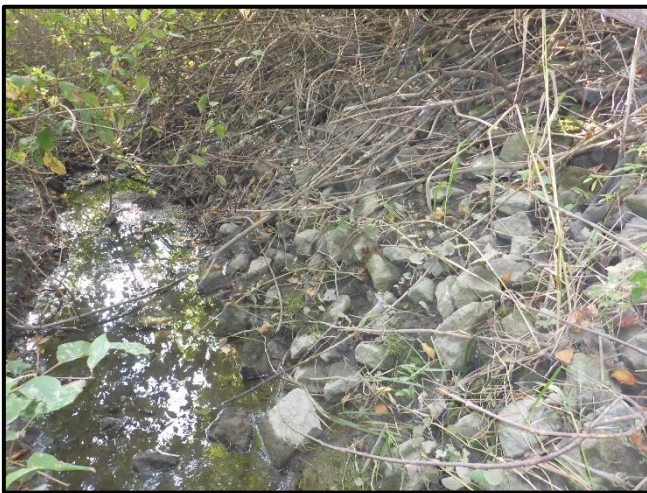
**Photo 11. Location 10.
Reach S2. Rip-rap protection along lower bank.
September 28, 2018.**

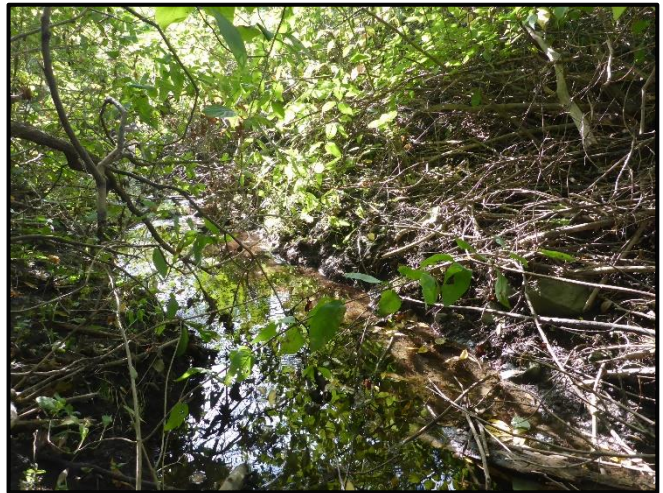
**Photo 12. Location 11.
General conditions downstream in Reach S2.
September 28, 2018.**

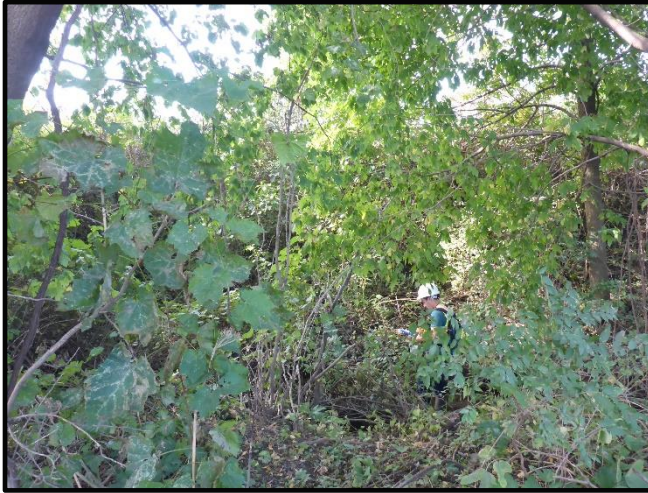
**Photo 13. Location 12.
Reach S2. General wooded valley and channel
location. September 28, 2018.**

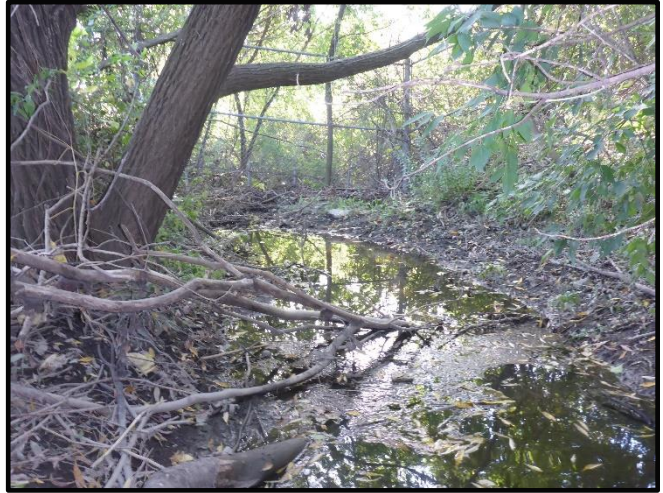
**Photo 14. Location 13.
Reach S2. Widening channel at property line due
to backwatering and variable lake levels.
September 28, 2018.**
