Report on

Supplementary
Geotechnical Slope Stability Assessment
East Side Slope of Serson Creek
Lakeview Village, 800 Hydro Road
Mississauga, Ontario

Lakeview Community Partners Limited

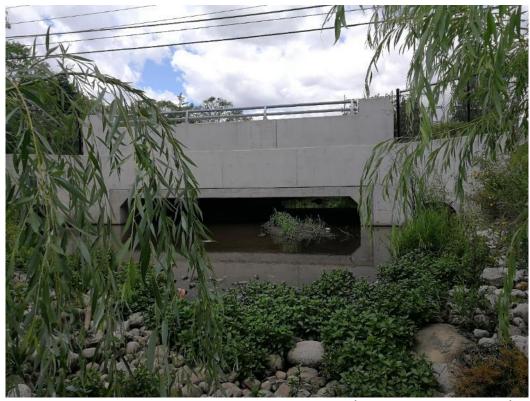
Photo 1: Creek and concrete culvert at Lakeshore Blvd (looking north - upstream)

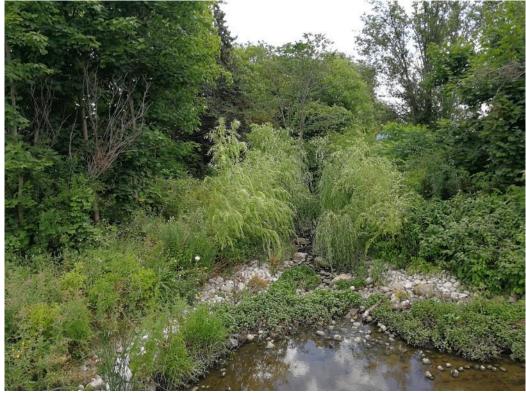
Photo 2: Creek conditions at south of Lakeshore Blvd (looking south - downstream)

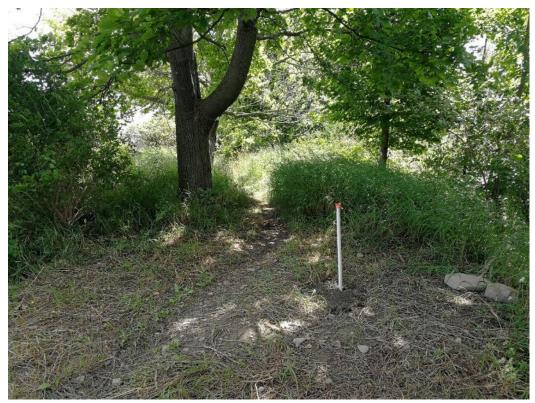
Photo 3: Top of slope area at BH20-1 (looking south)

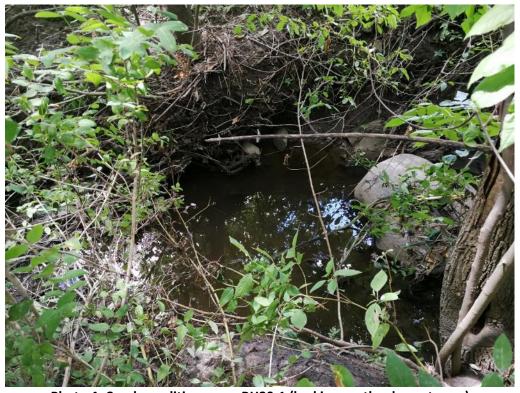
Photo 4: Creek conditions near BH20-1 (looking south - downstream)

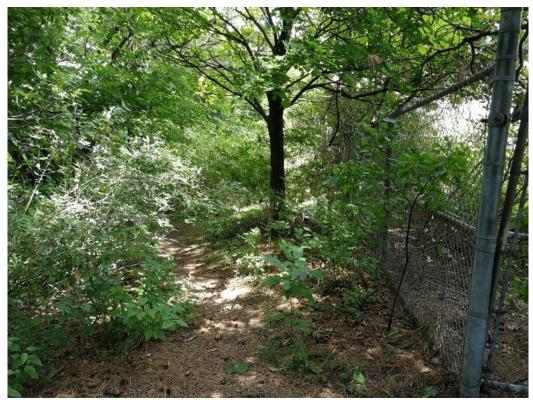
Photo 5: Top of slope conditions to north of Section L-L (looking north toward Lakeshore Blvd)

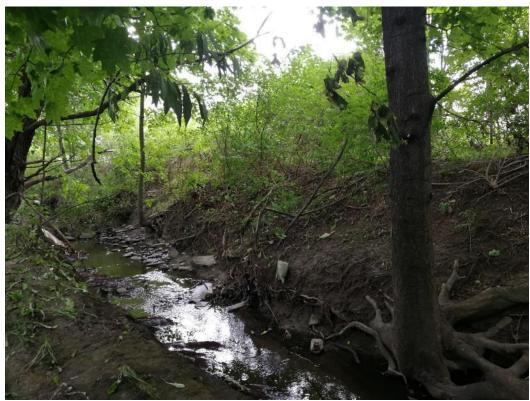
Photo 6: Creek conditions to north of Section L-L (looking northeast)

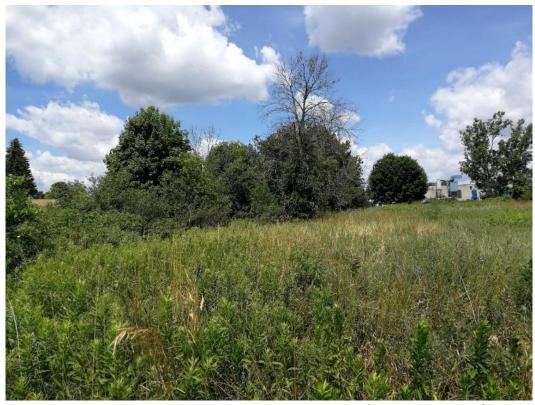
Photo 7: Top of slope area to north of Section M-M (looking northwest)

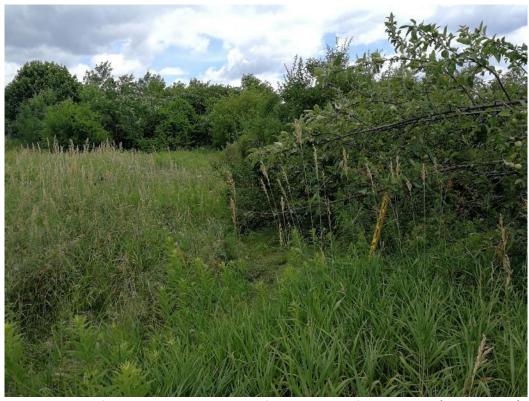
Photo 8: Top of slope conditions in area of and to west of Section N-N (looking east)

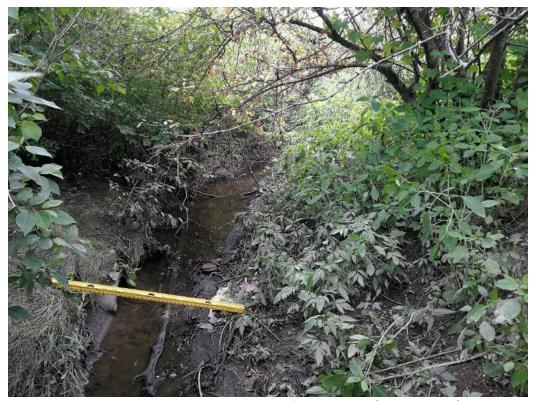
Photo 9: Creek conditions at west of Section N-N (looking west)

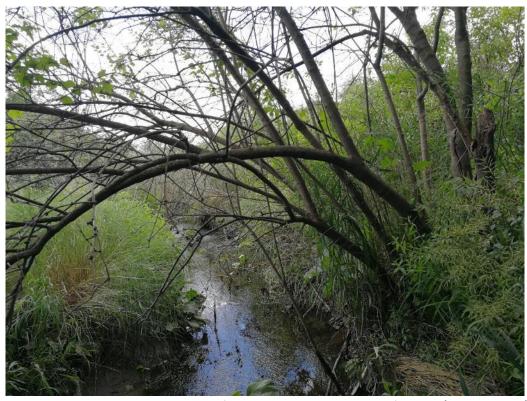
Photo 10: Creek conditions to east of Section N-N and to north of bridge (looking west)

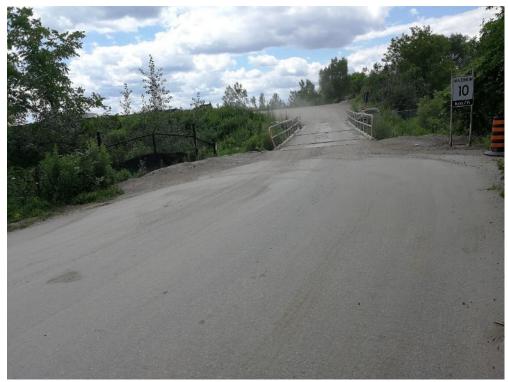
Photo 11: Road Bridge to north of Section A-A (looking west)

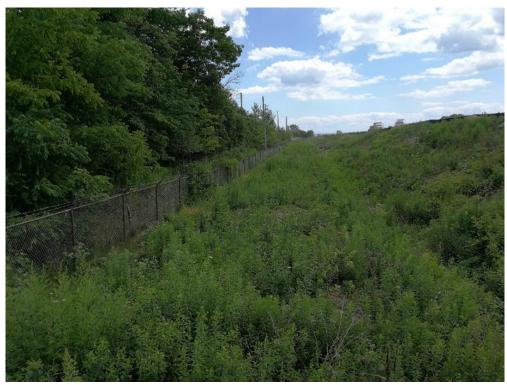
Photo 12: Creek and east slope conditions in Reach S2 (looking south from road bridge)

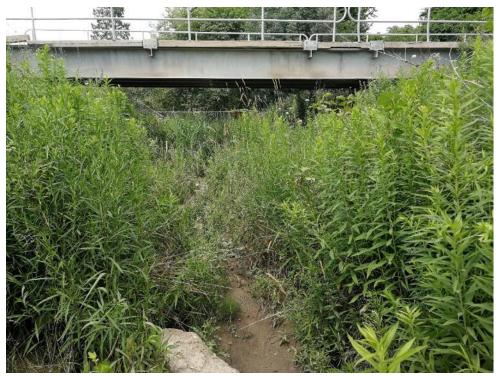
Photo 13: Creek conditions to south of road bridge (looking north - upstream)

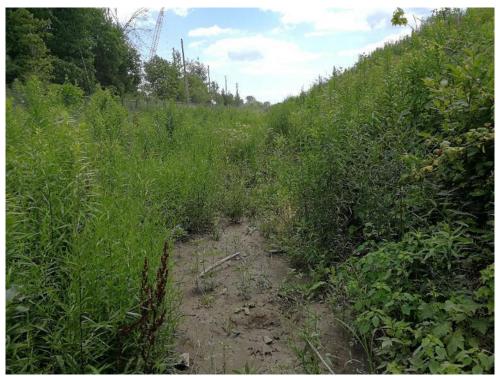
Photo 14: Creek and slope conditions to south of road bridge (looking south – downstream)

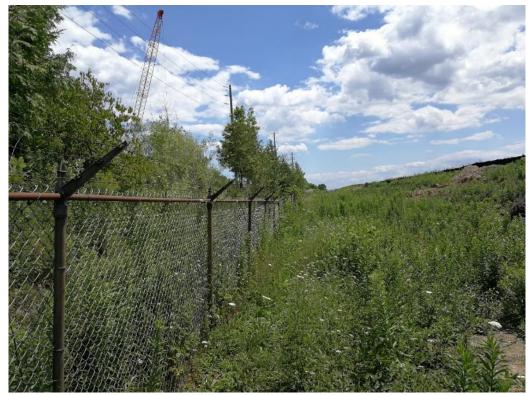
Photo 15: East slope near fence at north part of Reach S2 area (looing south - downstream)

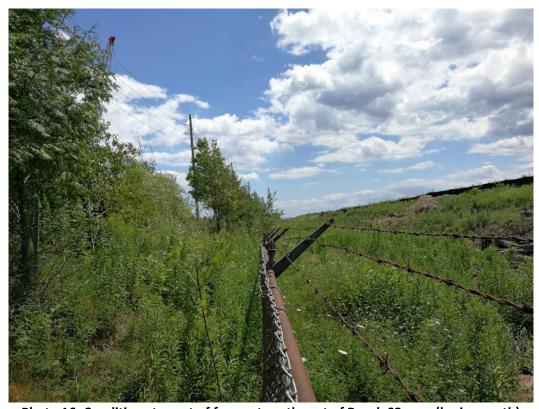
Photo 16: Conditions to east of fence at north part of Reach S2 area (looing south)

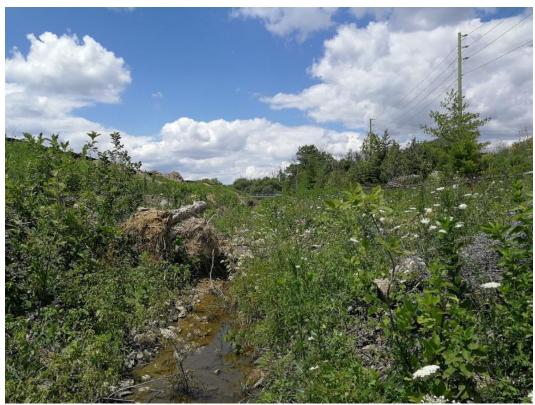
Photo 17: Creek conditions at middle-north part of Reach S2 (looking north - upstream)

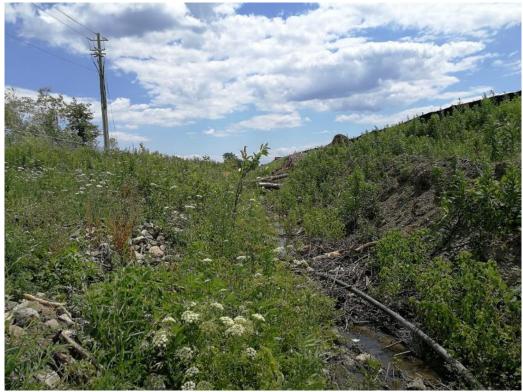
Photo 18: Creek conditions at middle-north part of Reach S2 (looking south - downstream)

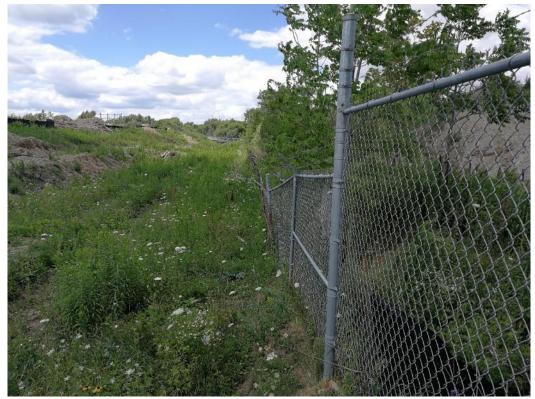
Photo 19: East slope near fence at middle-north part of Reach S2 (looking north - upstream)

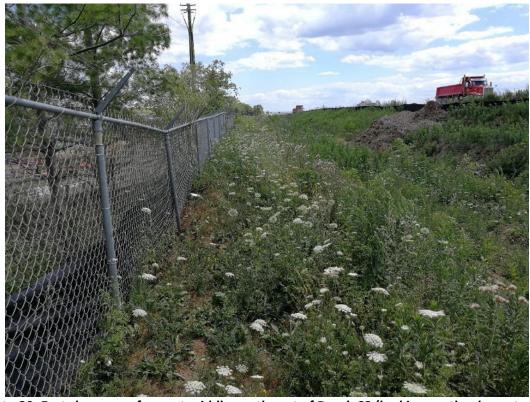
Photo 20: East slope near fence at middle-north part of Reach S2 (looking south - downstream)

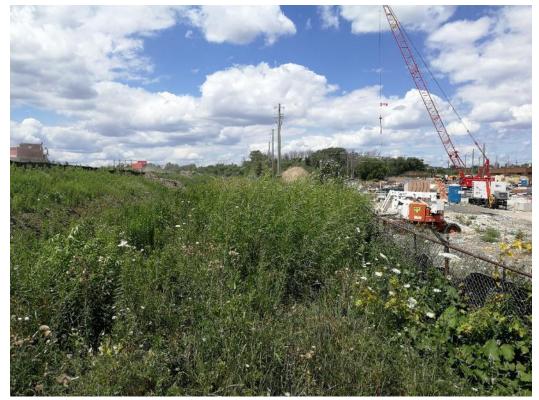
Photo 21: East slope near fence at middle-south part of Reach S2 (looking north - upstream)

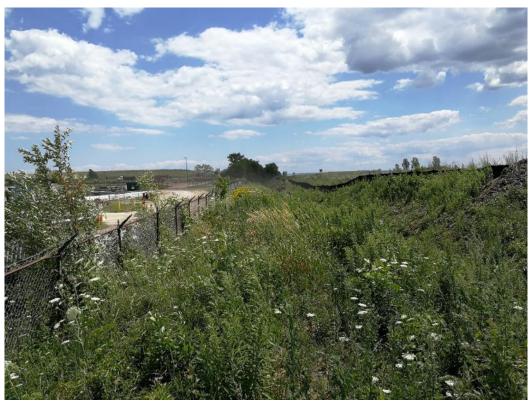
Photo 22: East slope near fence at middle-south part of Reach S2 (looking south - downstream)

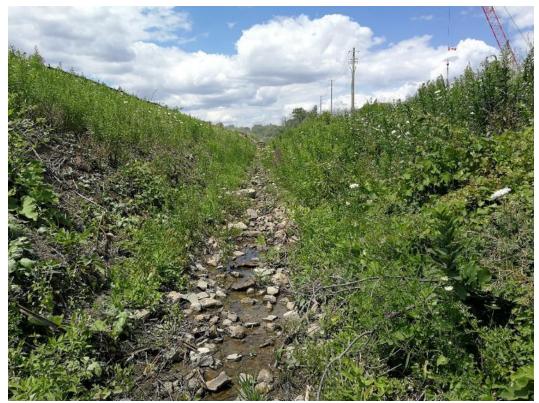
Photo 23: Creek conditions at middle-south part of Reach S2 (looking north - upstream)

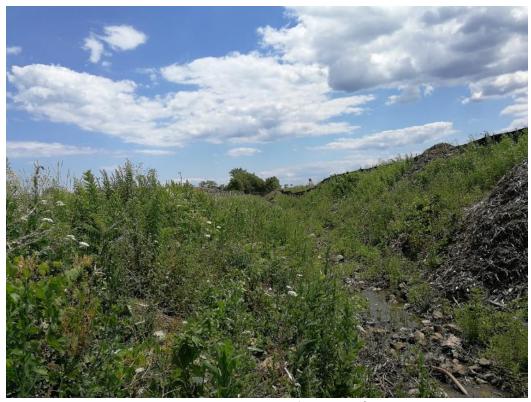
Photo 24: Creek conditions at middle-south part of Reach S2 (looking south - downstream)

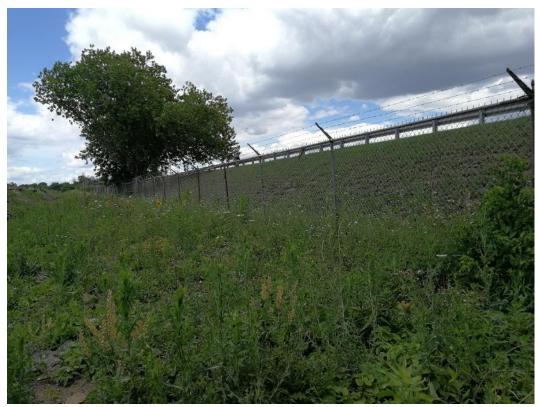
Photo 25: East slope near fence at south part of Reach S2 (looking northeast)

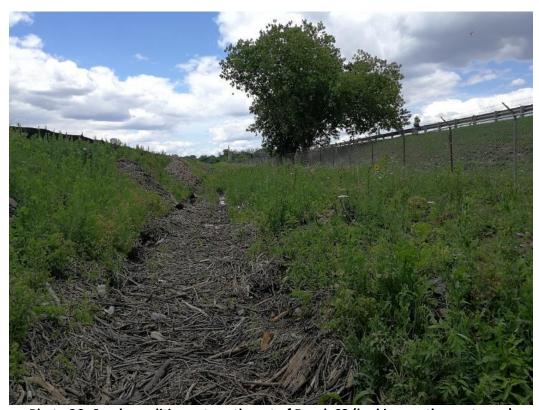
Photo 26: Creek conditions at south part of Reach S2 (looking north - upstream)

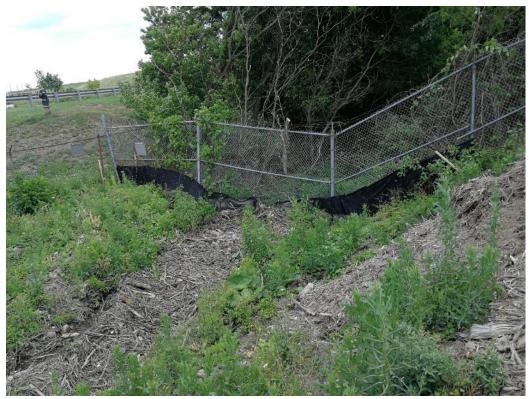
Photo 27: South end of Reach S2 (looking southeast from west side of creek)

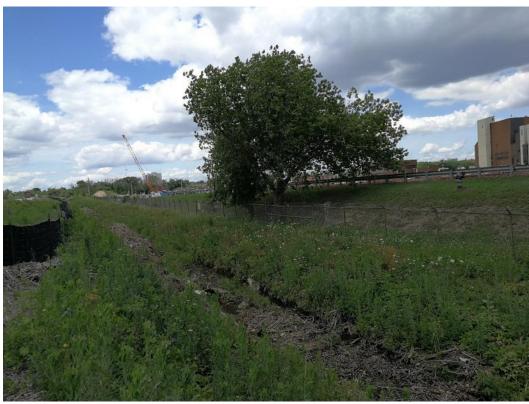
Photo 28: South part of Reach S2 (looking northeast from west side of creek)
