Arborist Report for

King Street East

Mississauga, Ontario

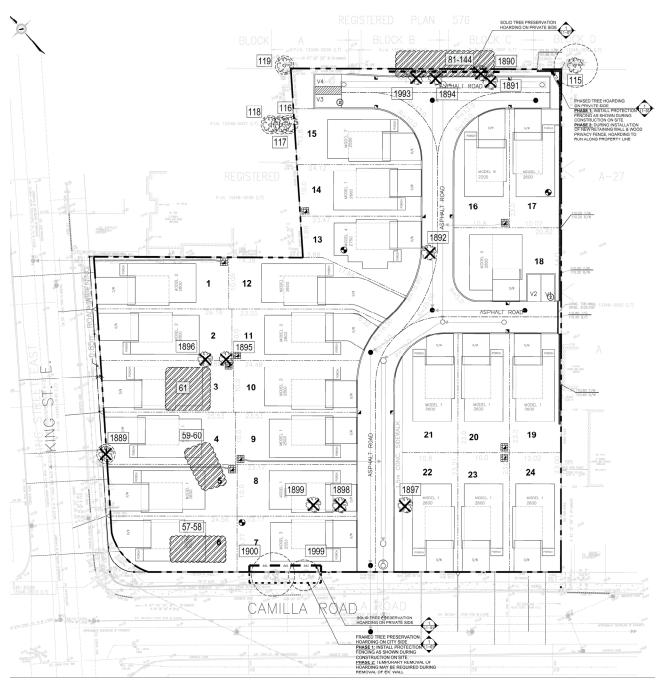
Figure #1: Tree locations on the King Street East development site

There are plans to develop the site at King Street East several non-exempt trees would need to be injured or removed, in order to allow for the proposed development (Table 1, Fig. 1).

One (1) border/city owned tree over 15cm DBH is proposed for removal. (Table 1, Fig. 1 Trees #1889). This tree is in conflict with the proposed driveway.

Two (2) city owned trees (#1900 & #1999) are to be retained and will require tree protection during the demolition and construction work on the site. They are in close proximity to the grading works on site and are potential Injury Candidates. Refer to tree & hoarding locations on the plan developed by MSLA Landscape Architects. (Fig. 1).

Ten (10) privately owned trees over 15cm DBH are proposed to be removal. (Table 1, Fig. 1). These trees are in conflict with the proposed development.

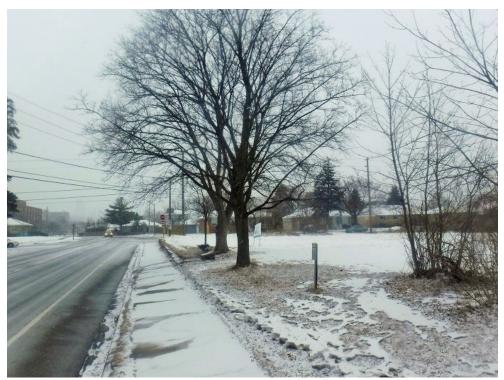
Image #1: Existing City Maple Trees along Camilla Road

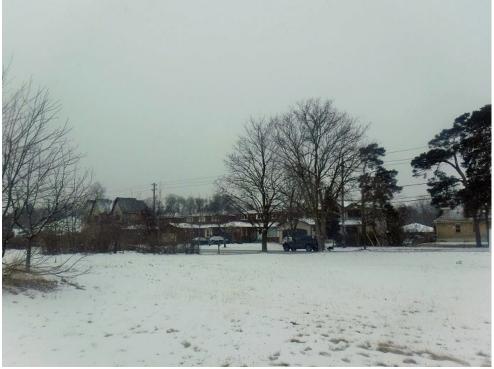
Image #2: Existing City Maple Trees

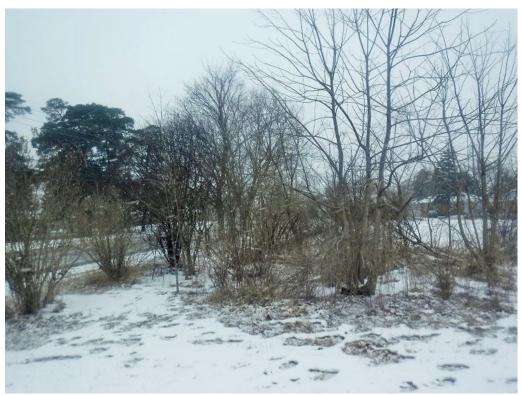
Image #3: Existing Walnut Trees

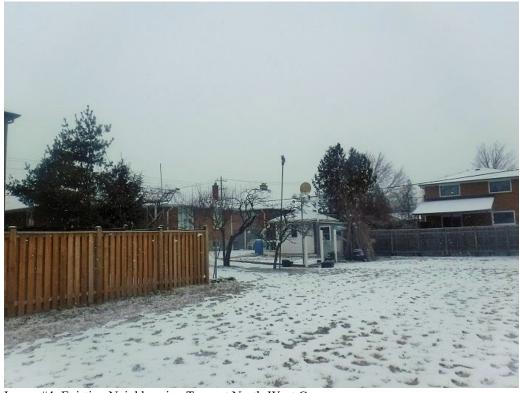
Image #4: Existing Neighbouring Trees at North-West Corner

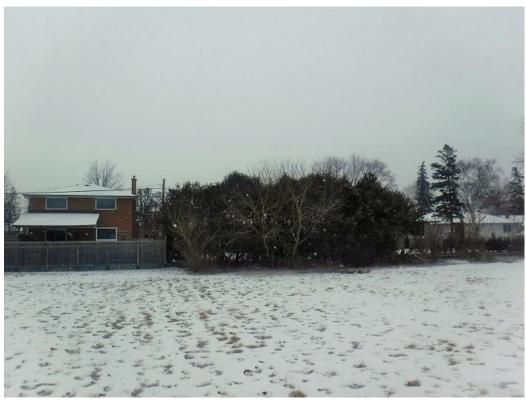
Image #5: Existing Neighbouring Trees along North Property Line

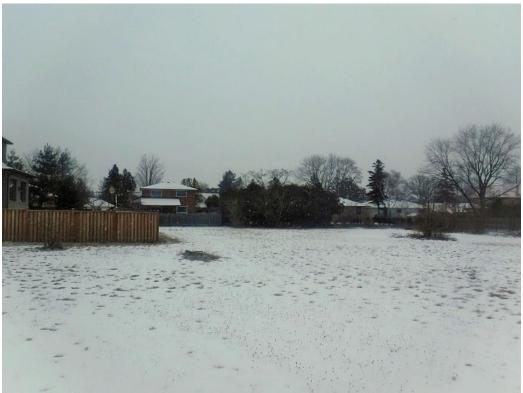
Image #6: Existing Trees – North View
