Our ref: 11227231

20 May 2021

Slope Stability Evaluation 904 Mississauga Heights Drive, Mississauga, Ontario

MR. POLLA 904 MISSISSAUGA HEIGHTS DRIVE, MISSISSAUGA, ON SLOPE STABILITY ANALYSES

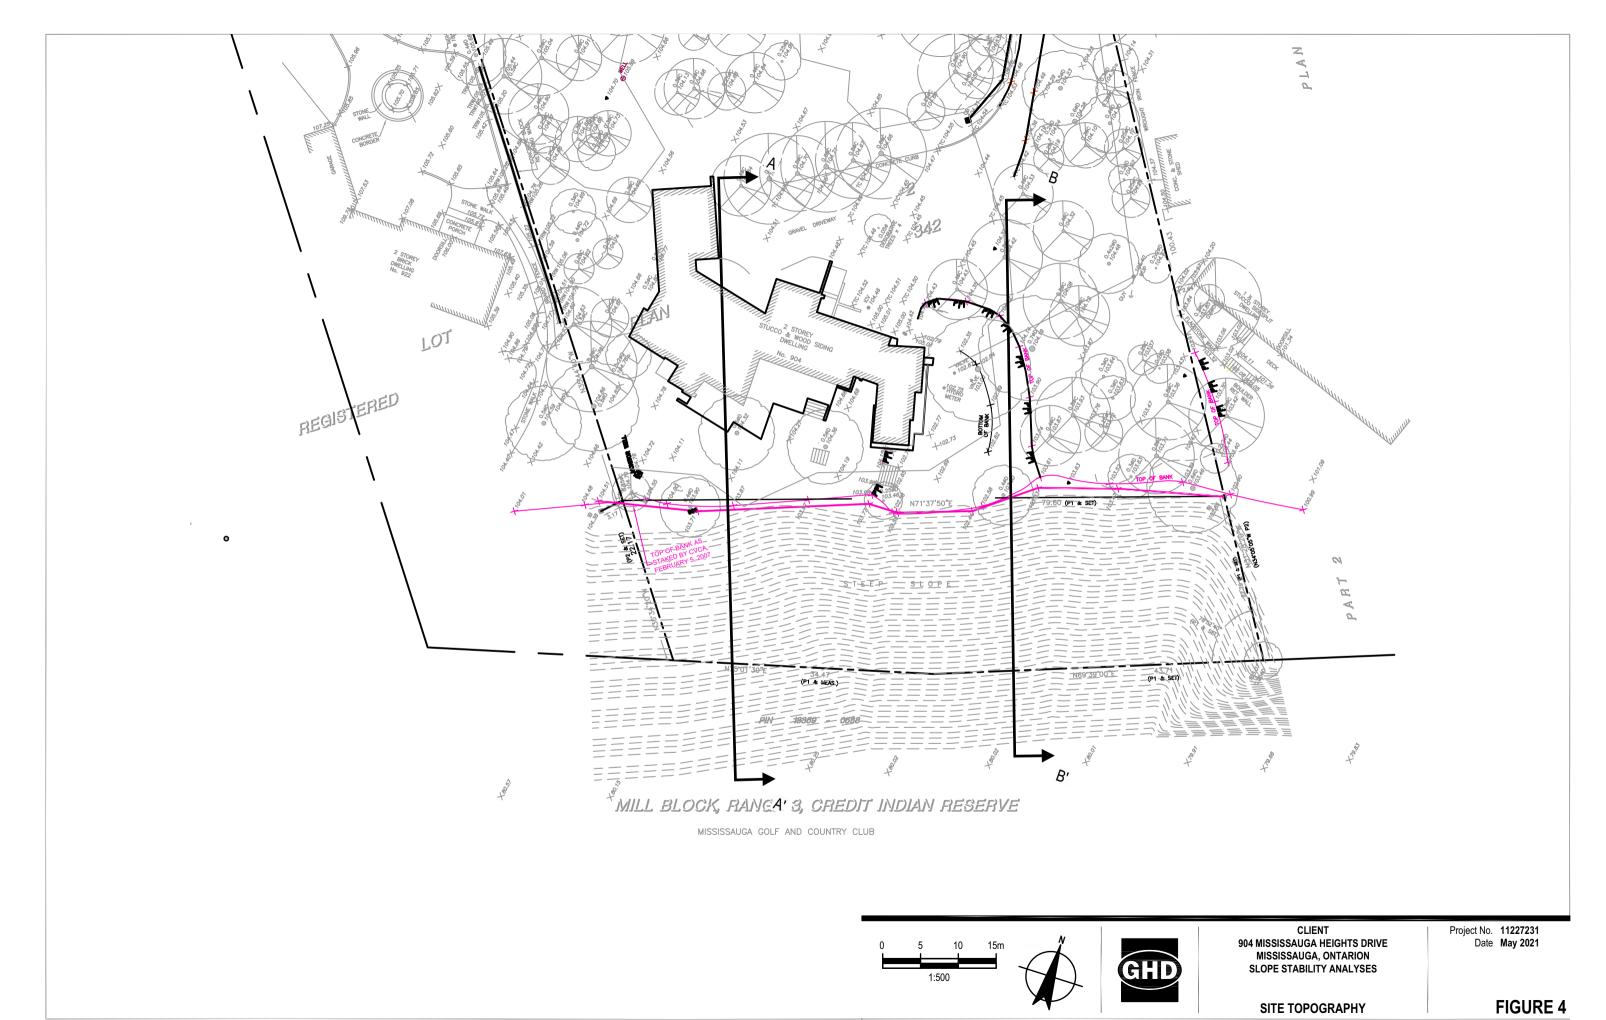
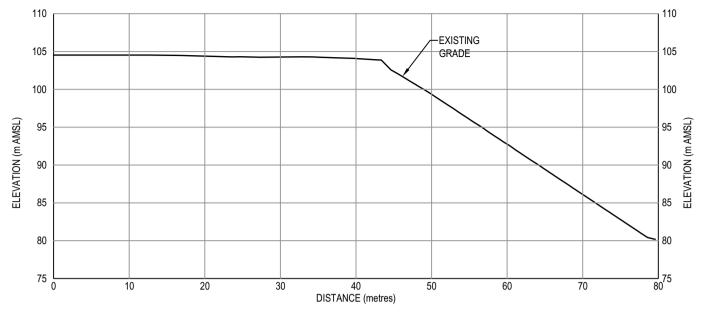
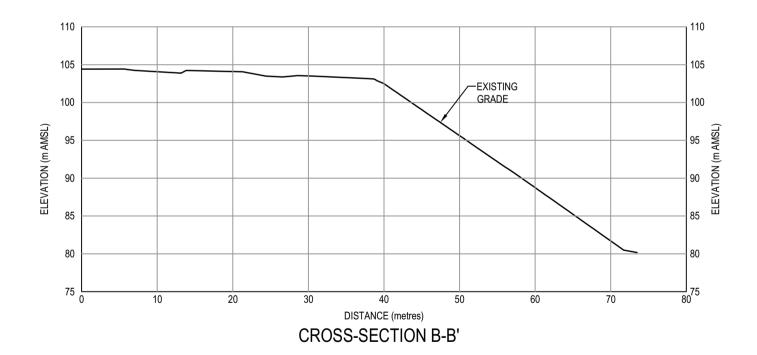
CROSS-SECTIONS A-A' AND B-B'

Cross-Section	Factor of Safety	Figure	Remarks
Cross-Section A-A	2.29	Figure 6	
Cross-Section B-B	2.77	Figure 7

A review of Figure 6 and Figure 7 and Table 4 shows that the factors of safety for both cross-sections A-A and B-B exceeded the targeted factor of safety of 1.5.

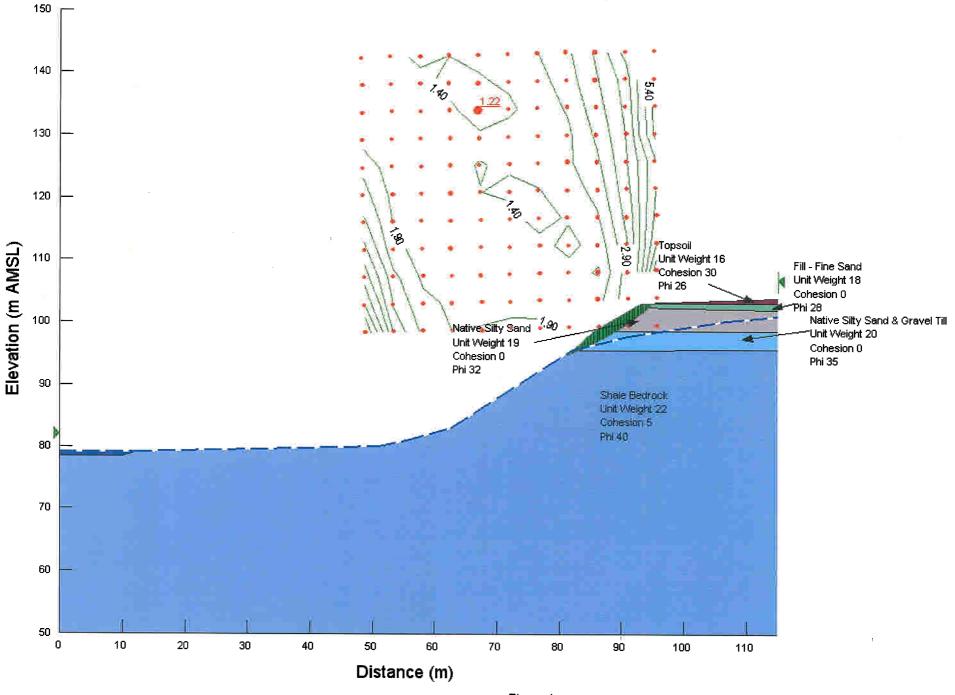
Figure 4 T040022-A1 Slope Stability Analyses Section A-A - Shallow Failure Proposed Residential Dwelling and Guesthouse 904 Mississauga Heights Road, Ontario

Section	Overall S	Slope Inclination	FOS against Shallow Slope Failure	FOS against Intermediate/Deep Seated Slope Failure
A-A	Upper:	2:1	1.22	1.54
	Central	1.3:1		
	Lower:	3:1

It is noted that the slope face comprises of tall mature trees and shrubs. No significant evidence of erosion, sloughing, or instability were observed on the slope face and there were no tension cracks observed parallel to the slope crest. Also, no wet areas or evidence of water seepage was observed emanating from the slope. The slope face was observed to be dry. Based on our observations, experience and analysis, the existing slope represented by Section A-A is considered safe against shallow slope failure.

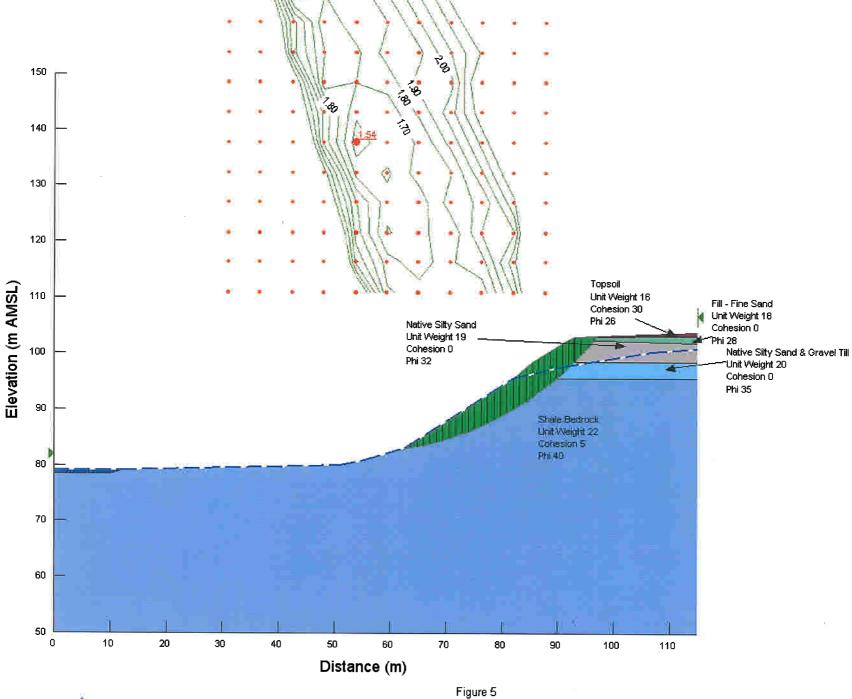
Figure 5 T040022-A1 Slope Stability Analyses Section A-A - Deep Failure Proposed Residential Dwelling and Guesthouse 904 Mississauga Heights Road, Ontario

Based on the results of our engineering analyses, the existing slope represented by Section A-A is considered to be safe against intermediate and deep seated failure (FOS > 1.5).

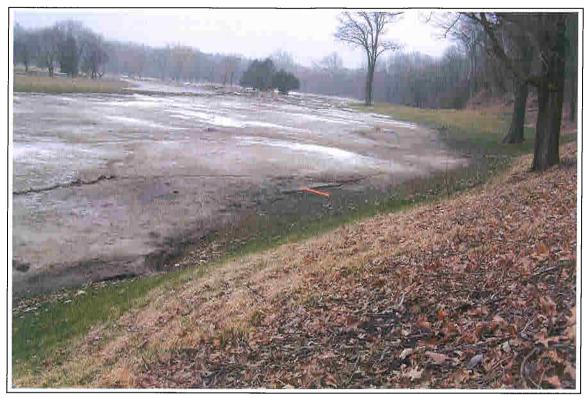
Photo No 5 – The bottom of the slope with the creek setback from the slope toe by a significant distance

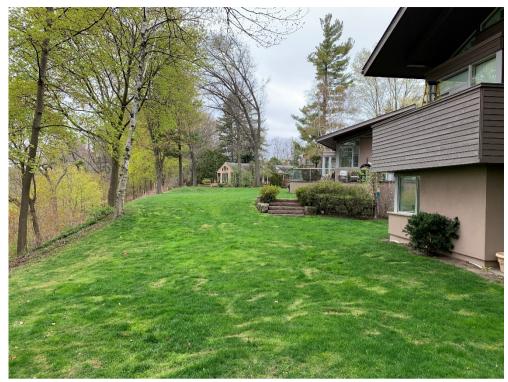
The existing residential structure is set approximately 15 m from the existing physical top of the approximately 23 m high slope with the southeast corner of the structure only about 10 m from the top of the bluff (Photo 1). The bluff top has a concave edge (Photo 1 and Photo 2) indicative of a relatively hard underlying stratum. The slope face at the time of inspection was covered with fallen leaves (Photo 3 to Photo 8) and was generally free of grass and shrubs.

Photo 1 - Residential Structure setback from the existing top of the slope

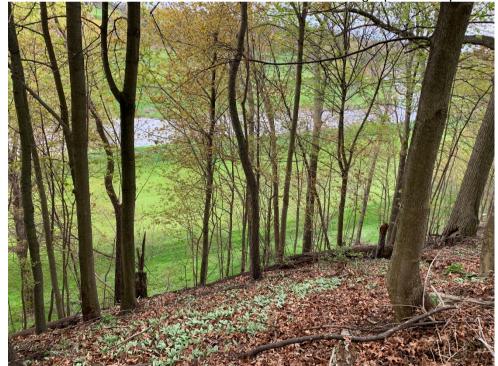
Photo 2 - Looking downslope towards the fairway; the Credit River in the middle of picture

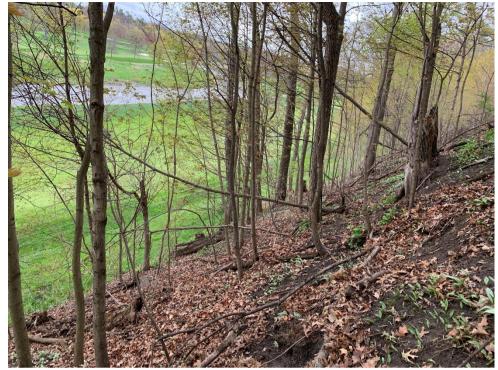
Photo 3 - View of the upper slope face. Fairway at the toe and the river, and golf greens beyond.

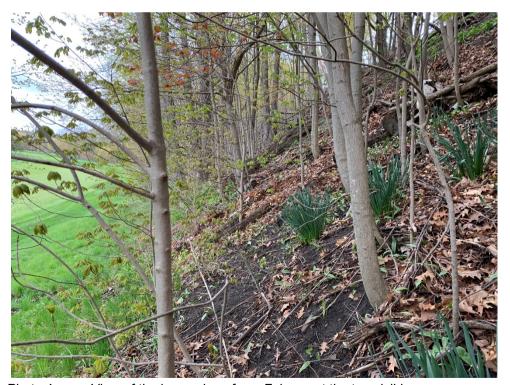
Photo 4 - View of the lower slope face. Fairway at the toe visible.

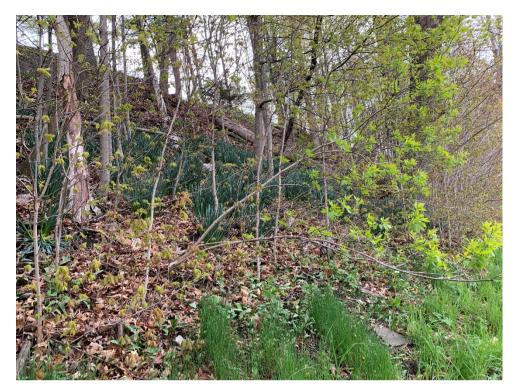
Photo 5 View of the slope looking up.

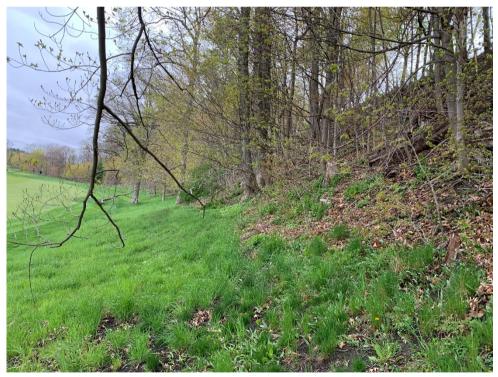
View of the slope along its toe.t Photo 6

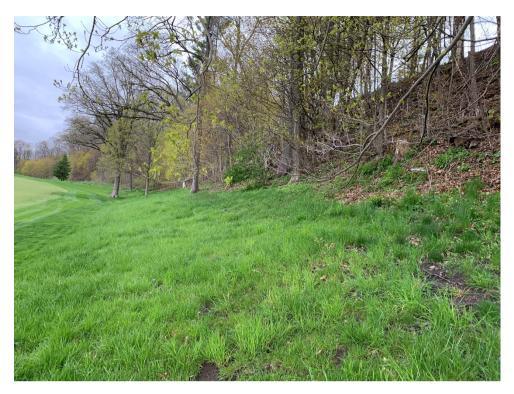
Photo 7 View of the slope and its toe area

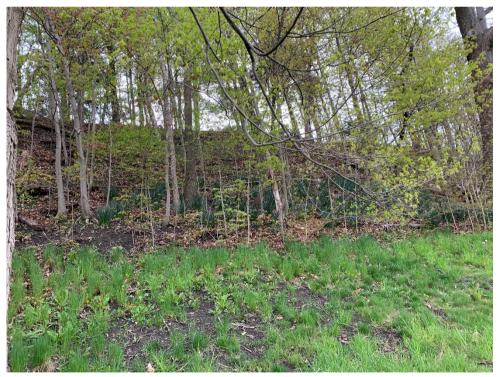
Photo 8 General view of the slope face
