S2S PROJECT NO. 9275

PHASE I ENVIRONMENTAL SITE ASSESSMENT

**5054 NINTH LINE
MISSISSAUGA, ONTARIO**

MARCH 6, 2020

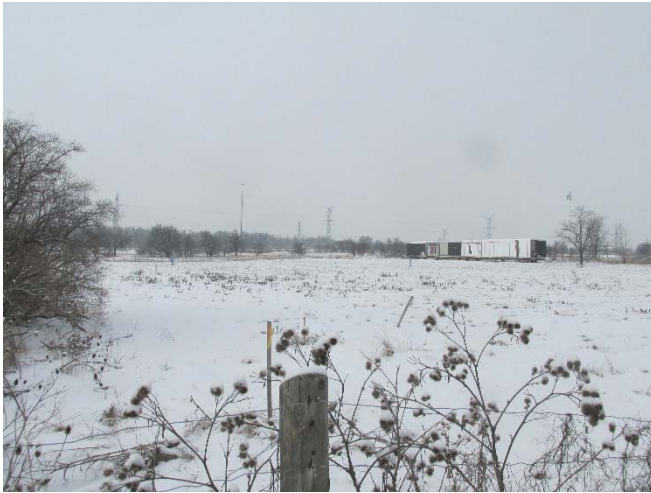
Pits, Monitoring and Potable Water Wells on the Immediate Adjacent/Neighbouring Properties	At least three groundwater monitoring wells were observed on the property adjacent to the north of the Subject Property; however, the exterior areas were partially covered with snow	Visual Observations

Photo 5: View of a portion of the residential/agricultural property, adjacent to the north of the Subject Property.

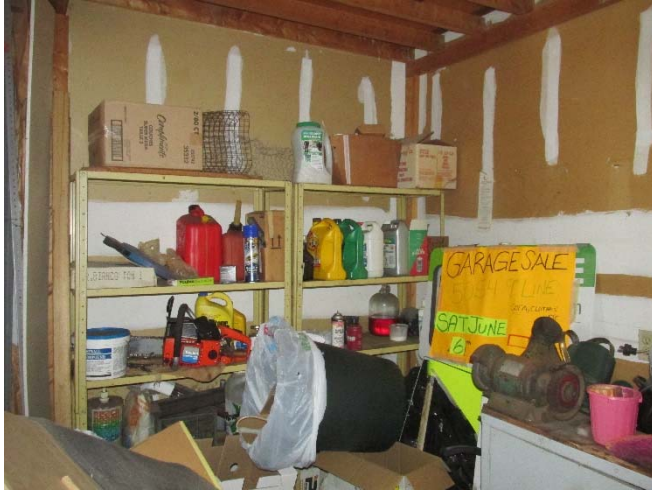
Chemicals located at the Subject Property (as observed in the accessed areas) primarily consisted of janitorial and maintenance supplies, and were stored in containers that were 20 L in size or smaller (or bags that were 25 kg in size or smaller) and located on wooden shelves the accessed areas of the single-family residential dwelling and attached parking garage. There was no obvious visual evidence of significant spills or leaks or stains identified in the vicinity of the chemical storage areas.

Photo 9: View of chemical storage in the attached parking garage of the Subject Building.

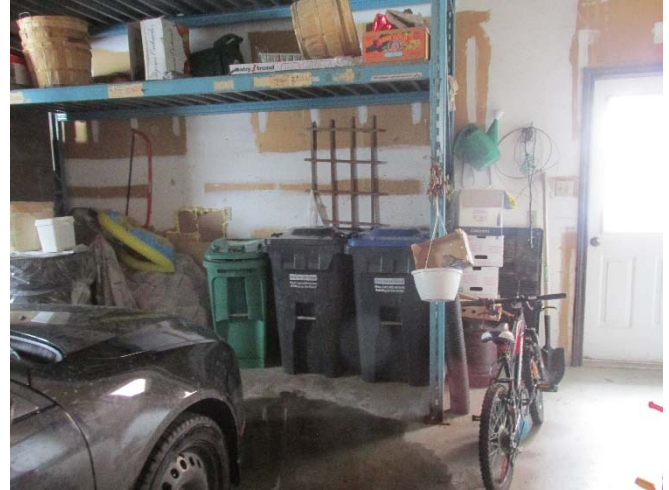
There was no evidence of the generation of hazardous wastes at the Subject Property at the time of the site visit. Waste materials generated at the Subject Property reportedly consisted of typical residential wastes (solid, non-hazardous wastes) including cardboard, plastic and other recyclable materials. The residential wastes were stored in plastic waste bins and were located in the attached parking garage. The waste materials were reportedly removed from the Subject Property by licensed waste haulers on a weekly basis.

Photo 10: View of the waste storage bins in the attached parking garage of the Subject Building.

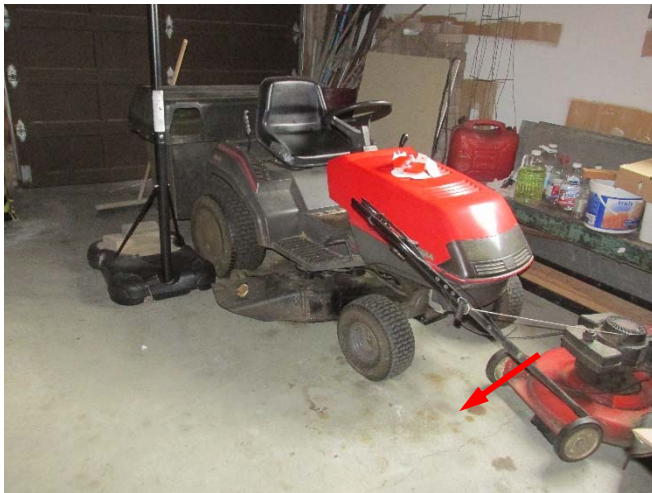
At the time of the site visit, no obvious visual evidence of significant staining or spills was observed in the accessed areas of the Subject Building and on the exterior areas of the Subject Property with the exception of minor localized staining from parked vehicles observed on the concrete floor slab in the attached parking garage. However, it should be noted that the exterior areas were partially covered with snow at the time of the site visit and therefore, some areas and property features could not be completely assessed.

Based on the information obtained during the site visit, the likelihood of current significant adverse environmental contaminant impact to the Subject Property from stained areas appears low.

Photo 11: View of minor staining from parked vehicles (see arrow) on the concrete floor slab in the attached parking garage of the Subject Building.

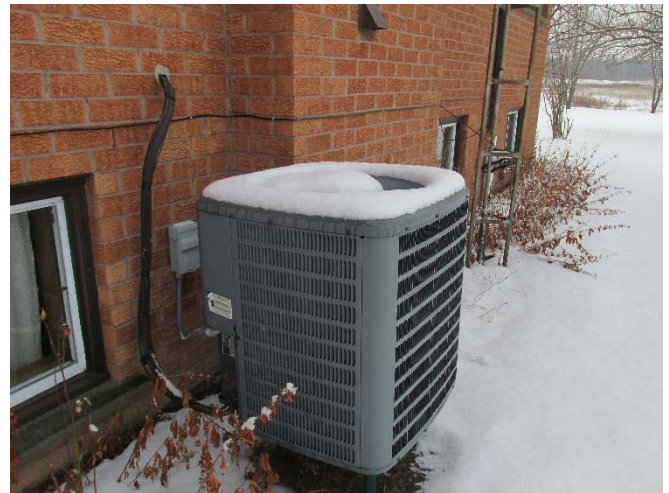
refrigerators were completed by appropriately licensed technicians. Furthermore, visual observations in the accessed areas during the site visit did not indicate leaks or damage associated with the visually observed on-site sources of ODSs.

There were no environmental concerns noted with respect to ODSs at the Subject Property.

Photo 12: View of the ground-mounted exterior AC unit on the north side of the Subject Building.
