ARBORIST REPORT

Ann St. & High St. Mississauga, Ontario

Owner
10 West GO GP Inc.

August 18, 2020

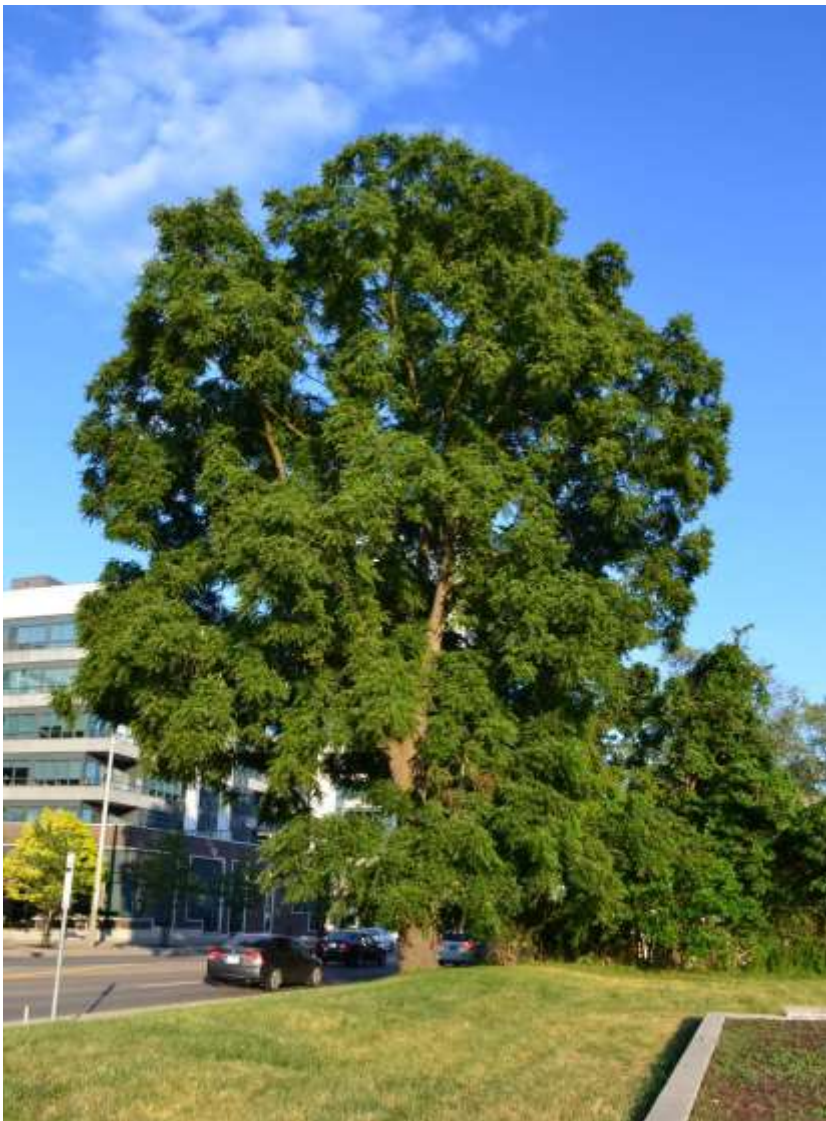
Figure 2: Tree number 2 mid-block along Hurontario St.

Tree No.	Species	dbh (cm)	Canopy diameter (m)	Biological Health	Structural Condition	Recommended Action	Comments	Subject Site (developer-owned)	Subject Site (city-owned)	City-owned boulevard
2	Juglans nigra	102	15	MH	MH	P	Grown over former fence still embedded in trunk, large hole/wound at 1m (15cm dia), some broken branches in interior of canopy but vigorous growth for size. Oe large crack and injury in upper canopy on central leader.			X
3	Acer platanoides	~55	10	M	M	P	Wounds from fence. Main union is in poor condition with 2 long healed cracks up to 8m height. There are 2 lower dead branches and one large broken branch. 10% of canopy covered in vine.			X
4	Morus alba	15, 15.5	7	MH	ML	RC	Multistem tree with included bark at unions. Leans towards park site. Some crossing branches.			X
5	Aesculus hippocastanum	35	5	ML	ML	RC	Growing through fence and vine covers 70% of canopy.		X	
6	Acer platanoides	22, 11	6	ML	ML	RC	Vine covers 70% of canopy and one med.-sized dead branch.		X

Preserve trees #1, 2, 3, 69, 70, 77 – 81 as identified on the Tree Inventory & Preservation Plan. Preserved trees should be enclosed within tree protection hoarding.

Trees 1, 2 and 3 are large trees within the city owned boulevard. These trees will be proximate to the excavation of parking on the site. It is likely possible to preserve these trees by making use of shoring at the limit of excavation and root sensitive pruning.

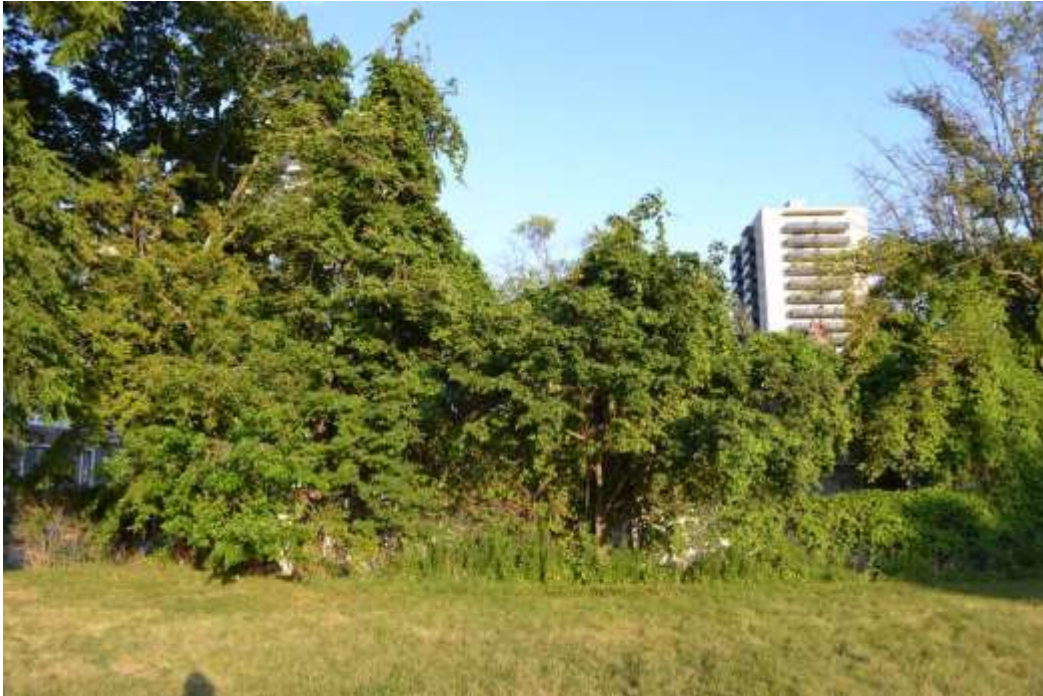
Figure 3: Trees 6, 7, and 66 along the south east property line of city-owned property.

7	Acer platanoides	31	6	M	M	RC	Growing through fence mesh and has thicket creeper in canopy.		X	
8	Acer saccharinum	32, 44.5	10	MH	M	RC	Co-dominant leaders, two large dead branches, growing through fence mesh.		X

66	Ulmus americana	44.5	8	L	L	R	50% of canopy is dead. Vine is covering 50% of remaining canopy.	X		
67	Gingko biloba	131.5	18	L	L	R	80% of canopy dead. Three leaders and included bark from base to 2m height also at 4 to 8m ht. Large cut at 1m height.	X

Remove trees #5 – 19, 21 - 25 for construction as identified on the Tree Inventory & Preservation Plan.

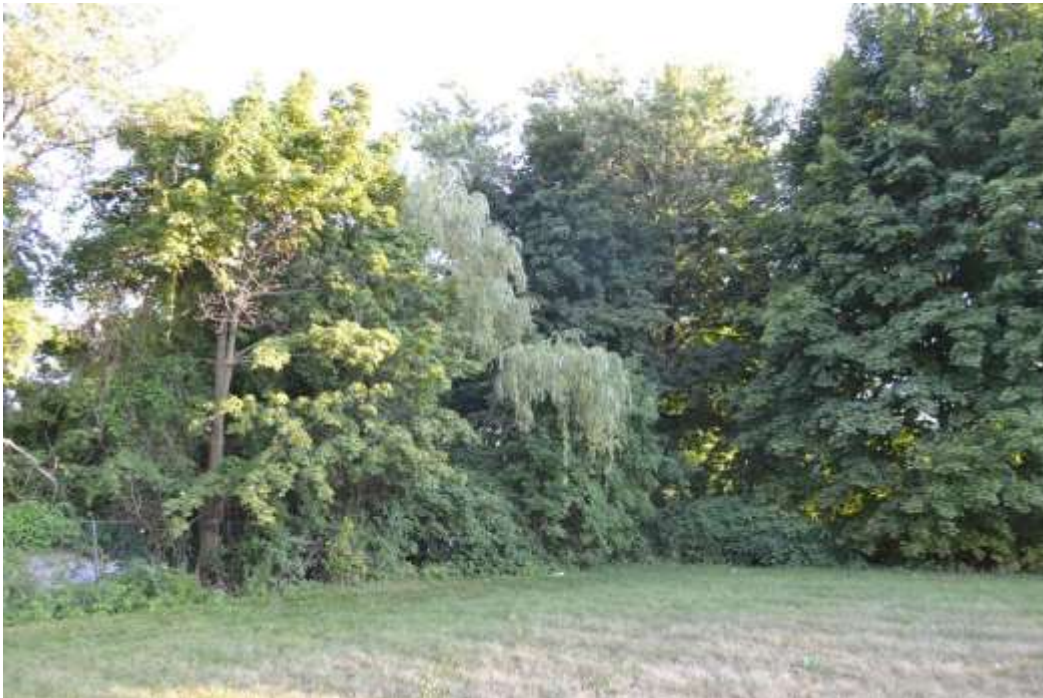
Figure 4: Trees at the south corner of the city-owned property.

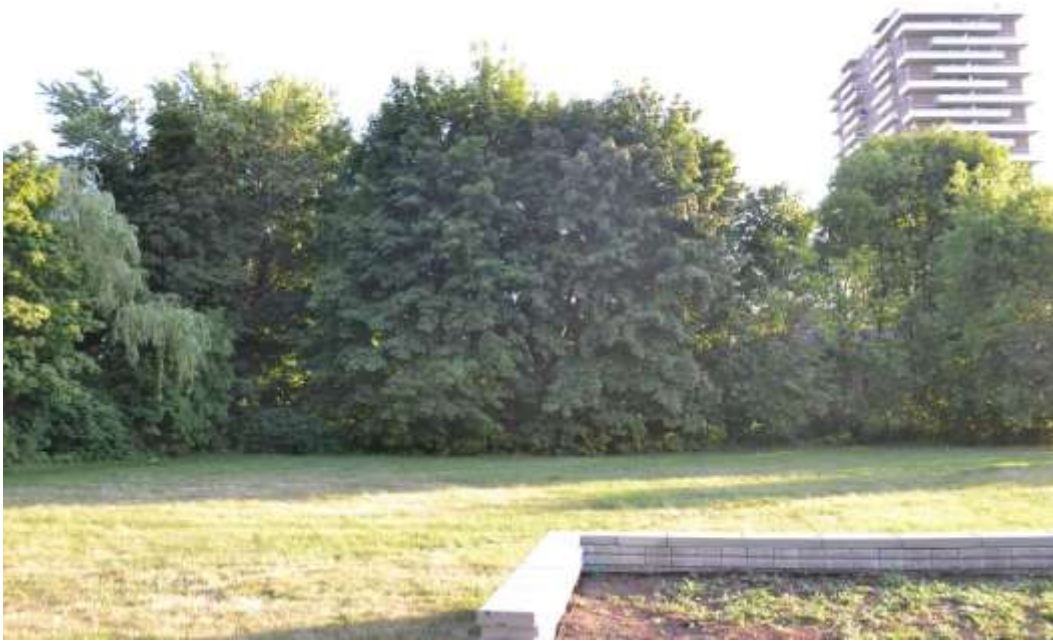
Figure 5: Trees X – X along south west property line of city-owned property.

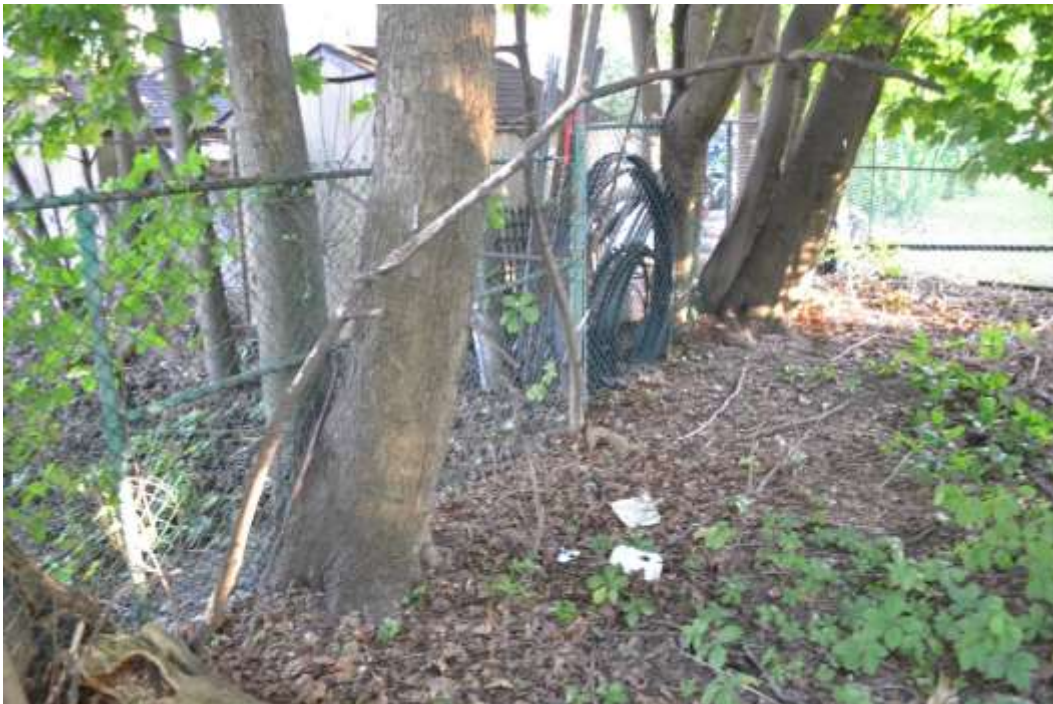
Figure 6: Trunks of trees 8 to 10 in the south corner of the city-owned property.

Tree No.	Species	dbh (cm)	Canopy diameter (m)	Biological Health	Structural Condition	Recommended Action	Comments	Subject Site (developer-owned)	Subject Site (city-owned)	City-owned boulevard
9	Acer platanoides	~32	10	M	M	RC	Growing through fence mesh, leans 10° to north east.		X	
10	Acer platanoides	31, 46.5	9	M	M	RC	Co-dominant leaders with included bark at base to 30cm ht. Leans 10° to north west. Has girdling root at base.		X	
11	Acer platanoides	22	6	M	ML	RC	Grows through fence mesh, suppressed, and leans 10° to north west.		X	
12	Acer platanoides	14, 15x2, 18x2, 19x2, 15, 26.5	10	M	ML	RC	Multistem tree with included bark between all trunks. Girdling roots across the base. Three large injuries from fuse branches.		X	
13	Acer platanoides	25, 33	8	M	M	RC	Included bark at base, leans 10° to east and a girdling root.		X	
14	Acer platanoides	16	4	M	M	RC	Girdling root with tree #13 and has a small canopy.		X

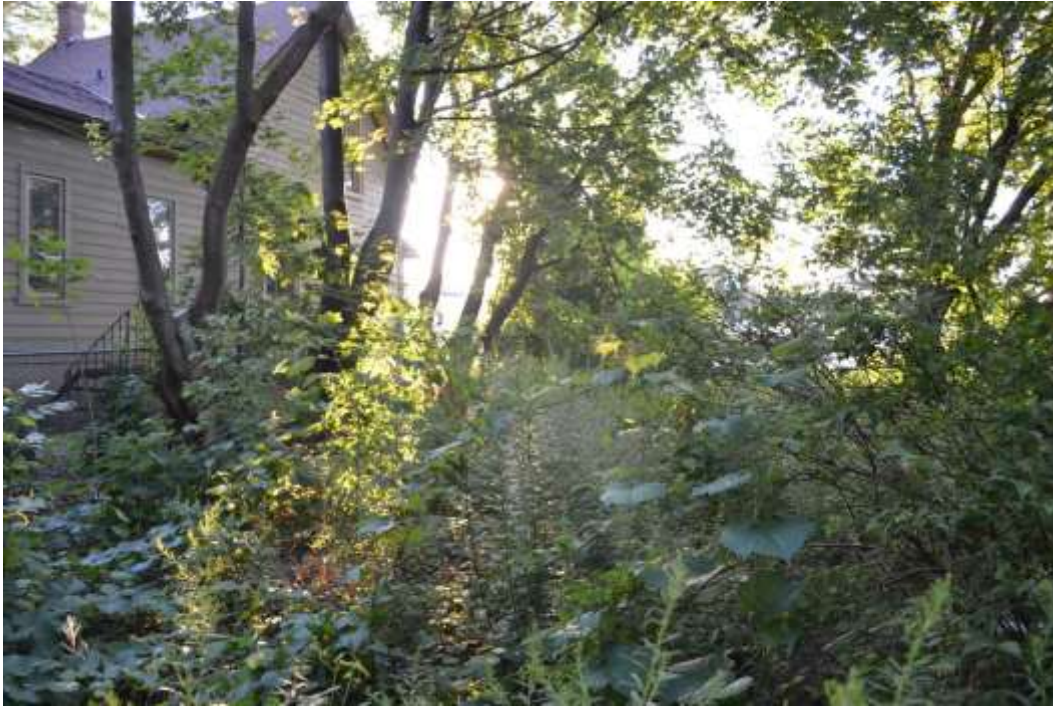
Figure 7: West corner of city-owned property with tree 23 – 25, tree 27 and 28 in distance, and tree 19 on the right.

Tree No.	Species	dbh (cm)	Canopy diameter (m)	Biological Health	Structural Condition	Recommended Action	Comments	Subject Site (developer-owned)	Subject Site (city-owned)	City-owned boulevard
19	Acer negundo	35.5, 40	9	M	M	RC	Co-dominant leader with one leader leaning 45° to north east. Some grape vine covers 5% of canopy.		X	
20	Fraxinus pennsylvanicus	14	5	MH	M	RC	Grape covers the lower 25% of canopy, but no EAB obvious yet.		X	
21	Acer platanoides	17	5	M	ML	RC	Supporting tree #22 and grows through a fence mesh.		X	
22	Acer negundo	27.5	8	M	ML	RC	45°L to south on tree #21.		X	
23	Acer platanoides	24, 25	8	M	ML	RC	Large central leader cut at 1.7m ht. an and wound from cut on remaining leader. Has included bark from 0.5 to 1.7m ht. One leader leans 30° to south. Has several small dead branches.		X	
24	Acer platanoides	35, 41	12	M	M	RC	Included bark from 1m to 1.7m, tight branching causing injury from fusing trunk.		X

25	Acer negundo	23	6	M	ML	RC	Leans 45° to north east and has a sparse canopy.		X	
26	Gleditsia tricanthos var. inermis	62	16	H	H	RC	Many 10 small dead branches.	X		
27	Acer negundo	35	7	M	M	RC	Large pruned limb at 4m, medium-sized wound at base of 3% trunk damage.	X

Tree No.	Species	dbh (cm)	Canopy diameter (m)	Biological Health	Structural Condition	Recommended Action	Comments	Subject Site (developer-owned)	Subject Site (city-owned)	City-owned boulevard
28	Acer negundo	32	7	M	M	RC	Medium-size wound from cut co-dominant leader covering 15% trunk damage. Girdling root also present.	X		
29	Thuja occidentalis (Hedge)	25x 2, 30x5, 15x2	5	M	M	RC	All multi-stem from 0.5m height.	X		
30	Acer negundo	14	4	MH	H	RC	Leans 15° to west.			X
31	Thuja occidentalis	20.5	5	M	M	RC	45oL to south west and 20% trunk wounded.			X
32	Thuja occidentalis	16	3	ML	M	RC	Suppressed.			X
33	Acer negundo	78	17	M	ML	RC	45oL, with more than 6 large branches cut of over 15cm dia. Also 2 large cuts of 30cm dia.	X		
34	Fraxinus pennsylvanicus	25, 25				R	DEAD	X		
35	Acer negundo	44	9	M	M	RC	Tip dieback of 10% and 2 large dead branches.	X		
36	Fraxinus pennsylvanicus	14				R	DEAD	X		
37	Acer platanoides	28, 38	9	MH	M	RC	tip dieback of 10% and 2 large dead branches.	X

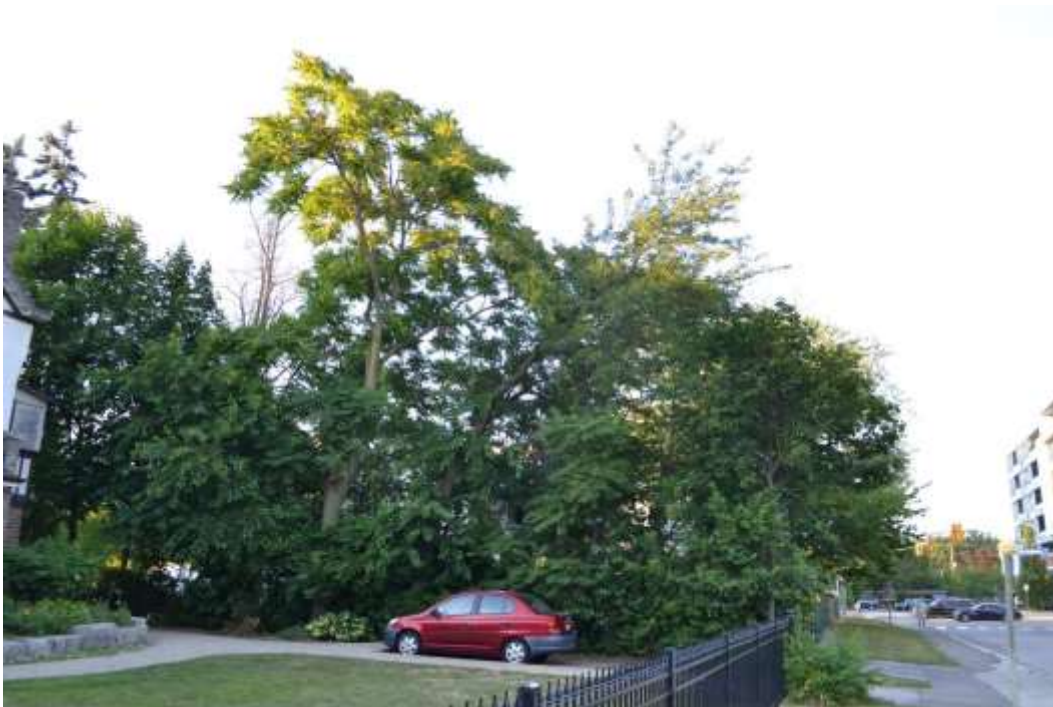
Figure 8: Trees 57– 60 along fence line between existing houses on High St.

Tree No.	Species	dbh (cm)	Canopy diameter (m)	Biological Health	Structural Condition	Recommended Action	Comments	Subject Site (developer-owned)	Subject Site (city-owned)	City-owned boulevard
55	Acer platanoides	20	6	MH	MH	RC	Several medium-sized prune cuts.	X		
56	Morus alba	14.5	5	H	MH	P	Small branch stubs	X		
57	Ailanthus altissima	51	8	H	MH	P	large pruned limb with ripping wound and two other medium-sized broken branch wounds.	X		
58	Morus alba	35	8	M	M	P	leans 30° to south.	X		
59	Ailanthus altissima	17	4	H	H	RC	unbalanced canopy to south.	X		
60	Acer platanoides	16	4	M	M	RC	backfilled, has 5 small prune cuts and a thin wound from 30cm to 1m ht.	X		
61	Acer platanoides	20.5	4	MH	MH	RC		X		
62	Acer negundo	19.5	5	M	M	RC	30° lean to south, one dead trunk fallen.	X		
63	Acer platanoides	35	6	MH	MH	RC		X		
64	Salix alba 'Tristis'	19	4	M	ML	RC	multibranch node.	X		
65	Salix alba 'Tristis'	25	6	MH	M	RC	10°L to north east.	X

Remove trees #26 – 29, 33, 35, 37 – 41, 43A, 43B, 45, 48 – 52, 53A, 54, 55, 59, 60 and 61- 65 for construction as identified on the Tree Inventory & Preservation Plan.

Preserve trees #56 – 58, 68, and 71 – 75 as identified on the Tree Inventory & Preservation Plan. Preserved trees should be enclosed within tree protection hoarding.

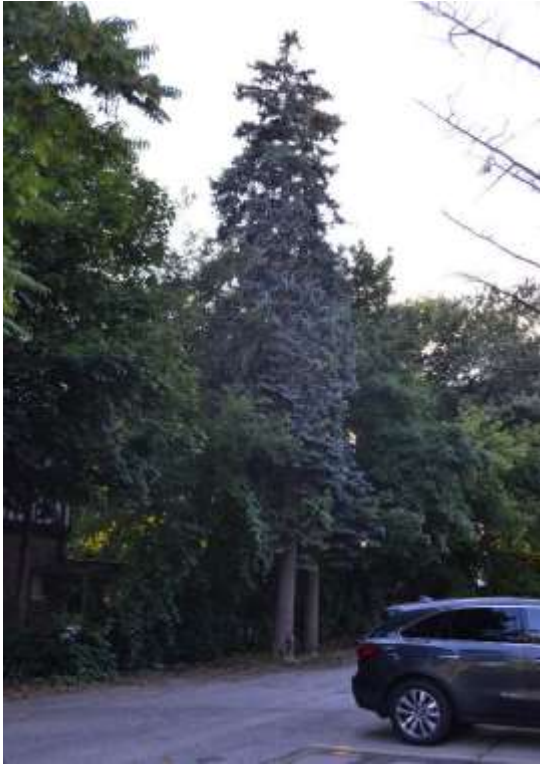
Figure 9: Trees 51 and 52.

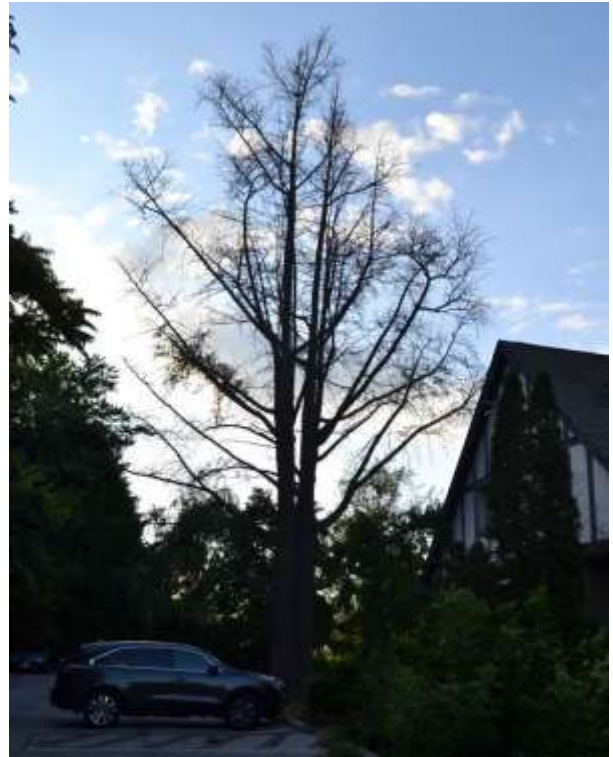
Figure 10: Tree 67.

Remove trees #34, 42, 44, 46, 47, 66, and 67 for poor health or dead as identified on the Tree Inventory & Preservation Plan.

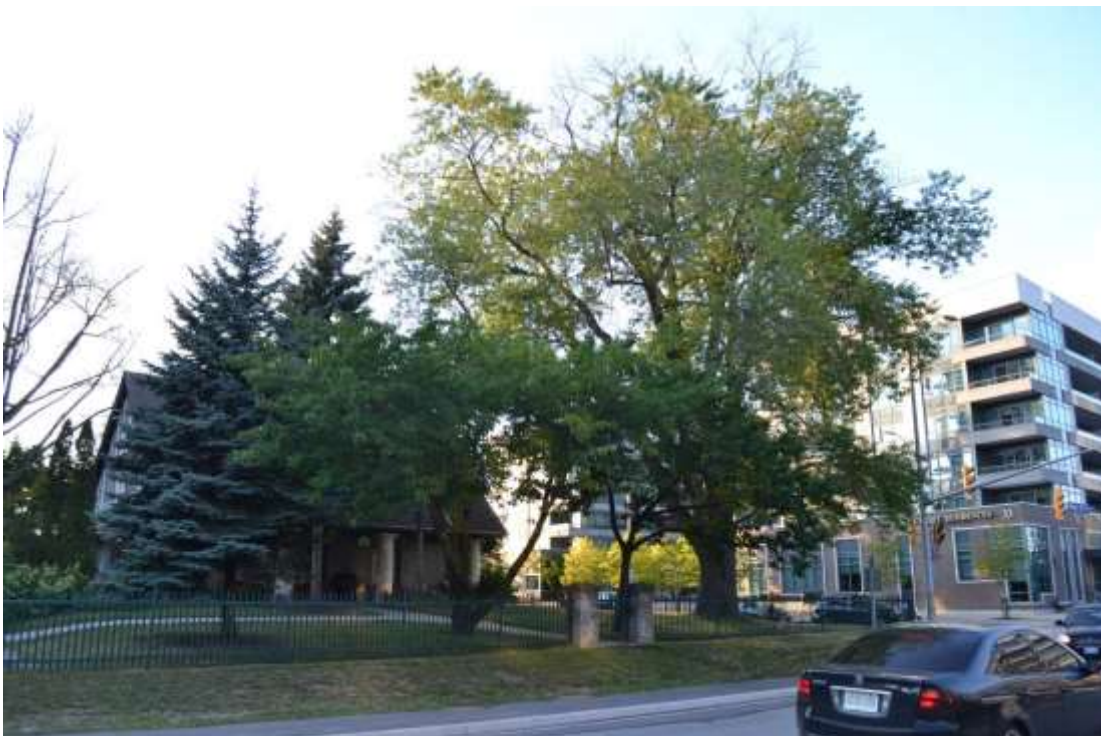
Figure 11: Trees 70 – 75 along High St. at corner of Hurontario St.

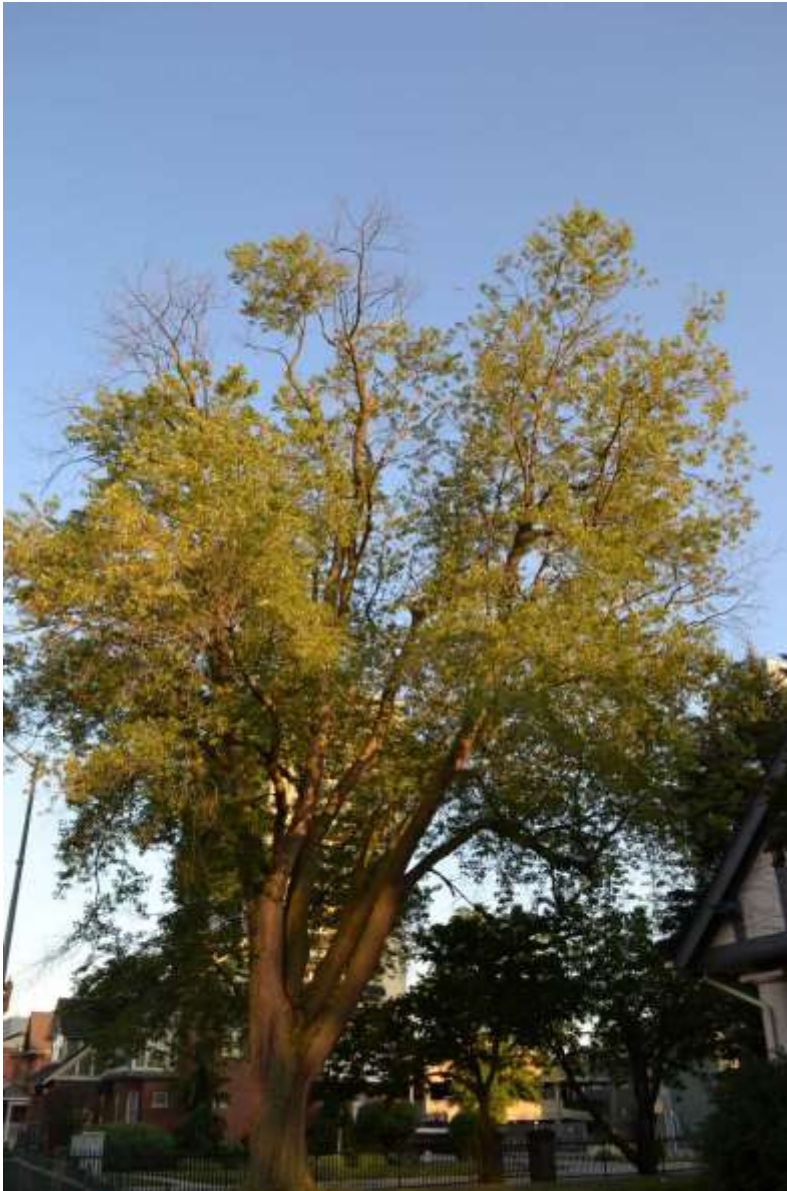
Figure 12: Trees 70.

Tree 70 is a large silver maple at the corner of Hurontario St and High St. This tree is large and beautiful but is showing signs of decline. There are many large limbs at the centre of the canopy that are now dead or dying. These limbs must be removed at the beginning of any work being done on the site. This tree should be monitored throughout construction.
