Project: 10-2434A

January 25, 2021

**Phase I Environmental Site Assessment Update
2570-2590 Argyle Road
Mississauga, Ontario**

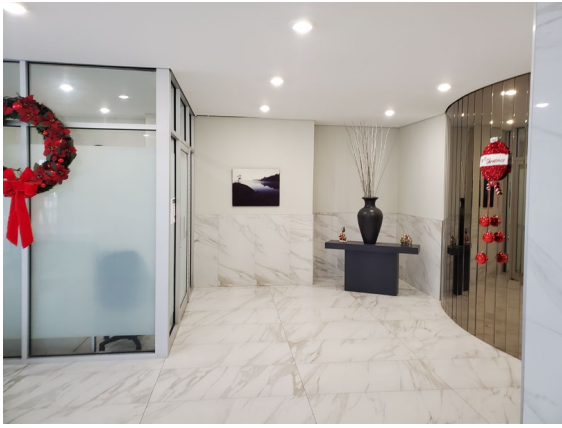
Lobby of 2570 Argyle Road

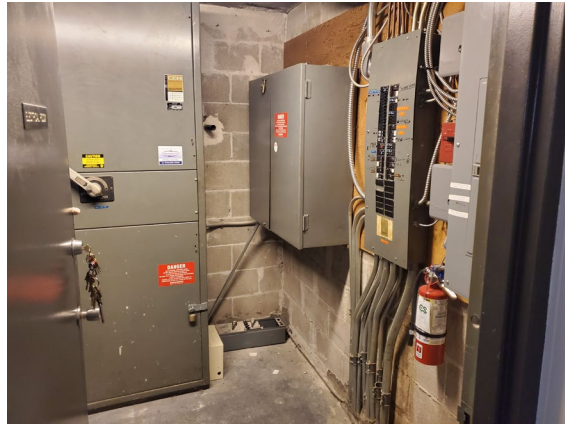
Electrical room 2590 Argyle Road

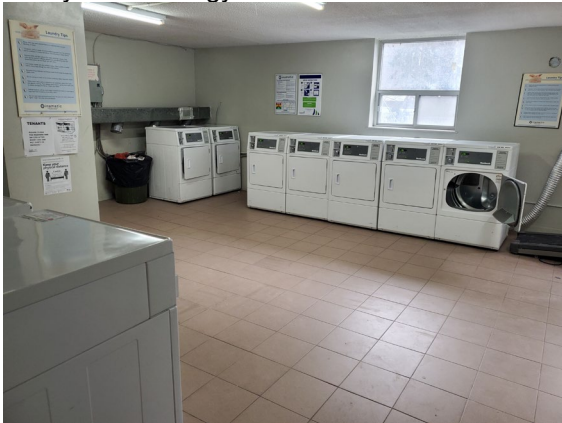
Laundry room 2570 Argyle Road

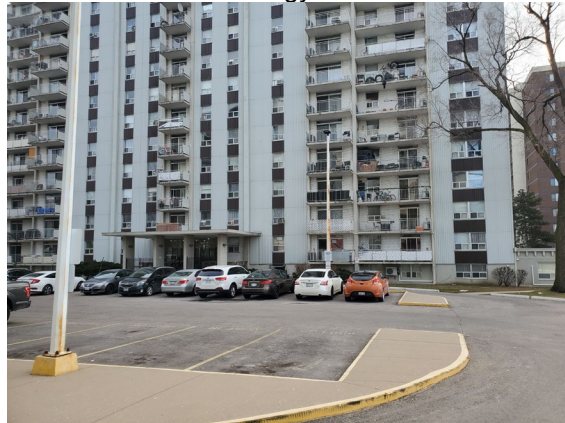
Facing south to front of 2570 Argyle Road

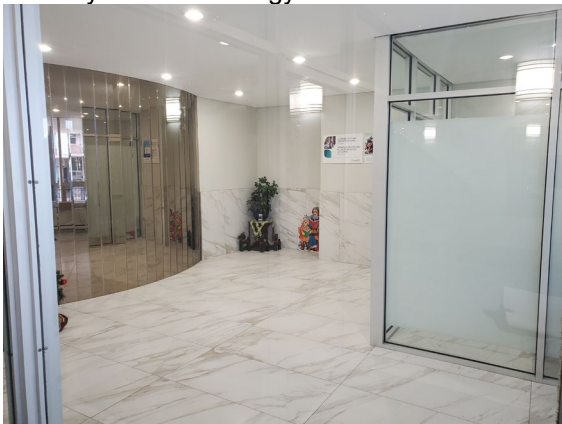
Lobby of 2590 Argyle Road

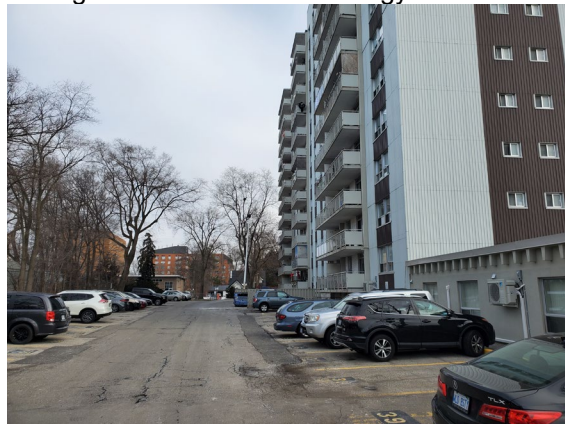
Facing east to north side of 2590 Argyle Road

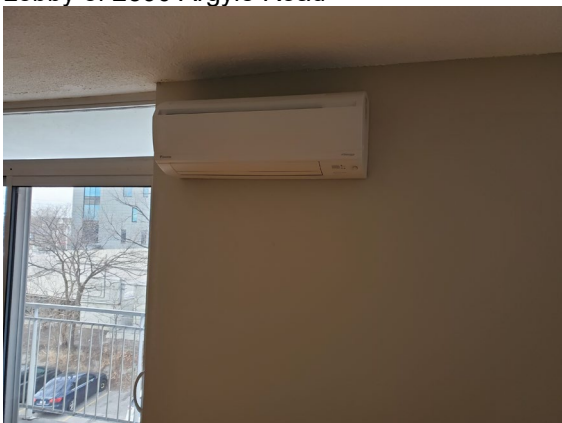
Electric heater in unit in 2590 Argyle Road
