Almega Asset Management
25 Watline Ave, Suite 501,
Mississauga, ON L4Z 2Z1

File No. 21-067
May 31, 2021

**Subject: Preliminary Assessment of Long Term Stable Slope Crest
60 Dundas Street East, Mississauga, Ontario**

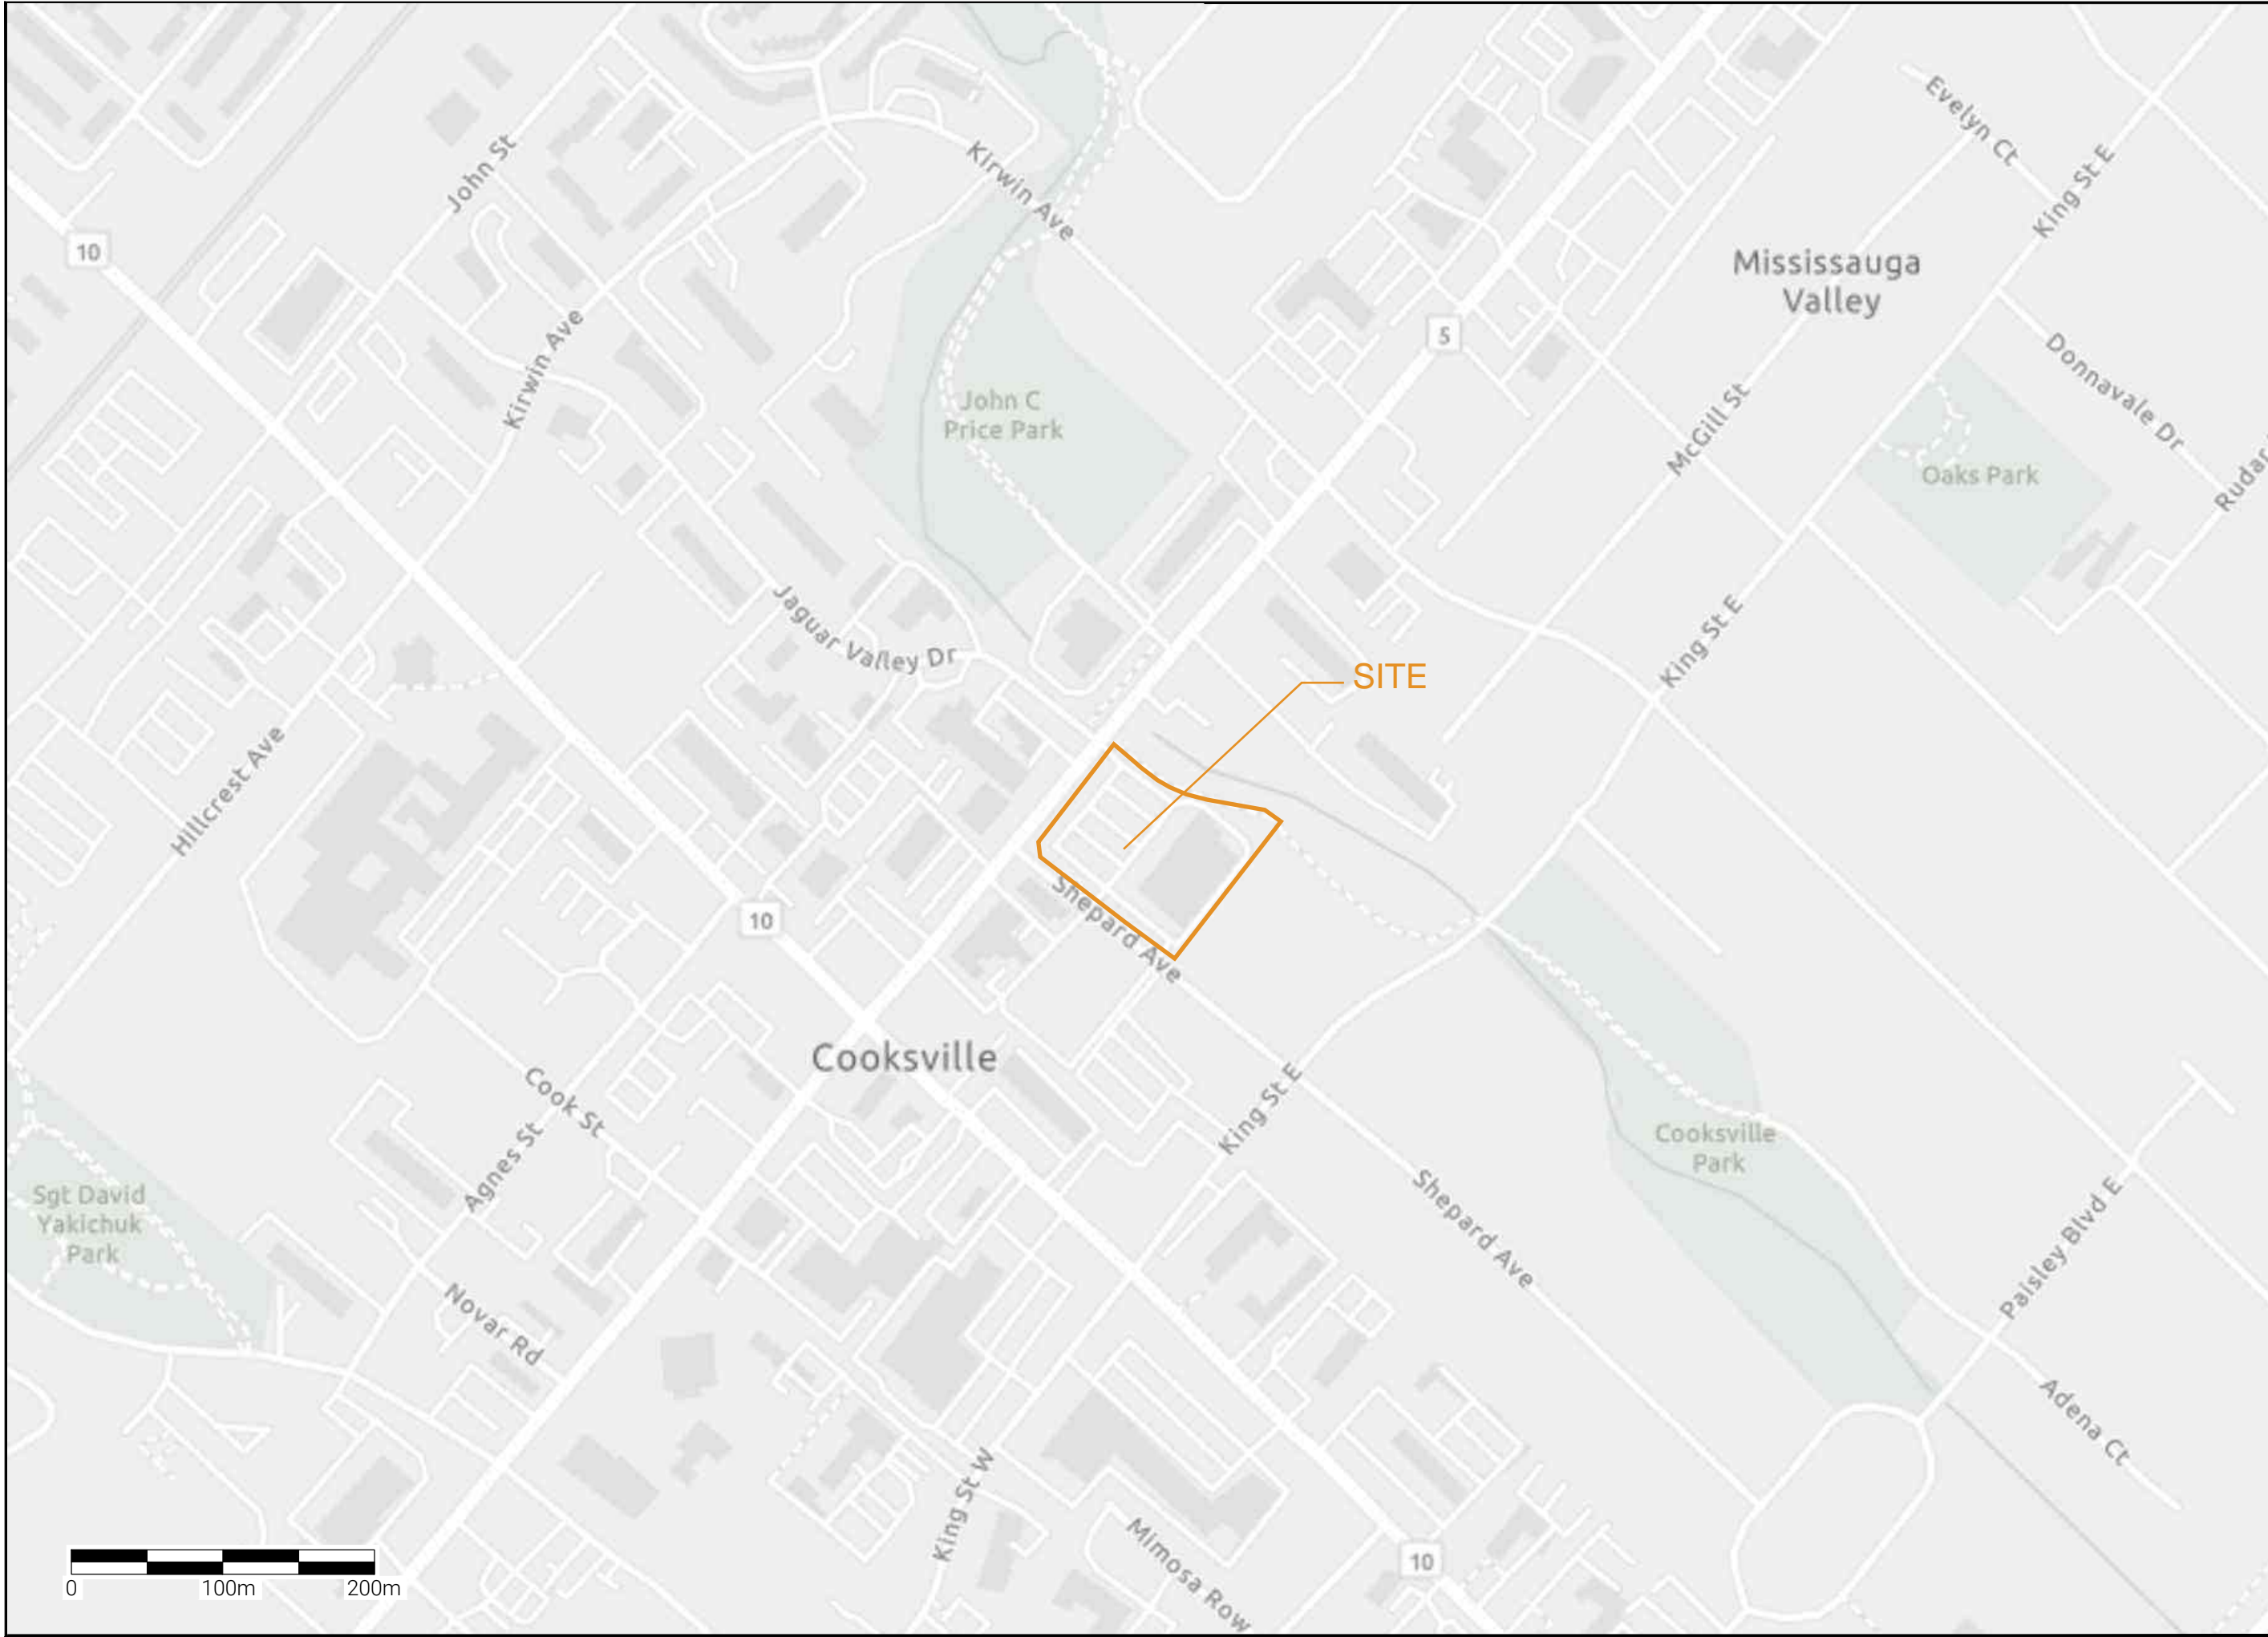
FIGURE 2

The preliminary LTSSC position is provided in plan on Figure 2, where the toe erosion allowance and stable slope inclination in section intersect the tableland. The preliminary LTSSC was determined using an estimated stable slope inclination of 2.5H:1V and a toe erosion allowance of 0 m or 5 m.

Based on the applicable toe erosion allowance and stable slope inclination, the LTSSC position is approximately 11.3 to 16.3 m from the existing top of slope at the north end of the site, and approximately 7.5 to 12.5 m from the existing top of slope at the south end of the site.

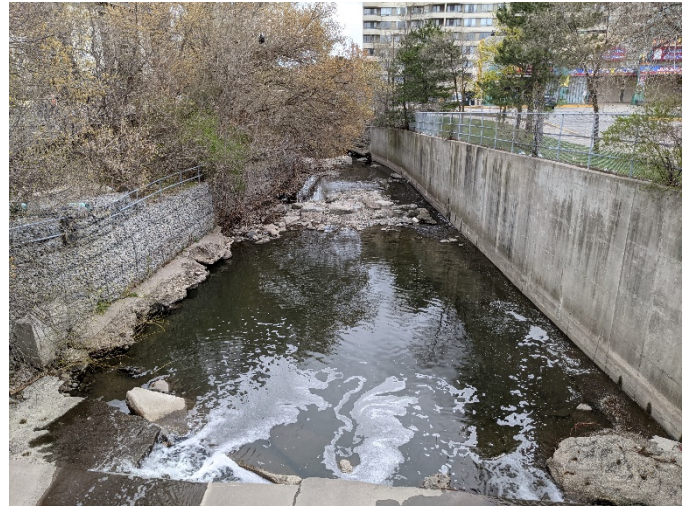
Photograph 1

Position: Tableland, north east of site

Direction/Object: South, down Cooksville Creek

Description: Cooksville Creek is present east of the subject site on private property. The sides of the creek are retained by a concrete retaining wall at the north end of the site and a block retaining wall at the south end of the site. The wall ranges from approximately 4.5 to 3.0 m in height.

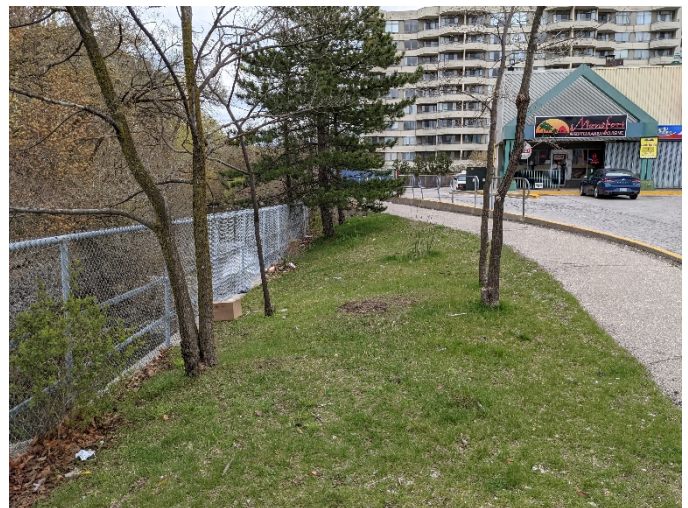
Photograph 2

Position: Tableland, east of site

Direction/Object: South, along crest

Description: There is a chain link fence along the top of the retaining walls. The tableland is slightly sloping towards the retaining walls. The tableland is vegetated with grass and young trees.

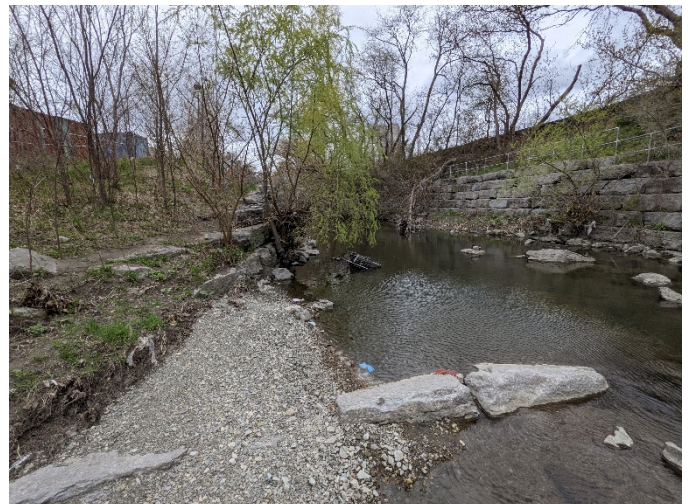
Photograph 3

Position: Valleyland, south east of site

Direction/Object: North, along toe

Description: At the south end of site there is a block retaining wall that decreases in height. The retaining walls appear to be in a good state of maintenance.
