Arborist Report and Tree Protection Plan for 65-71 Agnes Street, Mississauga, Ontario.

Prepared for Intentional Capital

April 29, 2022

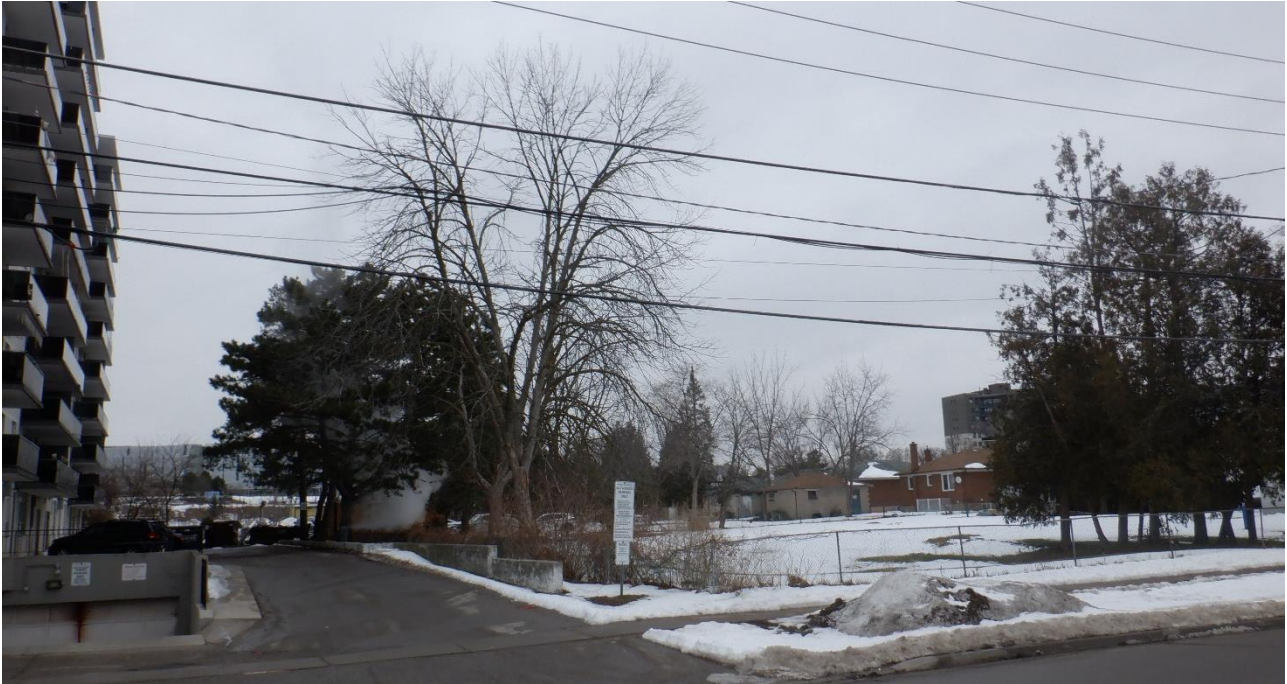
Figure 5: West-facing view of the south side of the site. Trees 20 and 21 are dead ashes, with mixed conifers near the southern and western property lines.

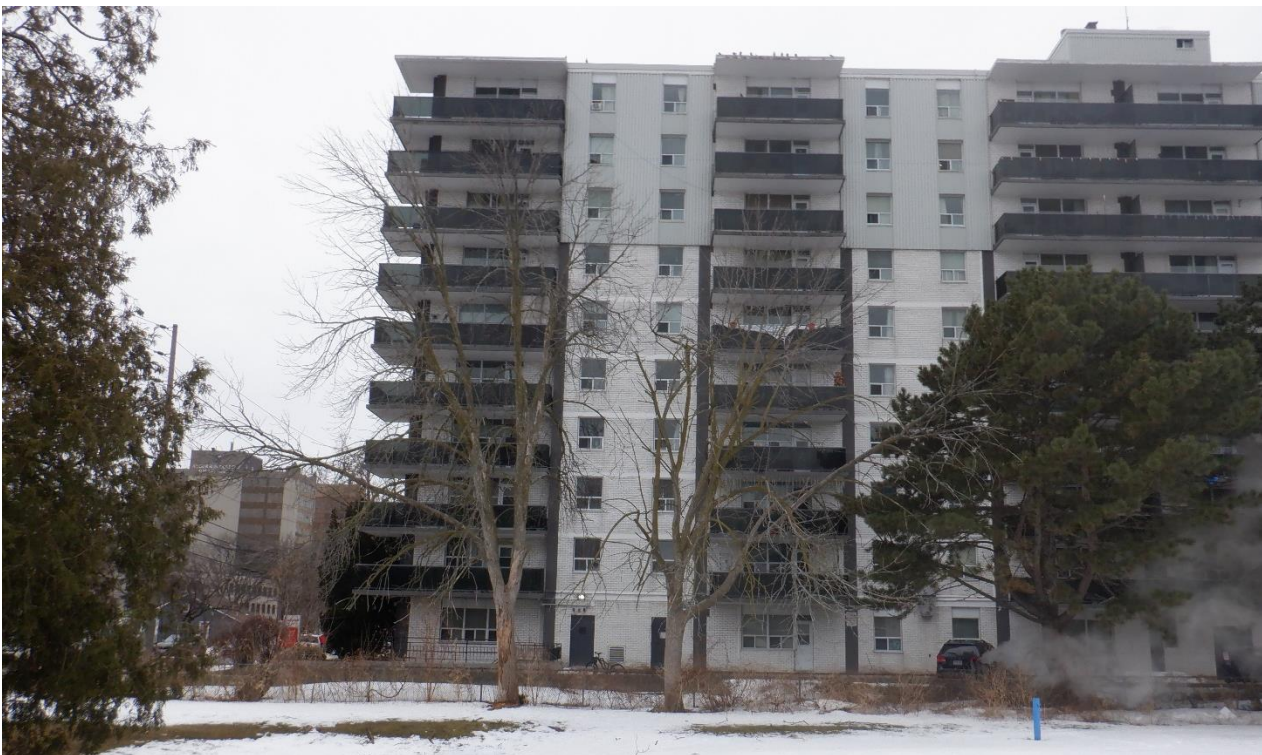
Figure 8: South-facing view of trees 21 and 22 (dead ashes).

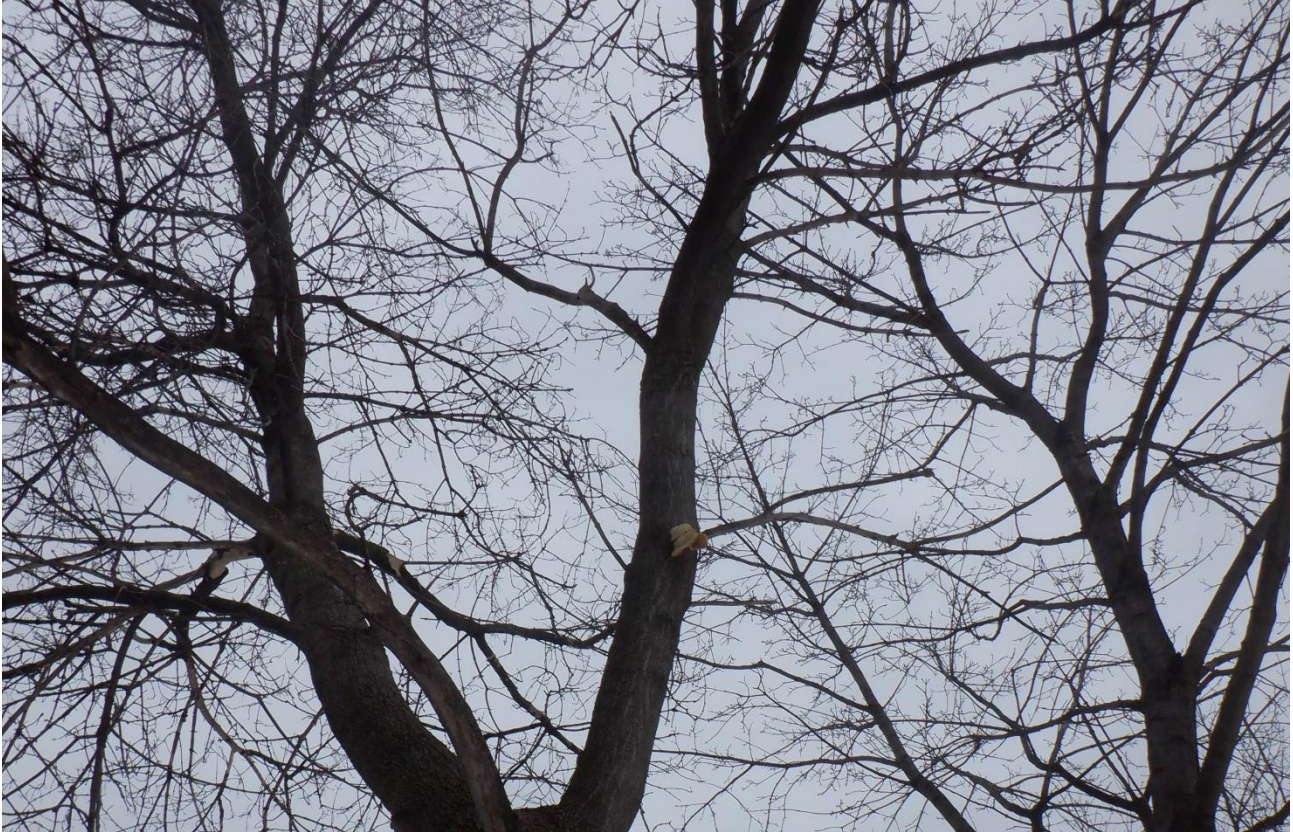
Figure 21: A fungal fruiting body is visible in the crown of tree 29 at 3060 Cook Street, which is proposed for removal.

Private Live Tree(s) Greater than 15cm and less than 45cm DBH Proposed for Removal due to Construction (15): 3, 5, 6, 7, 8, 9, 11, 12, 13, 15, 16, 17, 18, 29, 30. Trees 3, 6, 7, 9, 11, 12, 13, 29, and 30 are in poor condition. Trees 29 and 30 are shared with the neighbour at 3060 Cook Street and are showing advanced defects (see Table 1 and Figures 21-22 above).

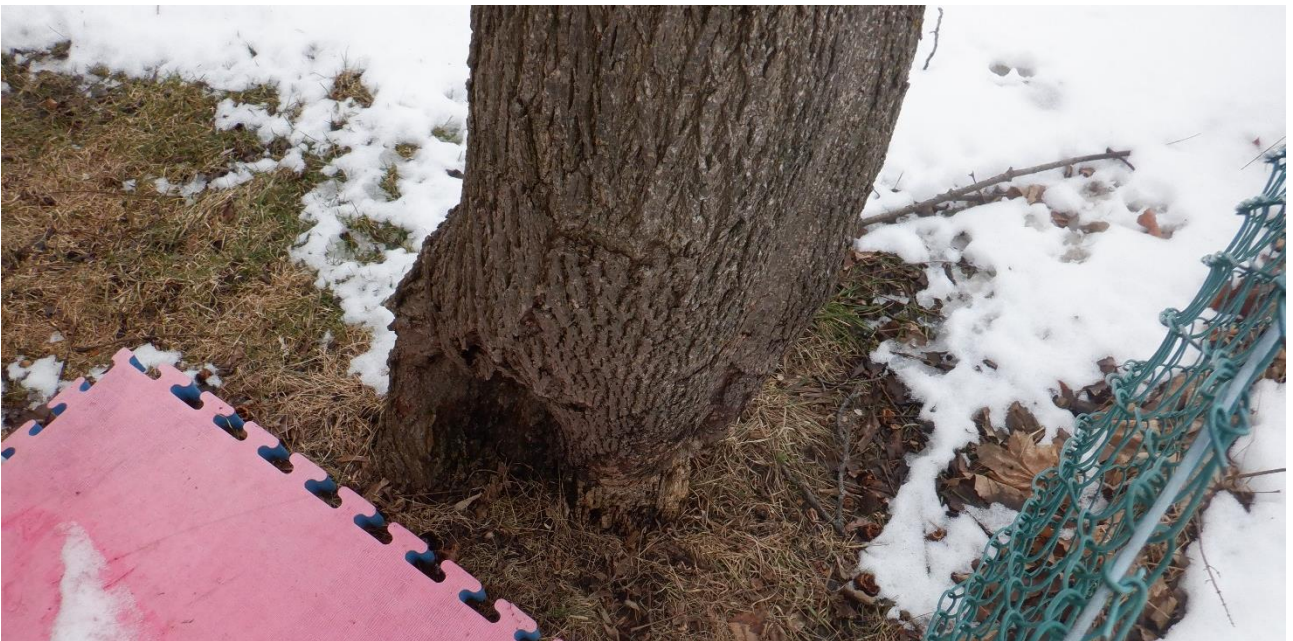
Figure 22: Advanced wounds were visible at the base of tree 30 at 3060 Cook Street, which is proposed for removal. Neighbour permission will be needed to remove trees 29 and 30.

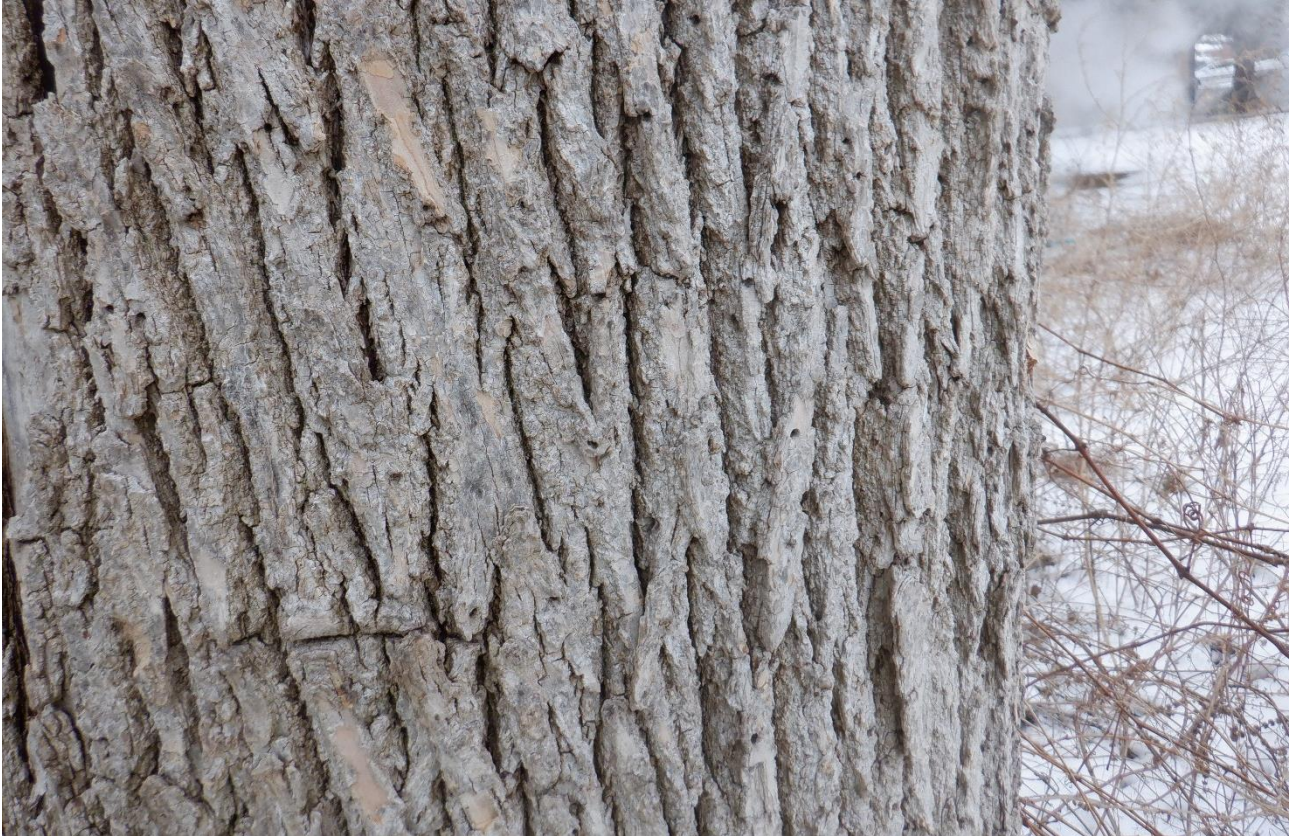
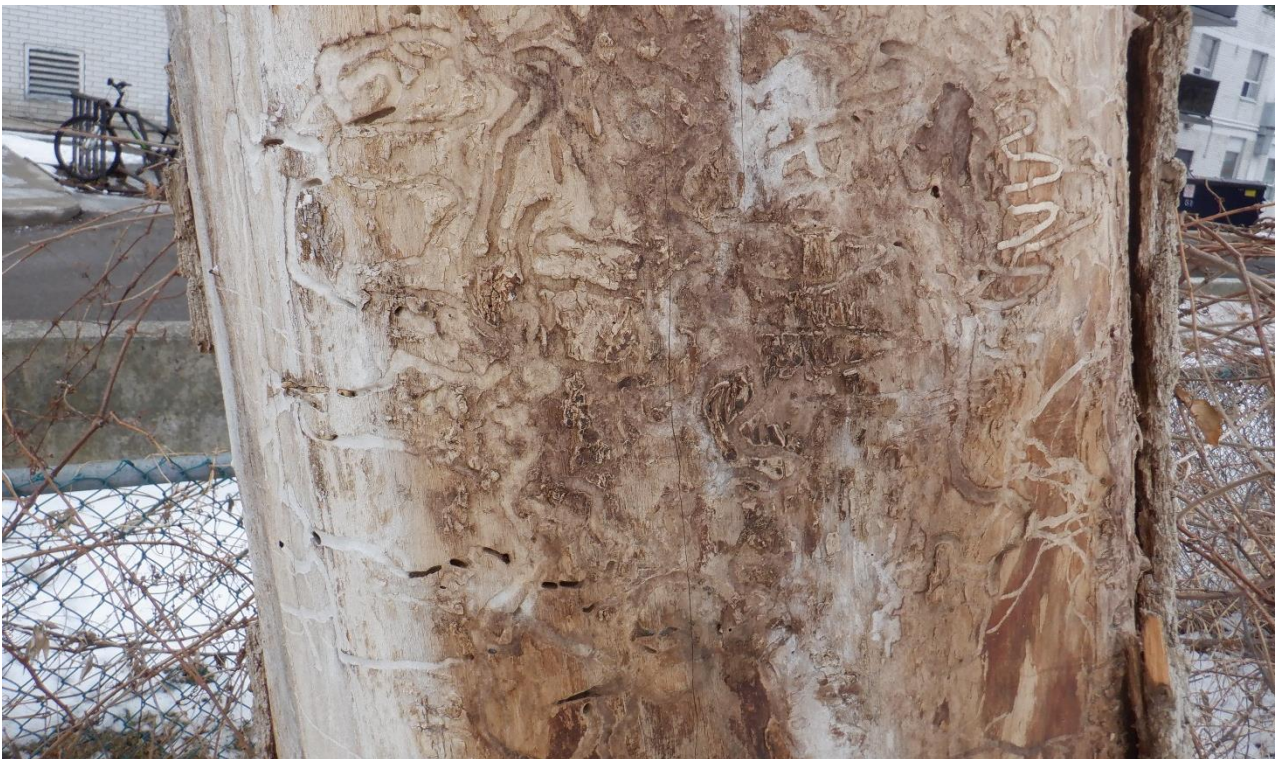
Figures 23-24: Trees 19-20 were showing advanced signs of emerald ash borer (EAB) infestation.

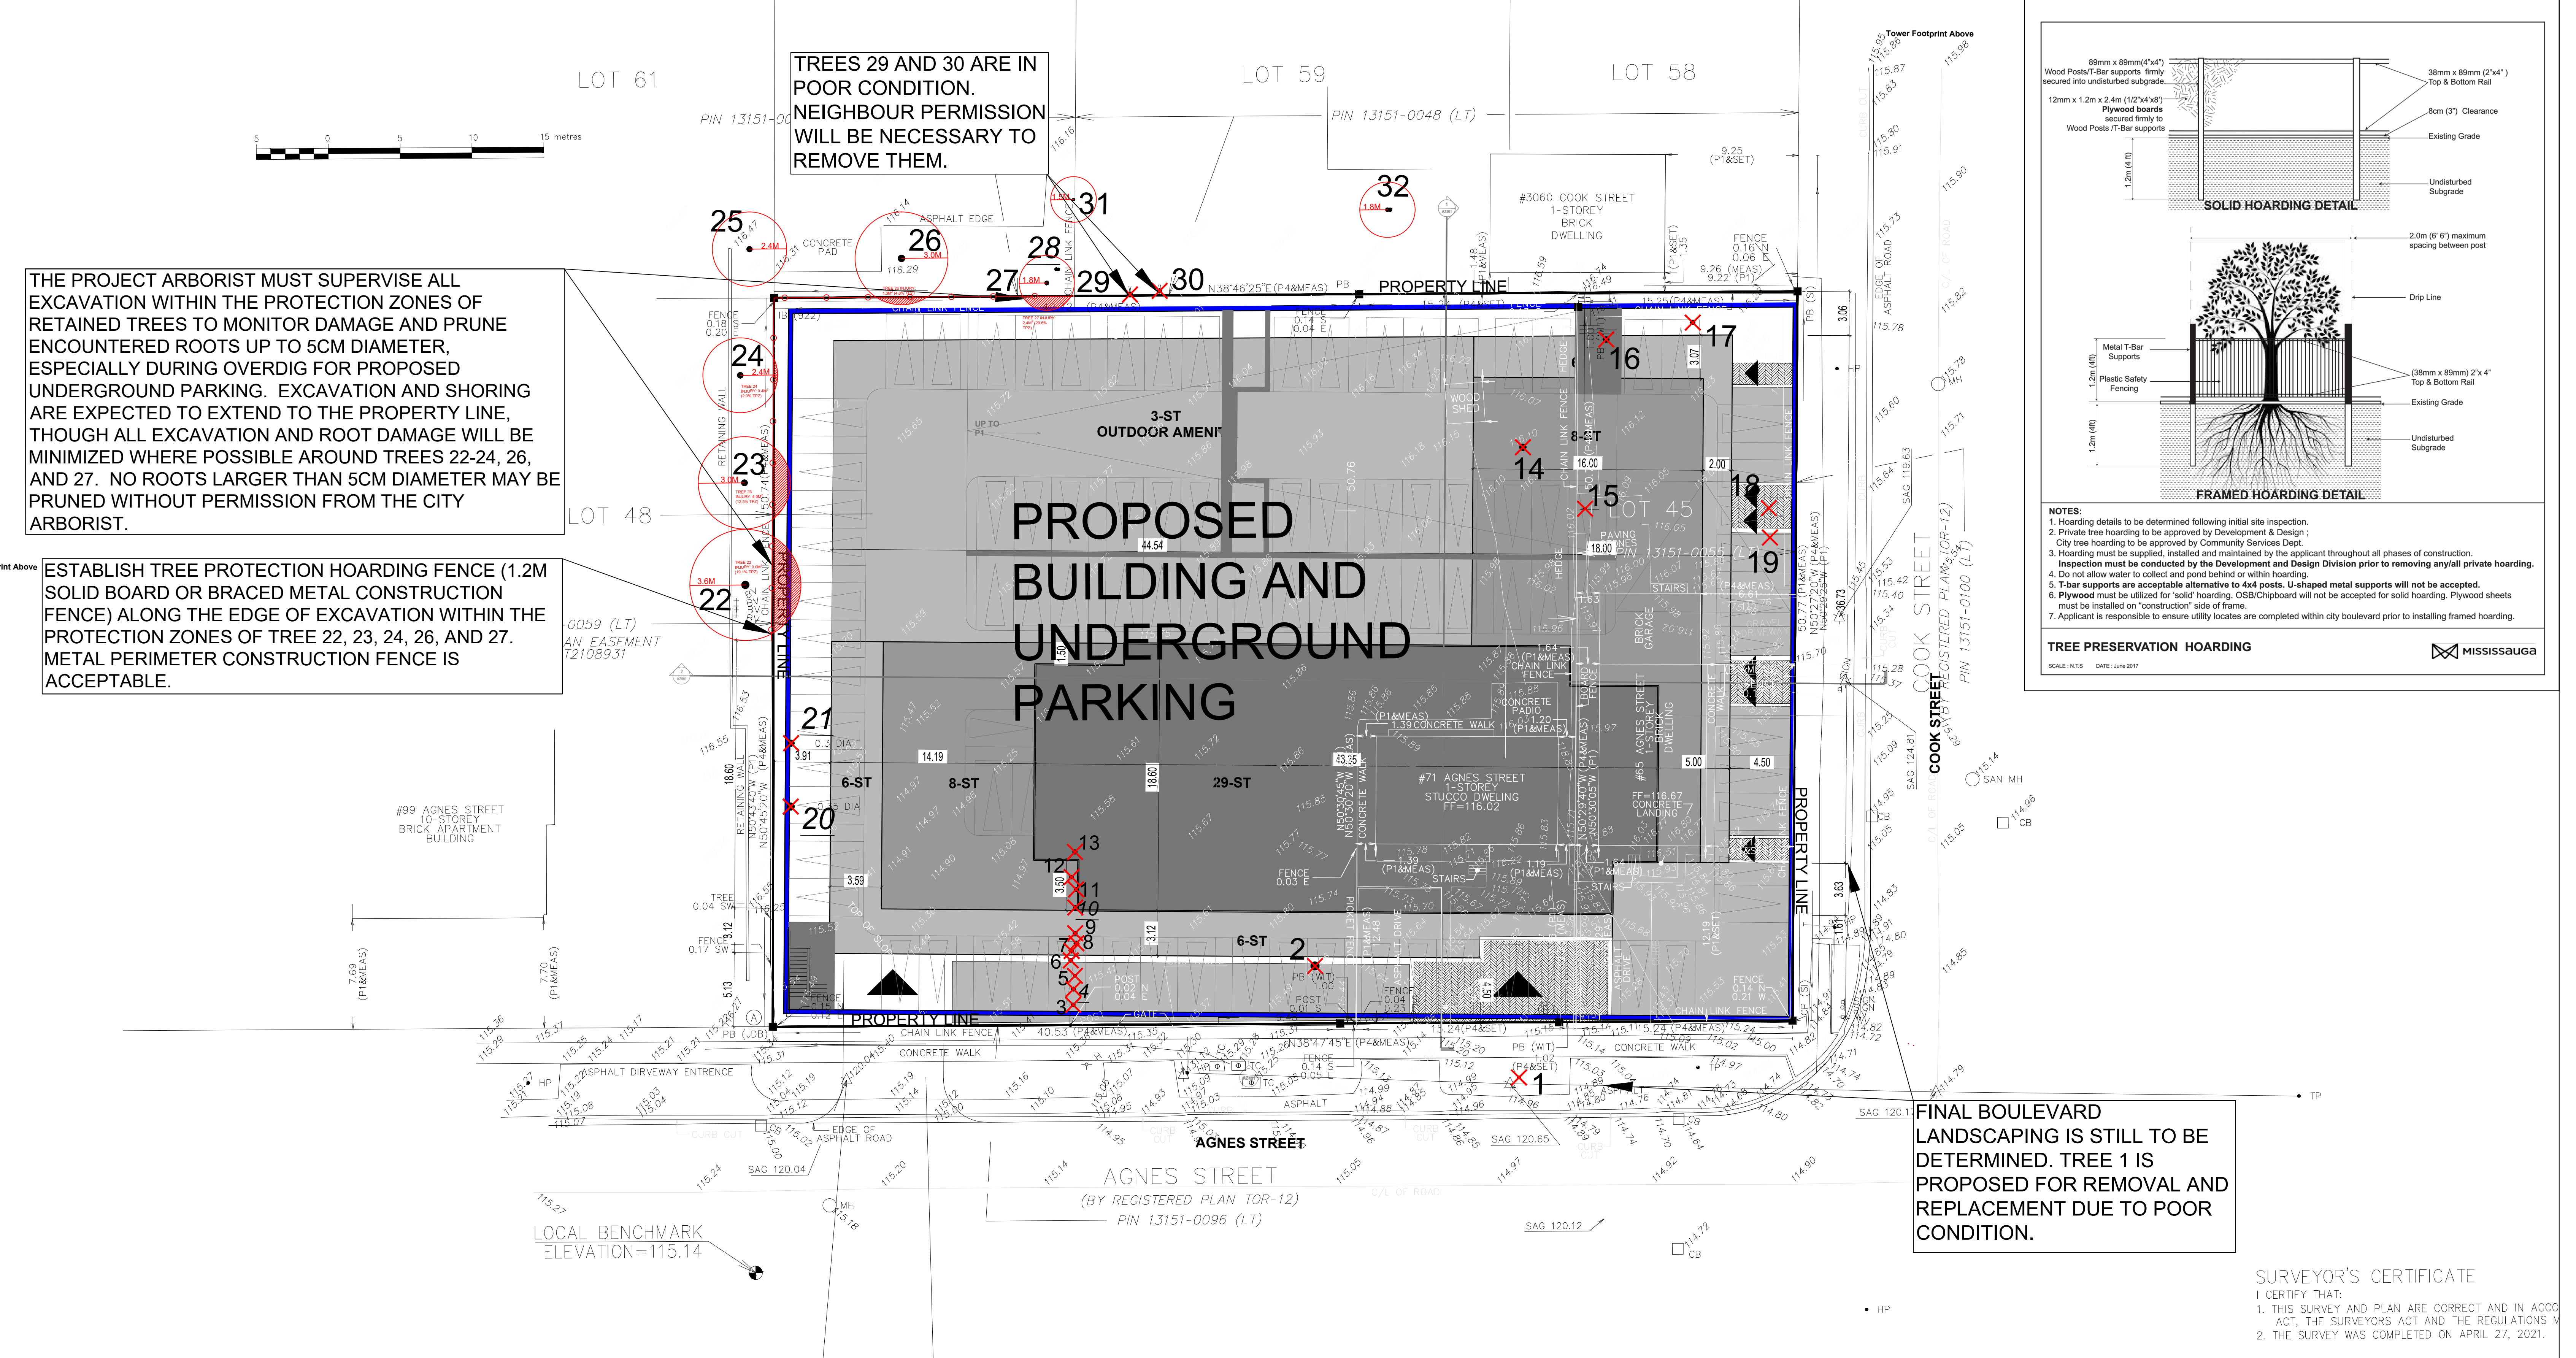
Private Tree(s) Greater than 15cm DBH Proposed for Injury due to Construction (5): 22, 23, 24, 26, 27. These trees are located at the neighbouring property at 99 Agnes Street. The injury to trees 24 and 26 is minor (<5% TPZ), while injuries to trees 22 (9.0m², 19.1% TPZ), 23 (4.0m², 19.1% TPZ), and 27 (2.4m², 20.6% TPZ) are within acceptable limits if excavation within TPZs is limited as much as possible and this tree protection plan is implemented as specified.

3. Tree protection fencing (1.2m solid board plywood hoarding) will be installed prior to demolition and construction according to City of Mississauga guidelines and remain in place until construction is complete. Braced metal construction fence is also acceptable, while snow fence (1.2m tall on a 2x4 or metal T-bar frame) may be installed on the City boulevard and/or adjacent to access routes. Metal perimeter construction (hoarding) fence at the periphery of the property and proposed excavation is expected to be sufficient in this case. Refer to Drawing AR-02 for location and details.
