June 23, 2022

ARBORIST REPORT

1225 Dundas Street East, Mississauga, Ontario

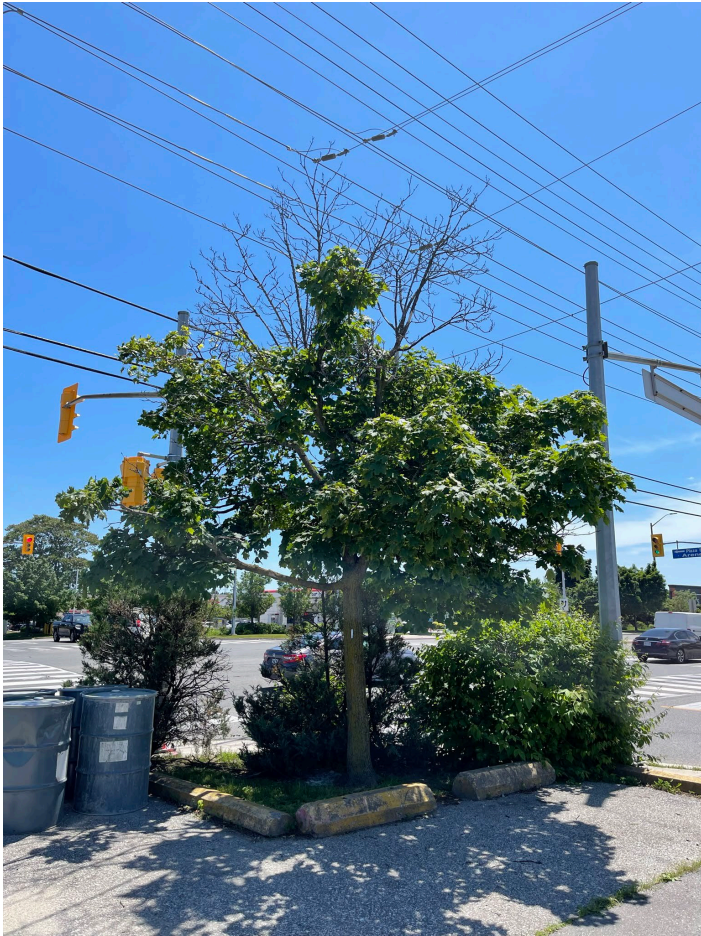
Tree 411

Tree #	Common Name	Botanical Name	DBH (CM)	Condition	Comments	Recommendation
411	Norway Maple	Acer platanoides	18	P	Significant crown die-back and leader die-back	Retain
412	Manitoba Maple	Acer negundo	37	F	Two stems at base, poor form, moderate deadwood in canopy, epicormics throughout	Retain
413	Slippery Elm	Ulmus rubra	17	F/G	Evidence of leaf miner	Retain
414	Slippery Elm	Ulmus rubra	16	F	Evidence of leaf miner	Retain
415	Slippery Elm	Ulmus rubra	17	F	Evidence of leaf miner, slightly imbalanced crown	Retain
416	Slippery Elm	Ulmus rubra	17	F/P	Evidence of leaf miner, moderate/significant die-back on north side of crown	Retain
417	Slippery Elm	Ulmus rubra	20	F/G	Evidence of leaf miner	Retain
418	Slippery Elm	Ulmus rubra	19	F	Evidence of leaf miner	Retain
419	Slippery Elm	Ulmus rubra	20	F/G	Evidence of leaf miner	Retain
420	Slippery Elm	Ulmus rubra	20	F/G	Evidence of leaf miner	Retain
421	Slippery Elm	Ulmus rubra	21	F/G	Evidence of leaf miner	Remove due to construction

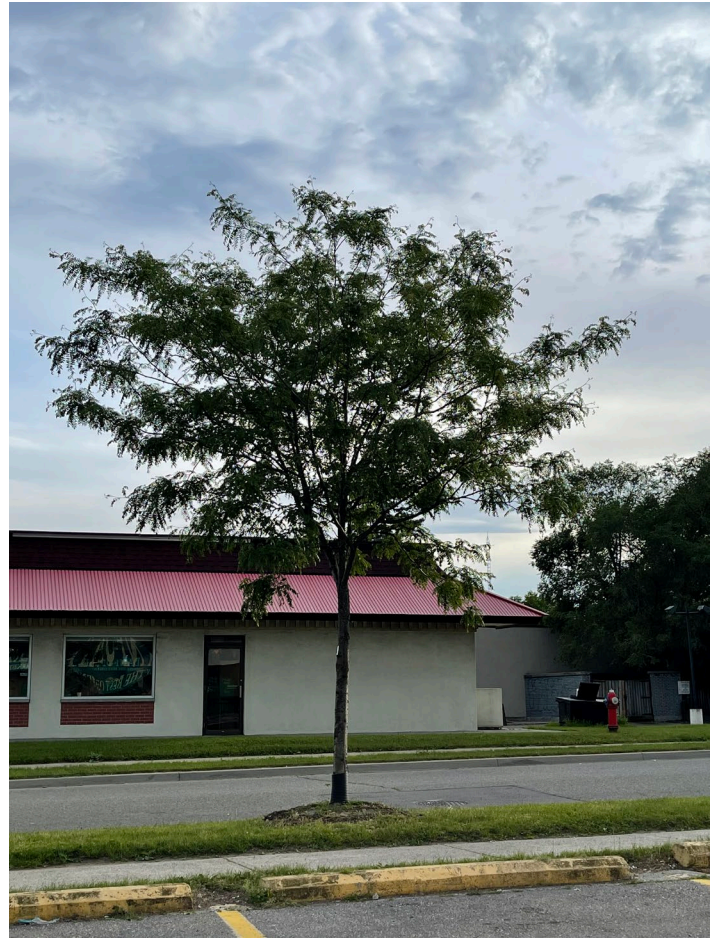
Tree 446

446	Honey Locust	Gleditsia triacanthos	13	F/G	Wound at trunk at 1.2 metres	Retain
447	Honey Locust	Gleditsia triacanthos	4	F/G	Newly planted, minor deadwood in canopy	Retain
448	Honey Locust	Gleditsia triacanthos	12	G	Good form, full canopy	Remove due to construction
449	Bradford Pear	Pyrus calleryana	7	F/G		Remove due to construction
450	Bradford Pear	Pyrus calleryana	8	F/G	Mild lean	Retain

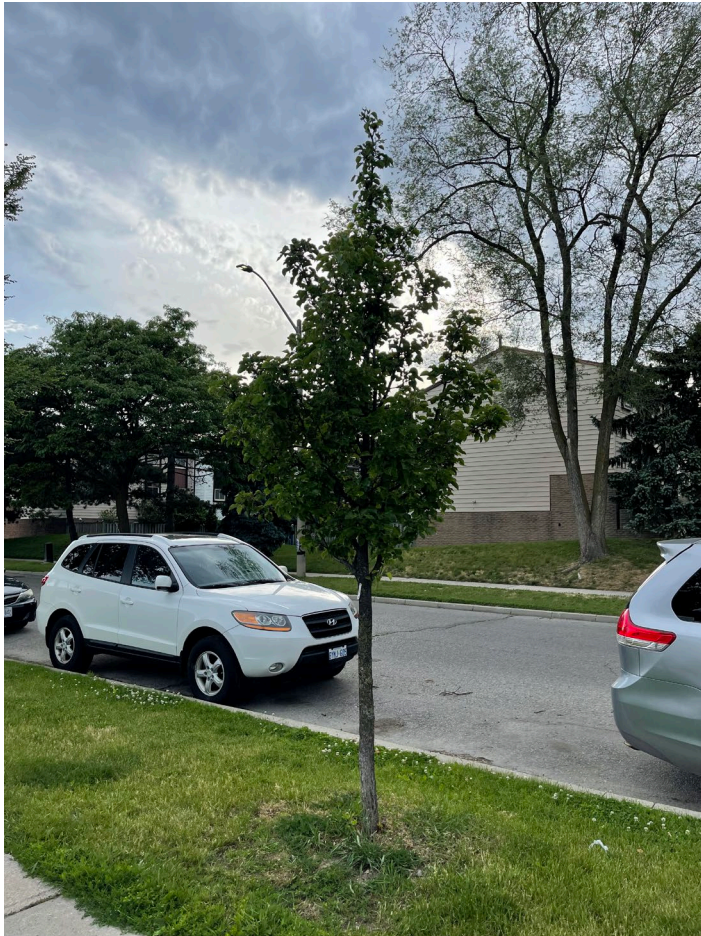
Tree 451

451	Bradford Pear	Pyrus calleryana	9	F/G	Slight bow in trunk	Retain
452	Bradford Pear	Pyrus calleryana	6	D	Tree 100% dead	Remove due to condition
453	Bradford Pear	Pyrus calleryana	6	D	Tree 100% dead	Remove due to condition
O1	White Mulberry	Morus alba	33	F	Growing between fences, self-seeded, multi-stemmed	Retain
O2	Manitoba Maple	Acer negundo	~25	F	Growing between fences, multi-stemmed, self-seeded	Retain
O3	Manitoba Maple	Acer negundo	27	F	Growing between fences, multi-stemmed, self-seeded	Retain
O4	Colorado Spruce	Picea pungens	24	F	Top of tree crowded and stunted due to adjacent tree cover	Retain
O5	Austrian Pine	Pinus nigra	18	F	Leader growing at severe angle due to adjacent tree cover	Retain
O6	Manitoba Maple	Acer negundo	45	F	Two stems at base, minor deadwood in canopy	Retain
O7	White Mulberry	Morus alba	36	F	Poor form, moderate deadwood in canopy, twisted main limbs with included bark	Retain
