# SLOPE STABILITY AND EROSION RISK ASSESSMENT

60 Dundas Street East  
Mississauga, Ontario

**File No.** 21-067

**Issued** August 2, 2022

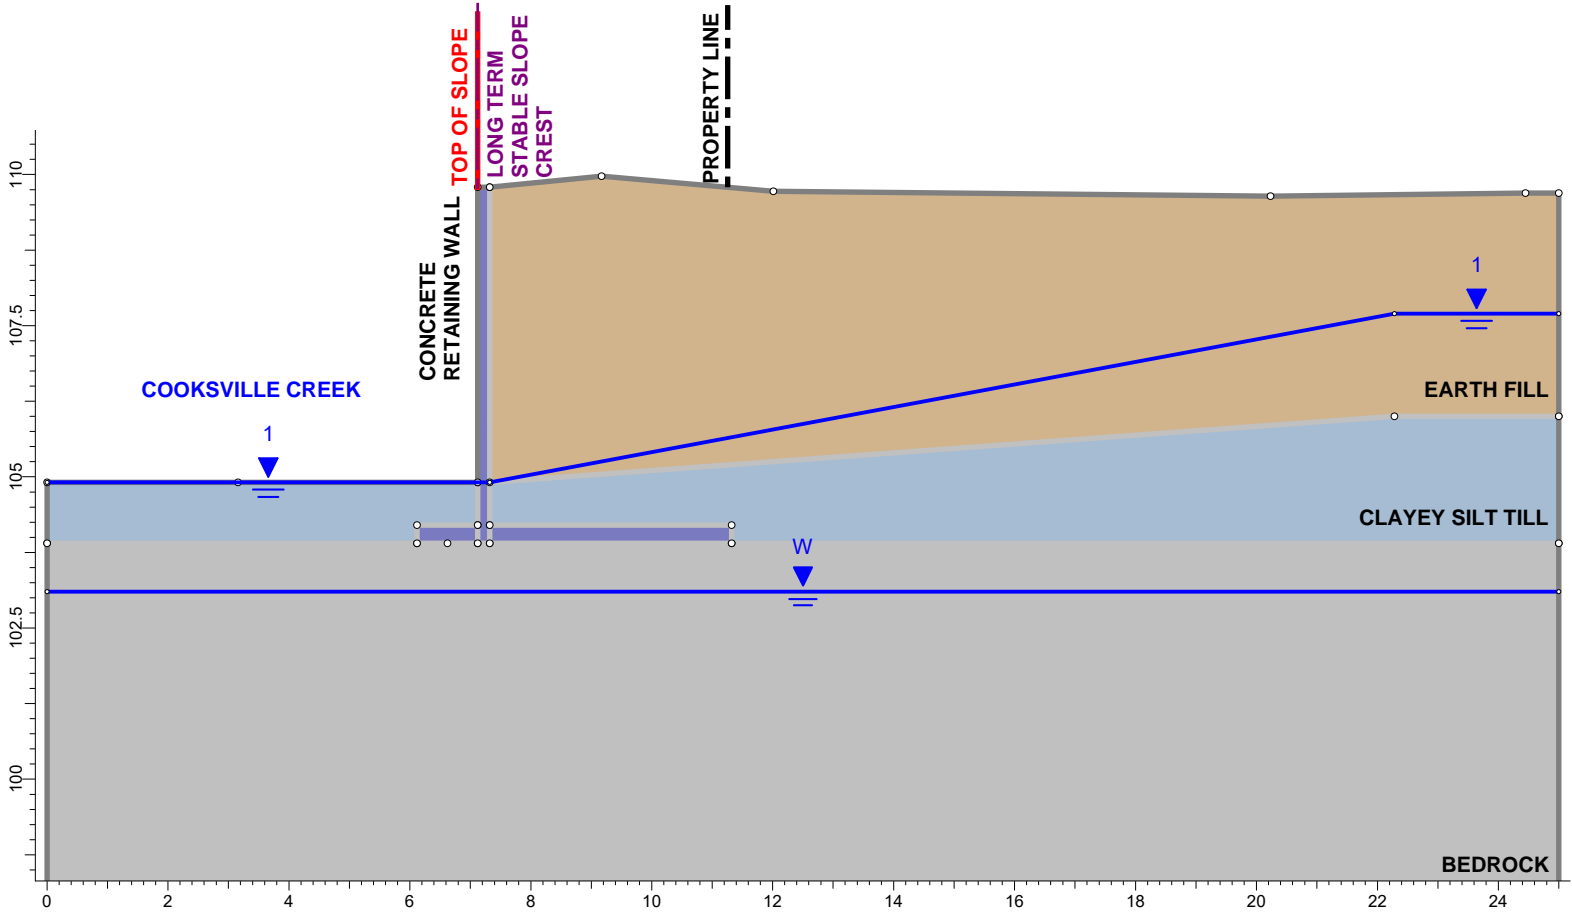
SECTION A

Based on the analyses of existing conditions, all four cross sections indicate a minimum factor of safety greater than 1.5. Therefore, given our assumptions and pending the required verifications, there is no requirement for a long-term stable inclination setback.

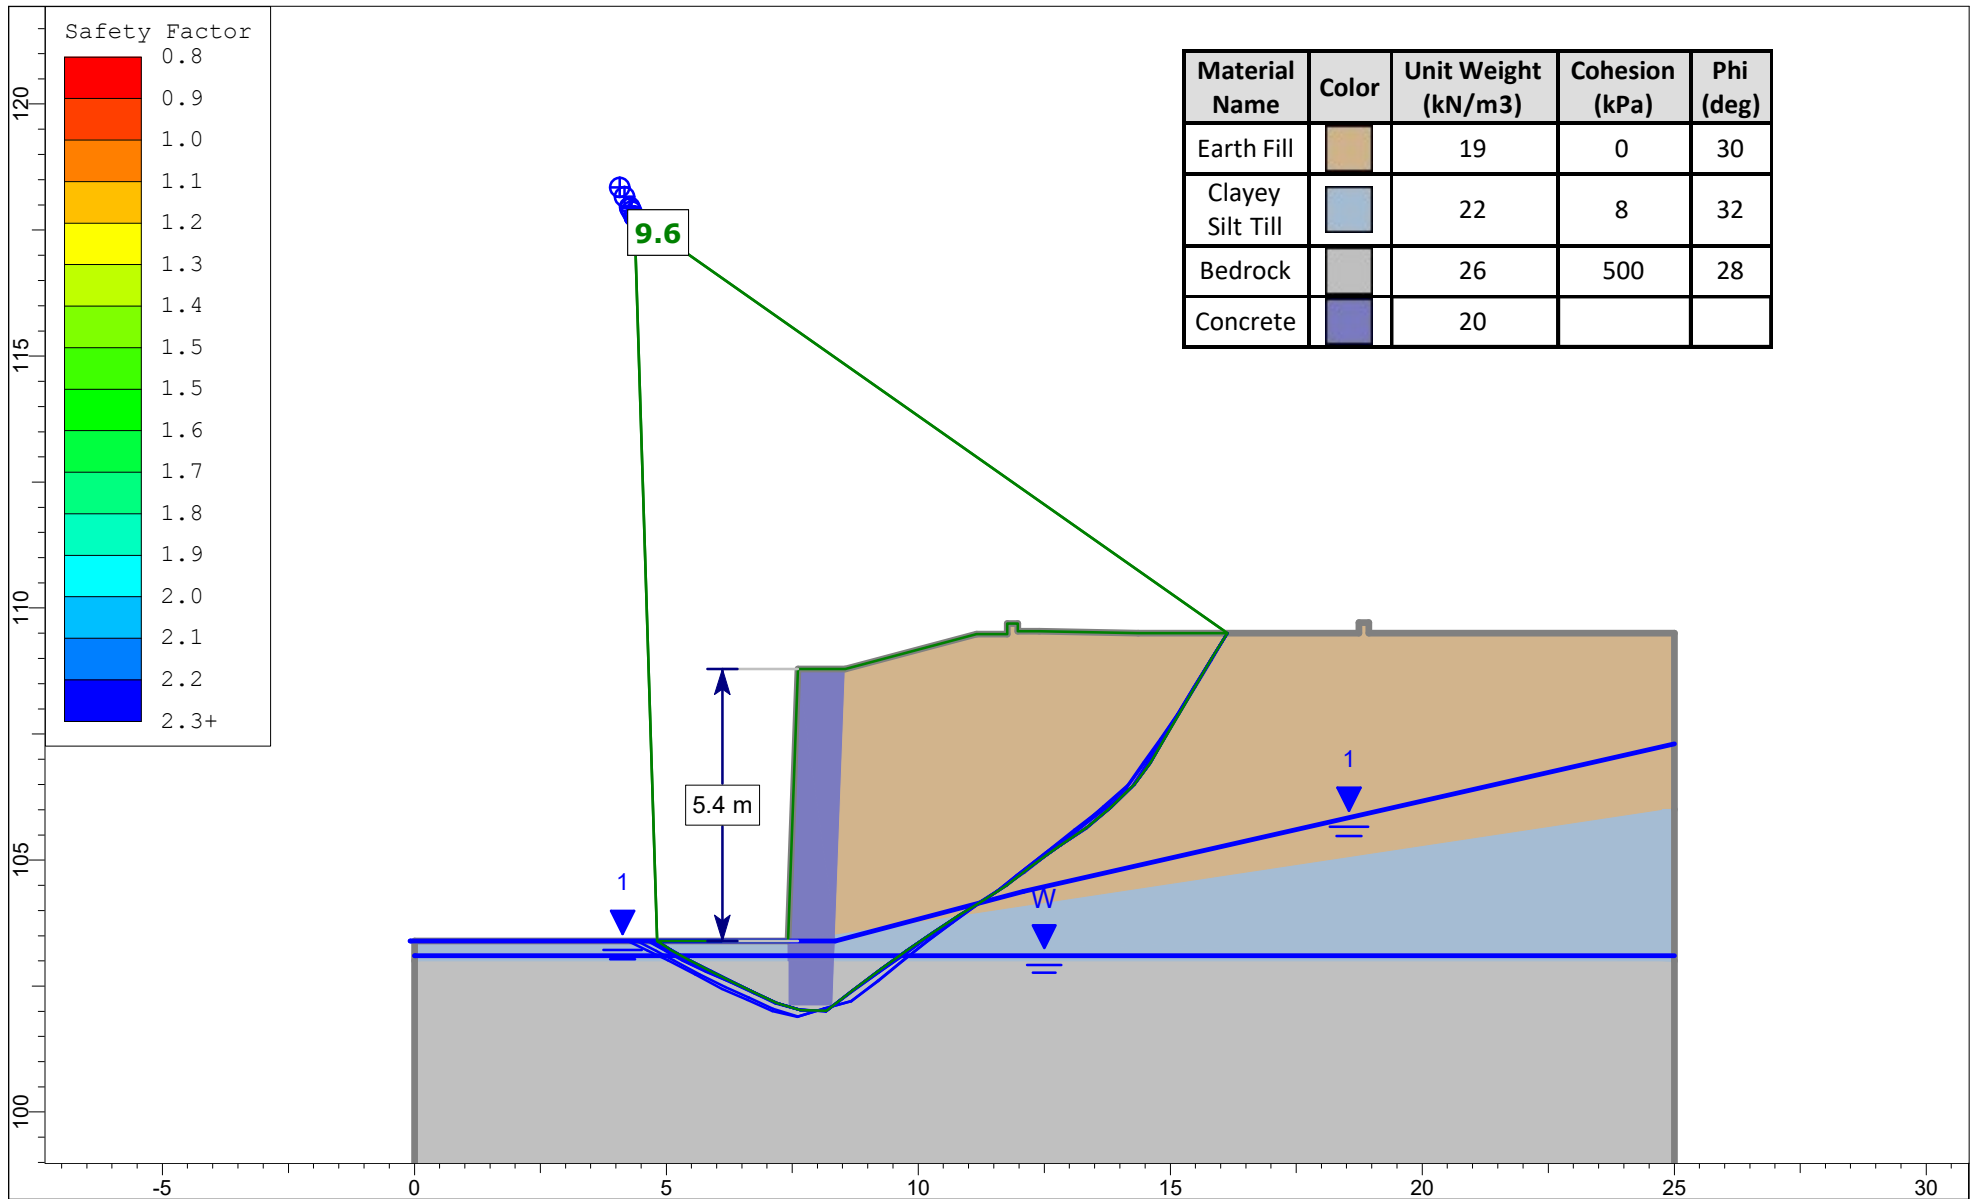
File	21-067   60 Dundas St E		
Analysis	Global Stability: Section C, Existing Conditions		
Ref.	Aksan Piller Corporation Ltd., Survey Drawing, Reference No. 20-21-14108-00, dated April 5, 2021		
RS2 File	21-067 60 Dundas St E Slope v2.slmd	Scale	1:150
		Eng	JH

The global stability around the retaining walls is considered stable, with minimum factors of safety of 1.6. Based on this information, the subject slope is considered to have a low risk of global instability under the present conditions.
