Re: 4099 Erin Mills Parkway - Mississauga - Tree Inventory & TPP

Tree Inventory

4099 Erin Mills Parkway Mississauga, ON

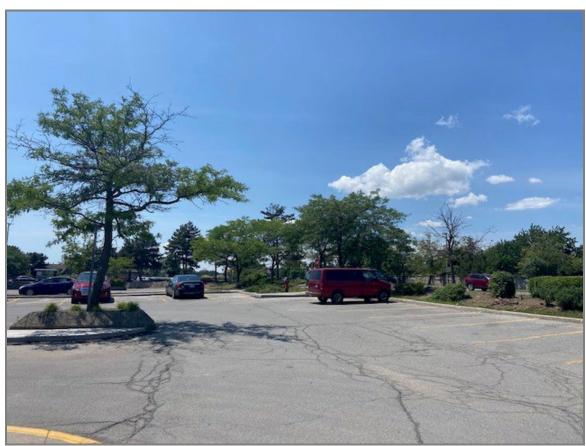
Photo #1: Trees no. 272-273, 278, C1 and C2 looking west.

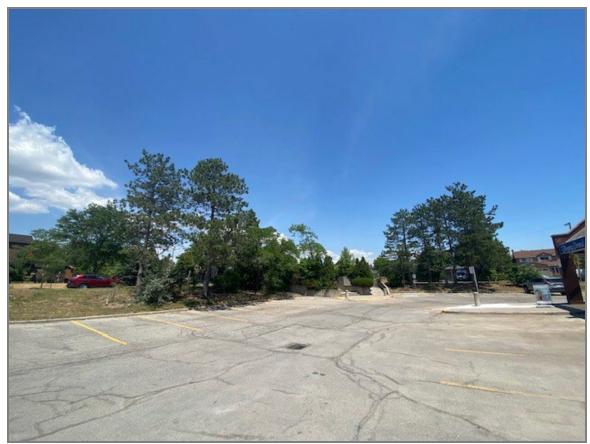
Photo #2: Tree no. 274-283 looking northeast.

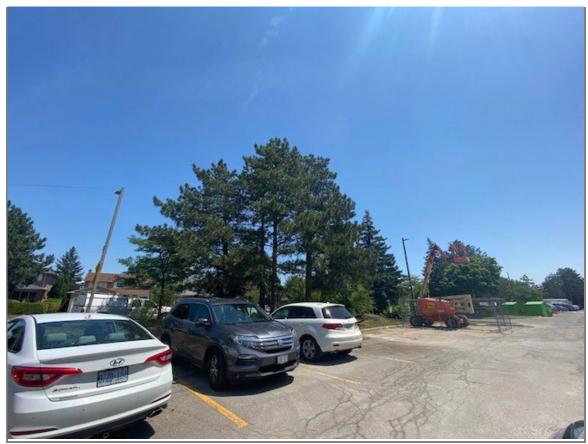
Photo #3: Tree no. 291-2994 looking southeast.

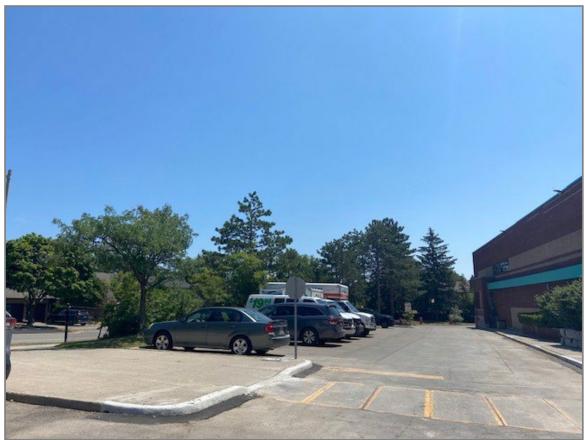
Photo #4: Tree no. 300-313 trees looking southeast.

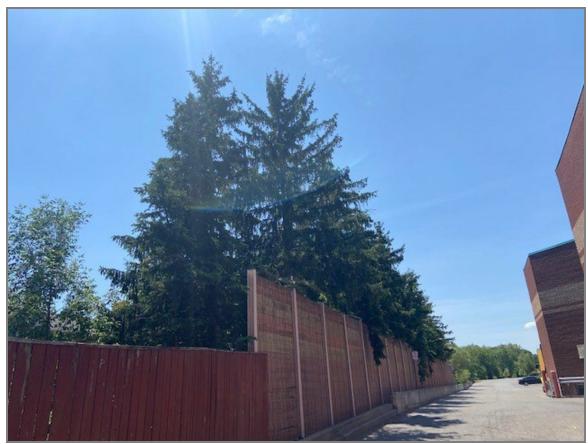
Photo #5: Tree no. 314-336 looking southwest.

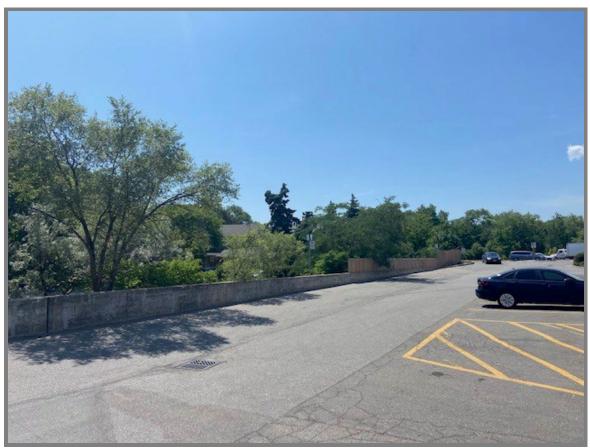
Photo #6: Tree no. 337-344 looking southwest.

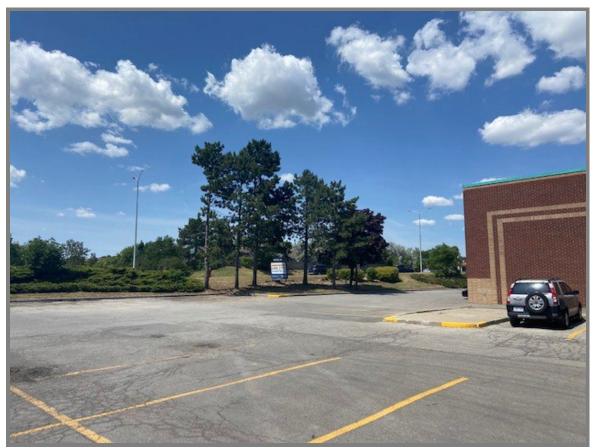
Photo #7: Tree no. 345-350 looking west.

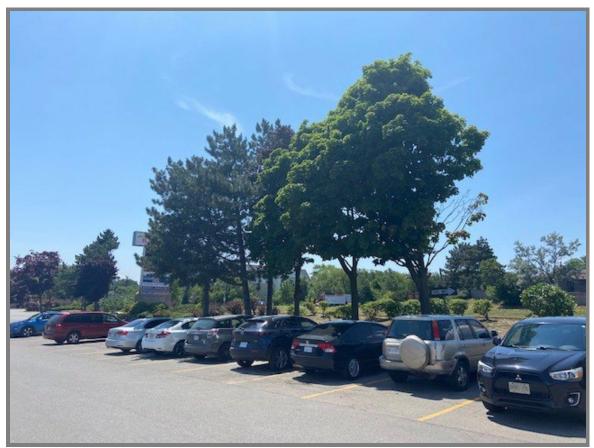
Photo #8: Tree no. 351, 353-358 looking southwest.

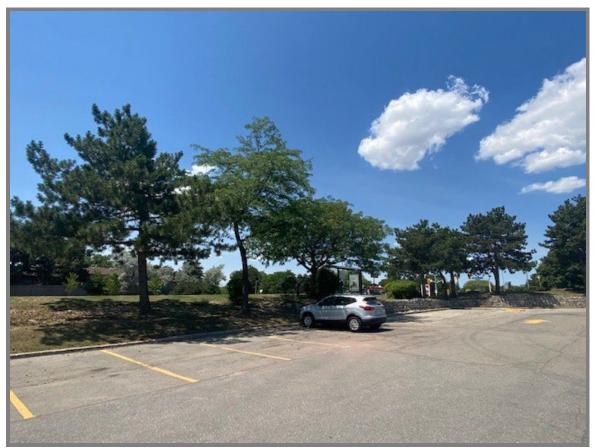
Photo #9: Tree no. 359-368 looking northwest.

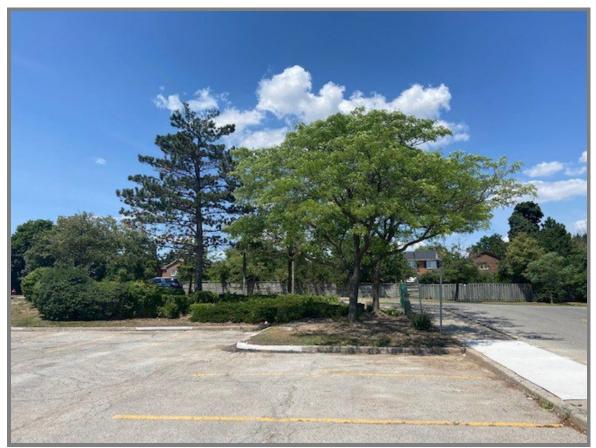
Photo #10: Tree no. 370-372 and C28-C29 looking southwest.
