**GEOTECHNICAL INVESTIGATION  
SLOPE STABILITY & STREAMBANK EROSION STUDY  
900 MISSISSAUGA HEIGHTS DRIVE  
MISSISSAUGA, ONTARIO**

File No. 1-18-0001-01

June 14, 2018

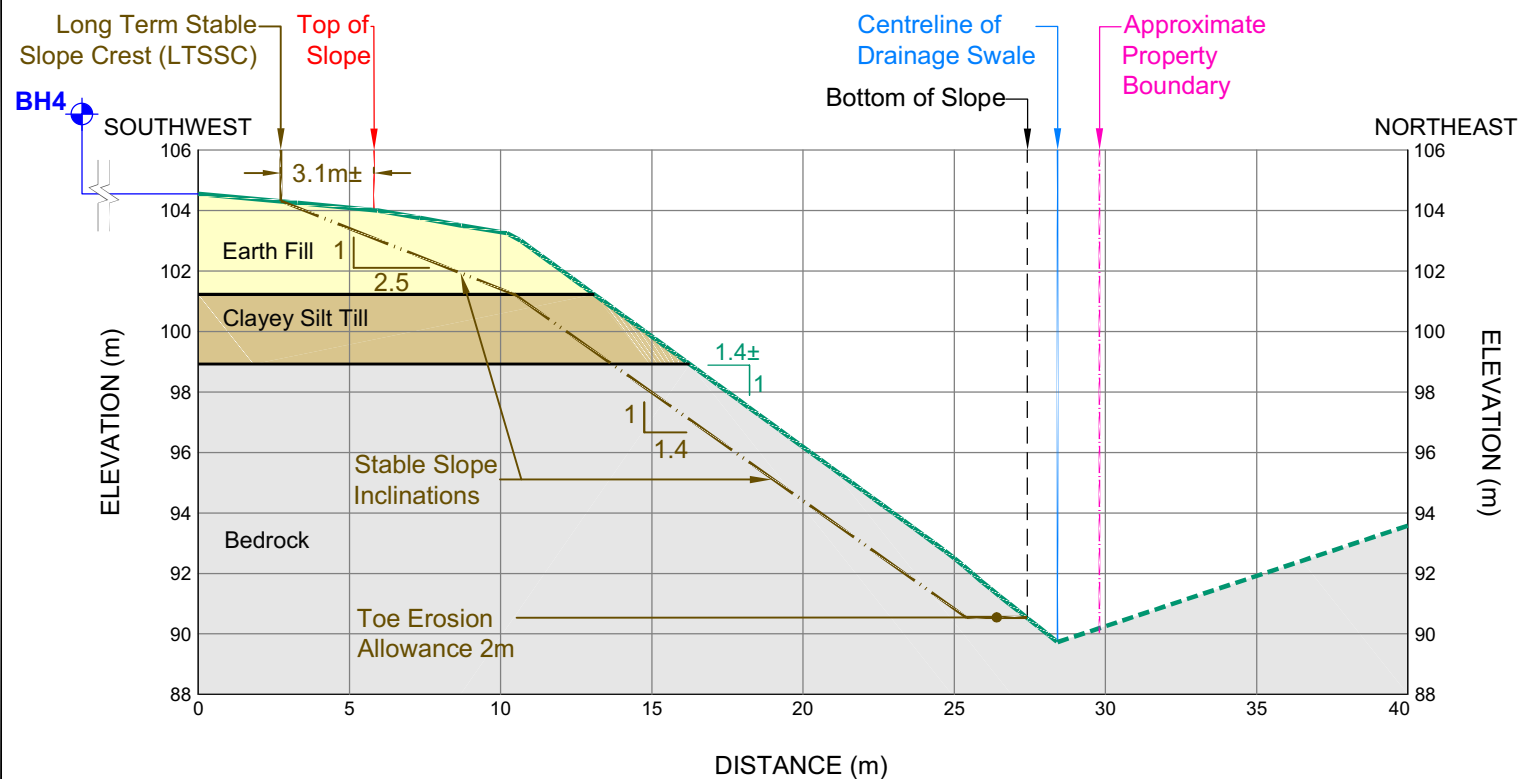
SECTION C-C'

The results of the analysis indicate that the existing slope has adequate Factor of Safety for both normal and elevated ground water conditions at Sections A-A', B-B', D-D' and F-F'. The relatively high Factors of Safety obtained for these Sections are representative of relatively thin overburden thickness as most of the slope at these sections comprises shale bedrock. However, at Section C-C', the slope does not have adequate Factors of Safety for normal ground water condition and elevated ground water condition, as the inferred overburden at this location is about 5 m thick. Therefore, the slope at the Section C-C' is not considered to be stable in the long term in its current configuration.

The results of the slope stability analysis at Section C-C' indicate that slope stability failure would likely be limited within the earth fill zone under the current inclination, therefore a hypothetical slope profile of the earth fill zone with a flatter inclination of 2.5 horizontal to 1.0 vertical was analysed for both normal and elevated ground water conditions to determine the stable inclination units. A Factor of Safety of 1.5 for normal and 1.3 for temporary/elevated groundwater conditions. The detailed results of the analysis are presented in enclosed figures. The Factor of Safety under the normal ground and elevated ground water level conditions for the hypothetical slope surface are tabulated below:

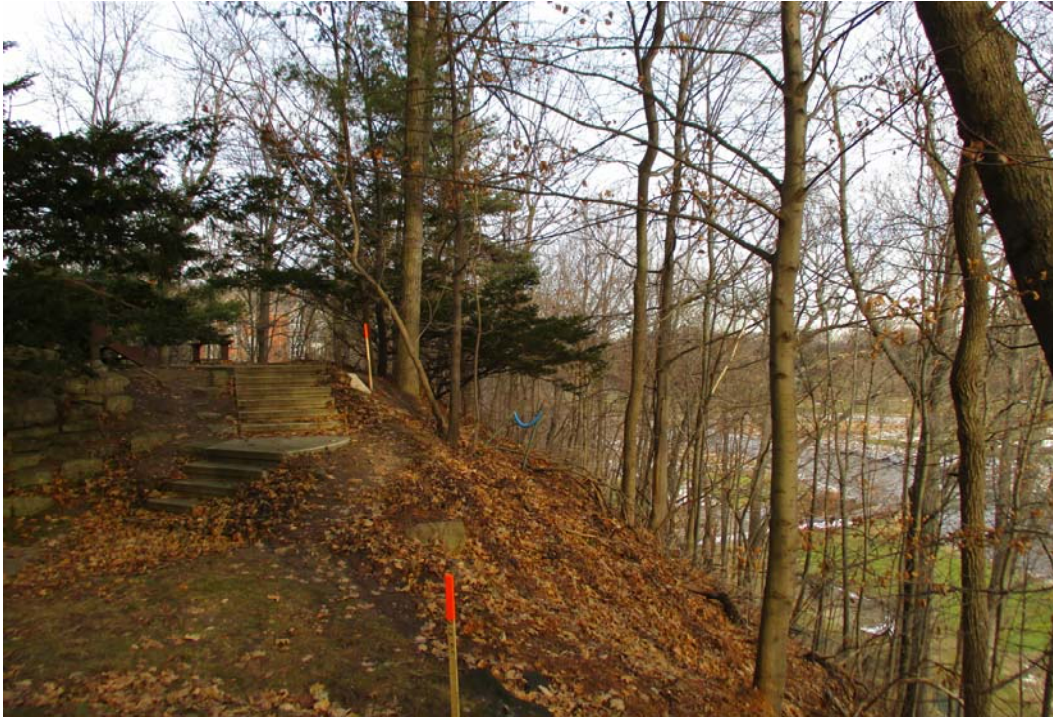
PHOTOGRAPH 3. Looking northeast, a view of slope crest and slope. A series of concrete steps is located at the slope crest. The slope is leaf littered and vegetated with saplings and mature trees. The tree trunk growth is generally straight and upright.

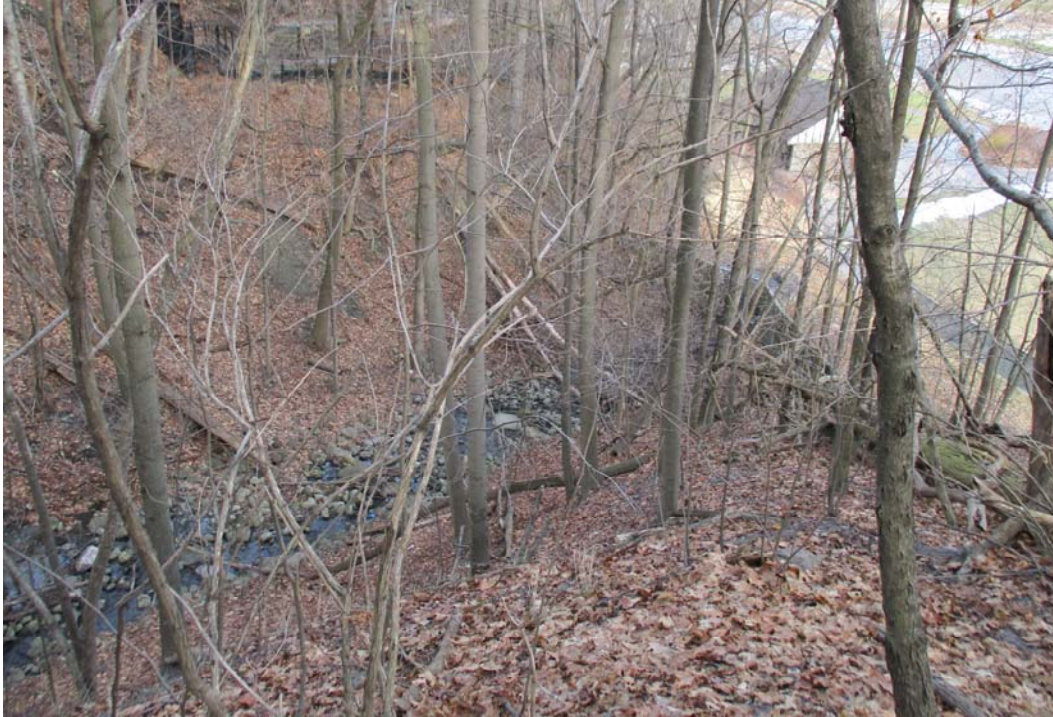
PHOTOGRAPH 9. Looking east, another view of ravine slope. A small drainage swale is located on the slope.

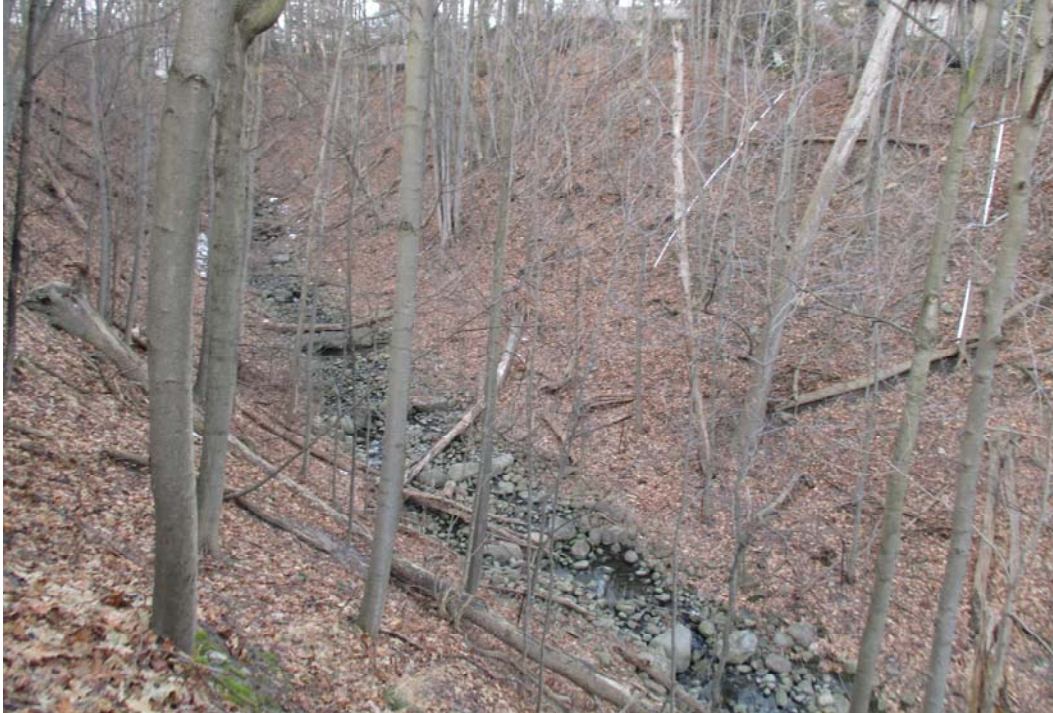
PHOTOGRAPH 11. Looking north, a view of the slope toe. A relatively shallow drainage swale is situated at the slope toe before the slope rise again on the other side of the swale.

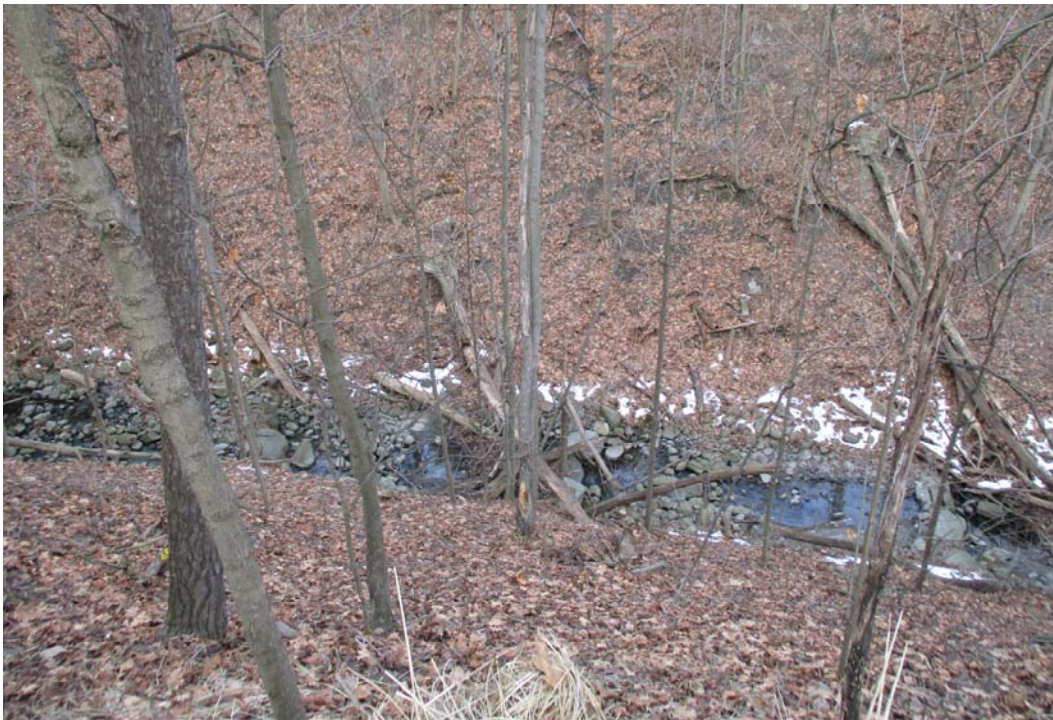
PHOTOGRAPH 14. Looking northeast, a view of the slope toe and drainage swale. The swale surface is covered with numerous field stone and cobbles. No evidence of bank erosion.

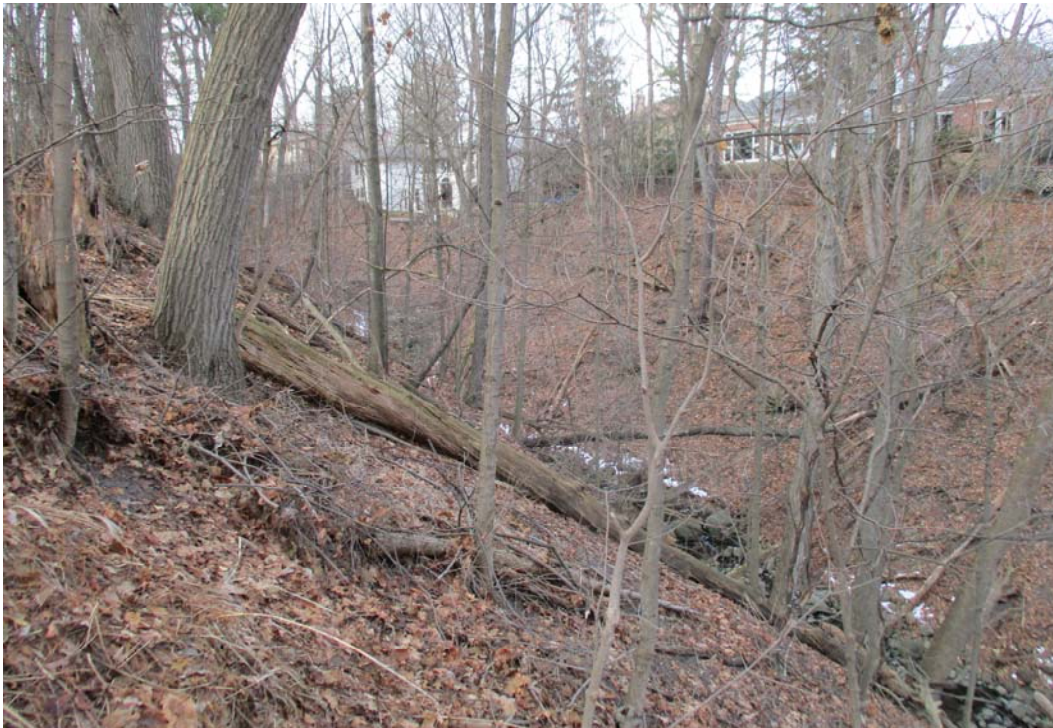
PHOTOGRAPH 15. Looking north, another view of the vegetated slope. No evidence of slope instability (i.e. scarp, slump, tension crack etc.

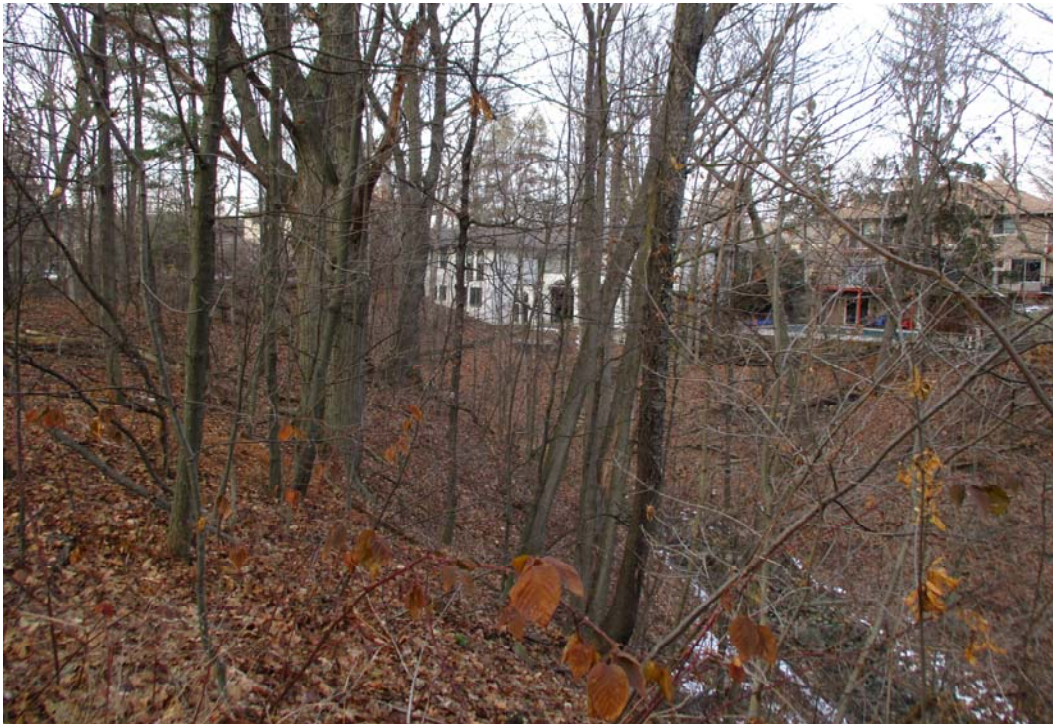
PHOTOGRAPH 17. Looking northwest, another view of the vegetated ravine slope. No conspicuous evidence of slope instability and toe erosion.

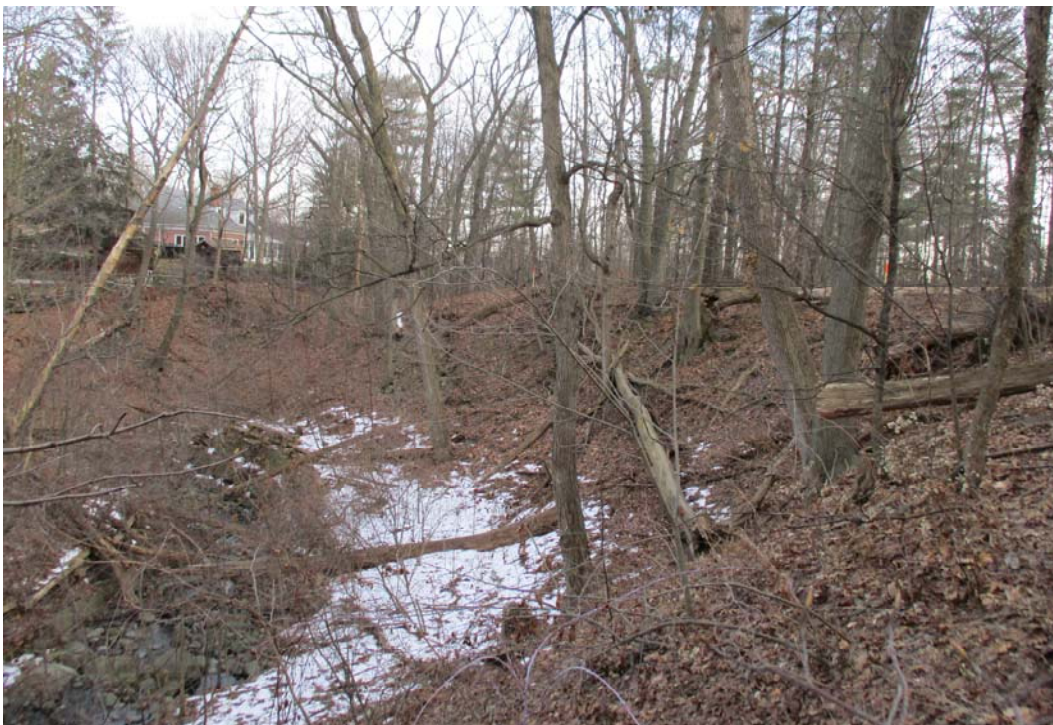
PHOTOGRAPH 18. Looking southeast, another view of the ravine slope and drainage swale. The swale bank includes field stone/gabion stone lining. No evidence of the slope toe/swale bank erosion.

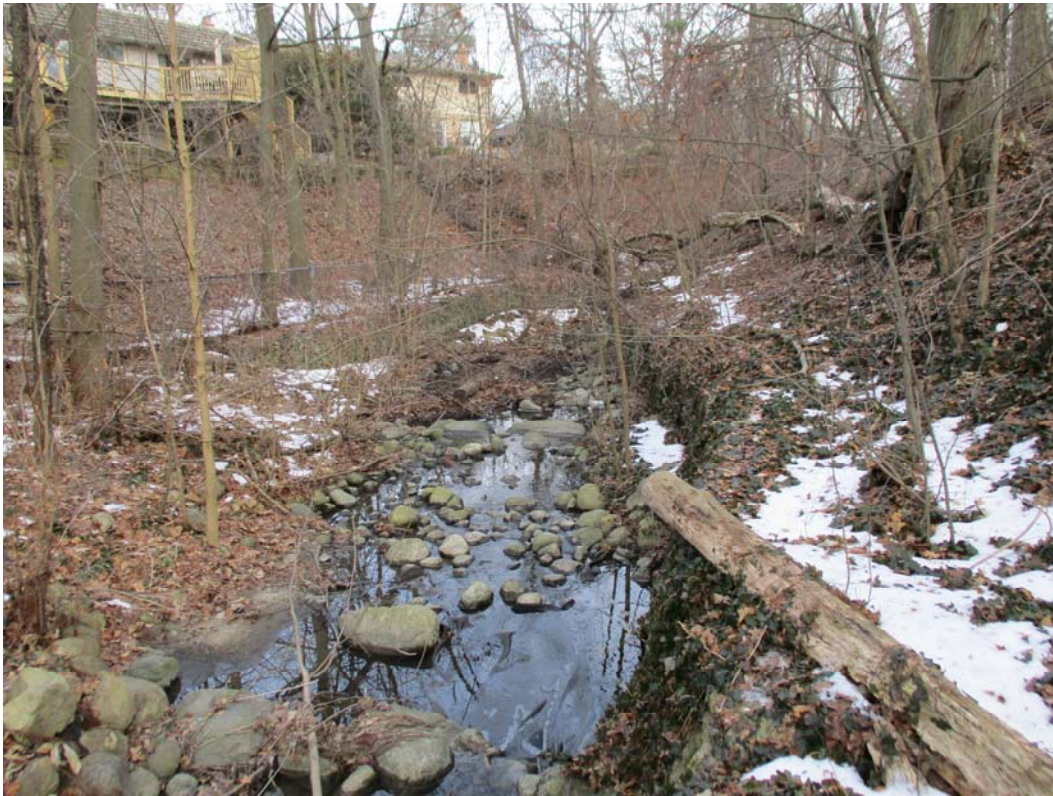
PHOTOGRAPH 19. Looking southeast, a view of the slope toe and drainage swale. The swale bank includes field stone/gabion lining.
