# Arborist Report

## Pre-Construction Assessment

**Site Address:**  
4094 Tomken Rd.  
Mississauga, ON, L4W 1J5

**Prepared: September 26<sup>th</sup>, 2022**  
**Revised: August 8<sup>th</sup>, 2023**

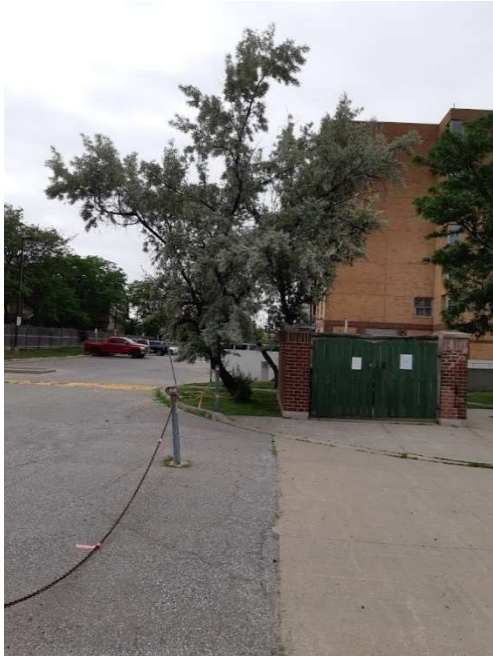
Fig 13. Trees #128-129 (left to right)

129	129	Willow	<i>Salix species</i>	29	Private	1.8	G	F	F	9.1	9.1	100	0	Y	H	Remove	Y	Multistem (18, 23), missing leaves, trunk wound
130	130	Honey Locust	<i>Gleditsia triacanthos</i>	32	Private	2.4	G	G	G	12.2	9.1	100	0	Y	H	Remove	Y	
131	131	Honey Locust	<i>Gleditsia triacanthos</i>	36	Private	2.4	G	G	G	12.2	9.1	100	0	Y	H	Remove	Y

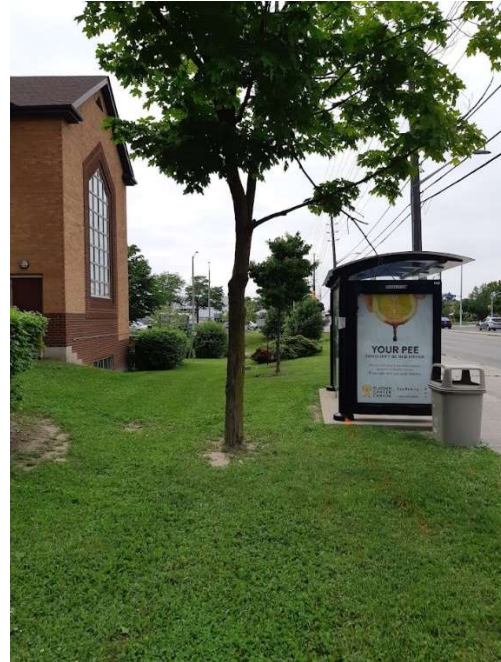
Fig 22. Tree #144

144	144	Norway maple	<i>Acer platanoides</i>	23	Private	1.8	F	F	F	12.2	9.1	70	30	N	L	Remove	Y	Missing leaves, trunk damage.
145	145	Sugar Maple	<i>Acer saccharum</i>	25	Private	1.8	G	G	G	12.2	9.1	100	0	Y	H	Remove	Y	
146	146	Sugar Maple	<i>Acer saccharum</i>	21	Private	1.8	G	G	G	12.2	9.1	100	0	Y	H	Remove	Y

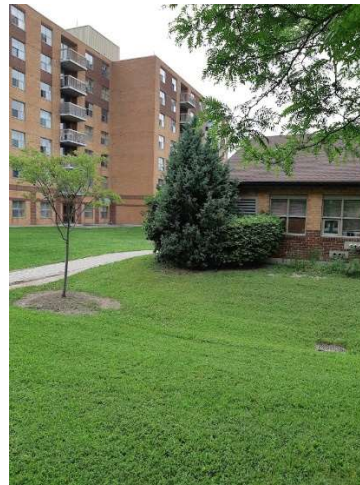
Fig 32. Tree #160 (tree close to building)
