Phase One Environmental Site Assessment 799, 801, 803 and 805 Dundas Street East Mississauga, Ontario

Project: 22-16145

June 17, 2022

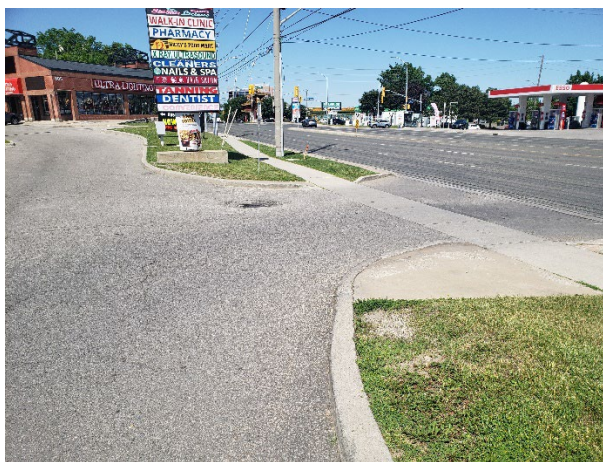
Photo No. 3: View of southeast (Dundas Street East) frontage of property from southwest, Esso Gasoline Station and Active Green and Ross auto repairs in background.

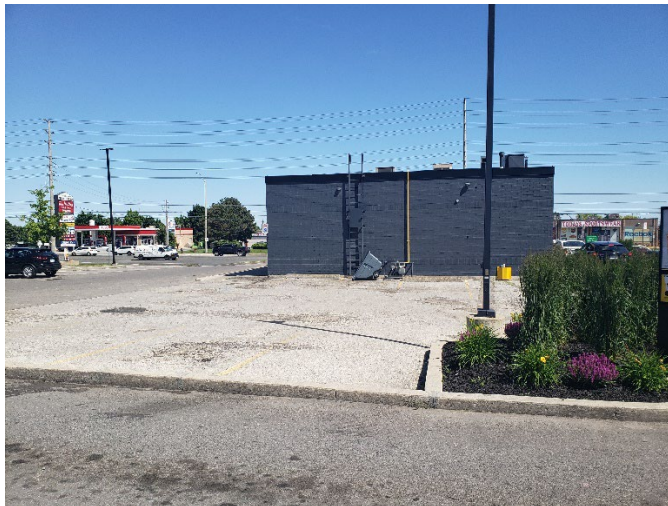
Photo No. 6: View of northwest side of 799 Dundas St E (Tim Horton's) building, from northwest

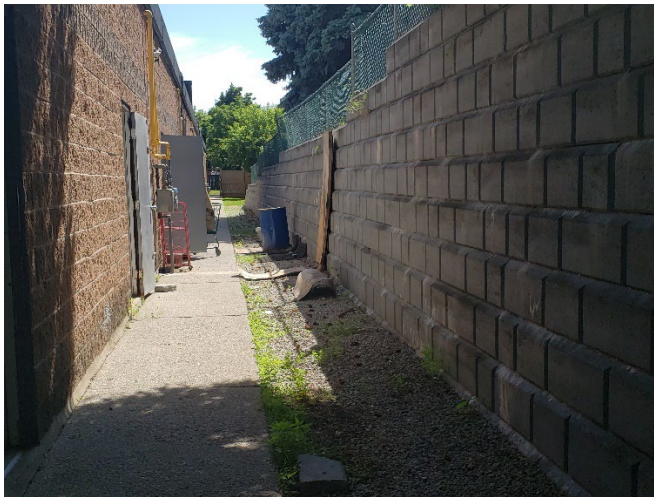
Photo No. 11: View of northwest side of 801 Dundas St E building, from northeast

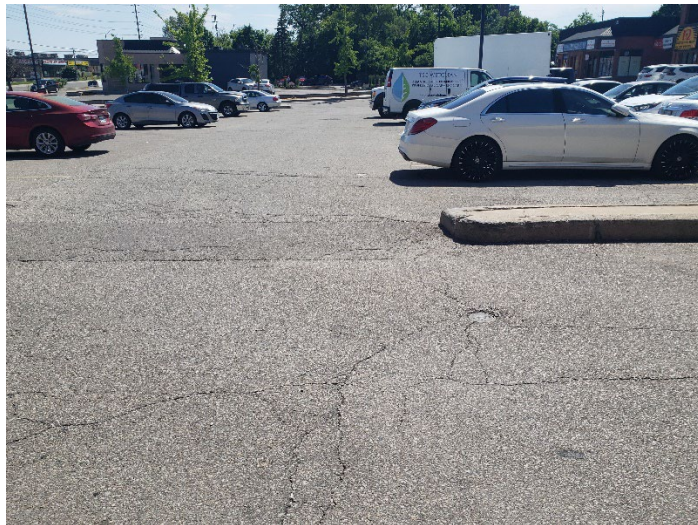
1. Covers for several monitoring wells were observed in the northeast section of the Phase One property, to the southeast of the 801 Dundas building and west from the 803 Dundas Building, as shown on the site plan, Drawing No. 3. An additional monitoring well was observed to the east of the 805 Dundas building.
2. No potable water supply wells or other monitoring wells were observed at the Phase One property at the time of the site visit.

Photo No. 13: View of parking area, west of 803 Dundas St E building showing existing monitoring well covers

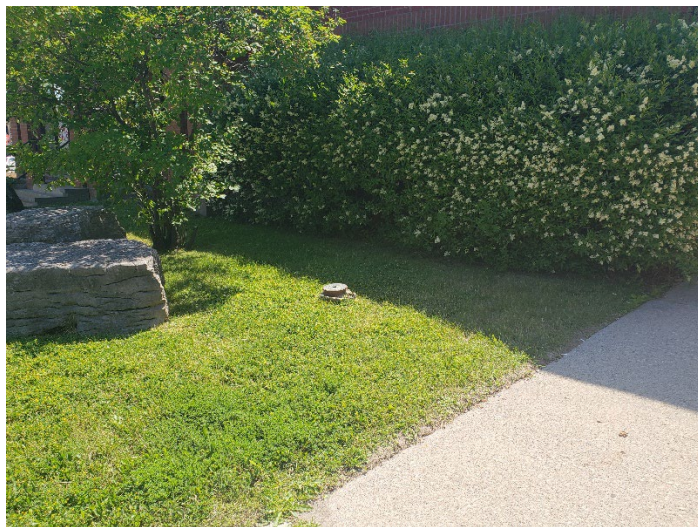
Photo No. 14: View of existing monitoring well cover, east of 805 Dundas St E building
