ARBORIST REPORT

Sunningdale Bend Residential

1667 Sunningdale Bend
Mississauga, Ontario

Baker Turner inc

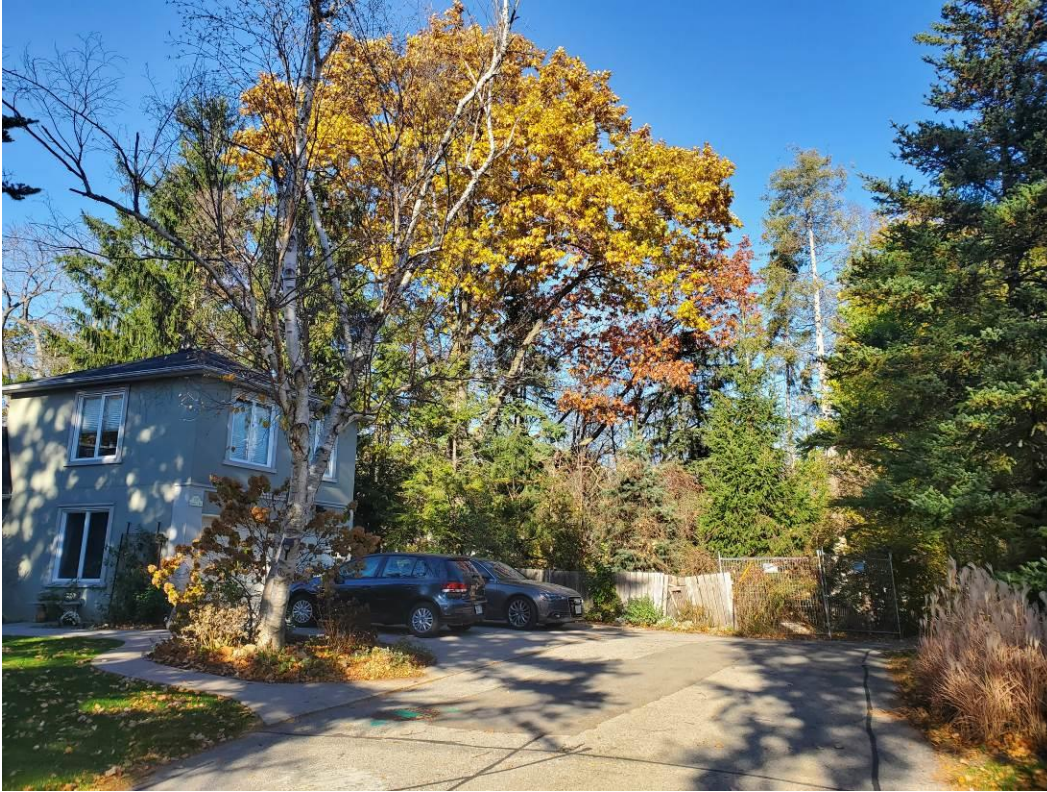
Figure 2: View to East at Site Access at Sunningdale Bend

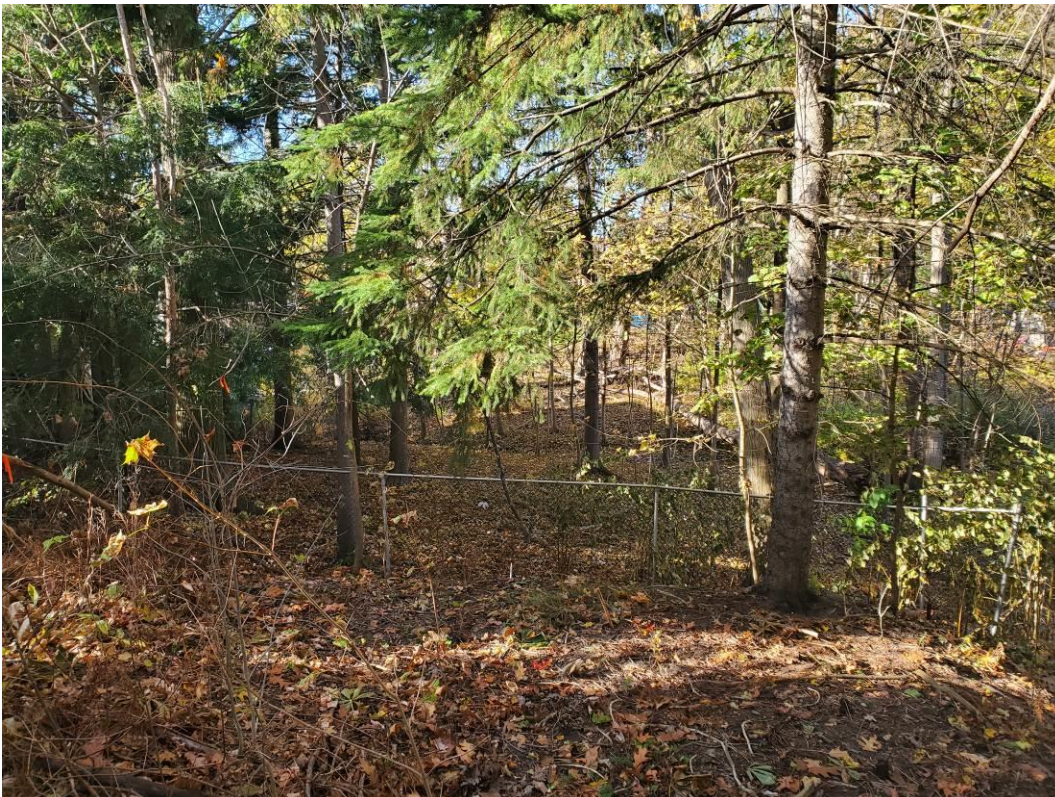
Figure 3: View to North of Naturalized Slope

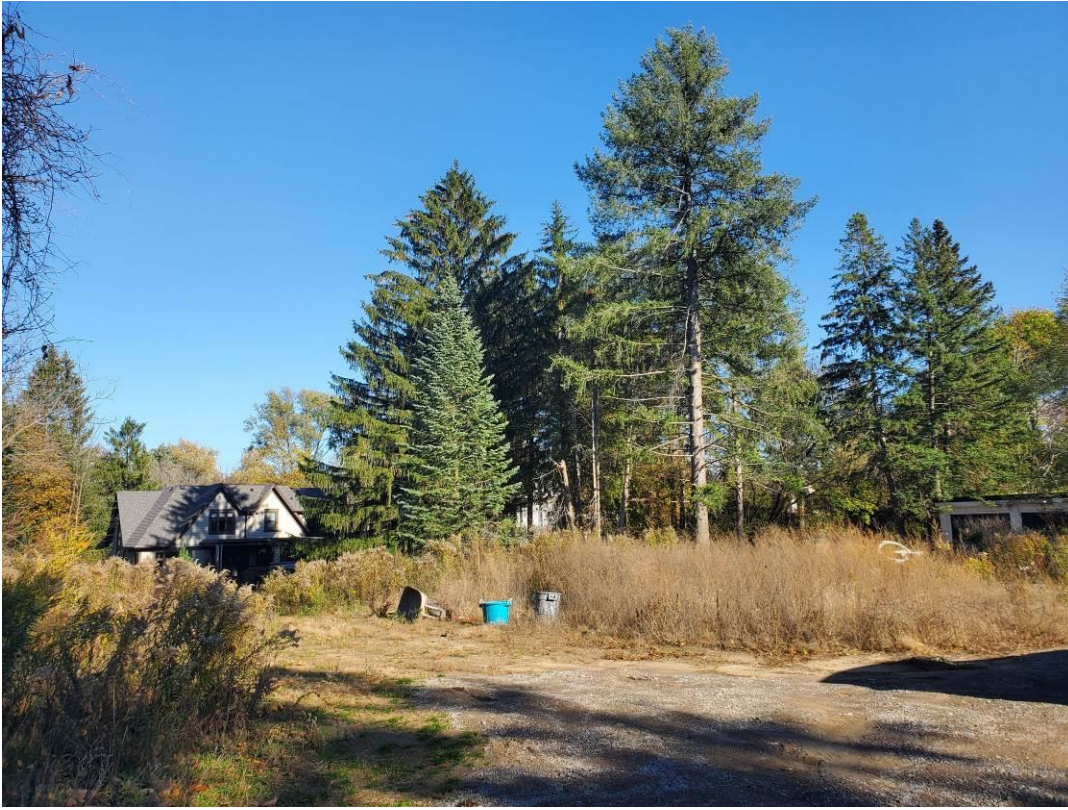
Figure 4: View to Southeast at Centre of Site.

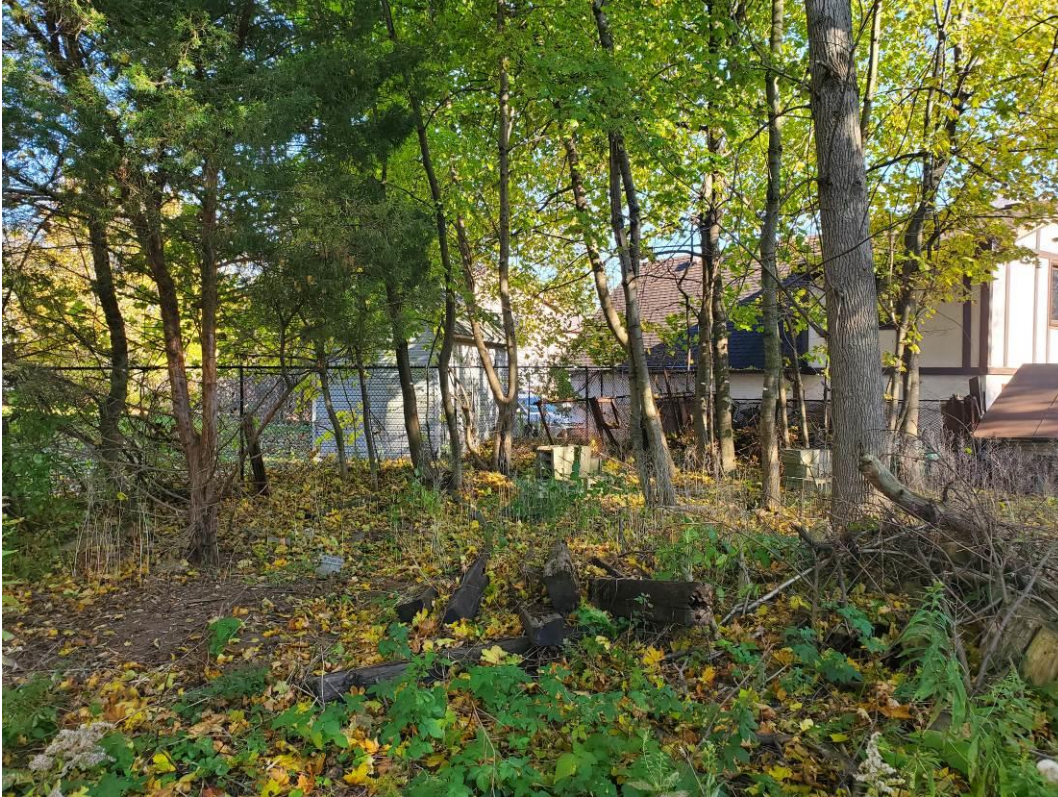
Figure 6: Trunks in Southeast Corner of the Site.
