APPENDIX C
Fluvial Geomorphology Assessment

**PRELIMINARY FLUVIAL GEOMORPHOLOGY ASSESSMENT OF LITTLE
ETOBICOKE CREEK
DIXIE-DUNDAS FLOOD MITIGATION**

Prepared for:
CITY OF MISSISSAUGA

Prepared by:
MATRIX SOLUTIONS INC.

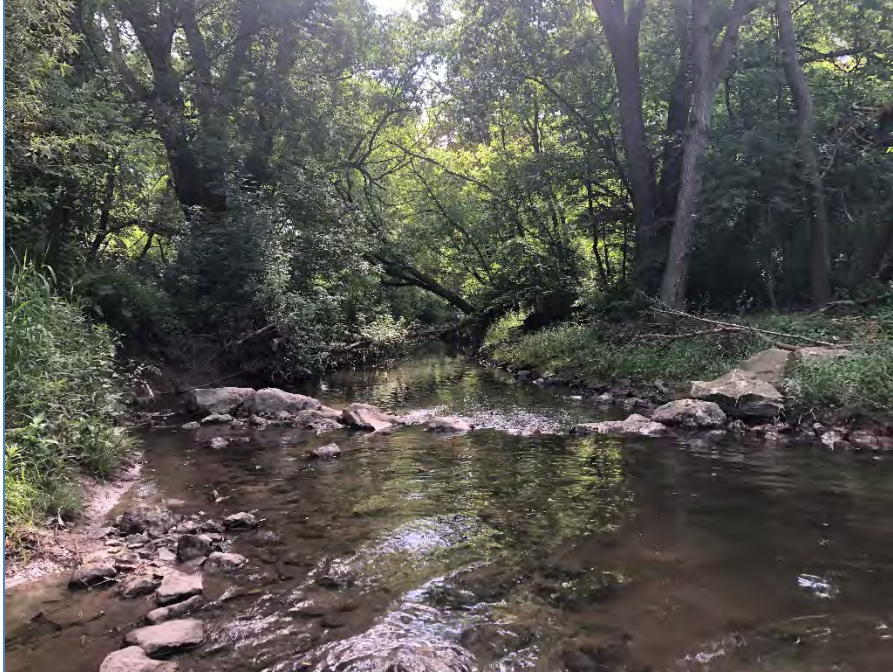
Photograph 1: R1 view downstream of rock vortex weir outflanked on left bank

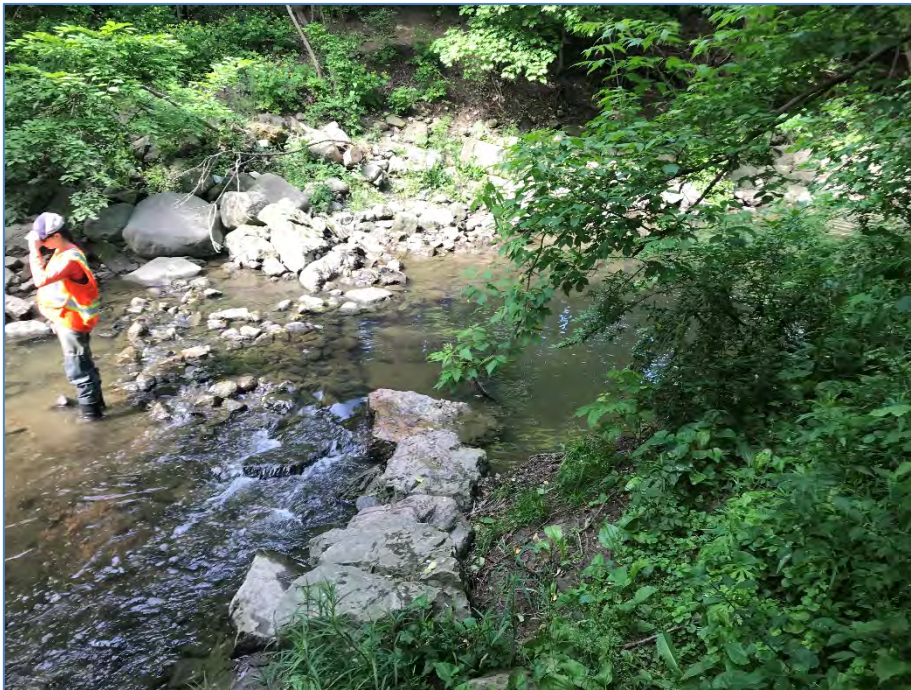
Photograph 2: R1 view of rock vortex weir

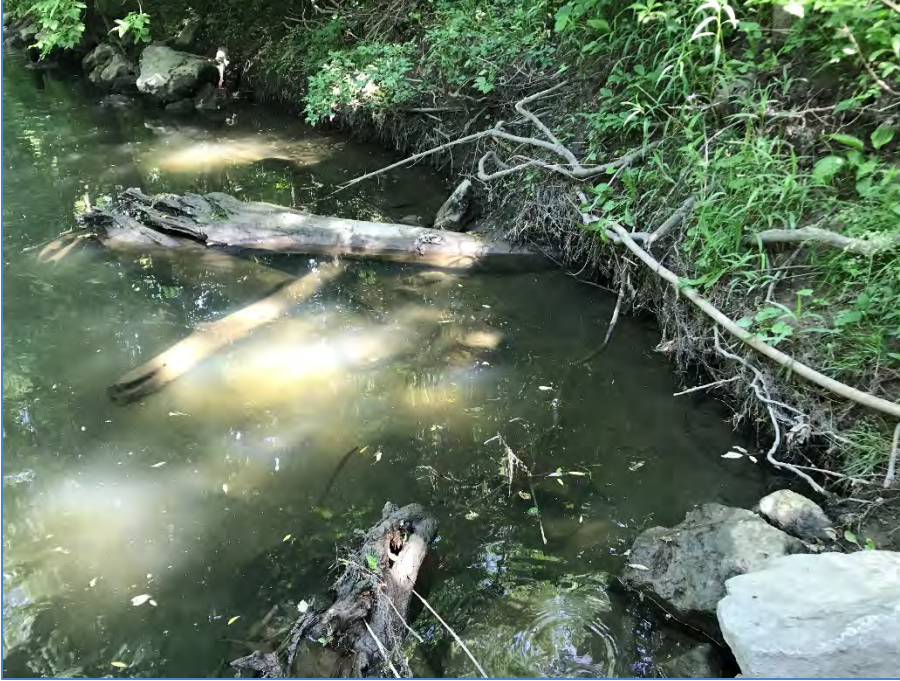
Photograph 3: R1 view of rootwad embedded in undercut channel bank

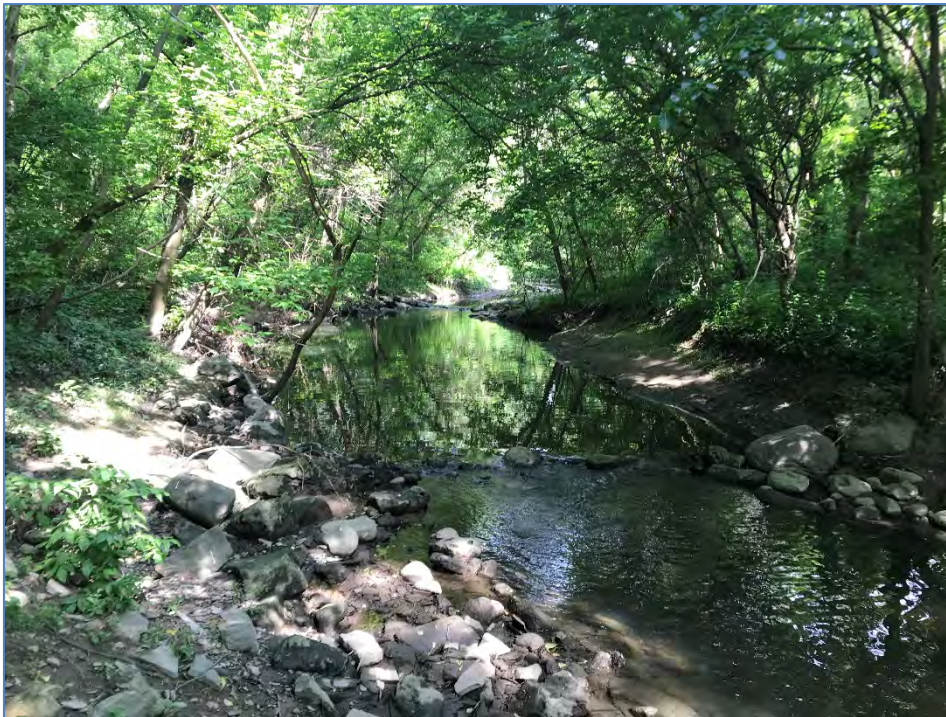
Photograph 4: R1 view downstream of outflanked bank treatments and eroded natural bank

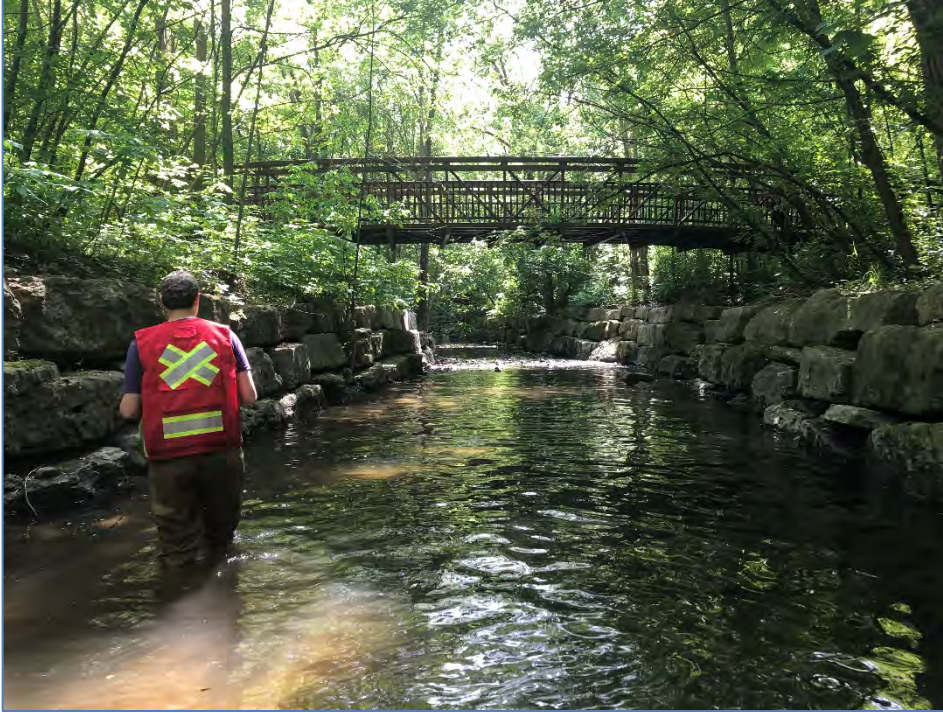
Photograph 5: R2a view downstream of armourstone blocks lining channel and pedestrian bridge

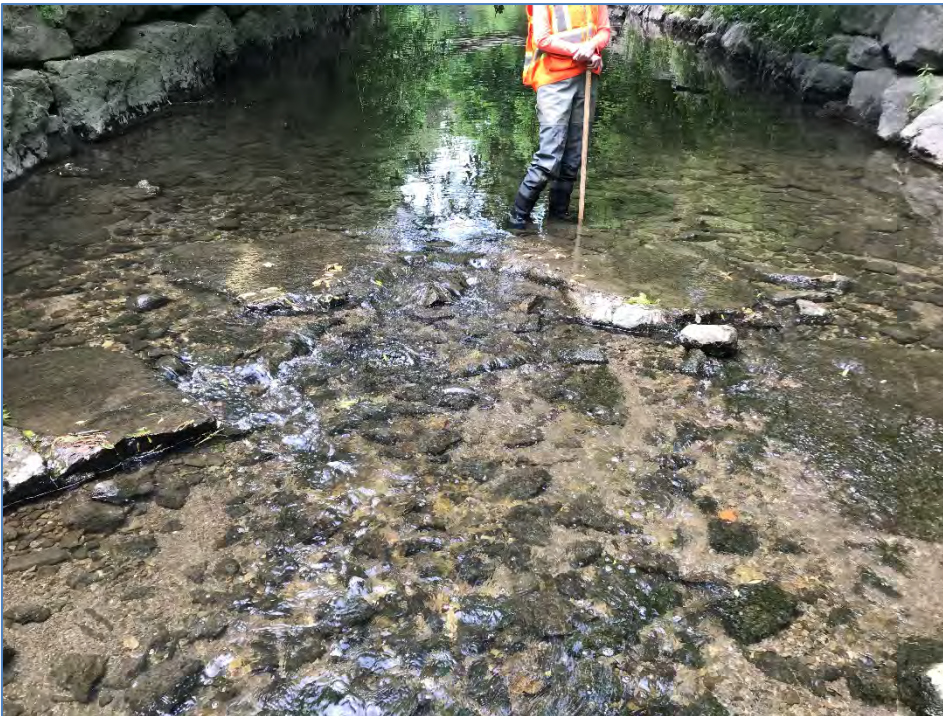
Photograph 6: R2a view upstream of armourstone grade control feature

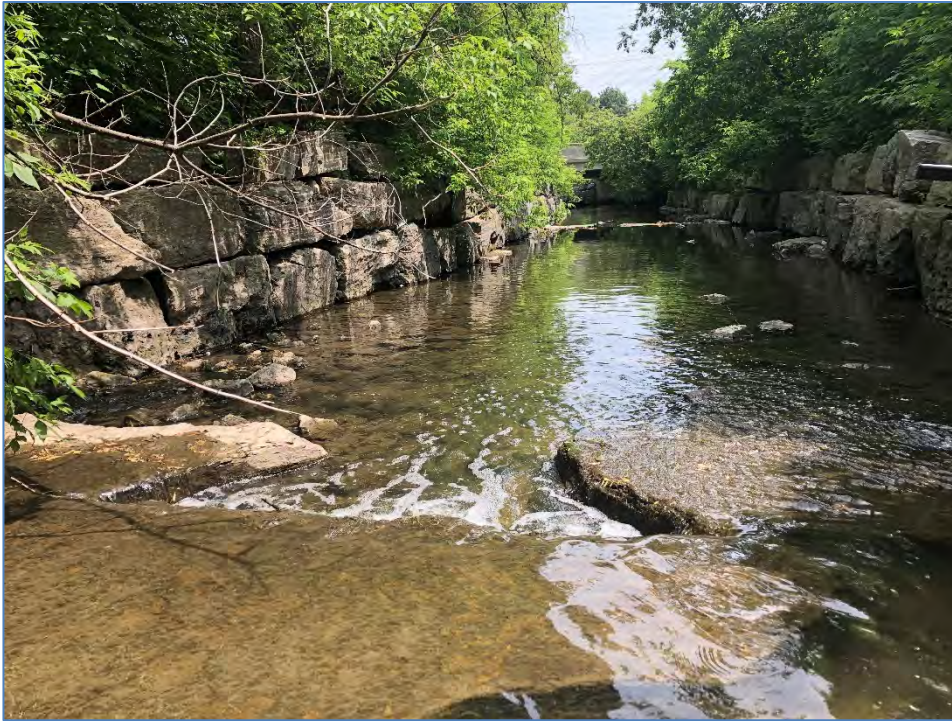
Photograph 7: R2a view downstream of armourstone grade control feature

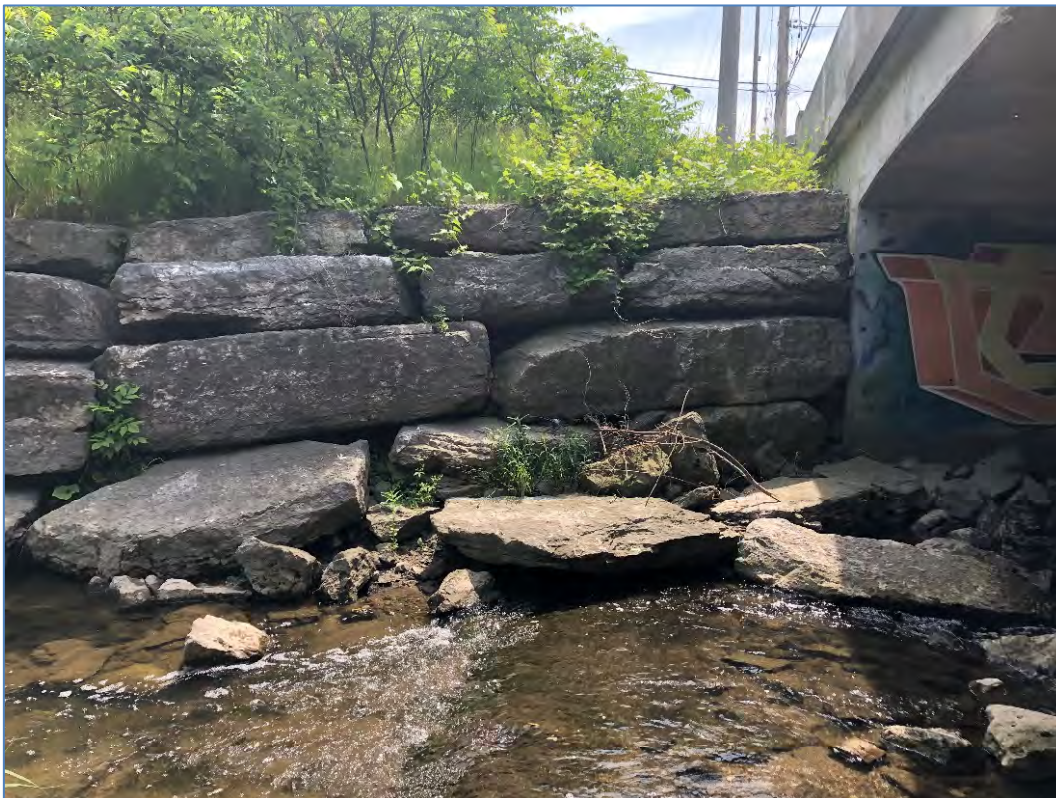
Photograph 8: R2b view of armourstone on right bank and concrete feature on bed

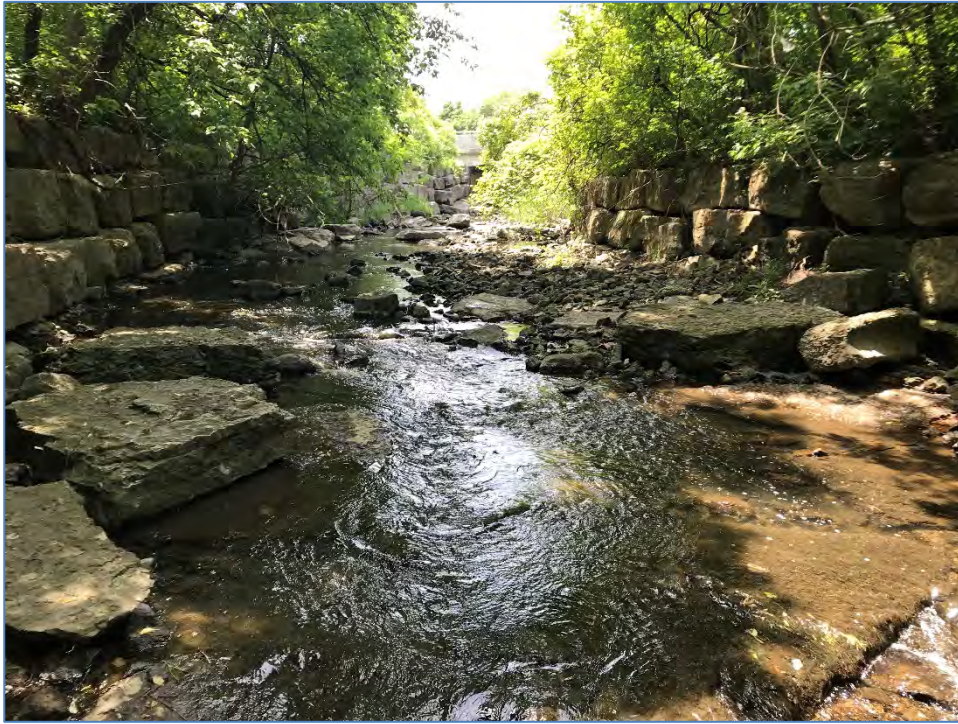
Photograph 9: R2b view upstream of armourstone blocks in channel

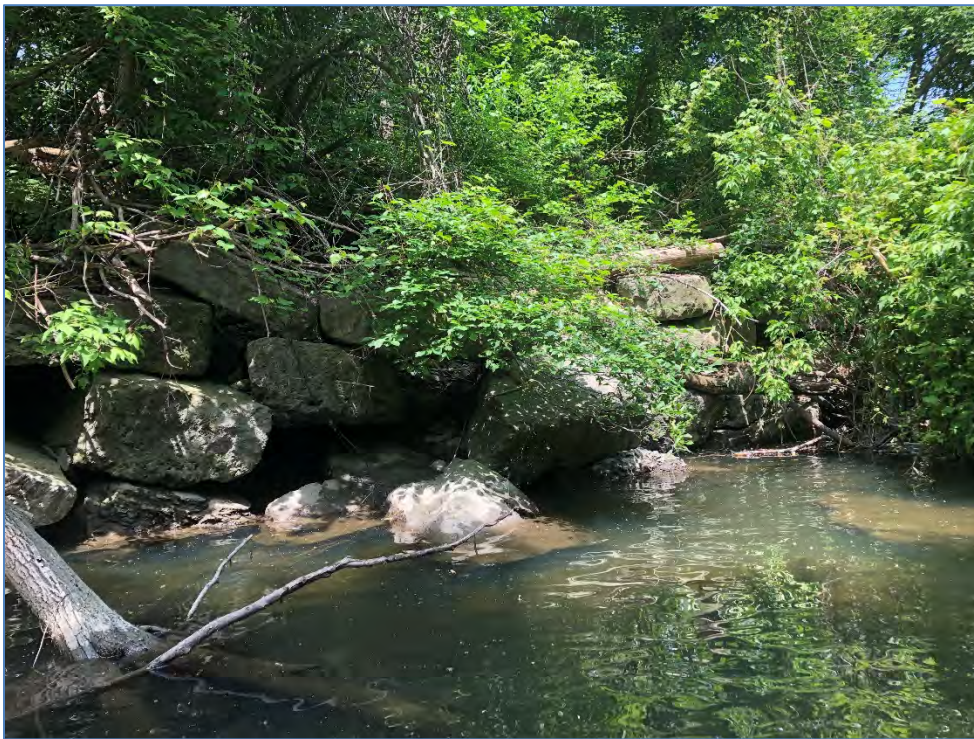
Photograph 10: R2b view of failed armourstone bank treatment on right bank

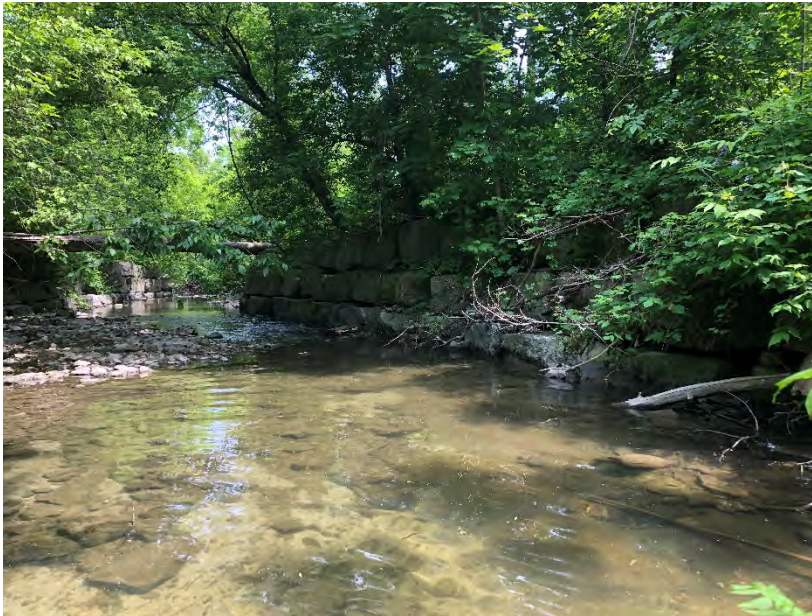
Photograph 11: R2b view downstream armourstone blocks on banks

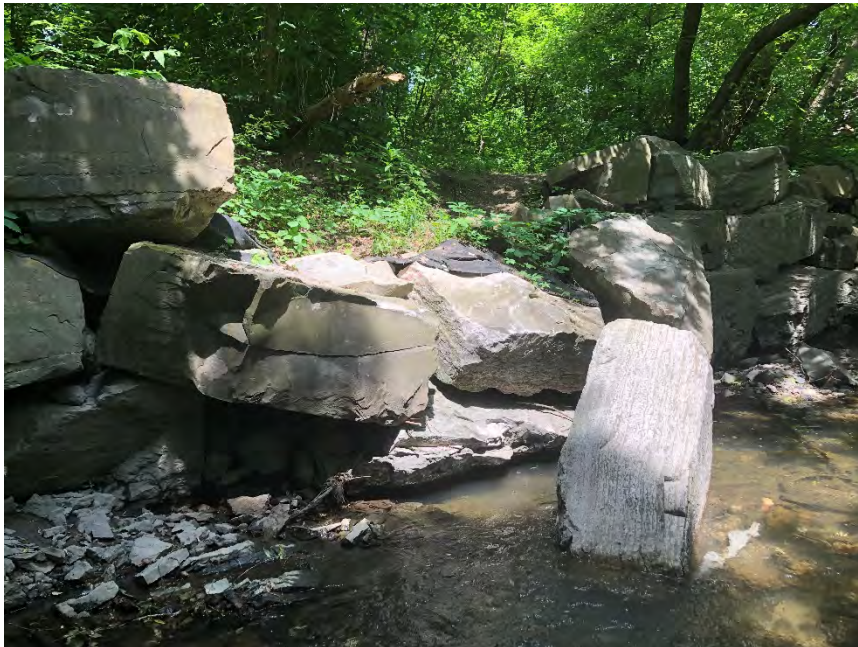
Photograph 12: R2b failed armourstone treatment

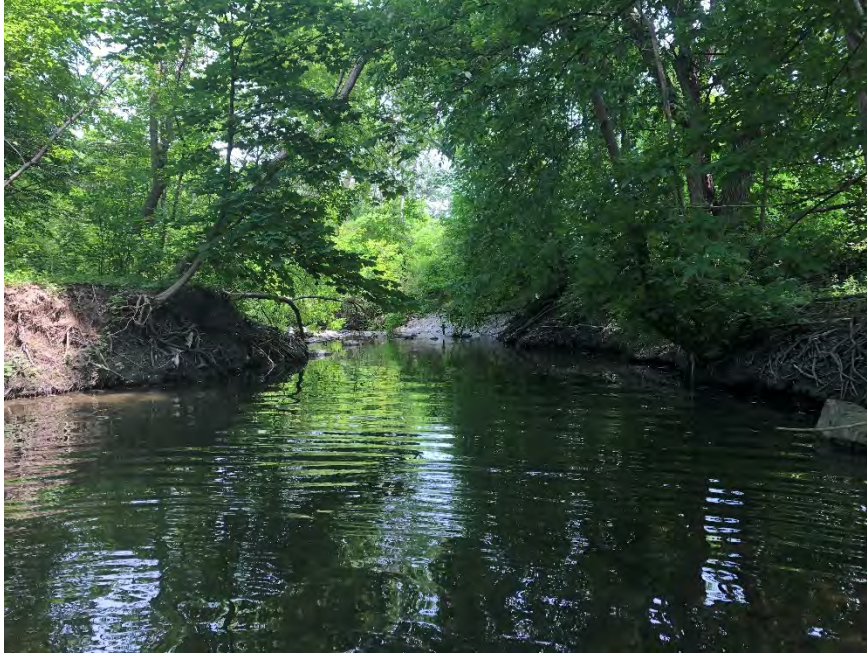
Photograph 12: R3 view downstream of widened section with bank erosion on right bank

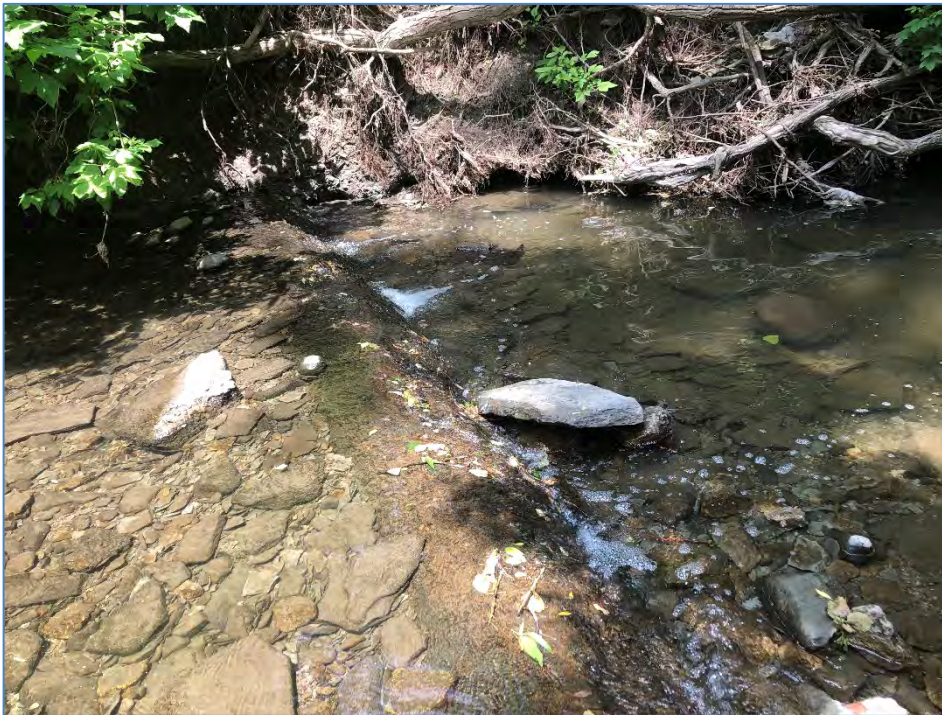
The upstream 200 m of R3 displays natural boundary materials but is highly eroded and may similarly benefit from stabilization works, including bank re-grading/restoration and profile modification. A key constraint is the exposed sanitary sewer crossing located 100 m downstream of the reach break with R2b. Extending further downstream, there is opportunity for local improvements along sections of the creek, such as gabion basket removal and replacement with a vegetated riprap treatment, for example. Existing channel treatments that are stable would ideally be maintained and newly introduced channel treatments should be designed in a manner that promotes consistency in channel form and continuity of channel processes.

Photograph 15: R3 potential exposed pipe on bed of channel

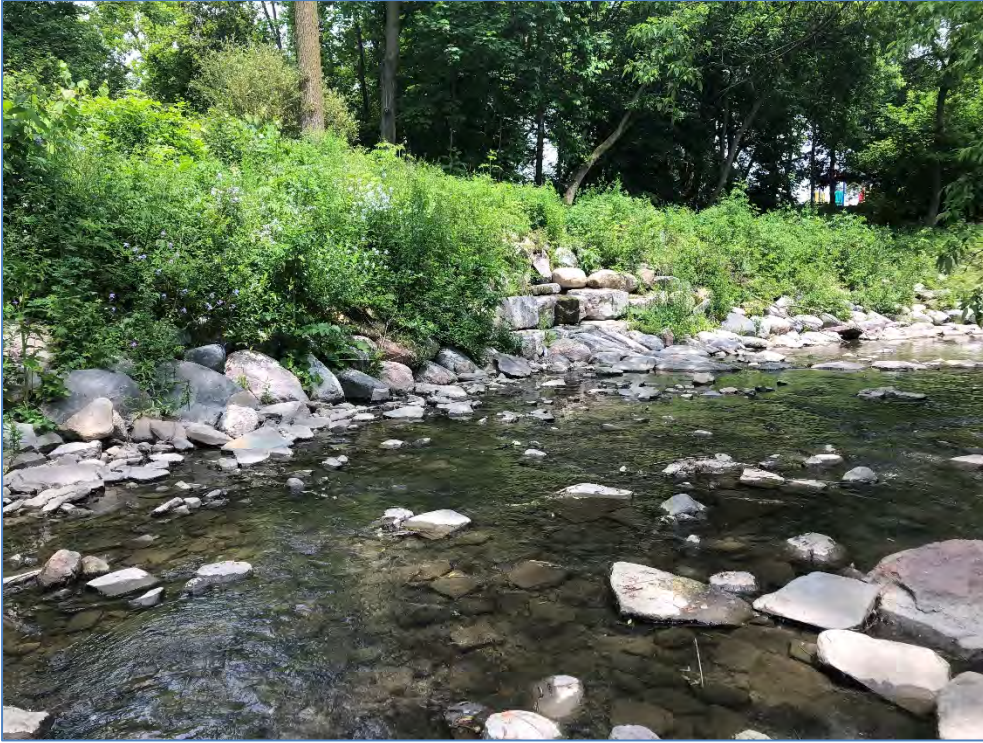
Photograph 16: R3 view downstream of bank stabilization and armourstone at stormwater outfall

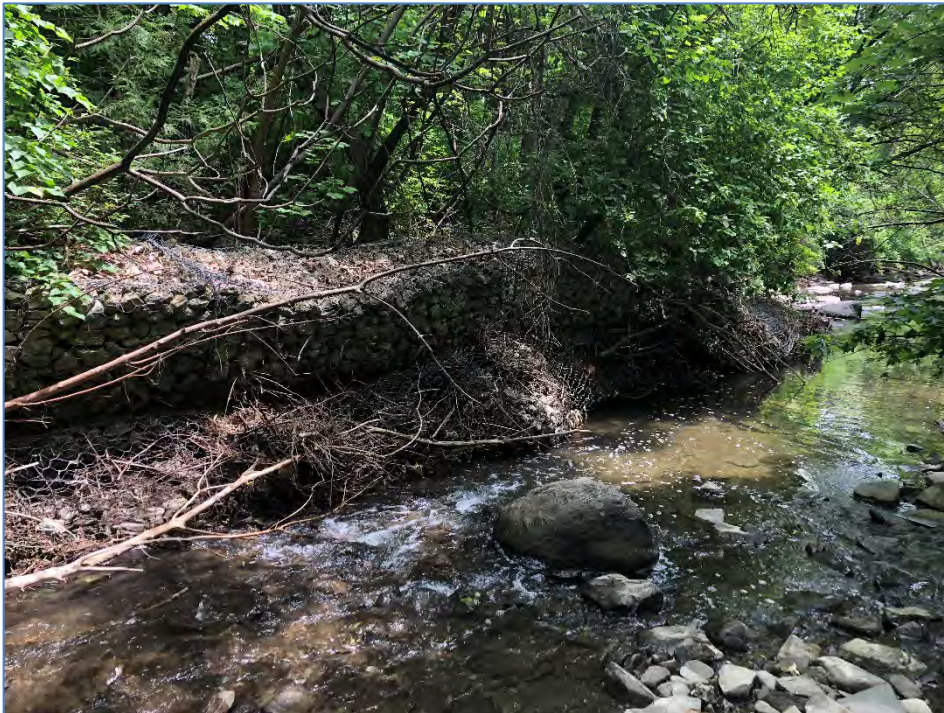
Photograph 18: R3 view downstream of failed gabion baskets on left bank

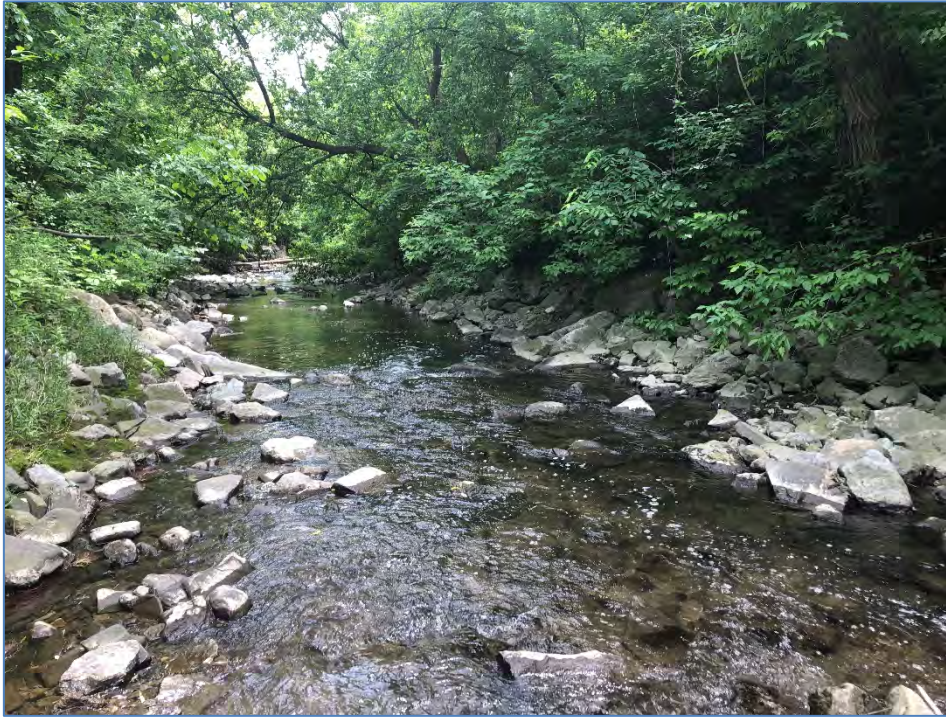
Photograph 19: R3 view downstream of channel stabilization design

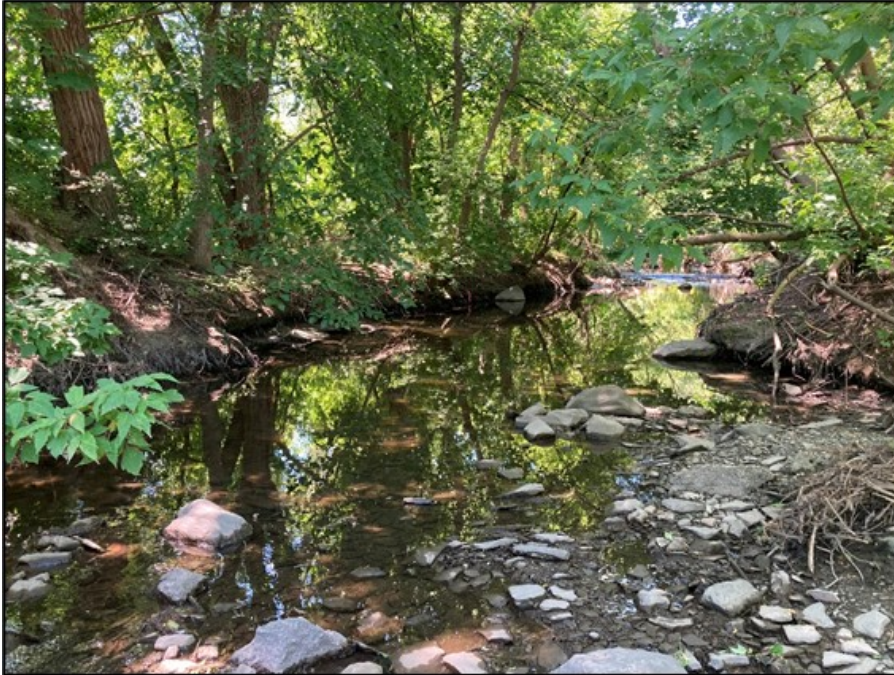
1. Reach R3 – Natural channel section downstream of Reach R2, with local undercutting of banks and some scour around large woody debris.

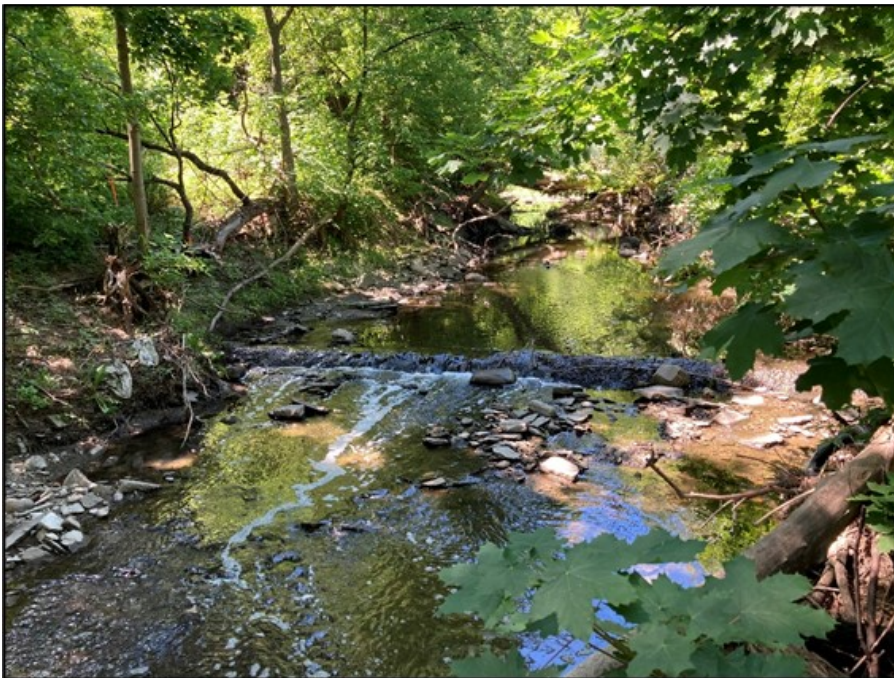
2. Reach R3 – Looking upstream at exposed sanitary sewer crossing, south of Tavinton Court.

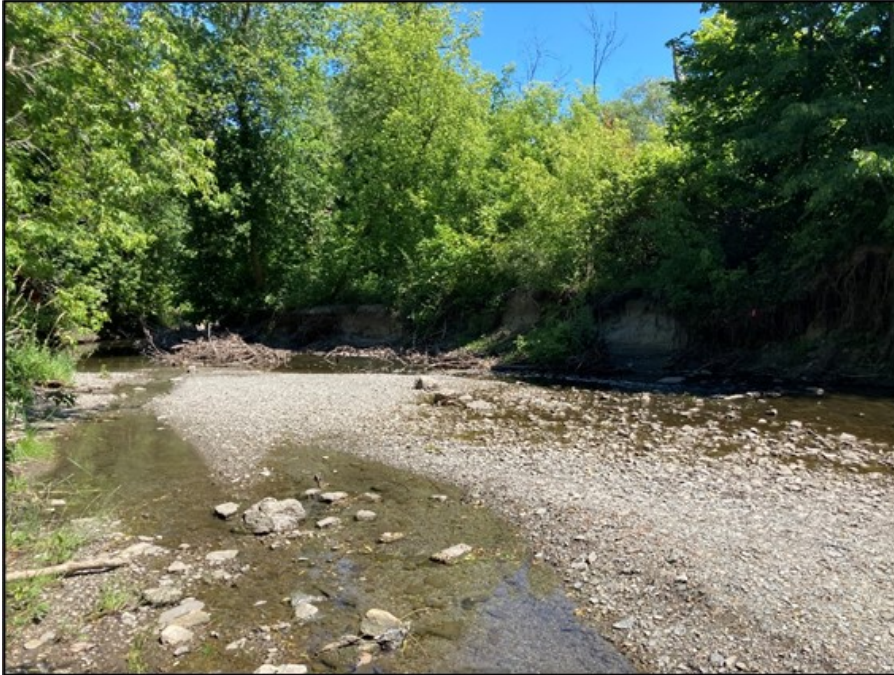
3. Reach R3 – Looking downstream at bank erosion and large channel bar near outfall channel south of Taviton Court

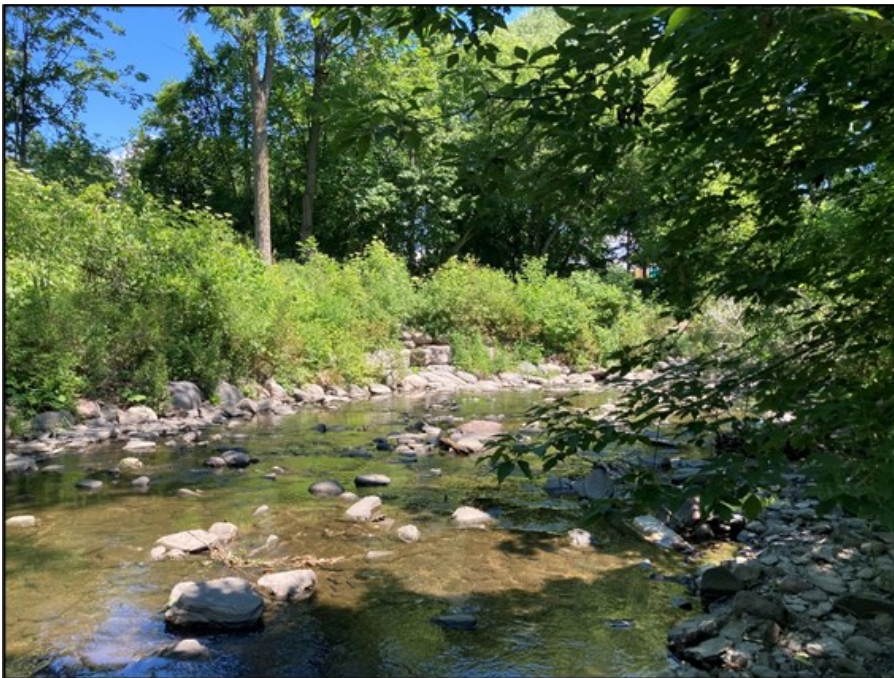
4. Reach R3 – Looking downstream at boulder bank revetment on east bank.

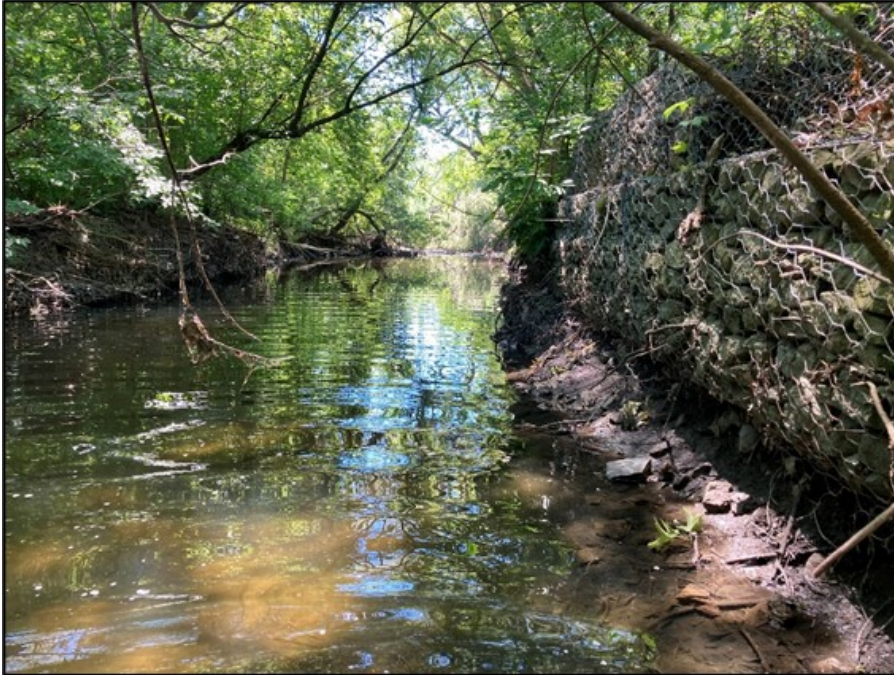
5. Reach R3 – Looking downstream at narrow channel confined by gabion baskets in poor to failing condition

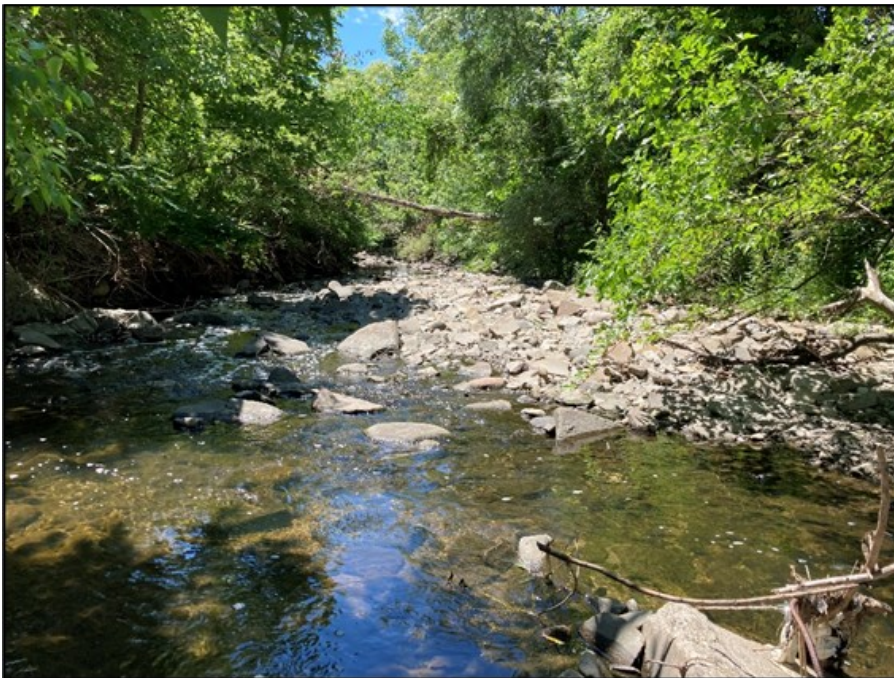
6. Reach R3 – Looking downstream at large accumulation of rip-rap and native limestone in channel

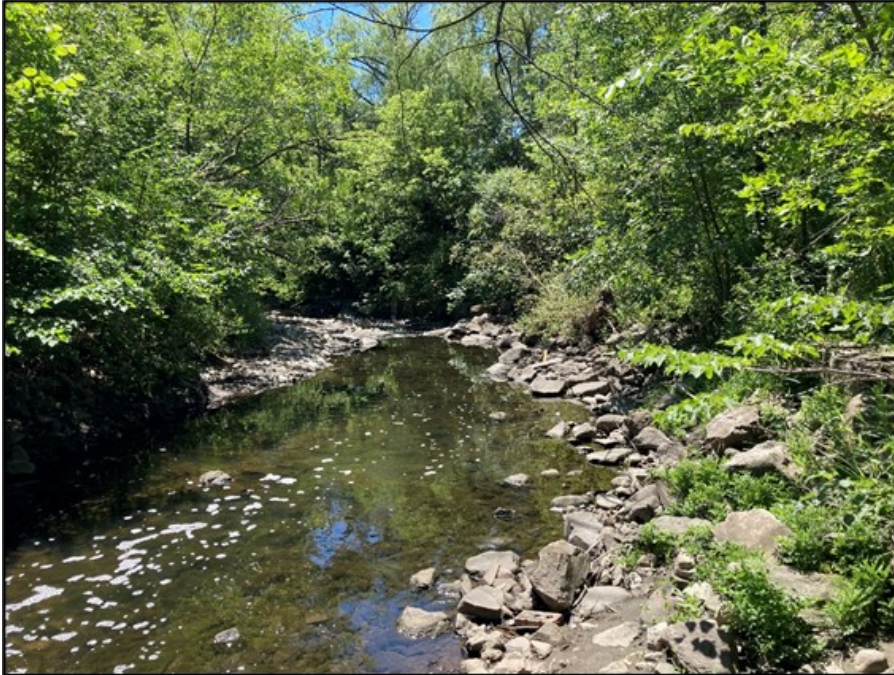
7. Reach R3 – Looking downstream at scoured pool and rip-rap along the bank, with riffle and gravel bar in the background.

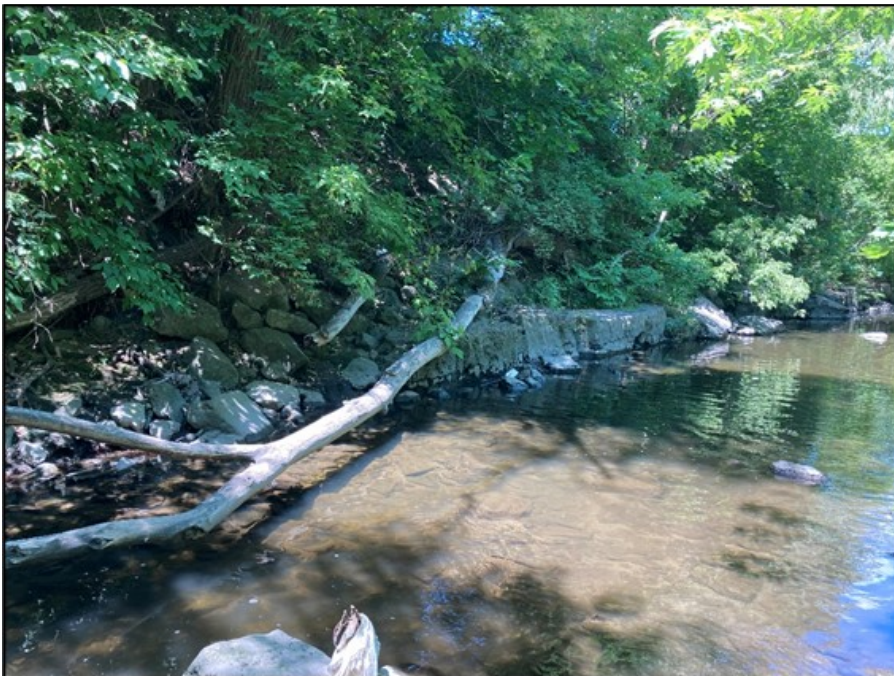
8. Reach R3 – Looking upstream at west bank where armourstone toe transitions to rip-rap along bank

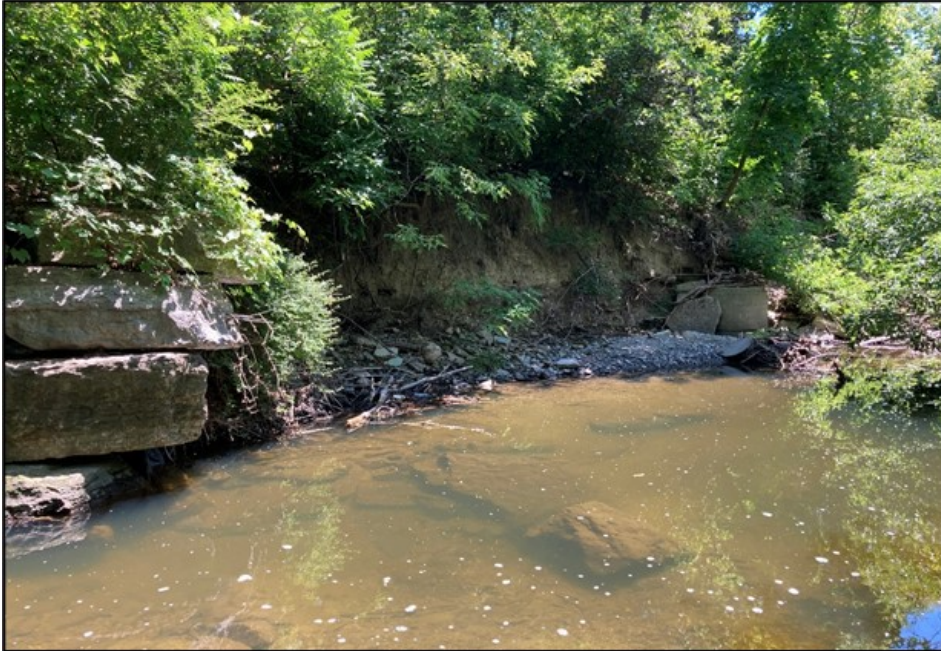
9. Reach R3 – Upstream of Dundas Street; right bank (looking downstream) is vertical and actively eroding upstream of armourstone bank protection.

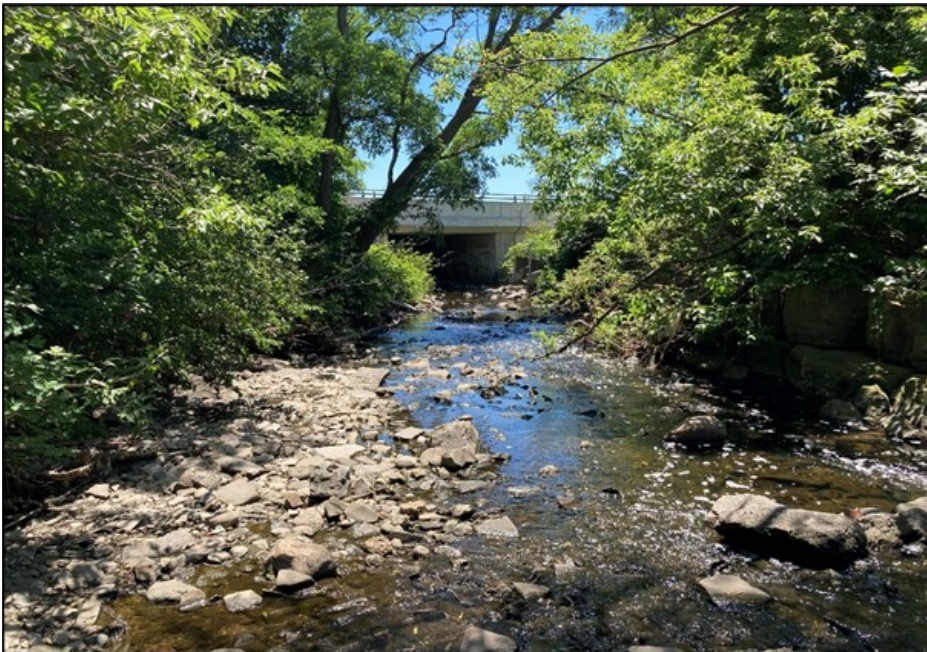
10. Reach R3 – Looking downstream towards Dundas Street road crossing.

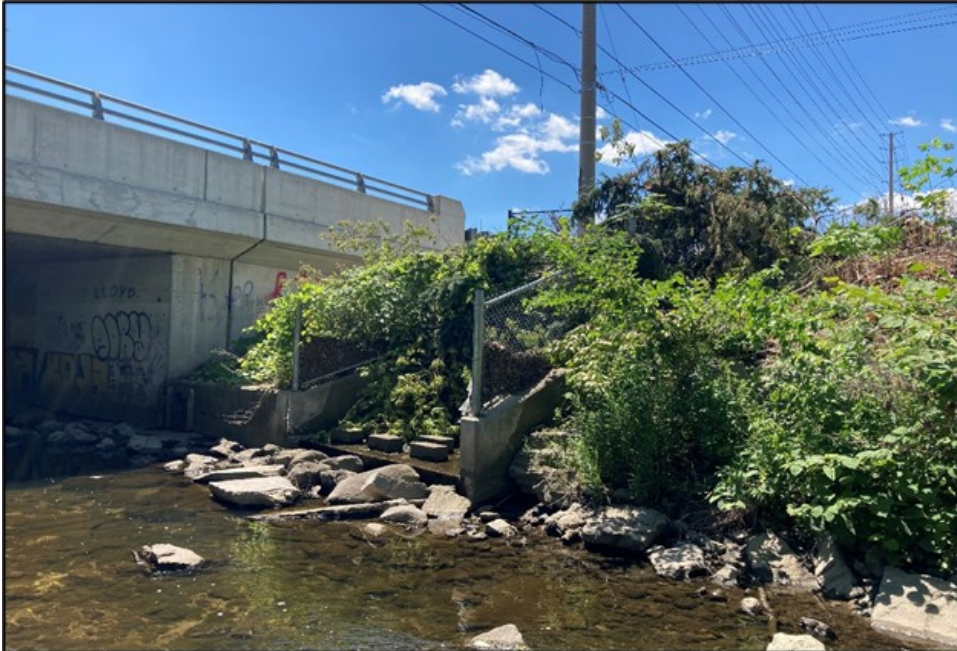
11. Reach R3 – Outfall on right bank upstream of Dundas Street Crossing; toe of bank is lined with remnants of riprap.

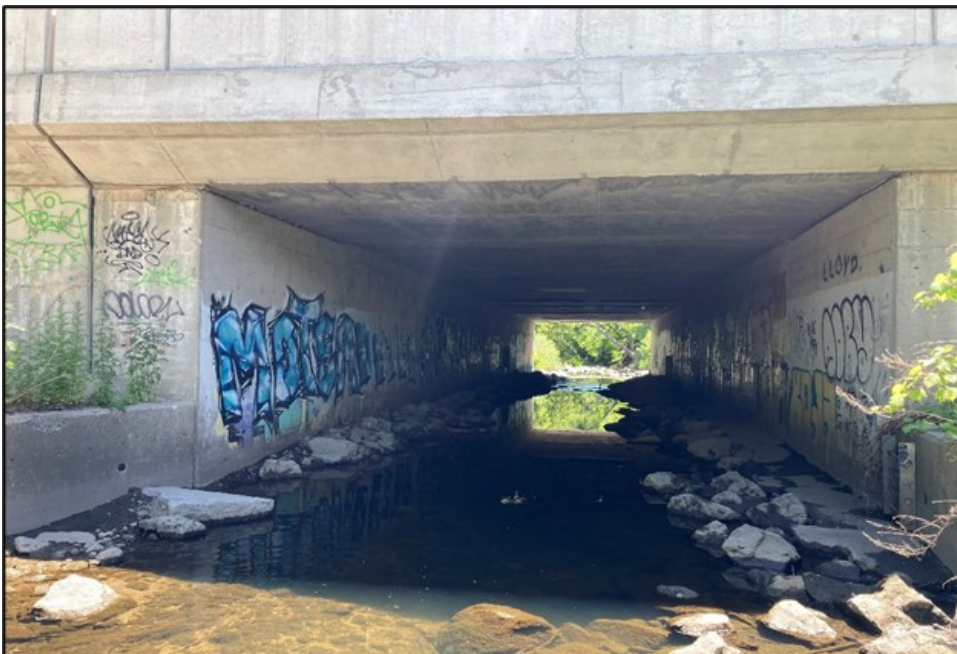
12. Reach R3 - looking downstream through Dundas Street crossing.

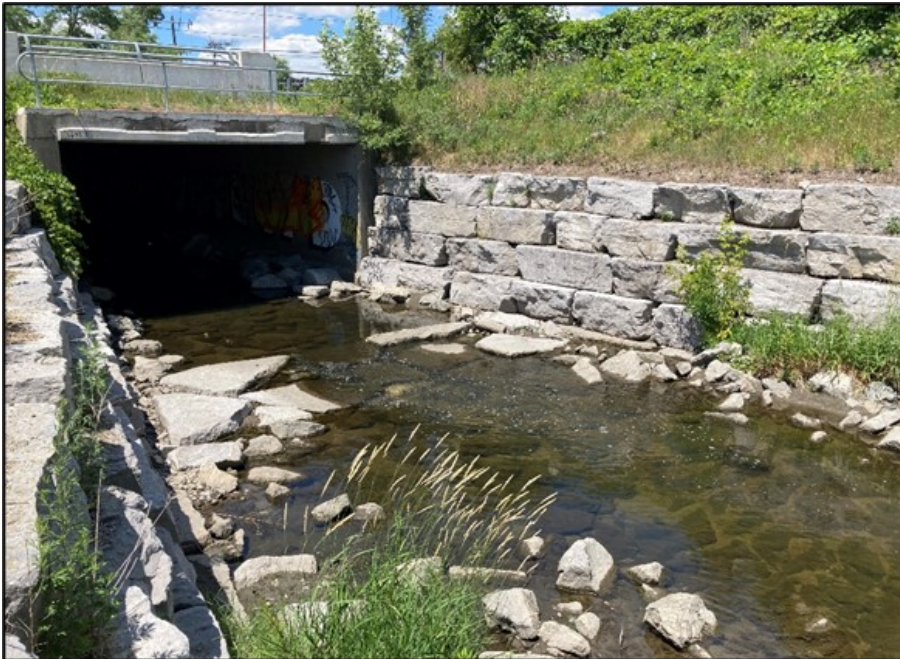
13. Reach R4 – Downstream end of Dundas Street crossing; both banks are well protected with armourstone blocks.

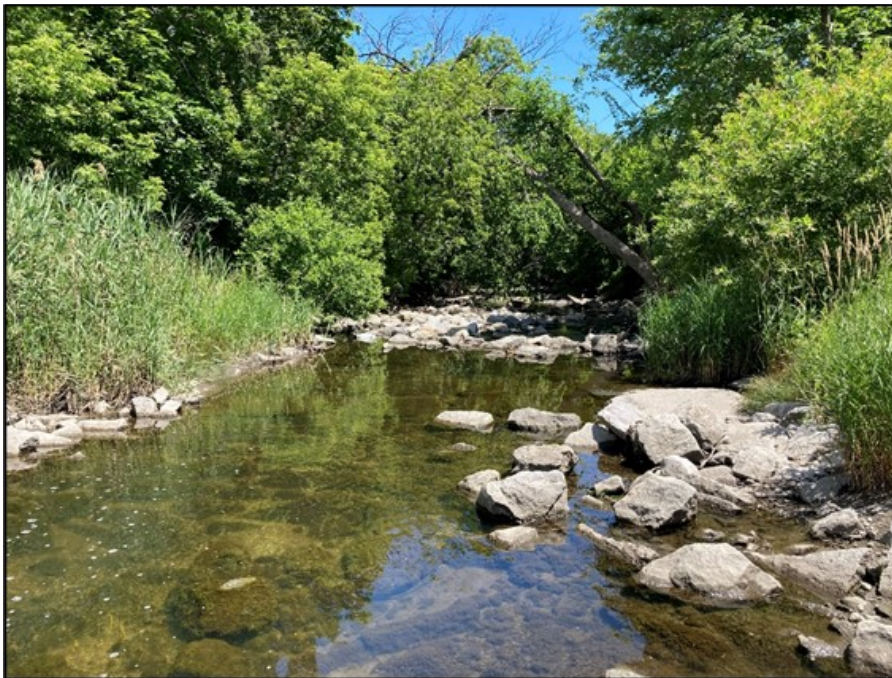
14. Reach R4 – Looking downstream of road crossing; channel substrate is generally coarse and consist of platy bedrock or riprap.

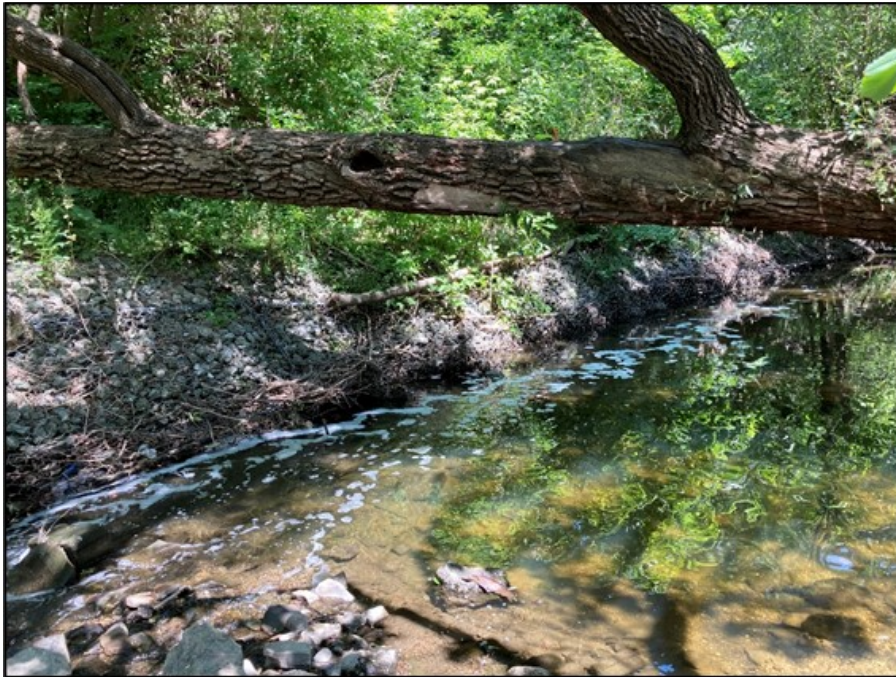
15. Reach R4 – Left bank (looking downstream) protected with gabion baskets – some of which are becoming undermined.

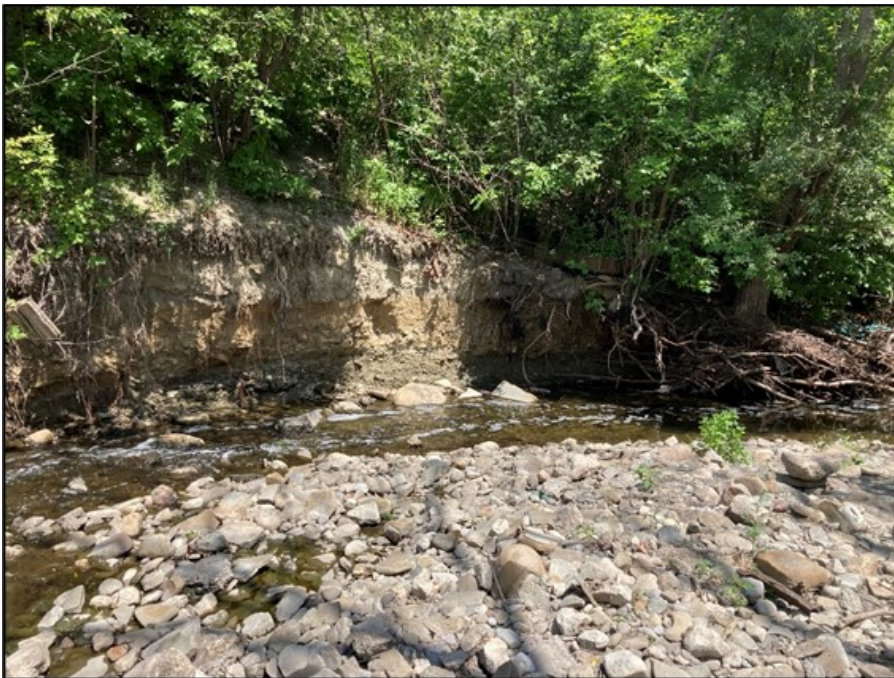
16. Reach R4 – Vertical bank face with exposed clay and till layers across from cobble/boulder point bar.

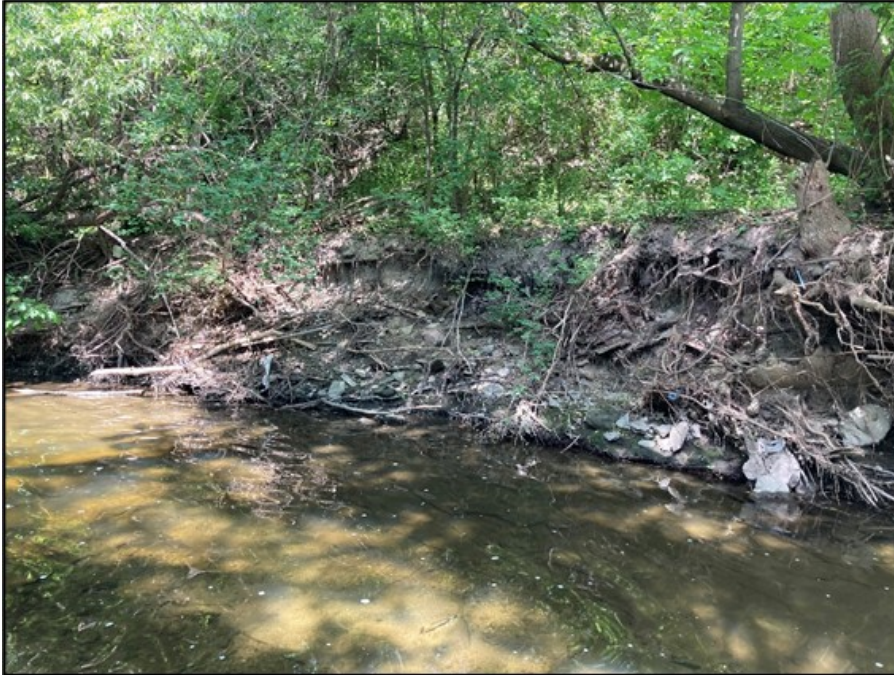
17. Reach R4 – Exposed bank face and abundant exposed tree roots within bank suggesting channel is widening.

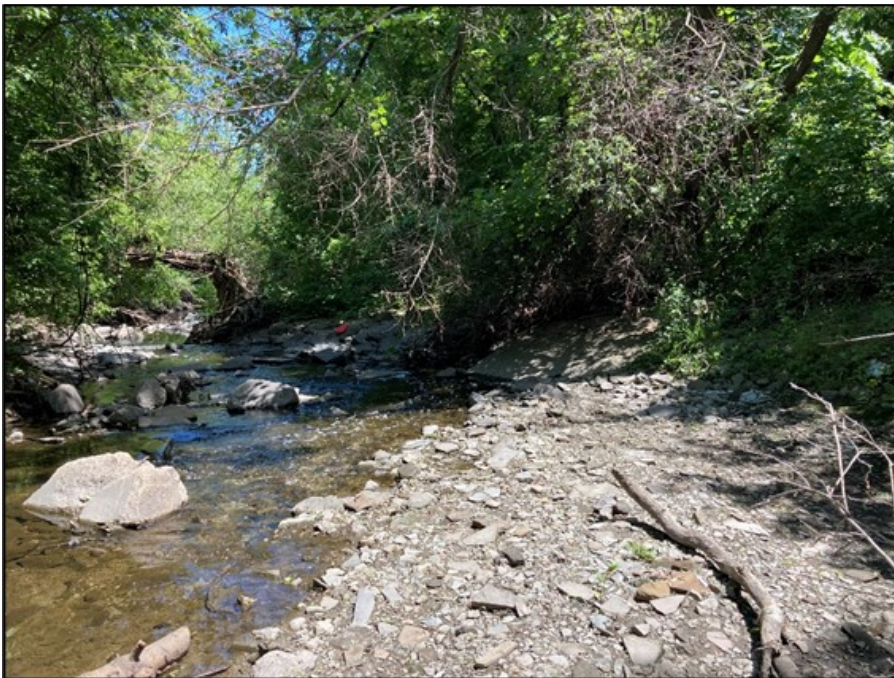
18. Reach R4 – Looking downstream – gravel/cobble point bar along right bank.
