APPENDIX C
Fluvial Geomorphology Assessment

**PRELIMINARY FLUVIAL GEOMORPHOLOGY ASSESSMENT OF LITTLE
ETOBICOKE CREEK
DIXIE-DUNDAS FLOOD MITIGATION**

Prepared for:
CITY OF MISSISSAUGA

Prepared by:
MATRIX SOLUTIONS INC.

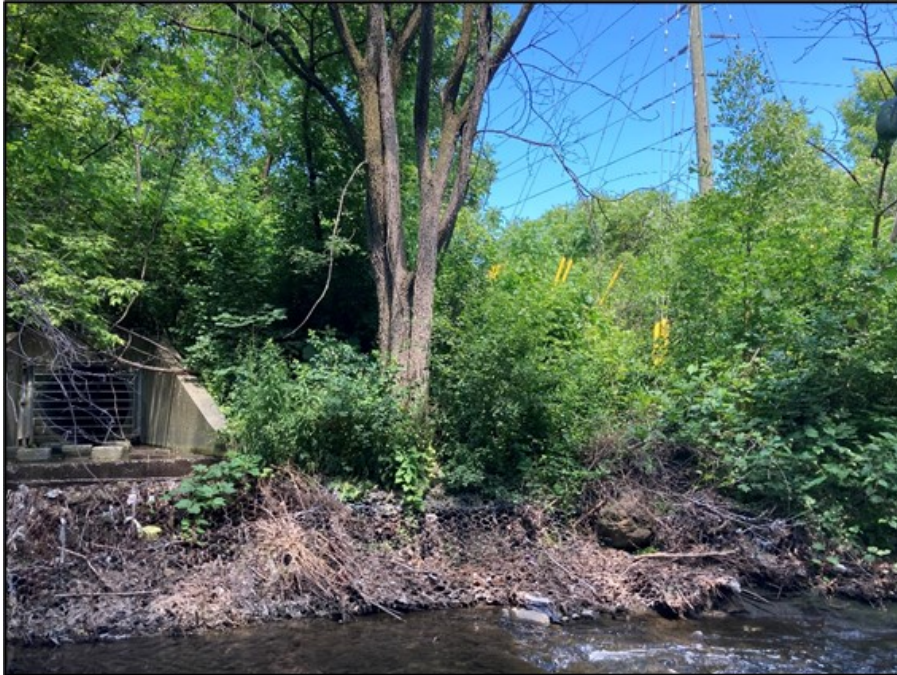
19. Reach R4 – Outfall along left bank – bank was protected with gabion baskets that have since become undermined and material has washed into stream

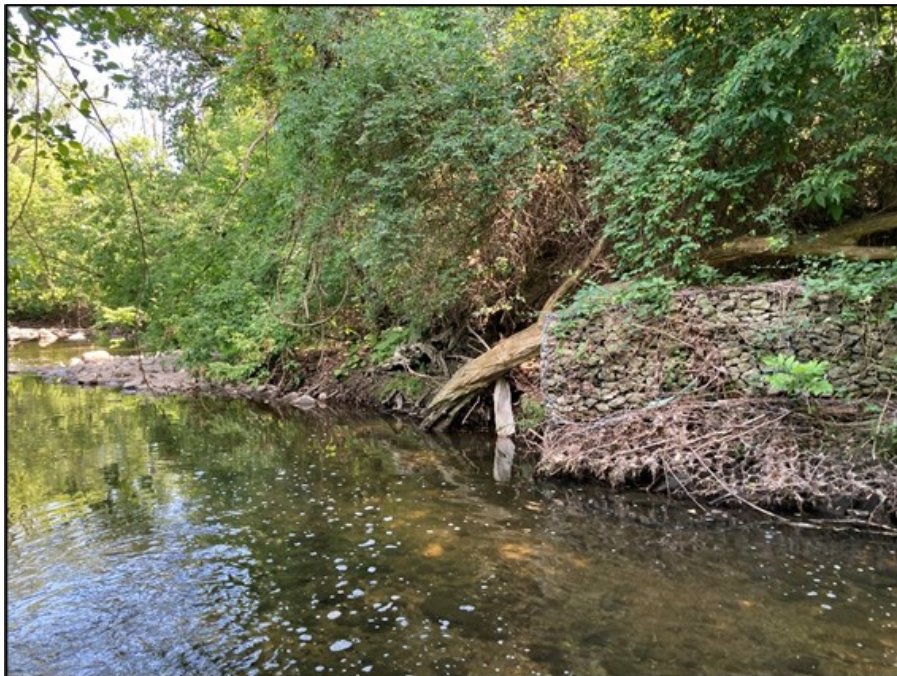
20. Reach R4 – Active bank erosion on right bank where gabion baskets stop.

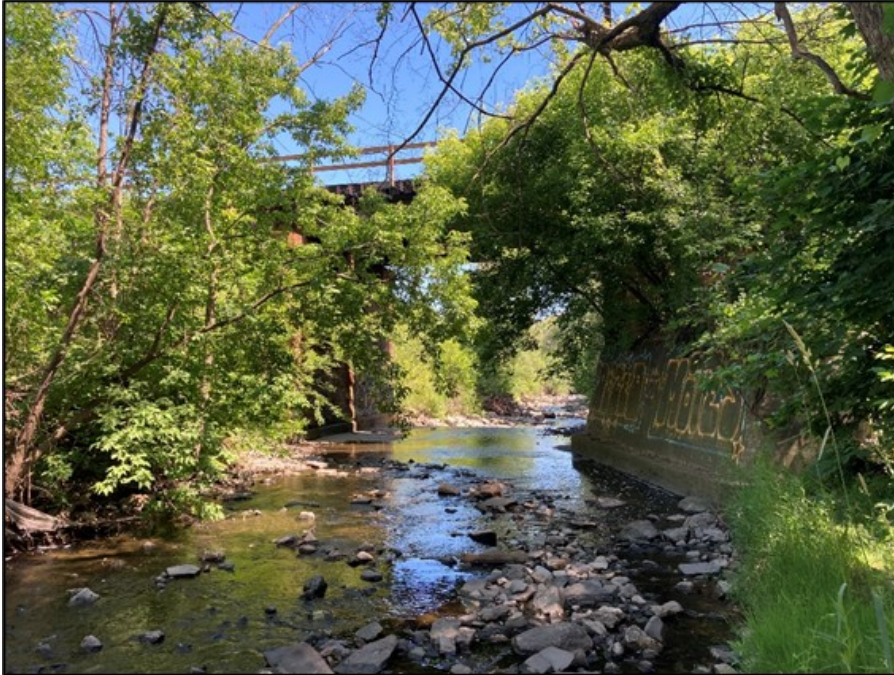
21. Reach R4 – Looking downstream toward railway crossing, channel bed still predominantly coarse substrate.

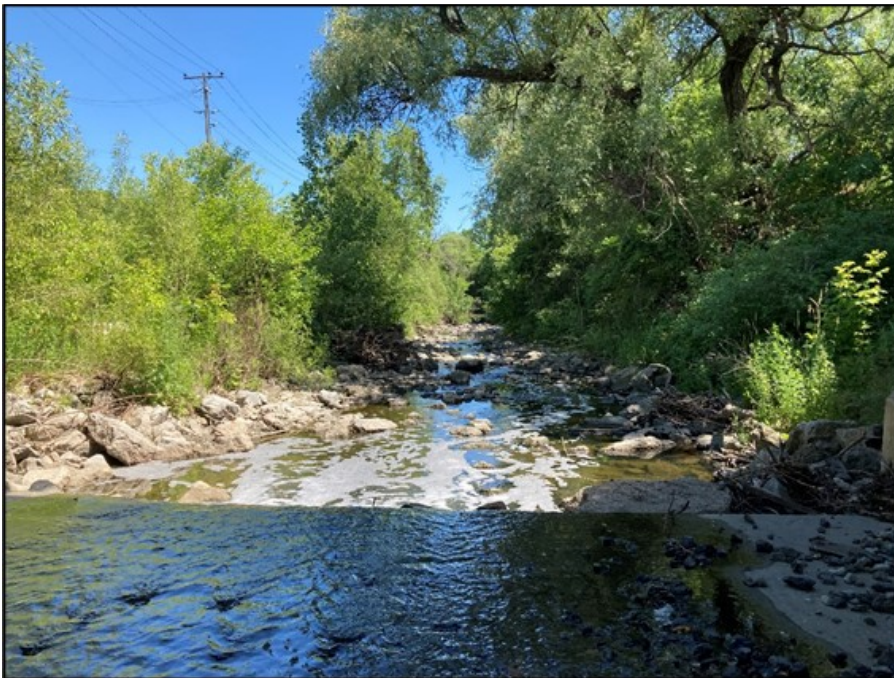
22. Reach R4 – Looking downstream at railway crossing – there is a drop in channel profile of approximately 0.5 m

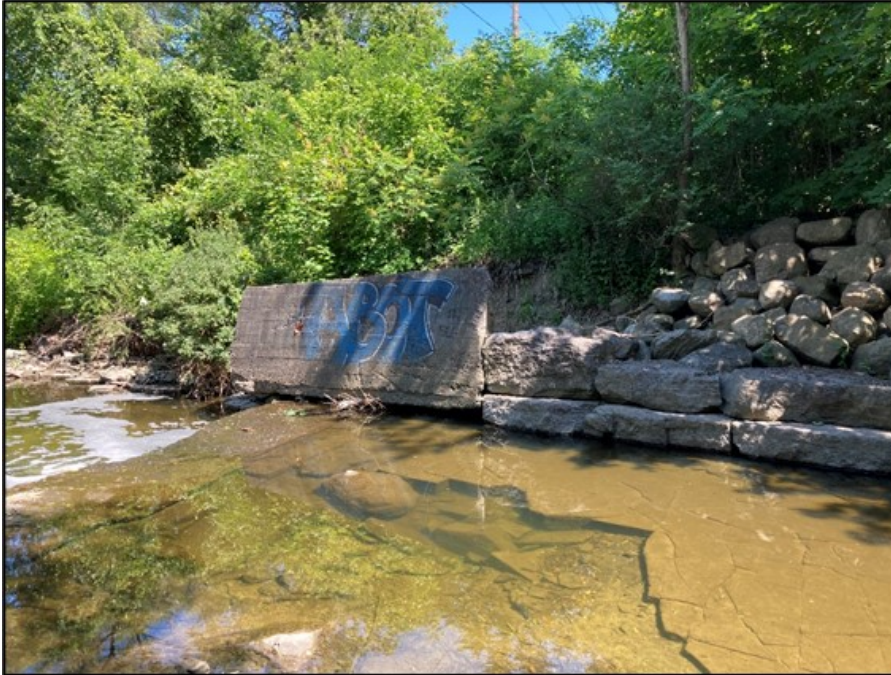
23. Reach R4 - Right bank at railway crossing – concrete on channel bed and along right bank is cracking and beginning to fail.

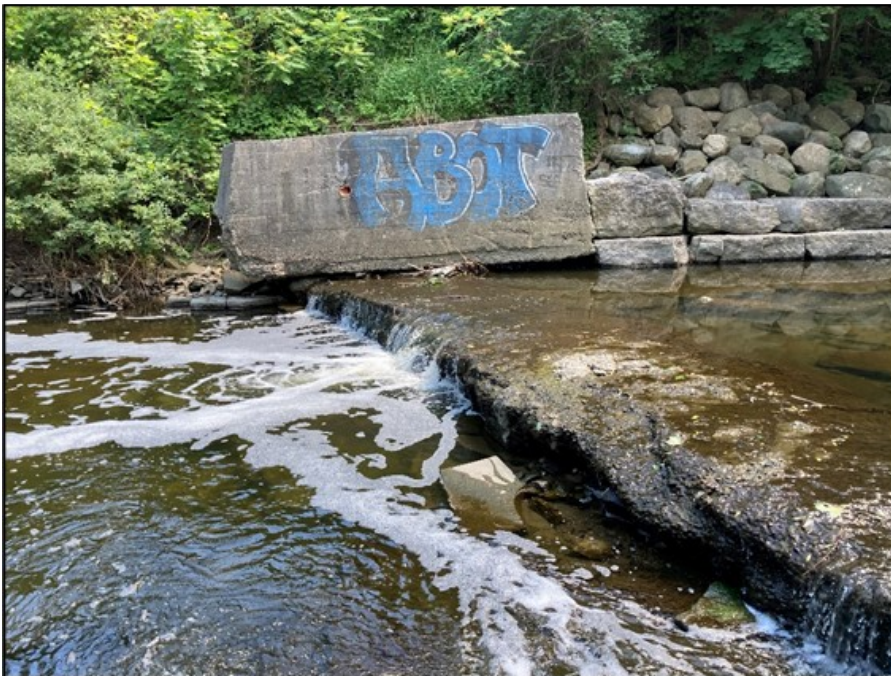
24. Reach R5 – Reach break downstream of railway; concrete weir over sewer crossing is cracking/eroding and will continue to crack/erode until pipe is exposed

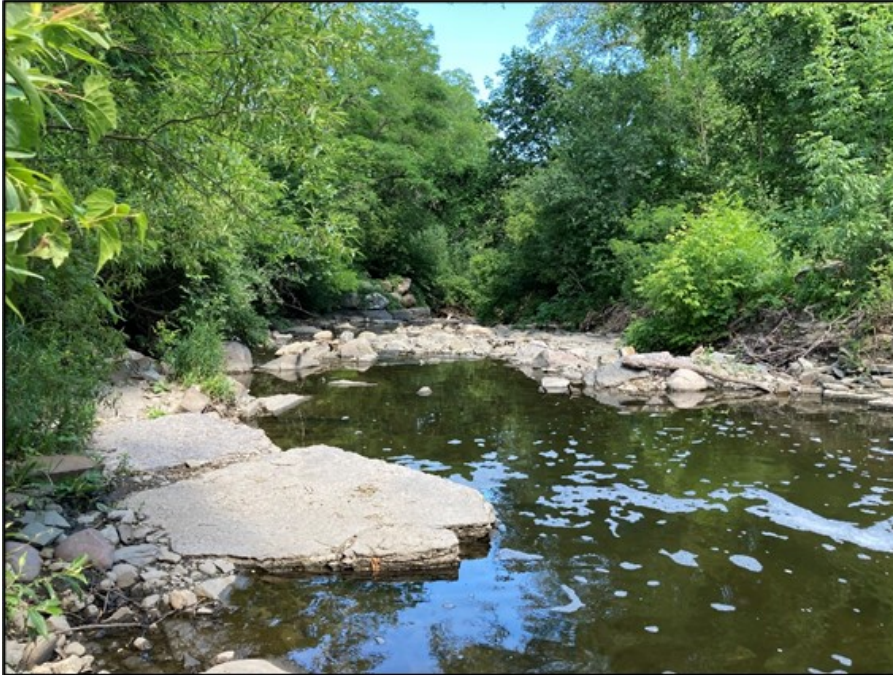
25. Reach R5 – Scour pool downstream of sewer crossing; slabs of concrete from railway have washed downstream.

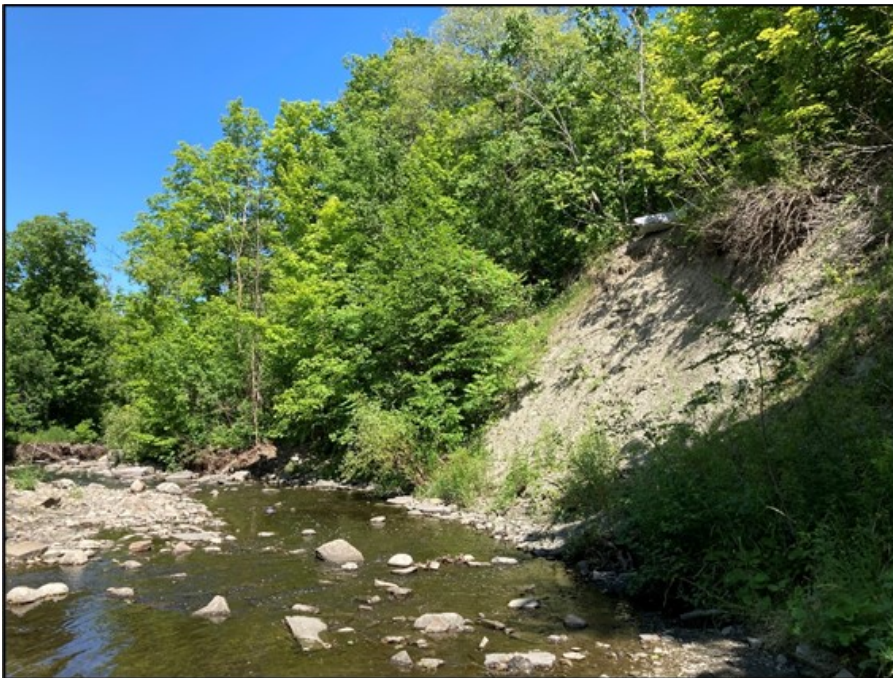
26. Reach R5 - Steep, eroding right bank with exposed tree roots and leaning trees; small pipe outlet at top of slope.

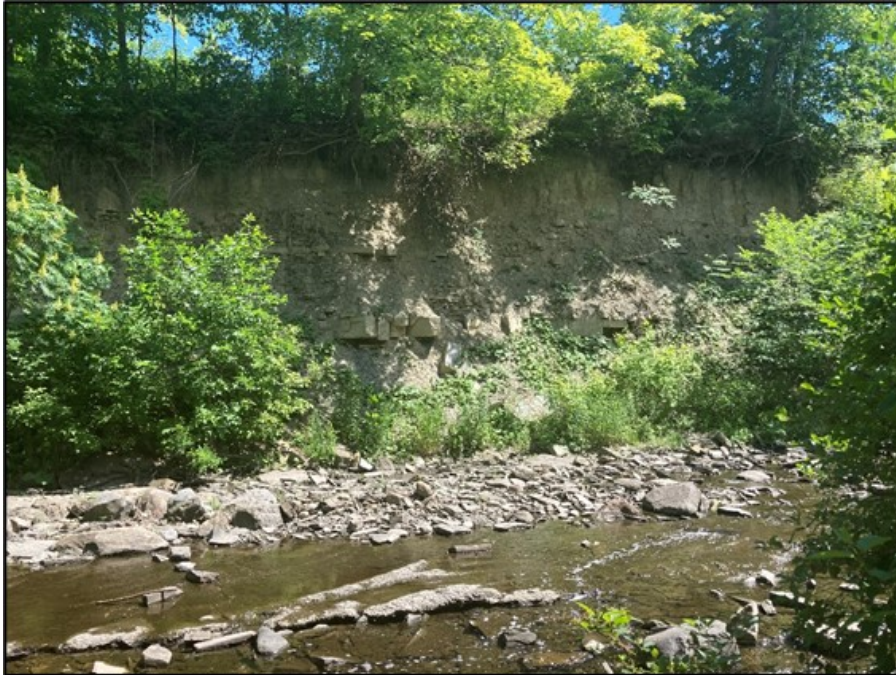
27. Reach R5 – Vertical right bank with exposed bank face and layers of limestone – platy material has accumulated along toe of bank

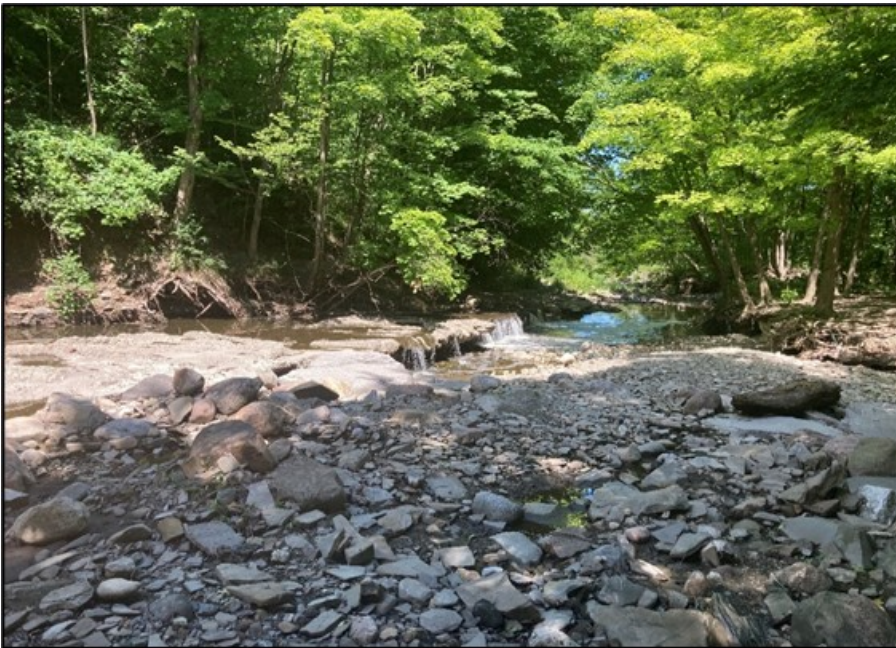
28. Reach R5 – Looking downstream towards trunk sewer crossing – active erosion is occurring around the sewer crossing causing it to become exposed

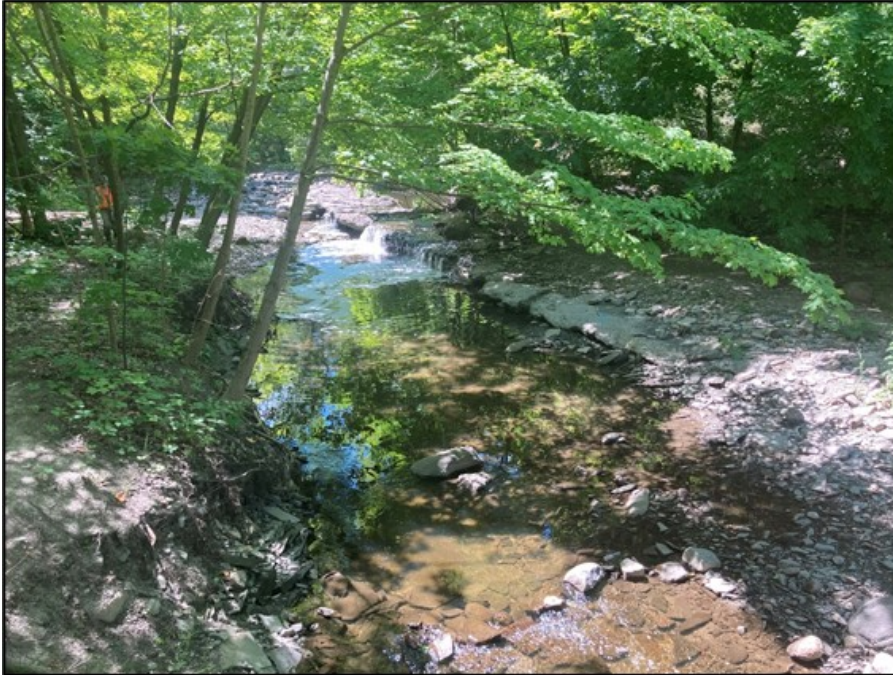
29. Reach R5 – Overview of exposed trunk sewer crossing before confluence into Etobicoke Creek
