Tree Inventory and Preservation Plan Report 23, 25, 27, 29, and 31 Helene Street North, 53 Queen Street East, and 70 Park Street East Mississauga, Ontario

17 November 2022, revised 3 January 2023

KUNTZ FORESTRY CONSULTING Inc. Project P3508

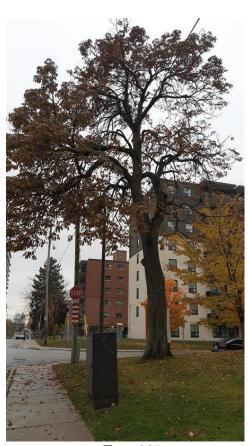
Tree 665

665	Horse Chestnut	Aesculus hippocastanum	72	F/P	F	G/F		6.5	4.8	asymetrical crown (M)	Public	Preserve
		pp.								Strangling root (M), exposed roots		
666	Hybrid Elm	Ulmus spp.	18	F	F	G		4.0	1.5	(L), union at 2m	Private	Preserve
667	Red Oak	Quercus rubra	24.5	G	G	G		4.0	1.8		Public	Preserve
668	Hybrid Elm	Ulmus spp.	19	F	F	G		3.5	1.5	Exposed roots)H), union at 1.8m, asymetrical crown (L), root injury (L)	Private	Preserve
669	Hybrid Elm	Ulmus spp.	19	F	F	G		3.5	1.5	Exposed roots (H), root injury (M), asymetrical crown (M)	Private	Preserve
670	Hybrid Elm	Ulmus spp.	24	G	G/F	G		3.5	1.8	Union at 1.4m	Private	Preserve
