ARBORIST REPORT

Polaris Drive Townhouses

Polaris Drive
Mississauga, Ontario

February, 26, 2024
*Revised December 23, 2024

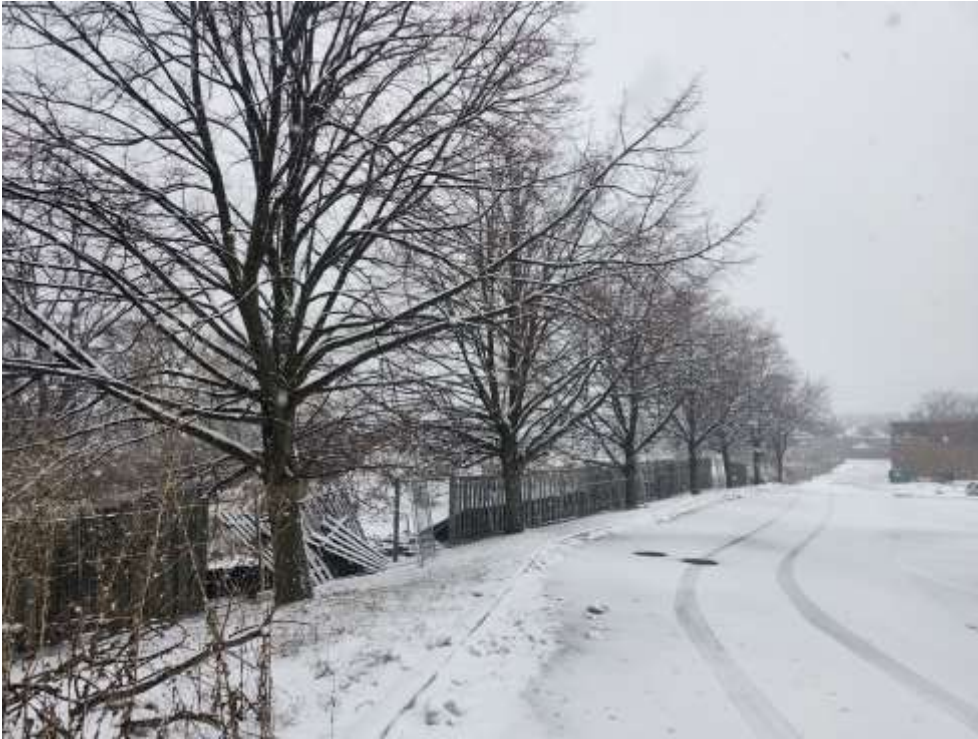
7	<i>Tilia cordata</i> (Little-leaf Linden)	35	7	L	L	RN	Large wound down trunk of approx. 50% of trunk circumference and 75% of canopy is dead.	N
8	<i>Acer negundo</i> (Manitoba Maple)	14	3	M	M	P	Growing against fence, 10° lean towards site and some medium-sized broken branches.	N
9	<i>Catalpa bignoides</i> (Northern Catalpa)	27, 29.5	9	M	ML	P	Co-dominant leaders, 1 dead limb and heavy vine.	N
10	<i>Juglans nigra</i> (Black Walnut)	18	4	MH	MH	P	Vine in canopy	N
11	<i>Crataegus sp.</i> (Hawthorn)	16, 17, 18	7	M	M	P	Heavy vine in canopy, many large wounds.	N

Figure 2: Trees 1 – 7 along north property line and on neighbour's property.

- a. **Removal recommended due to poor condition on the neighbouring property: #7.** Tree is in poor condition as such, the neighbouring property owner is encouraged to remove it.
- b. **Encourage neighbour to prune trees #20 and 30.** Trees to be preserved but neighbour to be encouraged to remove or to conduct careful mitigation strategies to reduce the potential for harm from existing hazards.

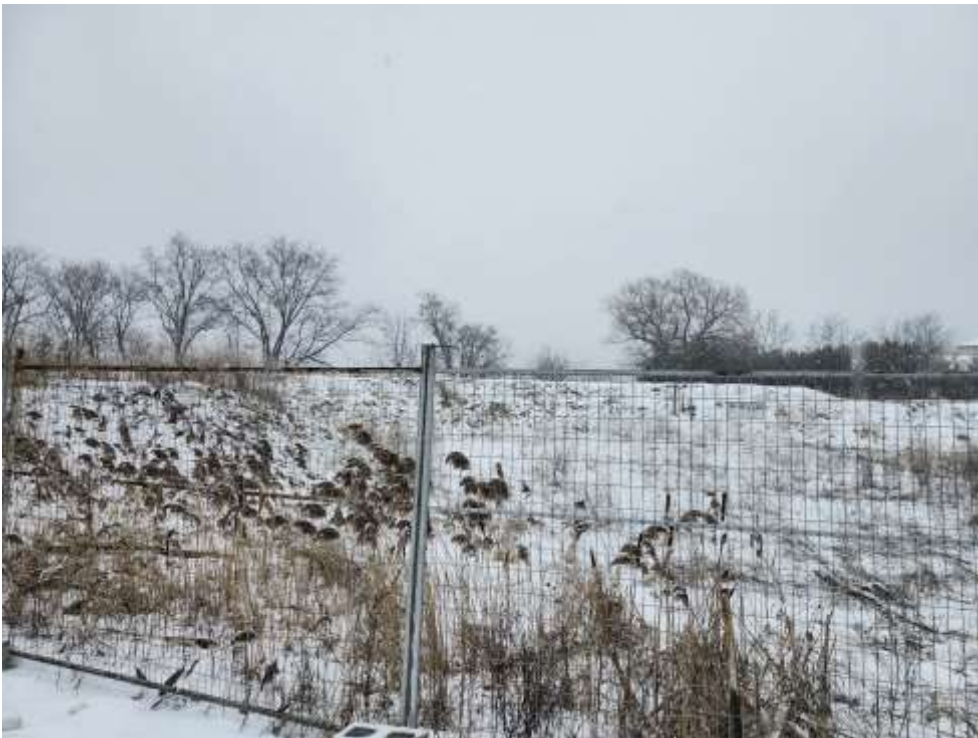
Figure 3: View of site from north property line looking southeast.

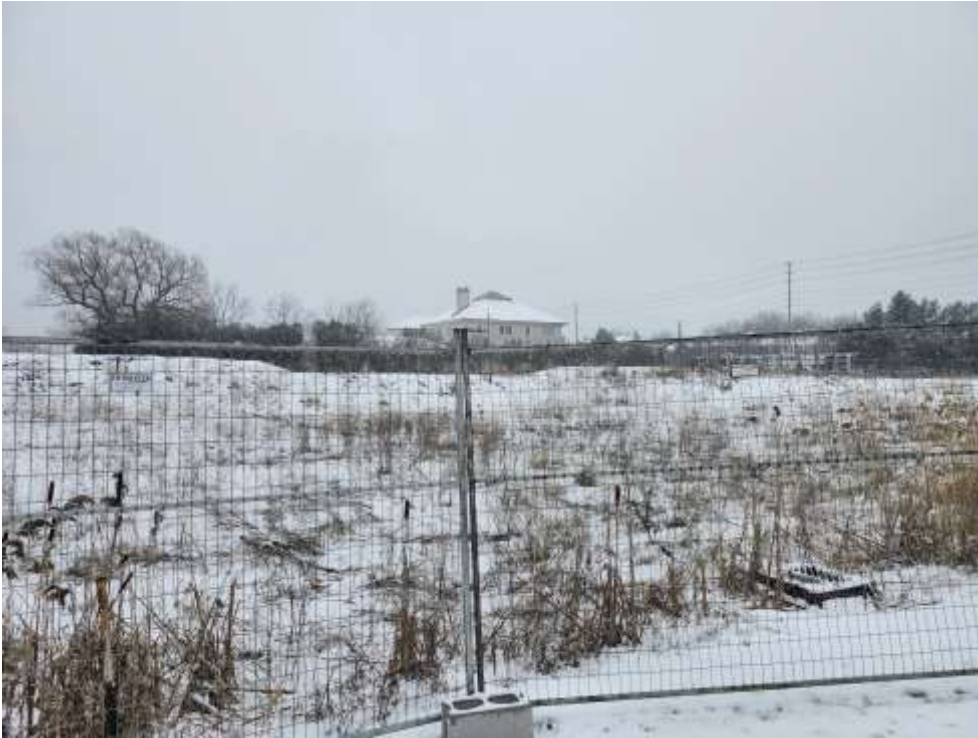
Figure 4: View of site from north property line looking southwest.

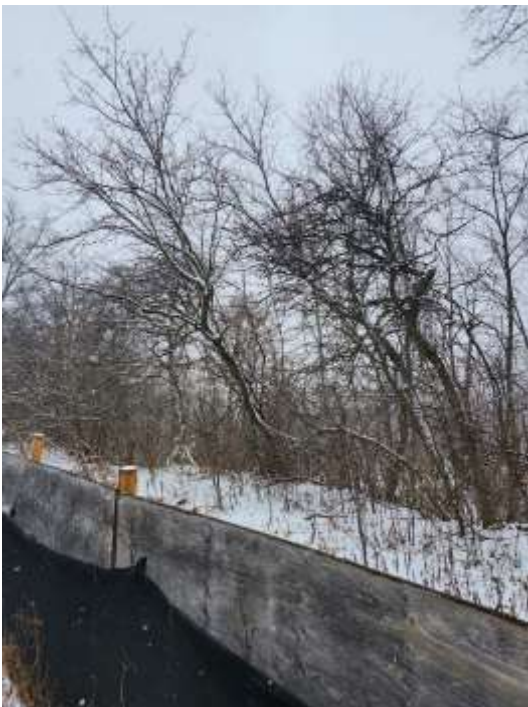
Figure 5: View of ravine along property Line at north-east.

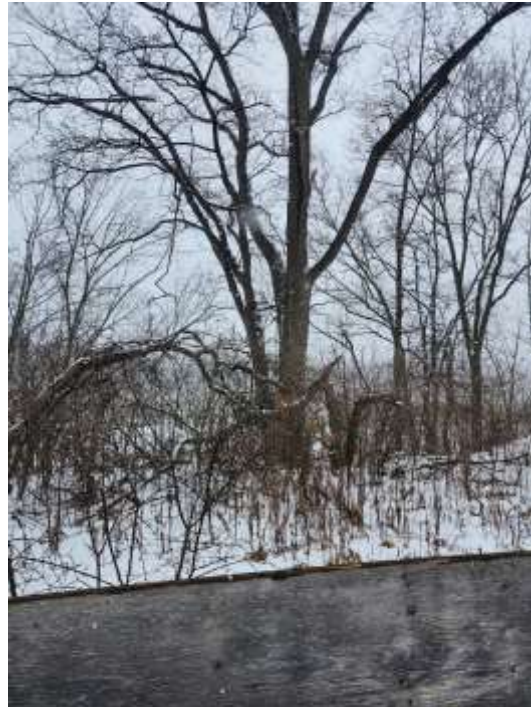
Figure 6: Tree along ravine at property line.

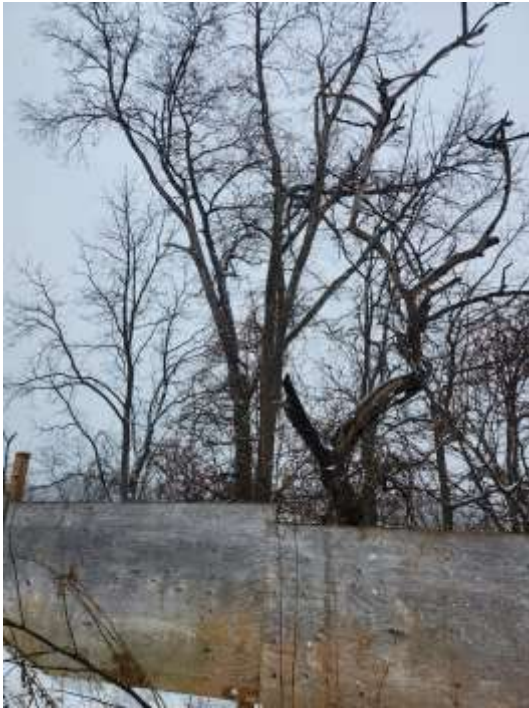
Figure 7: Tree along ravine.

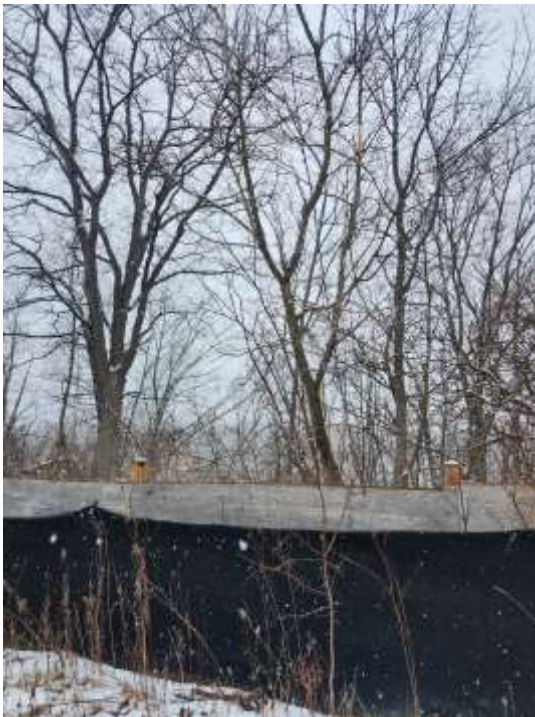
Figure 8: Tree along ravine
