Reference No. 2205-M163 Related Reference No. 1406-S151 Page 1 of 2

Re: An Geotechnical Review for Slope Stability Assessment

**Proposed Residential Development**

6620 Rothschild Trail City of Mississauga

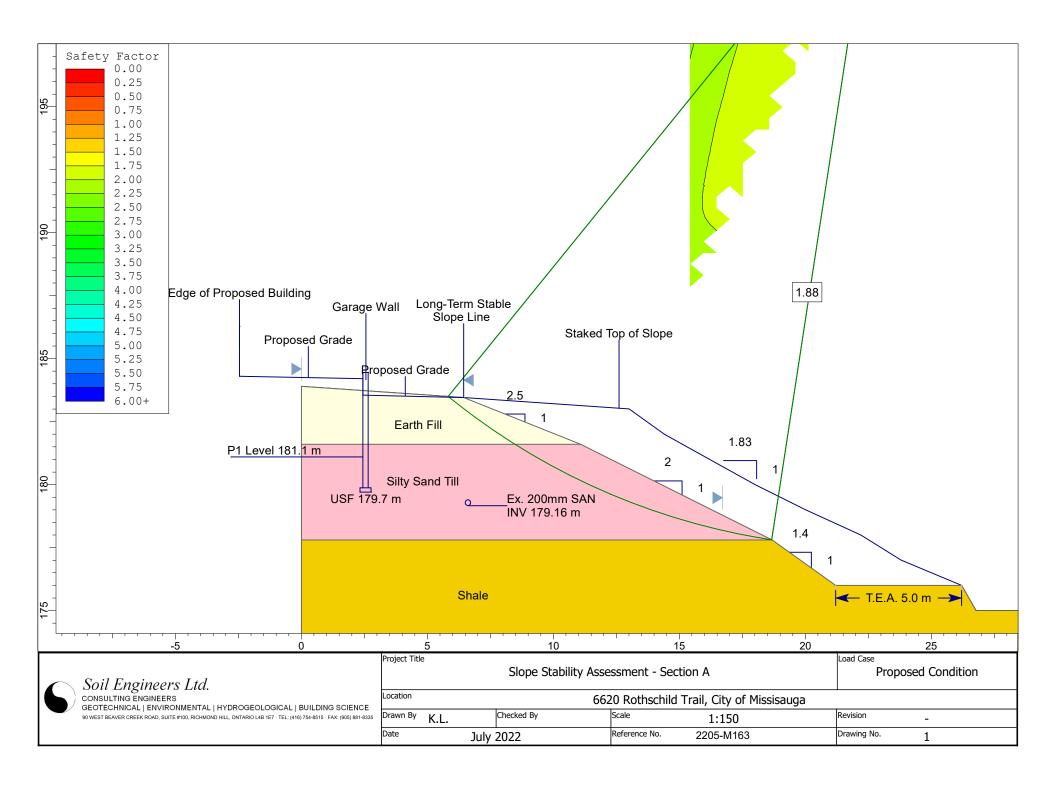
Slope Stability Analysis – Section A (Proposed Condition)...... Drawing No. 1

In determining the Long-Term Stable Slope Line (LTSSL), a toe erosion allowance of 5.0 m was applied along the creek bank due to active toe erosions were evident during the visual inspection. In addition, remodelled slope gradients ranging from 1 vertical (V): 1.4 to 2.5 horizontal (H), depending on the soil type, were also applied, and the minimum factor of safety (FOS) yielded 1.607 (local) and 1.87 (global), which meets the MNR guideline requirement (FOS of 1.5).

SEL reviewed the proposed site grading plan prepared by Skira & Associates Ltd. dated March 2018. It was noted that the portion of the development extended into the 6 m buffer as mentioned in the comment. Thus, SEL incorporated the design based on Section F-F, as shown on the grading plan, into the slope stability analysis to verify whether it would pose an adverse effect to the slope. Based on the analysis, the minimum FOS yield 1.87, which showed no difference from the existing condition. Thus, the proposed development does not pose an adverse effect to the stability of the slope. Furthermore, the critical failure slip surface did not extend into the proposed development. In case where the slope did fail, the proposed structure will not be adversely affected. The analytical result is presented on Drawing No. 1.
