Reference No. 1406-S151 Related Reference No.0709-S028 Page 1 of 5

Re: **Slope Stability Assessment**

**Proposed Residential Development**

6620 Rothschild Trail City of Mississauga

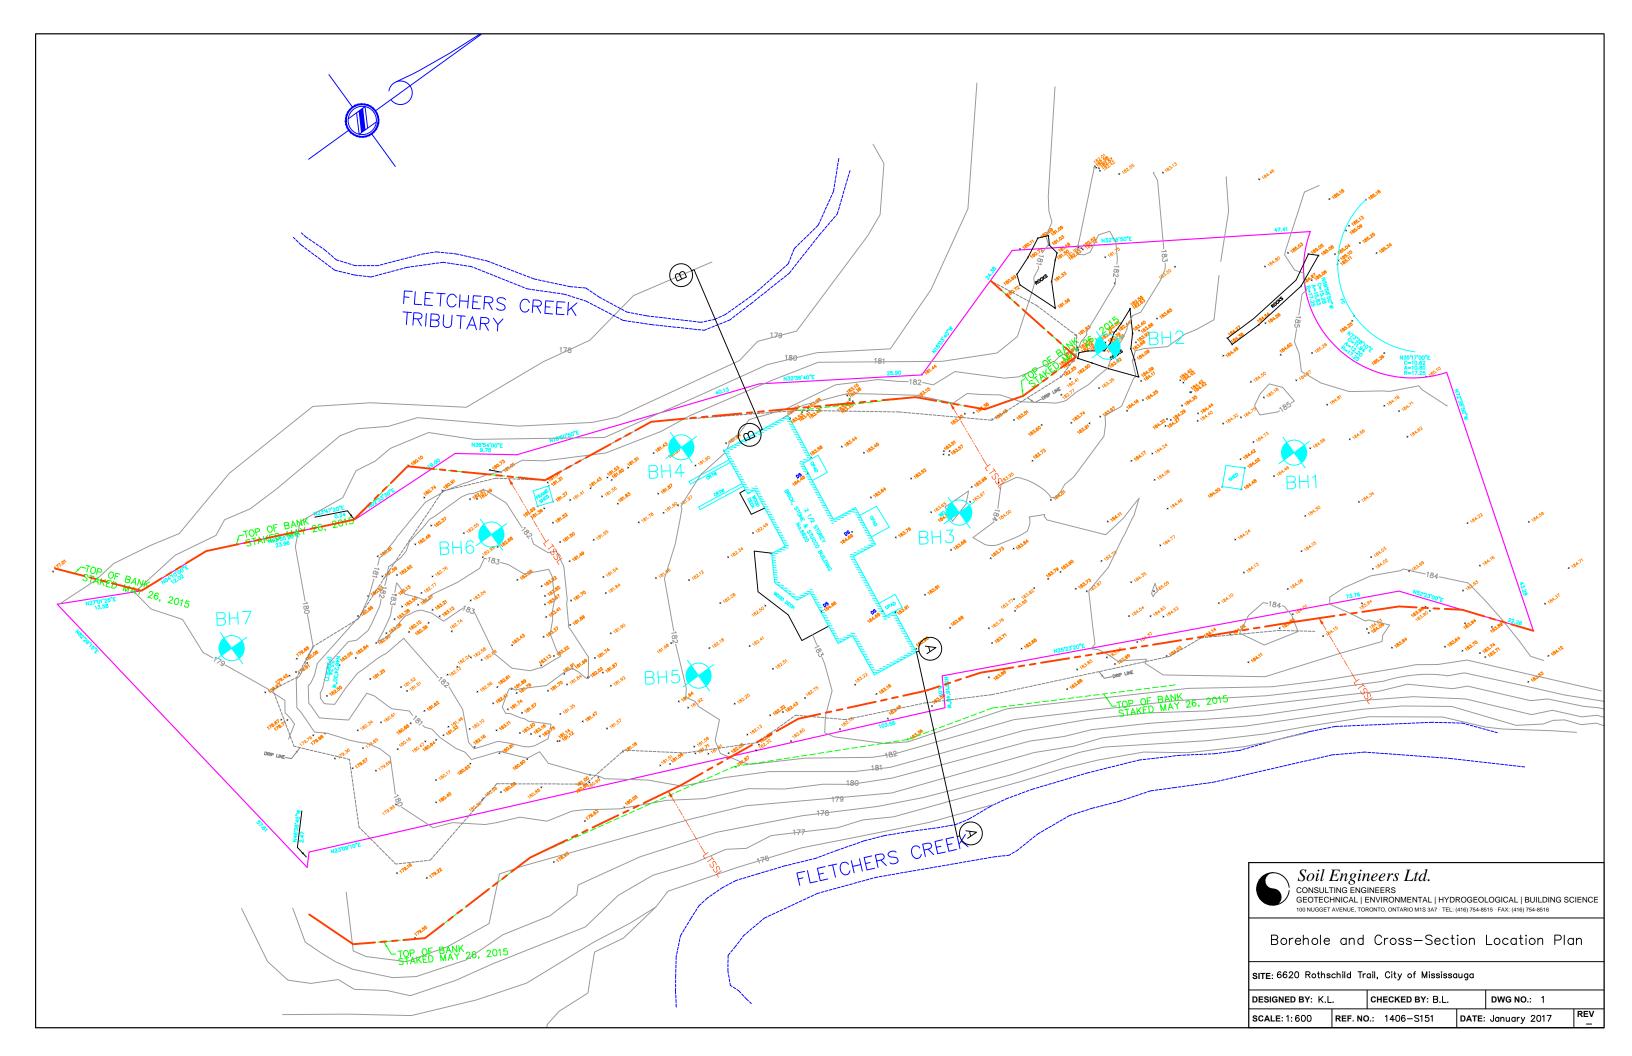
The staked top of bank and the Long Term Stable Slope Line (LTSSL), as determined by incorporating the stability setback and toe erosion allowance, are shown on Drawing No. 1.

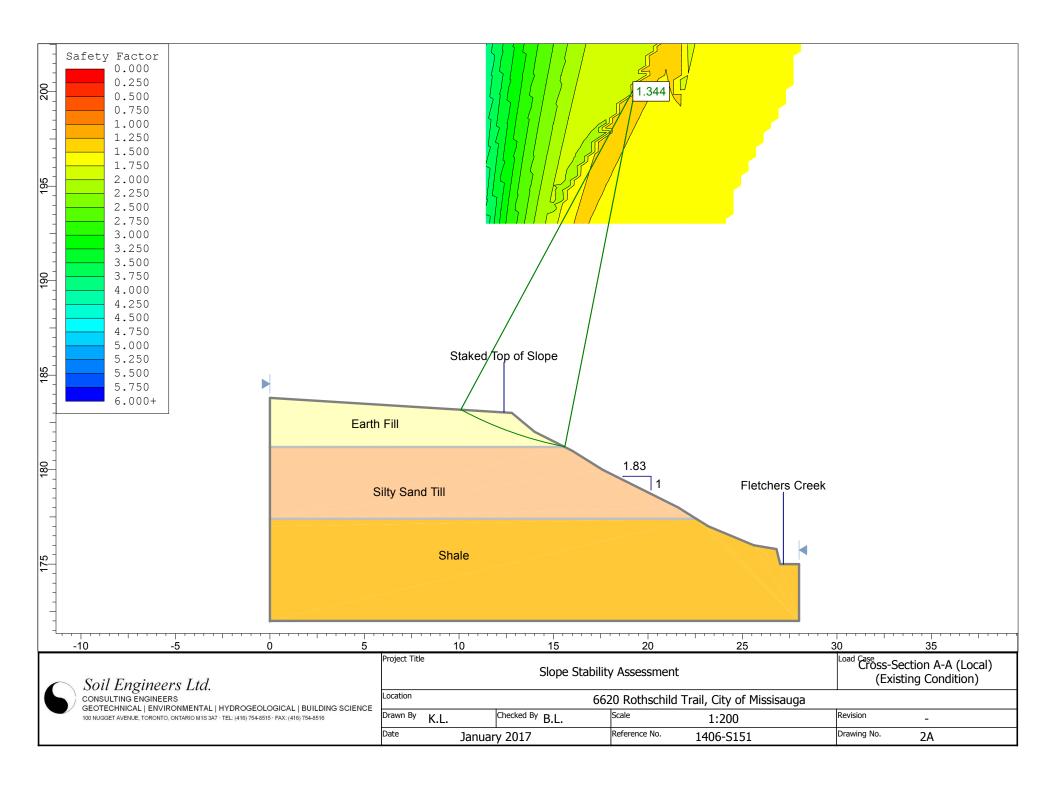
The factor of safety (FOS) for the existing slopes at the cross sections are generally above the Ontario Ministry of Natural Resources (OMNR) and Credit Valley Conservation Authority (CVC) requirement (FOS of 1.5), except Cross Section A-A (Local). The results of the analysis are presented on Drawing Nos. 2A, 2B and 3.

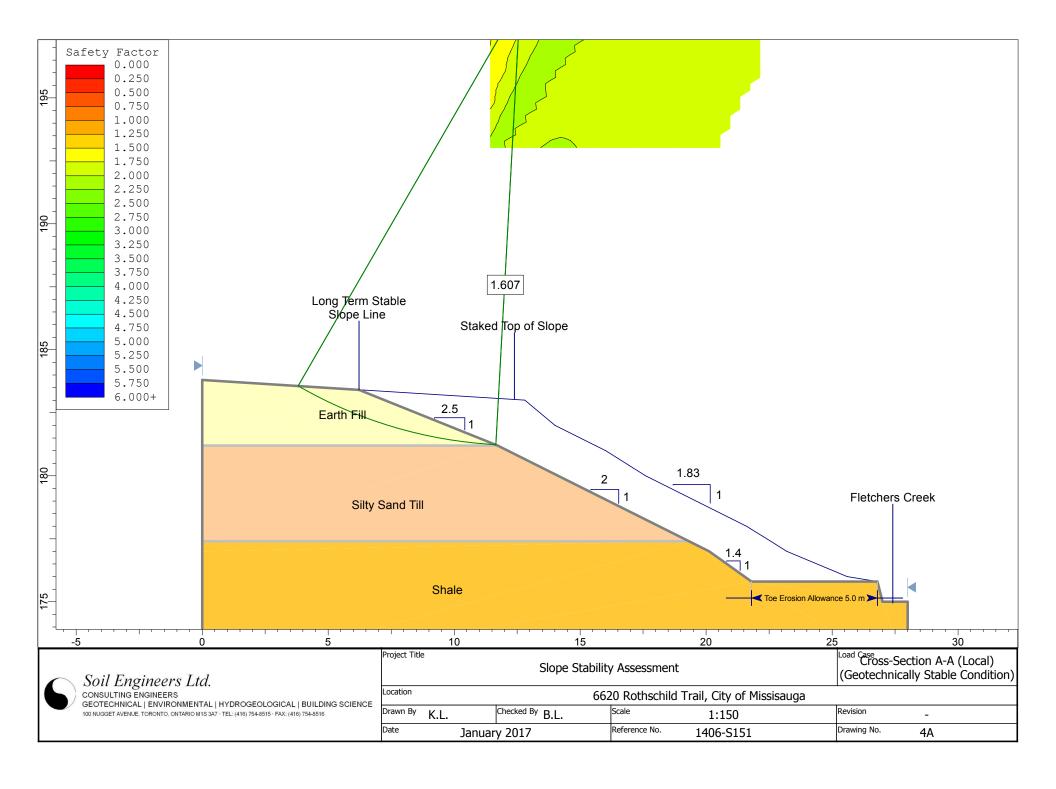
The slope at Cross Section A-A is remodeled and re-analyzed for its stability. The resulting FOS of the remodeled slope are 1.607 (Local) and 1.880 (Global), which meets the OMNR and CVC requirements. Therefore, the remodeled slope can be considered as geotechnically stable. The results of the analysis are presented on Drawing Nos. 4A and 4B.
