# ARBORIST REPORT AND TREE PRESERVATION PLAN

**1995 Dundas Street East**  
Mississauga, ON

**31 July 2024, revised 24 October 2024**

**Amy Choi Consulting**

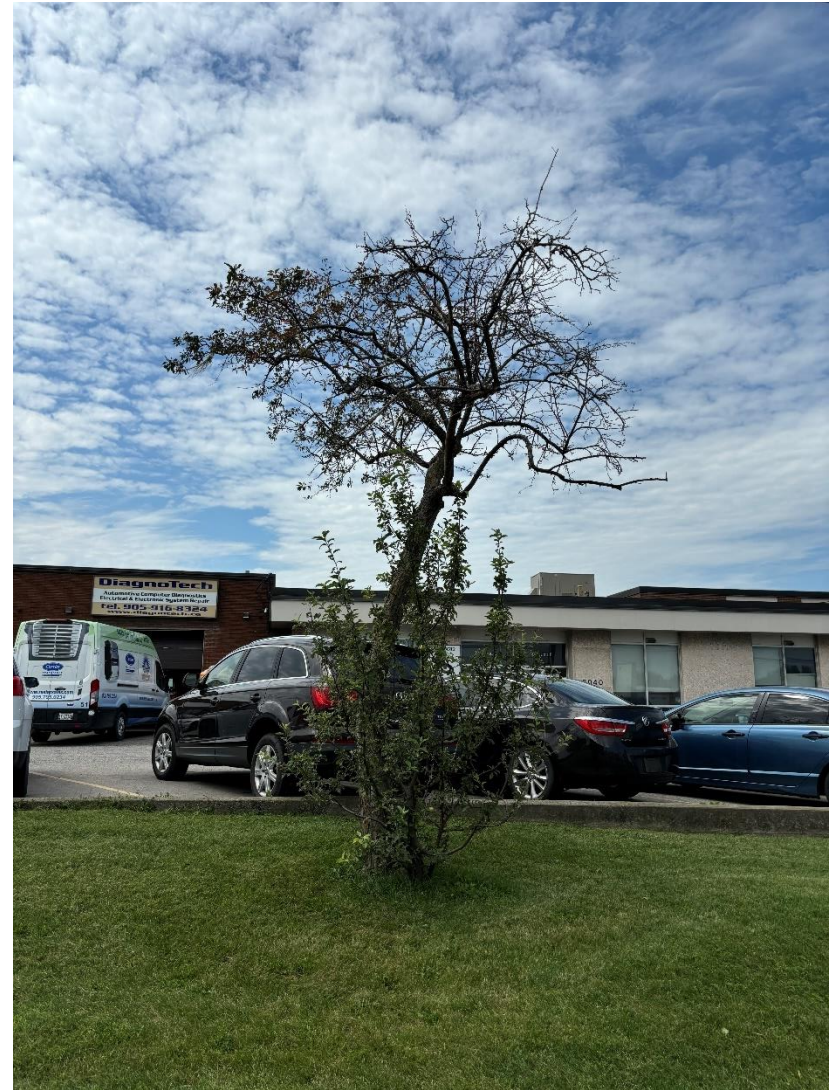
Photo 2. Tree 2, view looking west

The removal of a total of nine (9) will require removal to accommodate the proposed development or due to their condition. Six (6) trees will require removal to accommodate the proposed development and three (3) trees will require removal due to their condition. Trees 5 to 7, 9, 11, and 12 will require removal to accommodate the site access and walkway. Tree 2 is dying, Tree 3 is dead, and Tree 10 is in poor condition. A permit will be required for the removal of trees greater than 15 cm DBH, including all aforementioned trees. Trees 2 and 3 are dying/dead and an exemption from permit fees and compensation should apply.

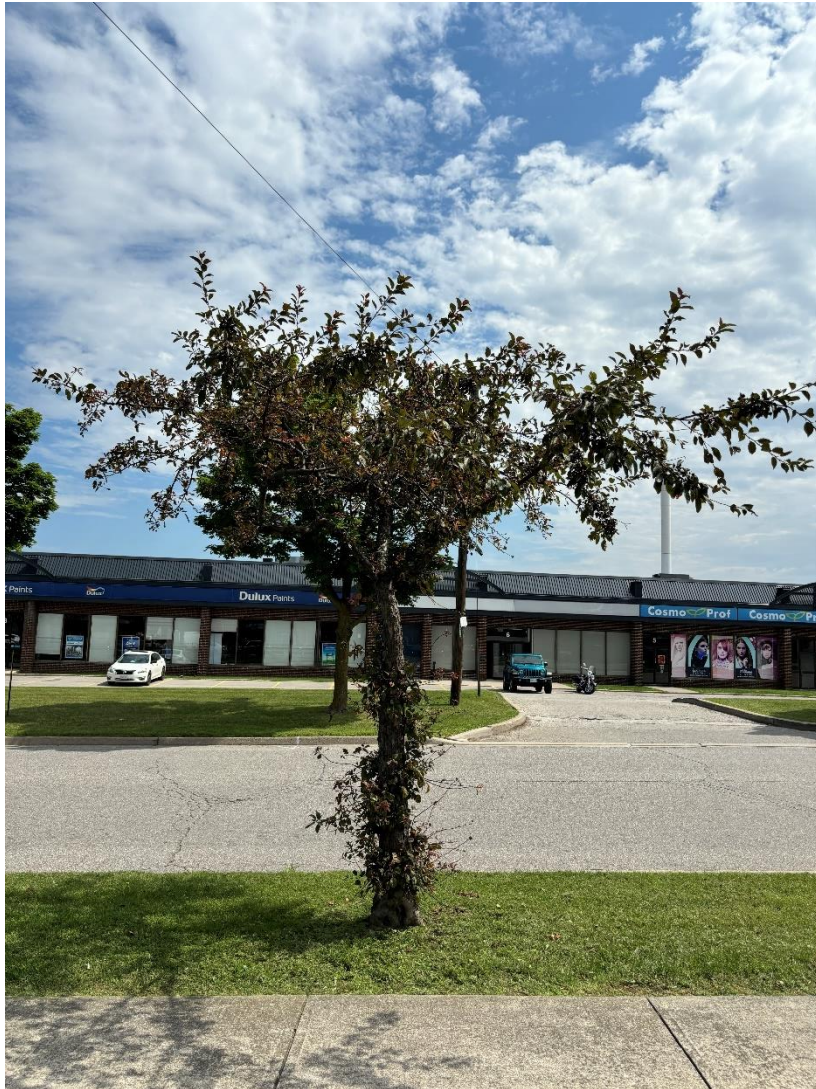
**Photo 5. Tree 5, view looking northeast**

Tree #	Common Name	Scientific Name	Diameter at Breast Height (DBH) <sup>1</sup>	Trunk Integrity	Crown Structure	Crown Vigour	Crown Dieback	Dripline (radius)	Minimum Tree Protection Zone (mTPZ) (radius) <sup>2</sup>	Comments	Proposed Action	Preservation Comments	Ownership
			(cm)	Good (G), Fair (F), Poor (P)			%	(m)	(m)				
1	Crabapple species	<i>Malus</i> sp.	17.5	F	F	F		2	1.5	Moderate epicormic branching, minor pruning wounds with decay	Preserve		City ROW
2	Crabapple species	<i>Malus</i> sp.	16	PF	PF	P		2	1.5	Major coppice growth, dying, moderate pruning wounds, major deadwood	Remove (dying)		Subject
3	Crabapple species	<i>Malus</i> sp.	21	DEAD				-	-		Remove (dead)		City ROW
4	Crabapple species	<i>Malus</i> sp.	17	F	F	F		1.5	1.5	Major epicormic branching, moderate pruning wounds with decay	Preserve		City ROW
5	Crabapple species	<i>Malus</i> sp.	18	F	F	F		1.5	1.5	Major epicormic branching, moderate pruning wounds with decay	Remove		City ROW

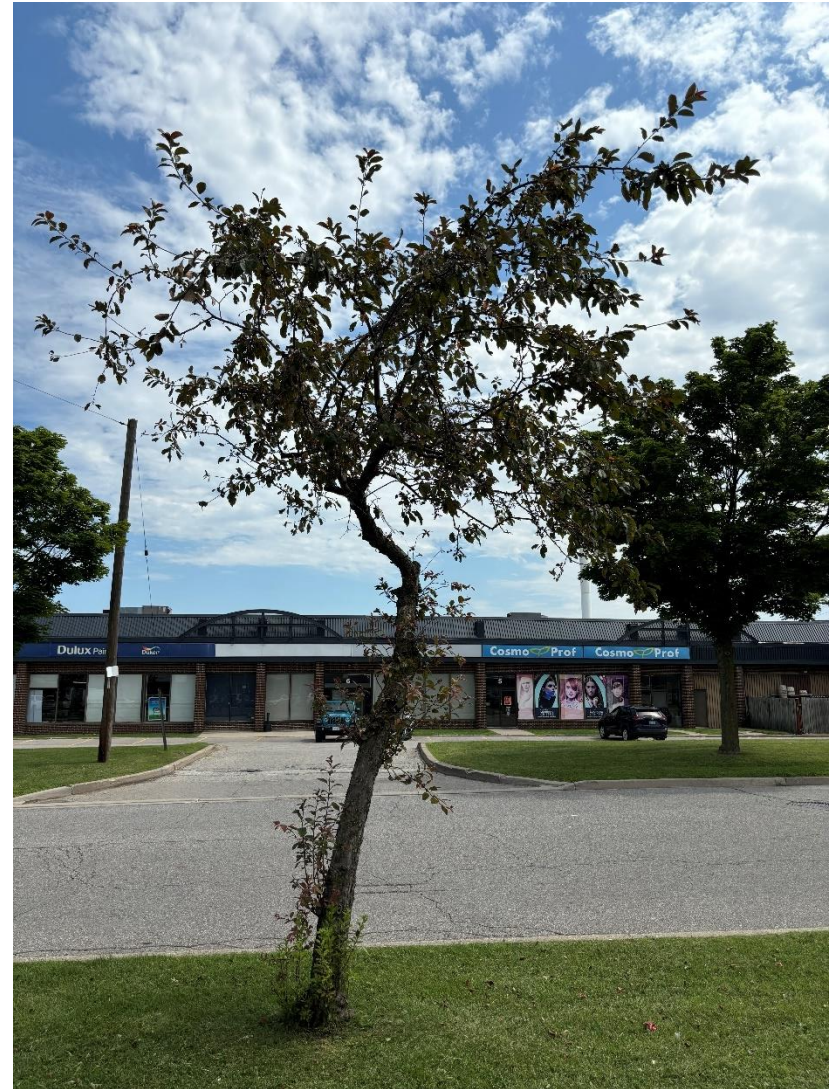
**Photo 6. Tree 6, view looking northeast**

6	Crabapple species	<i>Malus</i> sp.	15	F	F	F		1	1.5	Major epicormic branching, moderate pruning wounds with decay	Remove		City ROW
7	Crabapple species	<i>Malus</i> sp.	20	F	F	PF	20	2	1.5	Minor epicormic branching, moderate pruning wounds with decay	Remove		City ROW
8	Crabapple species	<i>Malus</i> sp.	22	F	F	F		2.5	1.8	Moderate stem wound with decay, moderate pruning wounds with decay, major epicormic branching	Preserve		City ROW
9	Crabapple species	<i>Malus</i> sp.	32.5	FG	F	F	5	3	2.4	Utility line through crown, minor pruning wounds with decay	Remove		City ROW
10	Crabapple species	<i>Malus</i> sp.	17,16 [23]	PF	F	PF	30	3	1.8	Co-dominant near base, major epicormic branching, moderate pruning wounds with decay, minor deadwood	Remove (poor condition)		City ROW

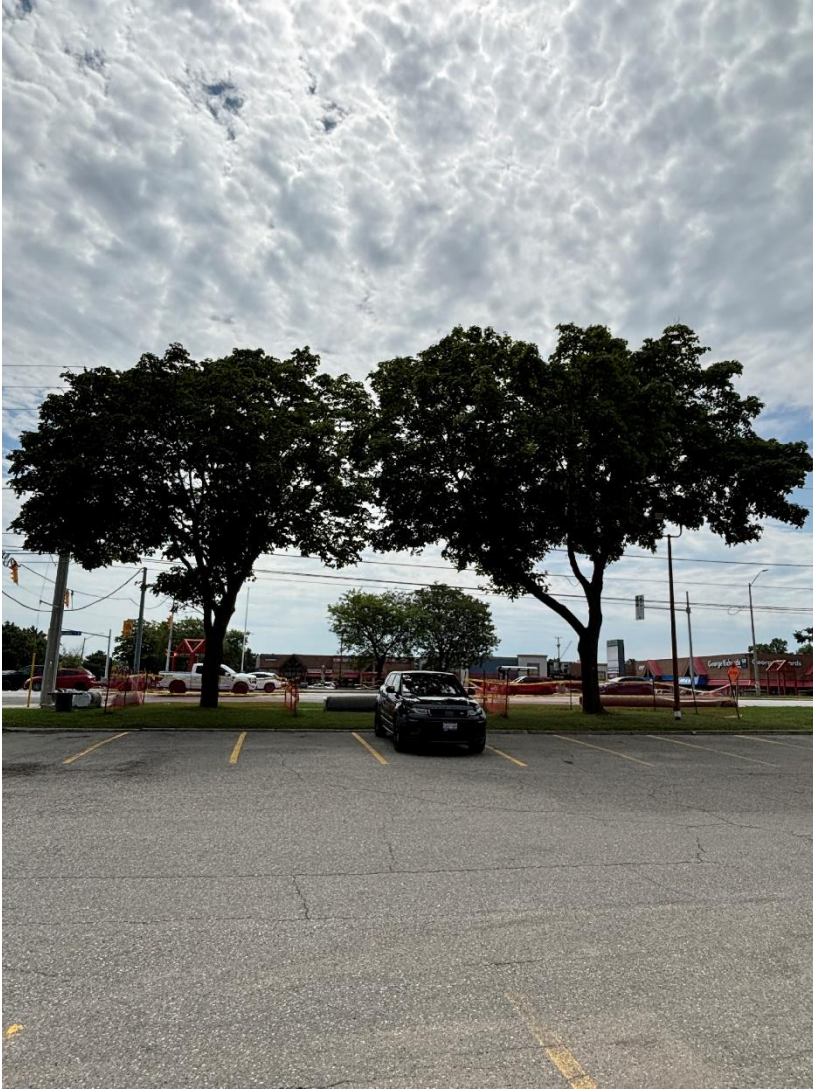
**Photo 11. Trees 13 and 14 (left and right), view looking southeast**

Tree #	Common Name	Scientific Name	Diameter at Breast Height (DBH) <sup>1</sup>	Trunk Integrity	Crown Structure	Crown Vigour	Crown Dieback	Dripline (radius)	Minimum Tree Protection Zone (mTPZ) (radius) <sup>2</sup>	Comments	Proposed Action	Preservation Comments	Ownership
			(cm)	Good (G), Fair (F), Poor (P)			%	(m)	(m)				
11	Austrian Pine	<i>Pinus nigra</i>	32	FG	FG	F		3	2.4	Utility line through crown, minor deadwood, crooks	Remove		City ROW
12	Austrian Pine	<i>Pinus nigra</i>	32	FG	F	PF		2.5	2.4	Utility line through crown, moderate deadwood, minor broken branches, missing leader	Remove		City ROW
13	Norway Maple	<i>Acer platanoides</i>	52	FG	FG	G		6	3.6	Vertical scaffold limbs, minor pruning wounds, exposed roots, tagged 891	Preserve - injure	Any work to be supervised by a Certified Arborist and any roots pruned according to good arboricultural practices.	Subject
14	Norway Maple	<i>Acer platanoides</i>	53	FG	FG	G		6	3.6	Vertical scaffold limbs, minor pruning wounds, moderate exposed roots and root wounds with decay, girdling root, tagged 890	Preserve - injure		Subject

Trees 1, 4, and 8 will be protected by plastic snow fence framed hoarding. This hoarding should be kept in place for the duration of construction. Tree 13 will be protected by plastic snow fence framed hoarding within the City road allowance, and solid board (plywood) framed hoarding within the subject property. Trees 14 to 16 will be protected by solid board (plywood) framed hoarding.

Minor to moderate encroachment into the mTPZs of Trees 13 to 16 will be required to remove existing asphalt, and/or install walkways. Any curbs should be removed gently by hand or light equipment only. Any excavation for the walkways should be done towards the end of construction (landscaping phase). Any work within the mTPZs is to be completed by hand-digging, air spade/vac, or hydro-vac technology and supervised by a Certified Arborist. Any exposed roots should be pruned by a Certified Arborist following good arboricultural standards. Tree 16 should be monitored annually during the growing season for changes in health and condition for a minimum period of two years following construction completion. All trees will benefit from watering during and for a minimum period of two years following construction.

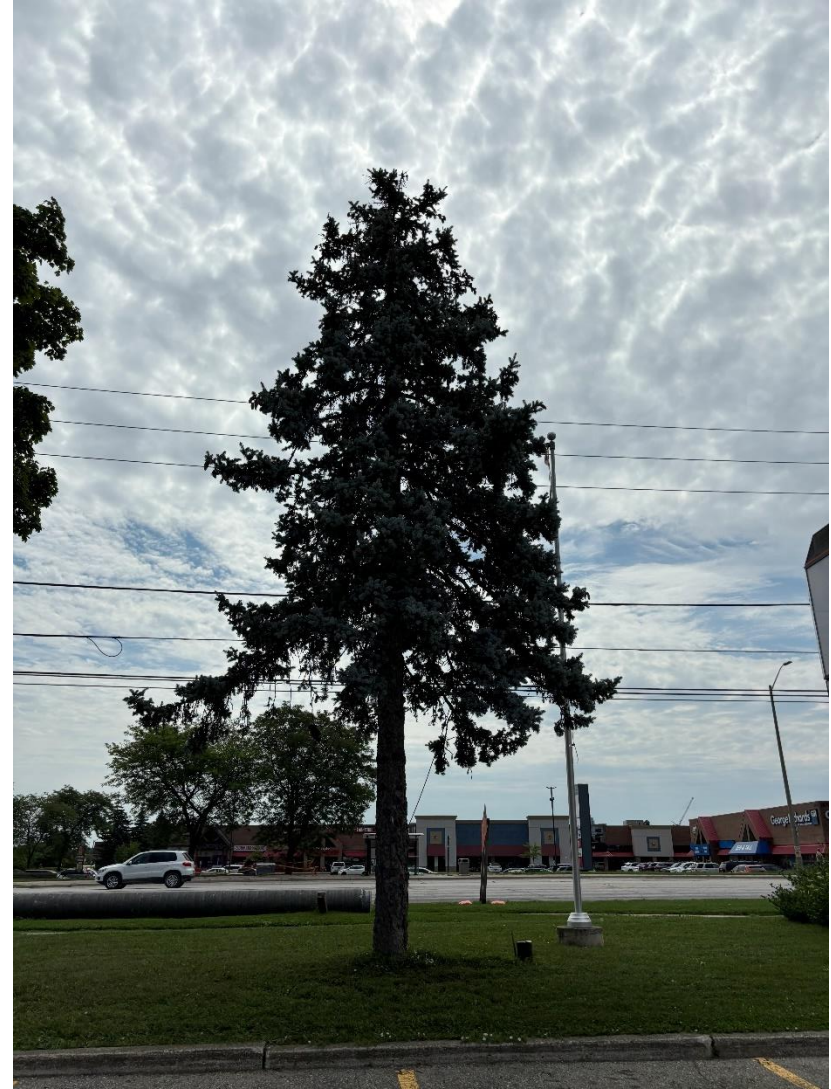
**Photo 12. Tree 15, view looking southeast**

15	Blue Spruce	<i>Picea pungens</i>	32	FG	F	FG		2	2.4	Dead leader, exposed roots, growth deficit, affixed wires, minor pruning wounds due to raised crown, tagged 889	Preserve - injure		Subject
16	Norway Maple	<i>Acer platanoides</i>	61	G	FG	G		7	4.2	Minor exposed roots and root wounds, vertical scaffold limbs, tagged 888	Preserve - injure		Subject
17	Austrian Pine	<i>Pinus nigra</i>	28	G	G	FG		2.5	1.8	Minor pruning wounds due to raised crown, tagged 886	Preserve		1945 Dundas Street East
18	Austrian Pine	<i>Pinus nigra</i>	33	FG	G	FG		2.5	2.4	Minor pruning wounds due to raised crown, crooks, utility lines through crown, tagged 887	Preserve		1945 Dundas Street East
19	Norway Maple	<i>Acer platanoides</i>	8	F	PF	F	15	1	1.2	Top of crown removed	Preserve		1945 Dundas Street East
20	Little-leaf Linden	<i>Tilia cordata</i>	15	F	PF	FG		1.5	1.5	Top of crown removed	Preserve		1945 Dundas Street East
END
