ARBORIST REPORT & TREE PROTECTION PLAN

900 LAKESHORE ROAD WEST
MISSISSAUGA, ON
L5H 1H9

Date: January 25, 2024

Revised: November 22, 2024

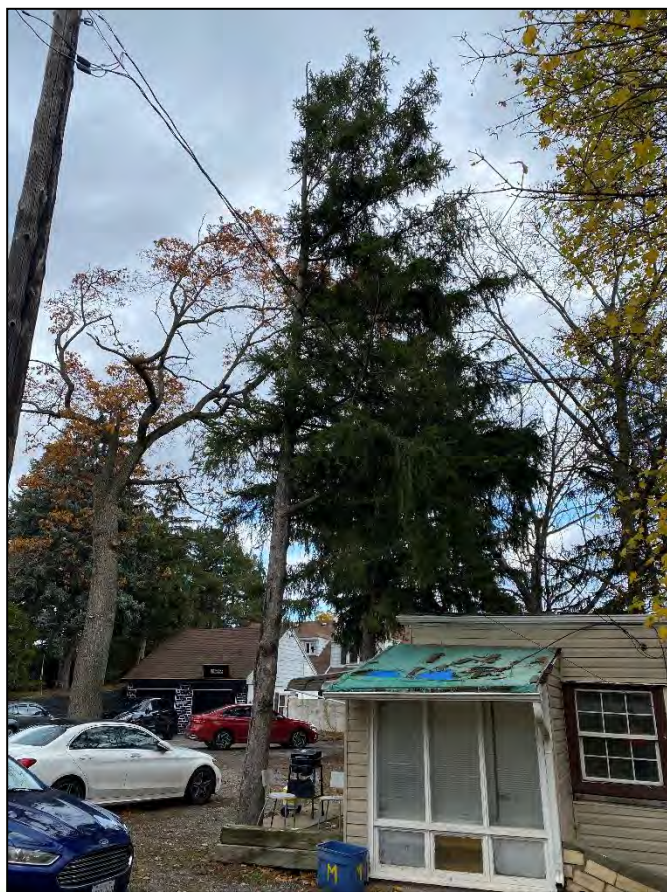
Tree #390 – Red Oak (79cm DBH)

Tree #	Tree Species	Botanical Name	DBH (cm)	Root Zone	Trunk Integrity	Crown Structure	Crown Vitality	Overall Condition
390	Red Oak	<i>Quercus rubra</i>	79	Fair	Poor	Fair	Fair	Fair

Tree #390, a 79cm DBH Red Oak (*Quercus rubra*) is a privately owned deciduous tree growing in the west portion of the property. This tree is growing on a lean, has unhealed trunk wounds, cavities with decay, and has been topped. Overall this tree is in fair condition.

Due to the location that this tree is growing and the proposed construction, this tree is recommended for removal. A permit is required for the removal of this tree.

Five (5) replacement trees will require to be planted as compensation. The compensation trees should be at least 6cm diameter (deciduous), or at least 1.8m tall (evergreen). Tree species and quantities will be included in the landscape design drawings.

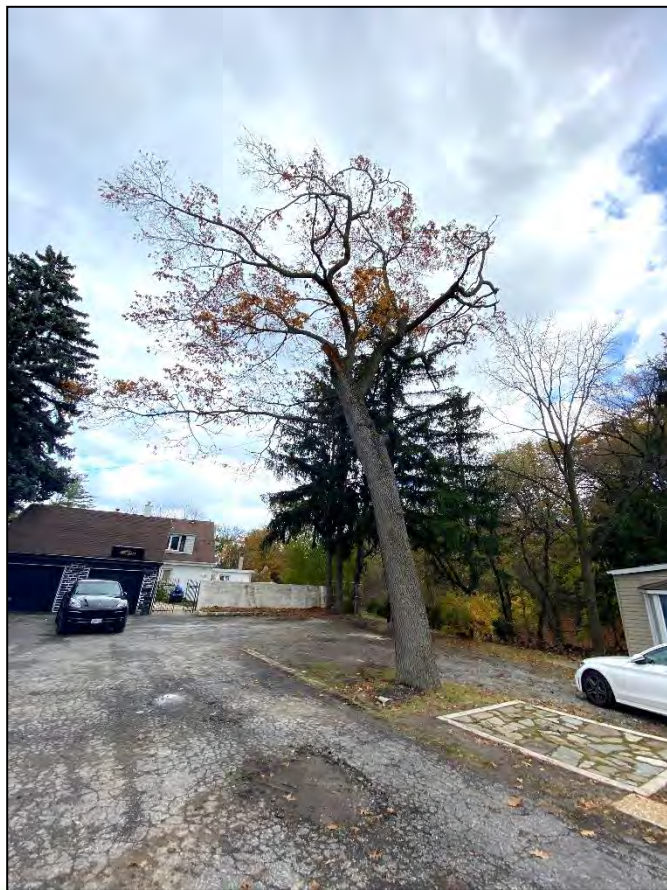
Tree #391 – Norway Spruce (49cm DBH)

Tree #	Tree Species	Botanical Name	DBH (cm)	Root Zone	Trunk Integrity	Crown Structure	Crown Vitality	Overall Condition
391	Norway Spruce	<i>Picea abies</i>	49	Good	Good	Good	Good	Good

Tree #391, a 49cm DBH Norway Spruce (*Picea abies*) is a privately owned evergreen tree growing in the west portion of the property. This tree has exposed and girdling roots, and unhealed pruning wounds. Overall this tree is in good condition.

Due to the location that this tree is growing and the proposed construction, this tree is recommended for removal. A permit is required for the removal of this tree.

Three (3) replacement trees will require to be planted as compensation. The compensation trees should be at least 6cm diameter (deciduous), or at least 1.8m tall (evergreen). Tree species and quantities will be included in the landscape design drawings.
