## **ARBORIST REPORT**

### **PROPOSED MIXED-USE HIGH-RISE DEVELOPMENT 2555 ERIN CENTRE BOULEVARD, MISSISSAUGA**

**November 18, 2024**

**Revised December 17, 2024**

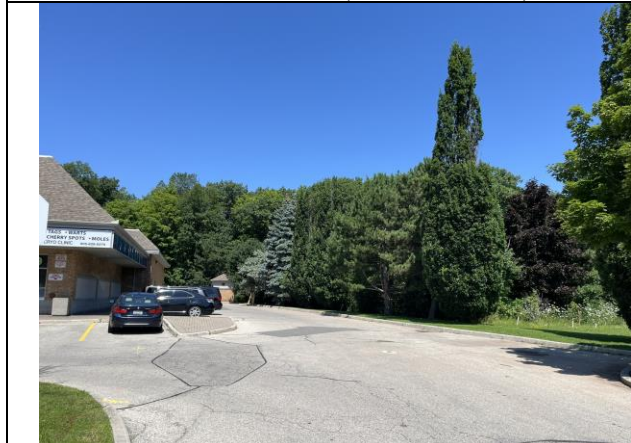
East side of site (view north)

The east site limit is composed of a planted row of semi-mature Austrian Pine, Colorado Blue Spruce and Pyramidal English Oak trees. These trees were likely planted as per the original site planning for the plaza. These trees are in generally fair to good health and condition.

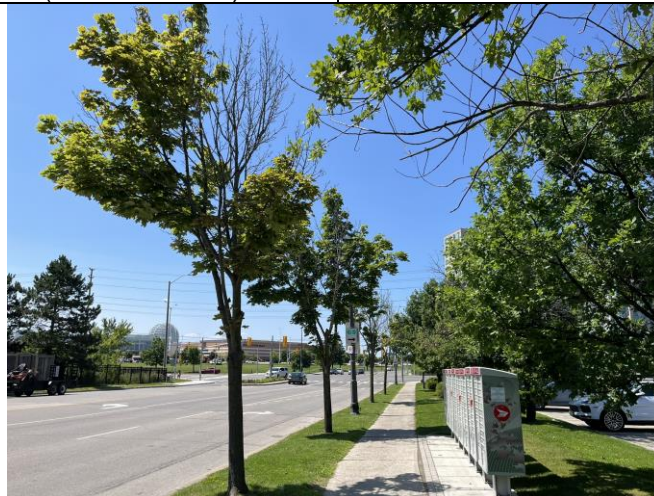
The site frontage flanking Erin Centre Drive is composed of buffer planting beds which include several Norway Maple and Pyramidal English Oak trees. The daylight triangle at the southwest corner of the site is composed of Colorado Blue Spruce and Norway Maple trees. Further, one Norway Maple and one Honeylocust flanks the west boulevard adjacent to Erin Mills Parkway. With the exception of a few, these semi-mature trees are in various levels of decline, and many are in generally poor condition.

Blvd. Trees along Erin Centre Dr.

Based on the constraints of the proposed Site Plan, all trees within the subject site require removal. All of the municipal street trees along Erin Centre Blvd. are either dead or in decline and are to be removed as well. All trees associated with the adjacent woodlot parklands are to be preserved and protected.
