ARBORIST REPORT

Thorny Brae Residential

1765, 1775 Thorny Brae Place
Mississauga, Ontario

June 20, 2025

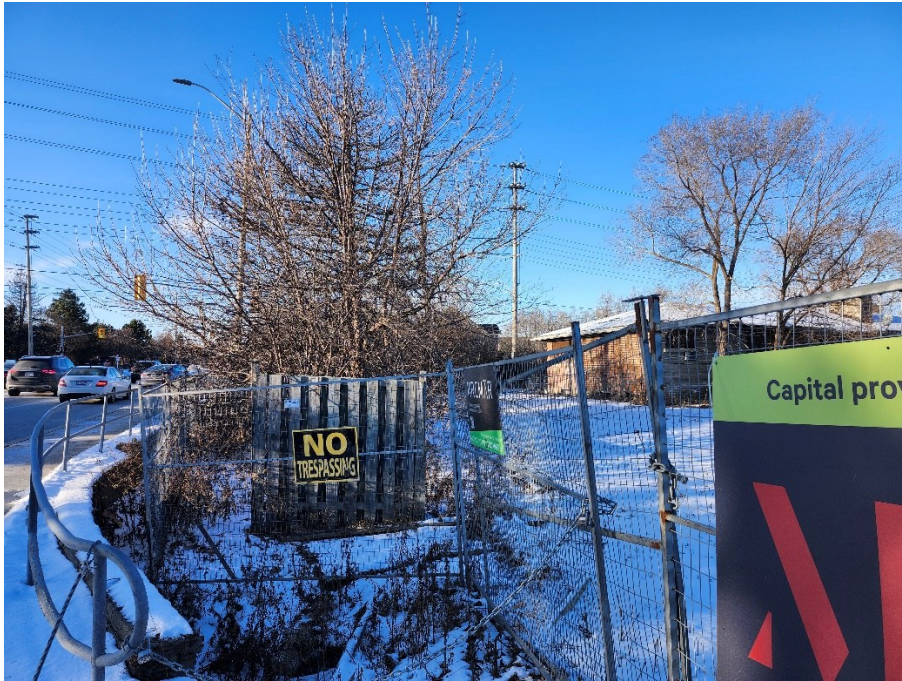
Figure 2: Former Thorny Brae intersection looking north too single-family dwelling and corner of Eglinton Ave. and Mississauga Rd.

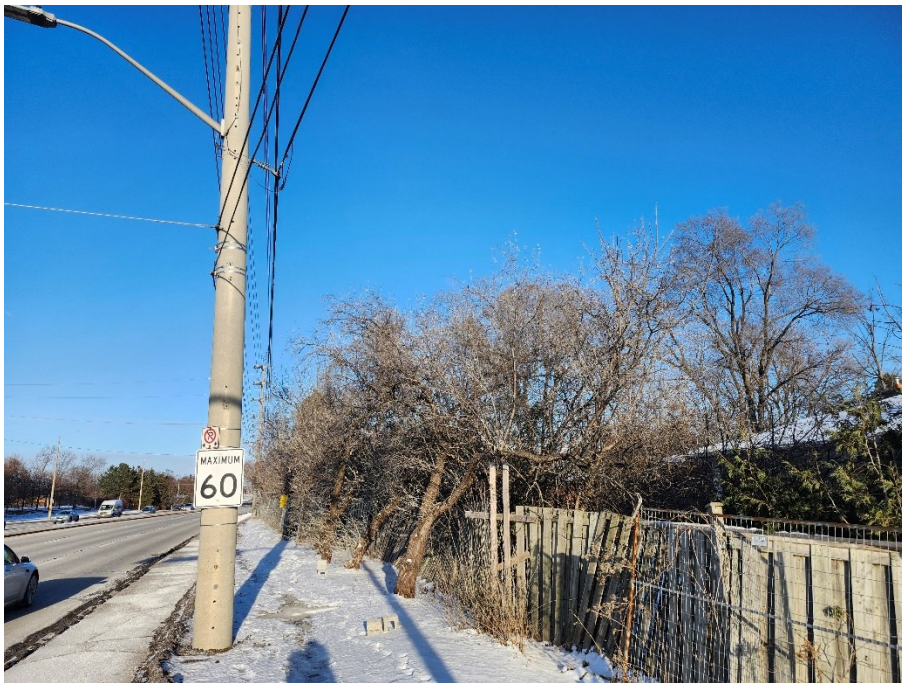
Figure 3: Corner of Mississauga Rd. and Eglinton Ave looking east.

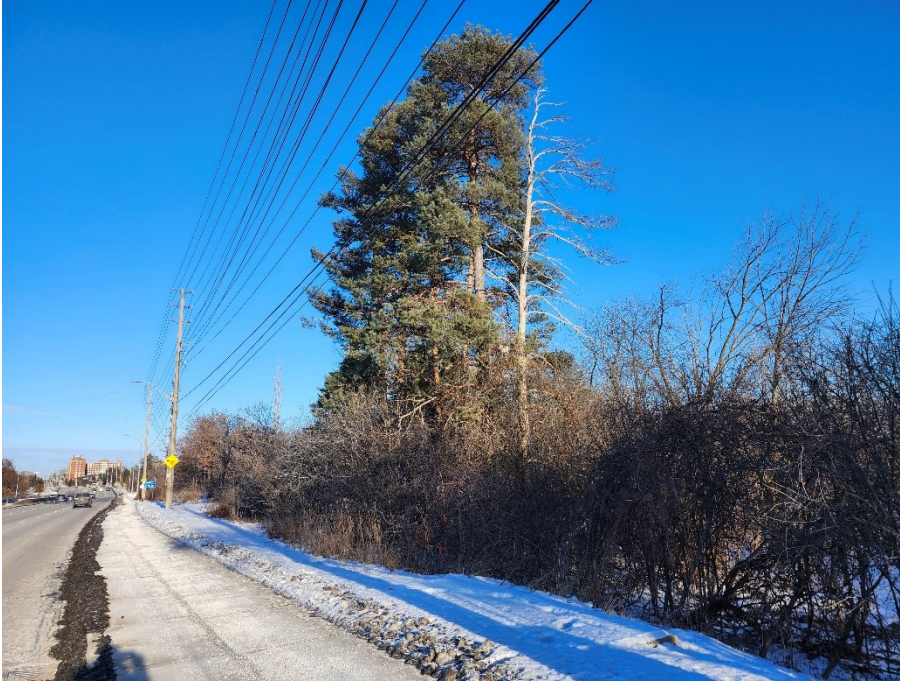
Figure 4: Looking east along Eglinton Ave. to row of Scots pine.

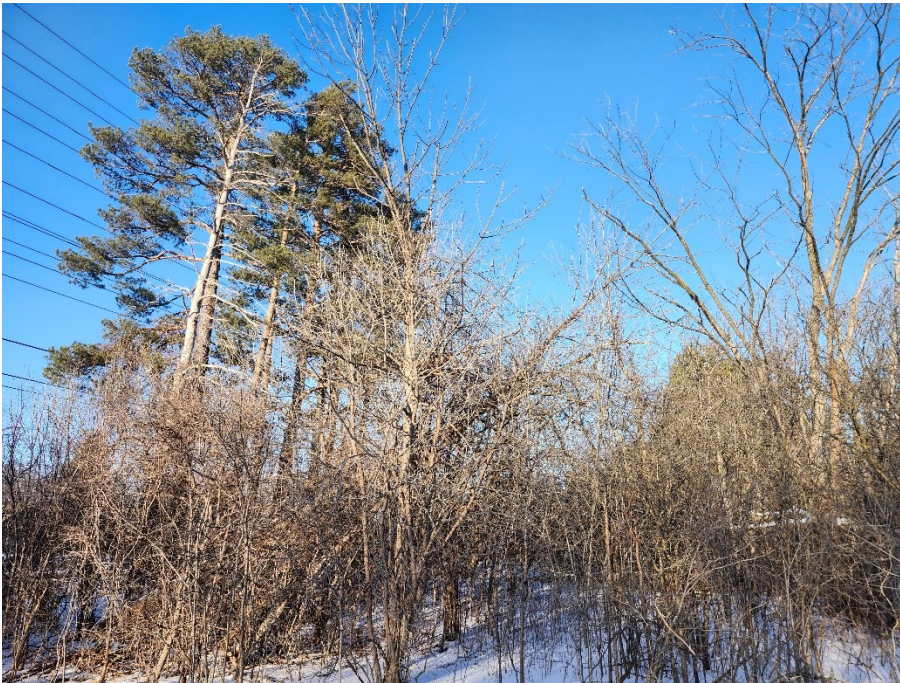
Figure 5: View of Scots pine row amongst understorey brush.

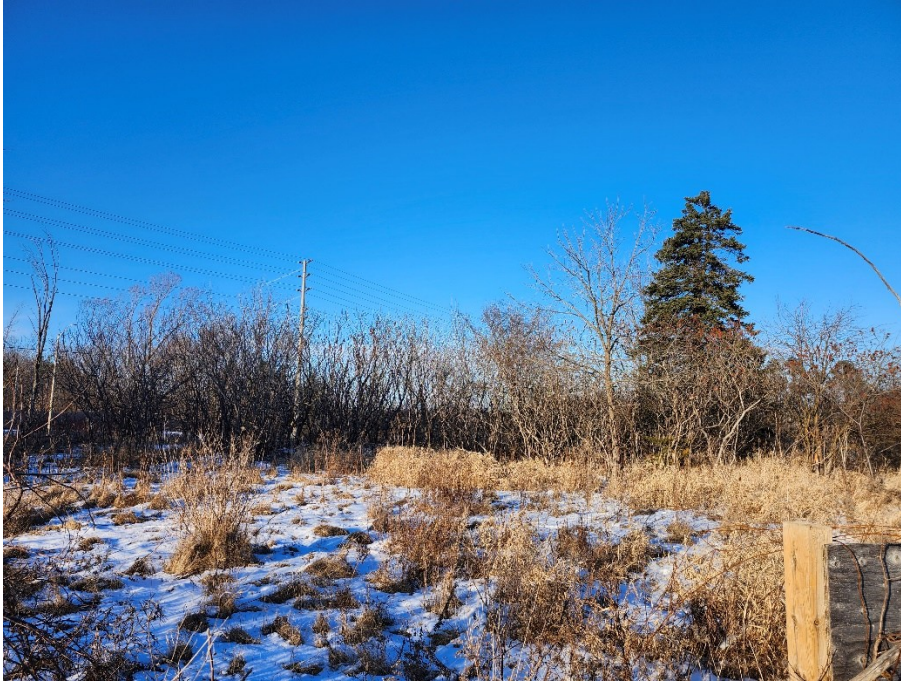
Figure 6: Canopy opening at centre of site looking north west towards rear of site and Eglinton avenue in the background.

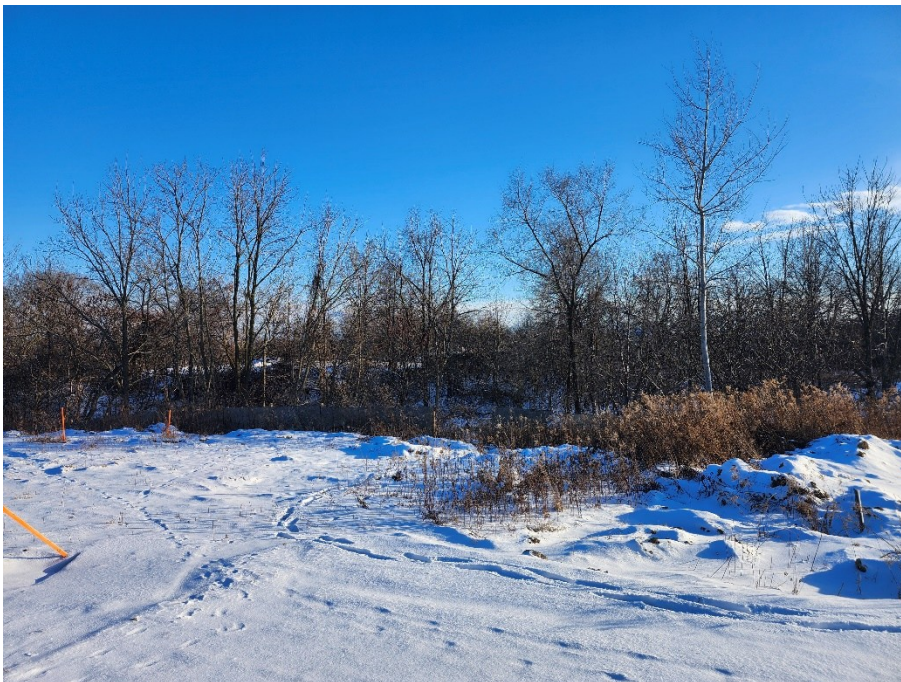
Figure 7: former Thorny Brae cul-de-sac looking south towards trees amongst scrubland.

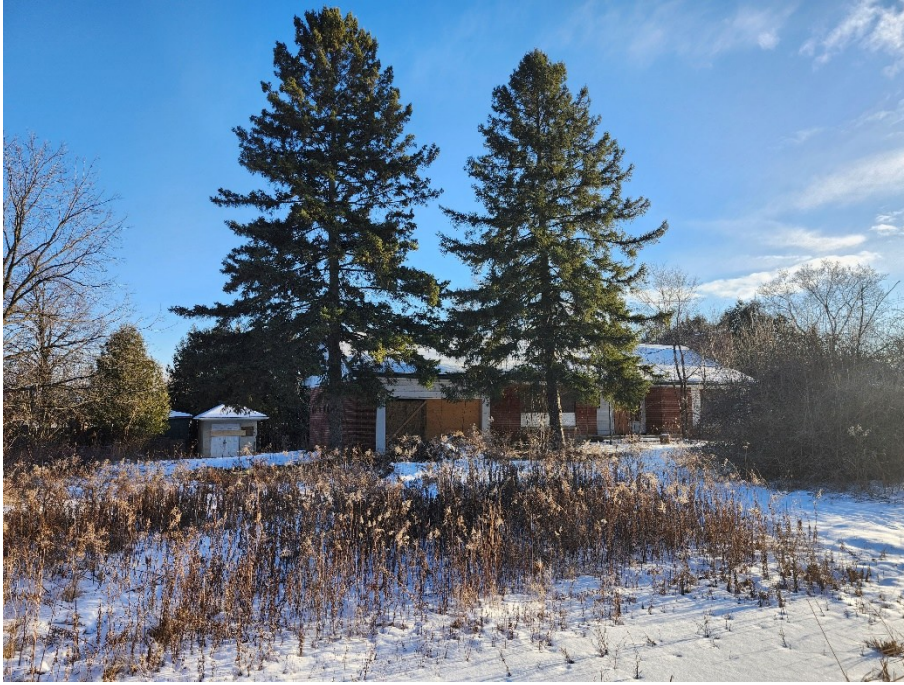
Figure 8: Trees along single-family house on south side of former Thorny Brae Pl.

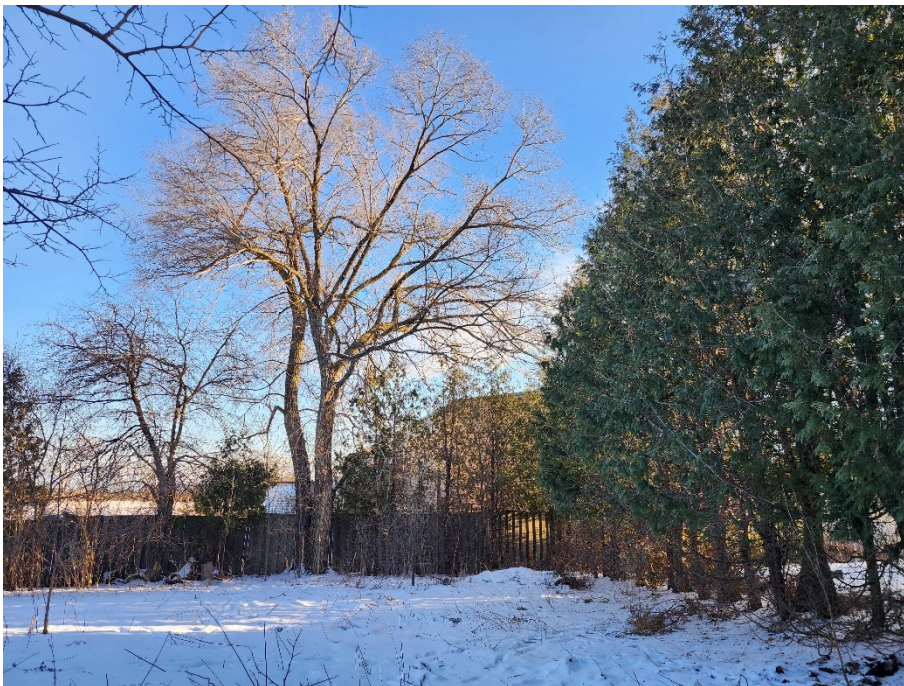
Figure 9: Trees and hedges at south side of property.
