Thorny Brae Residential
1765, 1775 Thorny Brae Place
Mississauga, ON

Tree Protection Plan

Sheet Number File Number
TS.3 of 4 FILE NO.

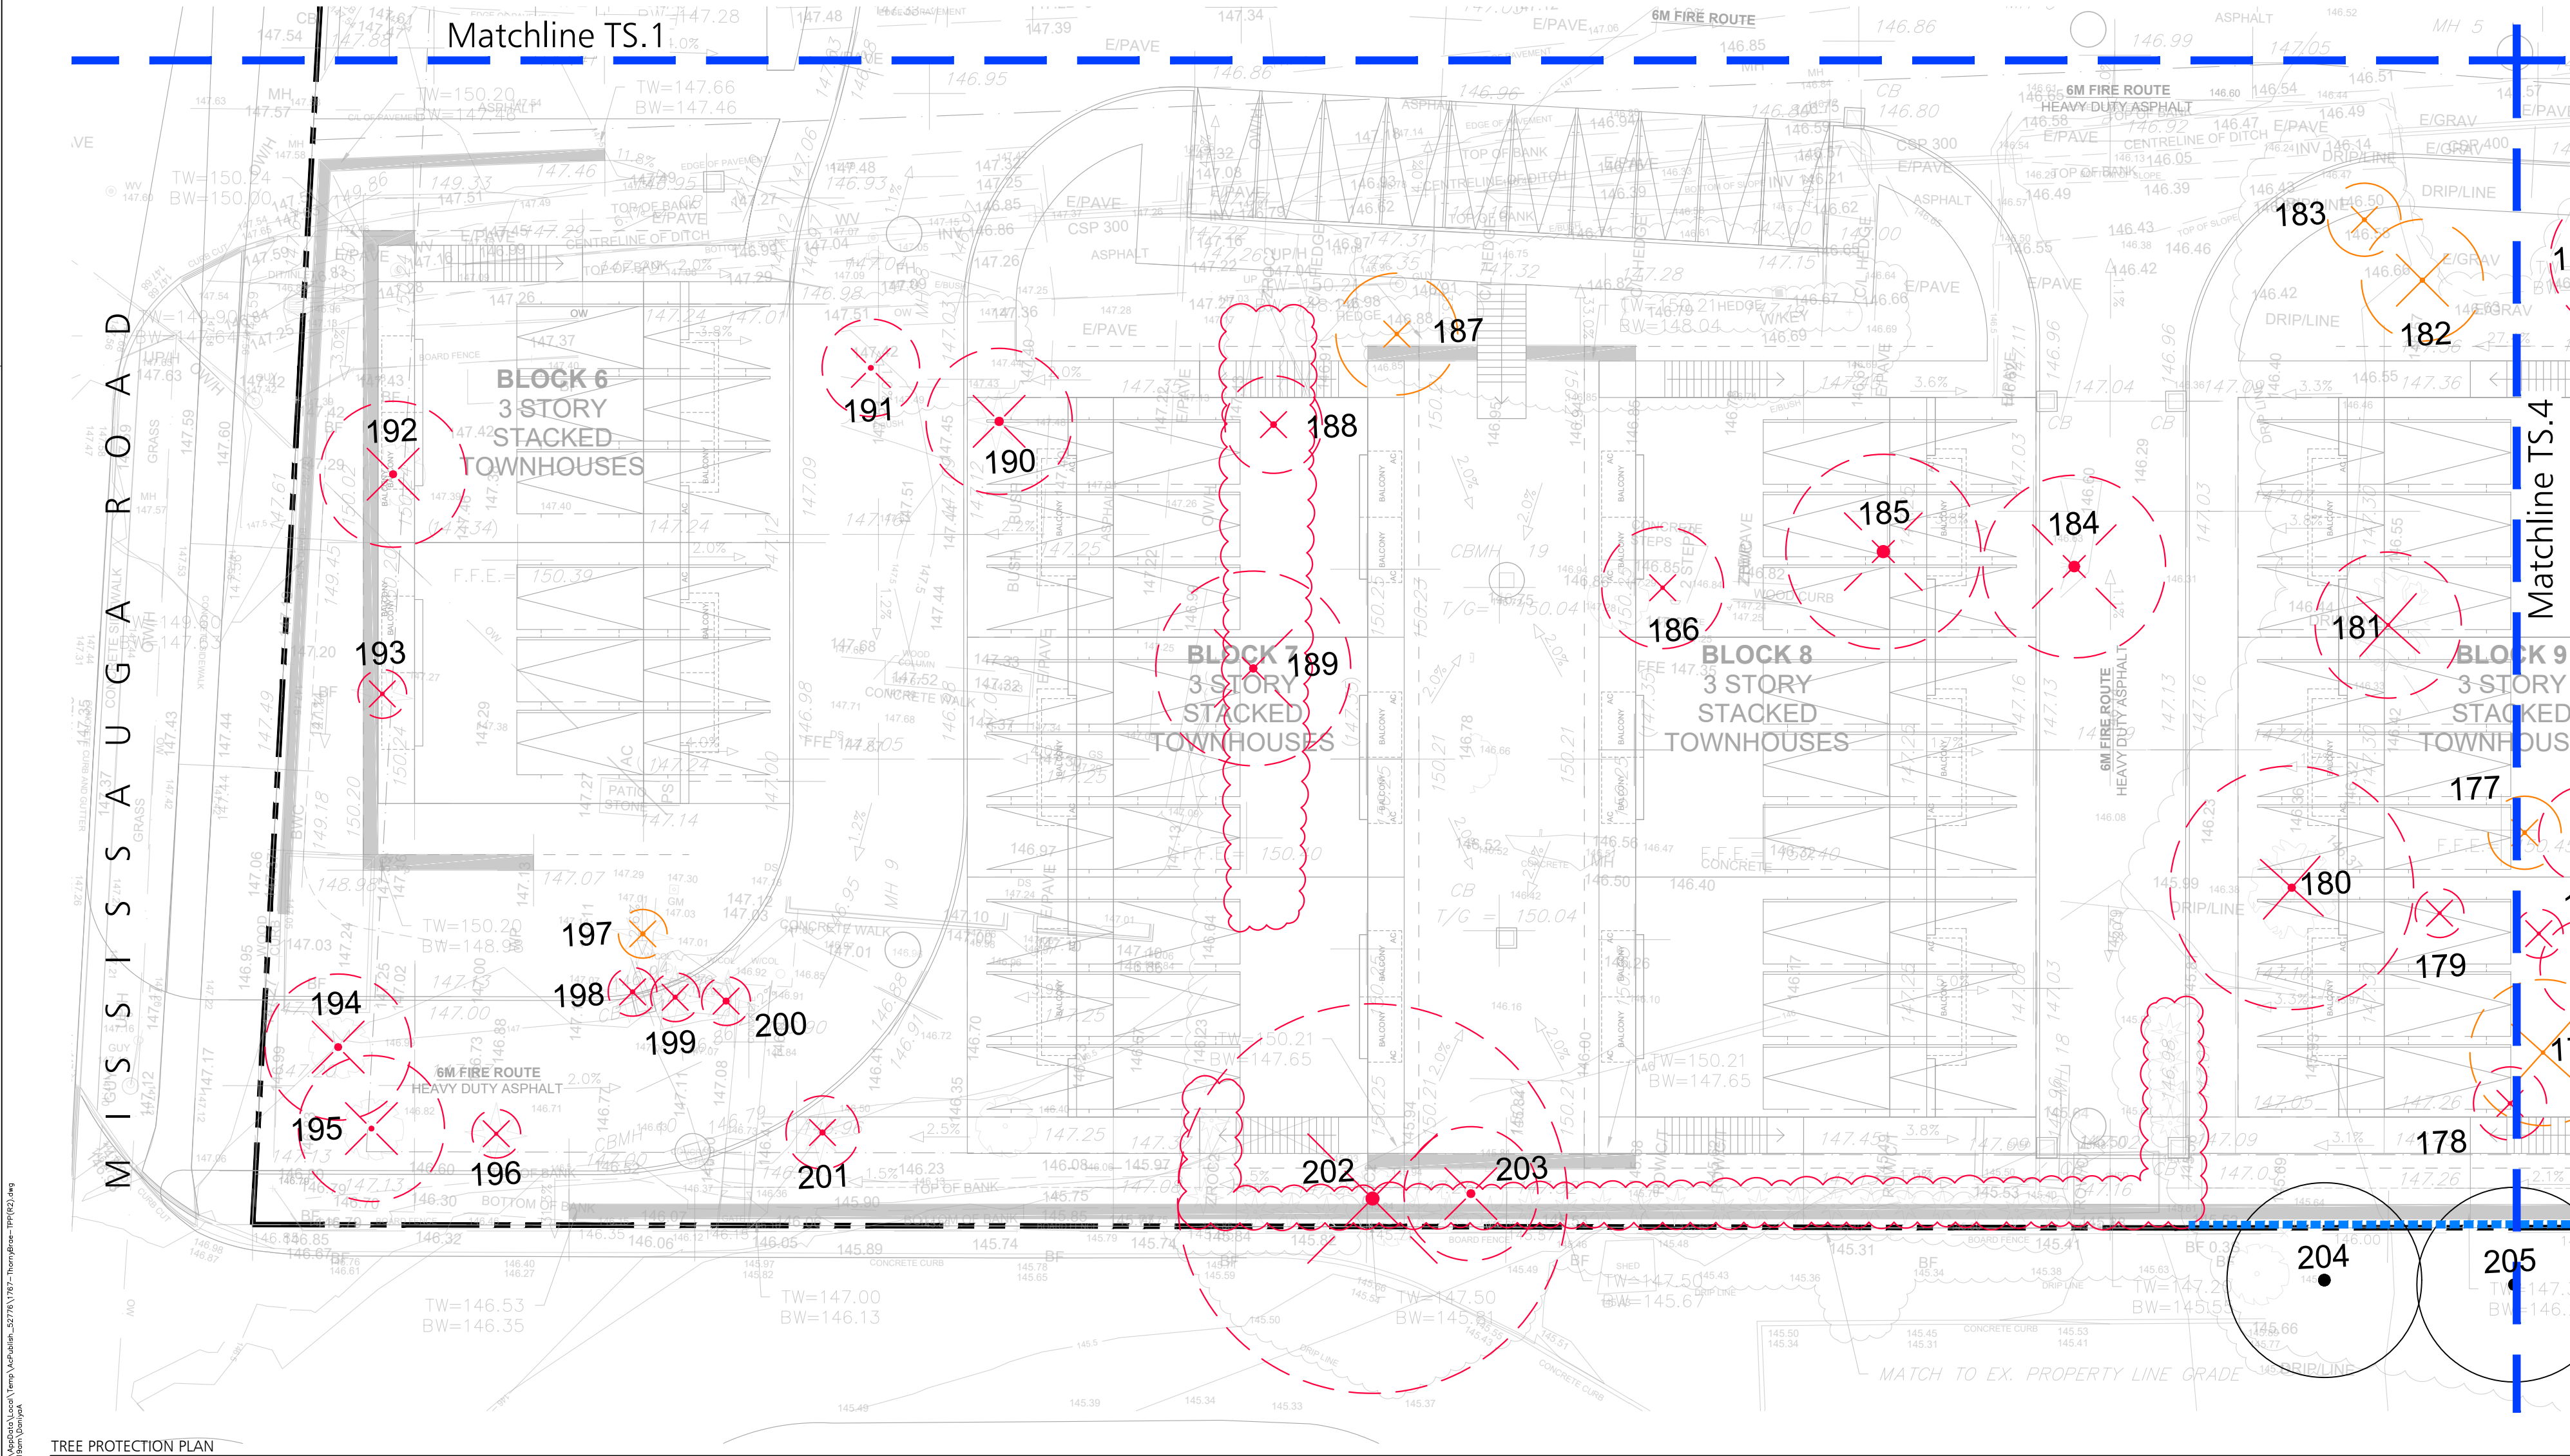
TREE PROTECTION PLAN
1:200

New Tree No.	Tree No.	Species	DBH (cm)	Combined DBH	Measure to Drop Line diameter (m)	Biological Health	Structural Condition	Recommended Action	Comments	Location Designation
178		Tilia Americana	12		3	H	MH	RC	89? Crossing branches	S
179		Tilia Americana	10		2	M	ML	RC	Vine, 30% TD	S
180	88	Juglans nigra	37.9, 26.4	25.4	10	H	H	RC	2L, WS	S
181	87	Juglans nigra	32.2		8	H	H	RC		S
182		Fraxinus pennsylvanica	16, 14	17.3	5	L	L	R	2 Leaders, Vine	S
183		Fraxinus pennsylvanica	13.4		3	L	L	R	EAB	S
184		Picea glauca	41.8		7.5	H	H	RC		S
185		Picea glauca	48.4		8	H	H	RC		S
186		Ulmus pumila	11.7, 12.4	15.5	5	H	MH	RC	2L, IB	S
187		Fraxinus pennsylvanica	12, 9, 7	16.7	5	L	L	R		S
188		Ulmus pumila	21.8		4	ML	ML	RC	Little budding could be dead, at least 50% dead canopy	S
189		Ulmus pumila	28.1		8	M	M	RC		S
190		Picea pungens	32.1		6	M	M	RC	20% canopy dieback	S
191		Ulmus pumila	18		4	H	MH	RC	wire through canopy	S
192		Acer platanoides	26.8		6	H	H	RC		S

193		Picea pungens	12		2	M	M	RC		S
194		Prunus avium	26.2		6	M	M	RC	several cracks, IB with branch	S
195		Prunus avium	17, 18, 12, 10, 10	25.9	6	M	M	RC	MB, IB at main union	S
196		Picea pungens	9		1.5	M	M	RC	Top dead	S
197		Picea glauca	-15		2	D	D	R	DEAD	S
198		Thuja occidentalis	10, 15, 10	18.7	2	M	M	RC		S
199		Thuja occidentalis	10, 10, 9, 14	20.7	2	M	M	RC		S
200		Thuja occidentalis	23, 15	19.5	2	M	M	RC	10' lean (SE)	S
201		Picea pungens	19		3	H	H	RC		S
202		Salix rubens	47.4, 51.7, 21	34.7	16	M	M	RC	2L, -6 large dead/ broken limbs griddling wire, 20% TD	S
203		Malus sp.	30		5.5	M	ML	RC	2L, IB crossing branch, UB (W)	S
204		Tilia x cordata	47.4		8	M	M	P	4 pruned limbs, leaving 2 holes	N
205		Tilia x cordata	46.1		8	M	M	P	5 pruned limbs, tight unions	N
206		Tilia x cordata	43.2		8	M	M	P	Multibranch node, 3 pruned limbs leaving 1 hole, IB	N
207		Tilia x cordata	34.8		6	M	M	P	3L, 1 pruned limb, 10' lean to parking lot, BF, 1 hanging branch	N

208		Tilia x cordata	39.4		8	M	M	P	2 pruned limbs, 1 hanging branch	N
209		Tilia x cordata	49.2		8	M	M	P	Crossing branches, IB, med. Pruned branch, 3 holes in trunk, BF	N
210		Malus sp.	18.5, 23	20.4	3	ML	ML	P	50% dead canopy, 1 dead trunk, 2L	N
211		Tilia Americana	18.7, 32.3	22.6	7	M	M	P	IB, 25' lean to parking lot	N
212		Juglans nigra	26.8		7	H	MH	P	vine, hanging branch	N
213	180	Juglans nigra	27		9	H	H	P	V	S
214	179	Juglans nigra	16		4	H	H	n/a	Tree removed since original survey	S
215	60	Ulmus laevis	20		6	D	D	R	DEAD	S
