SLOPE STABILITY ASSESSMENT

**900 LAKESHORE ROAD WEST,
MISSISSAUGA, ONTARIO, L5H 1H9**

Project No. FG25-15006_V4

Revised March 19, 2026

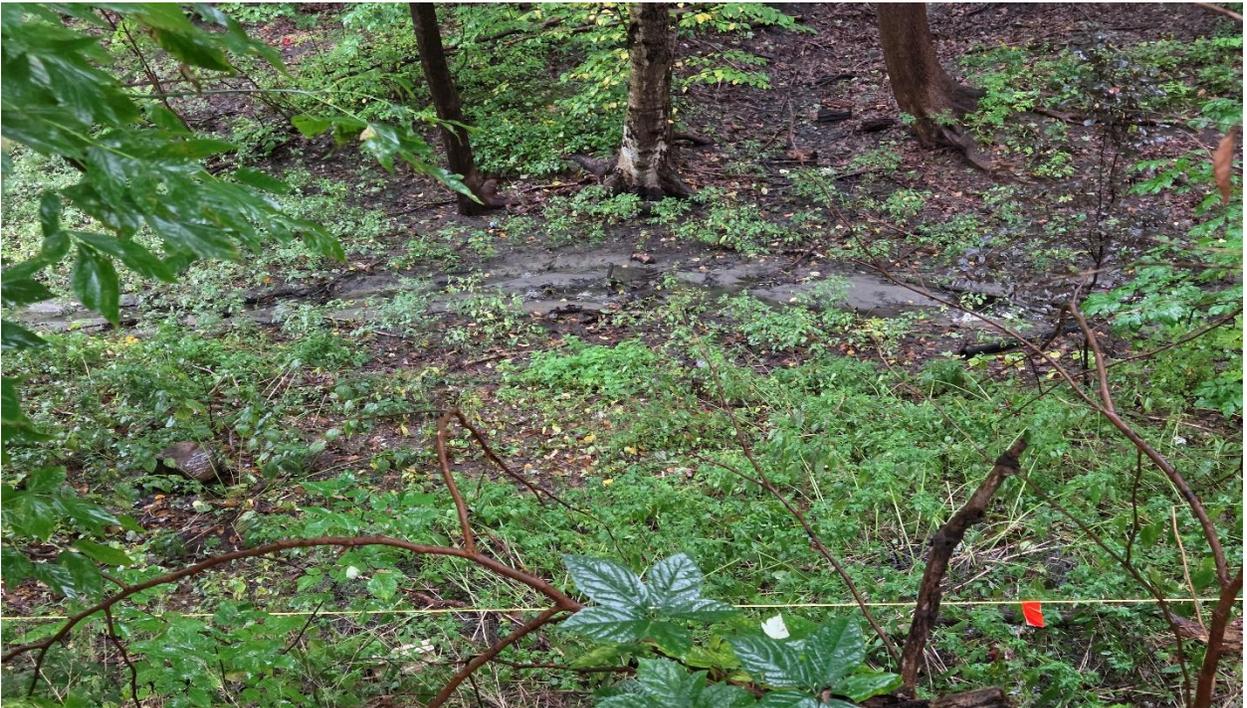
1. Section A-A' looking from east to west

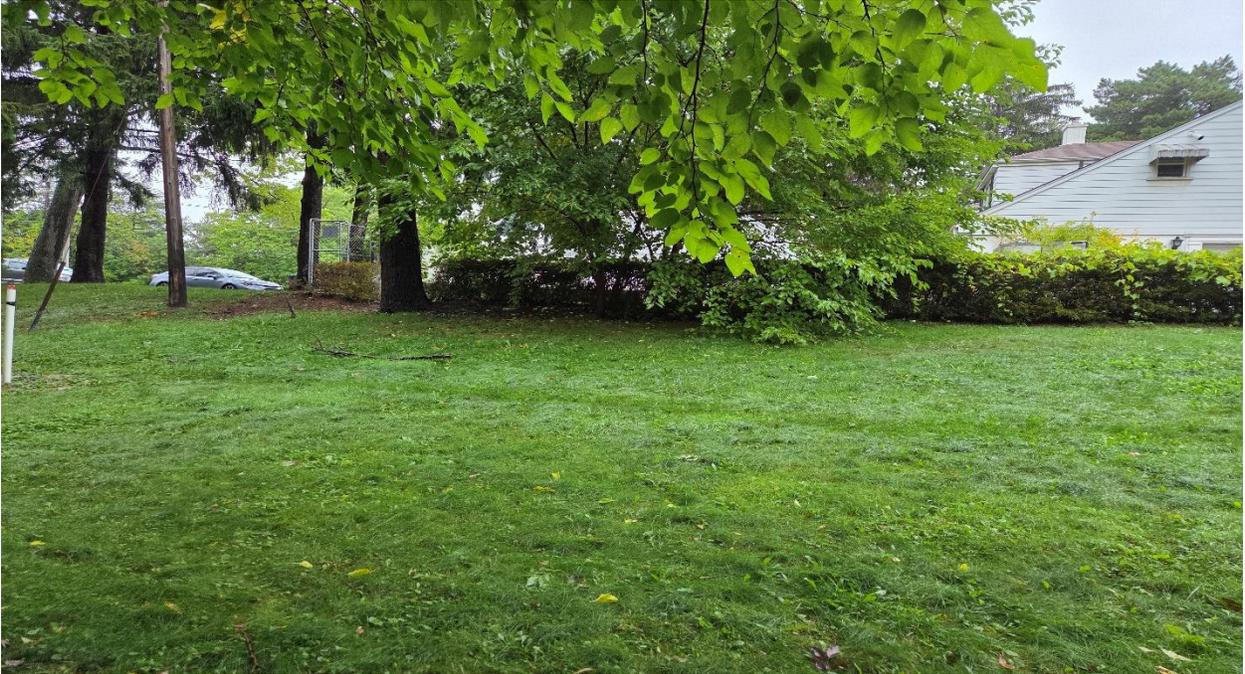
2. Section A-A' looking from north to south showing mature trees and the creek

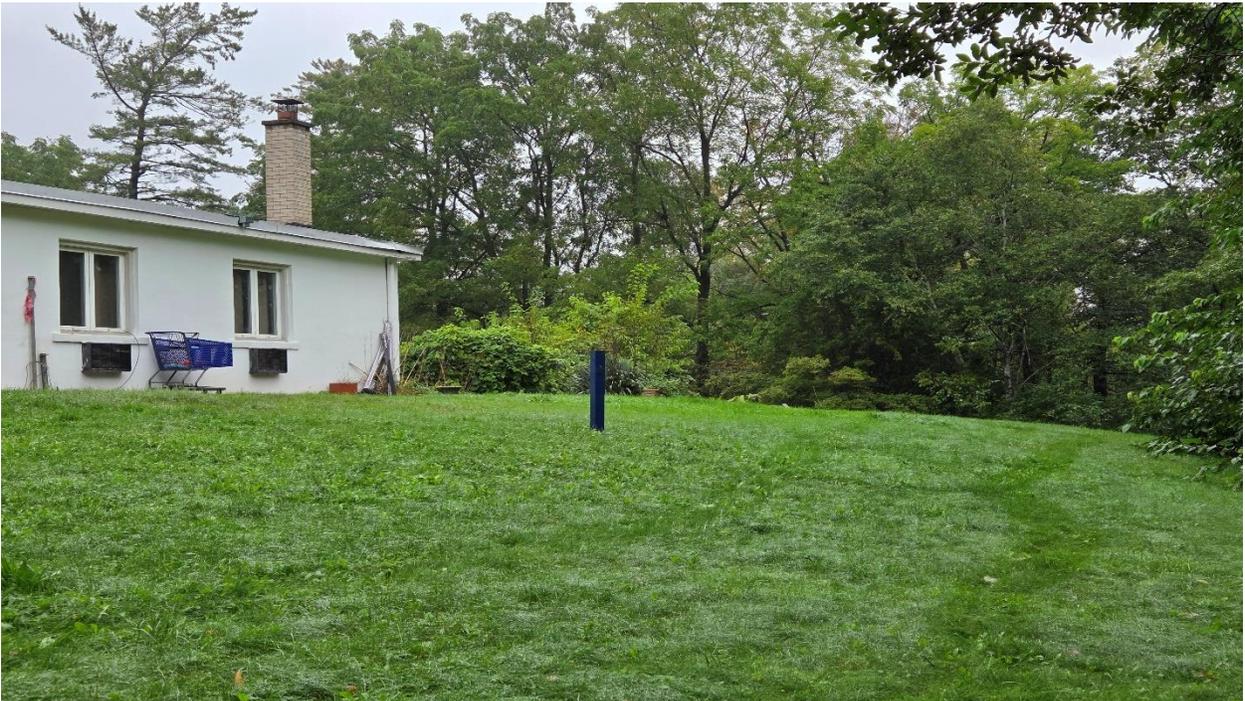
3. Section A-A' looking from south to north

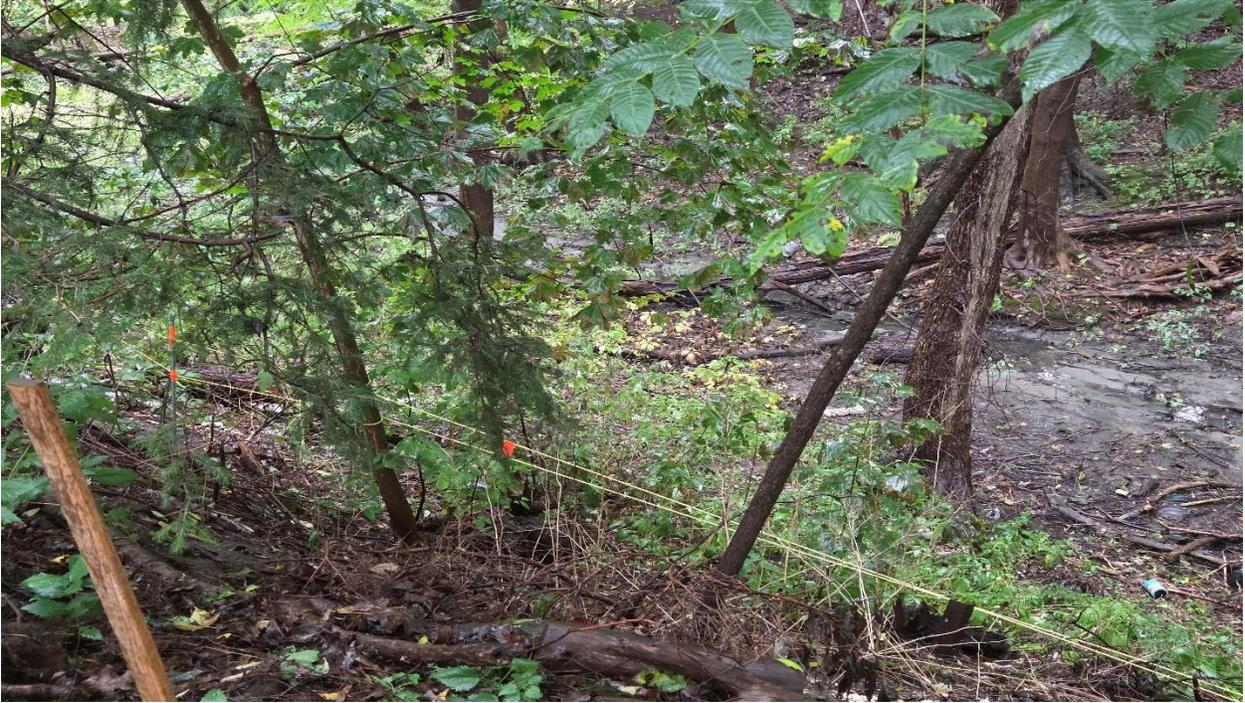
4. Section B-B' looking from west to east

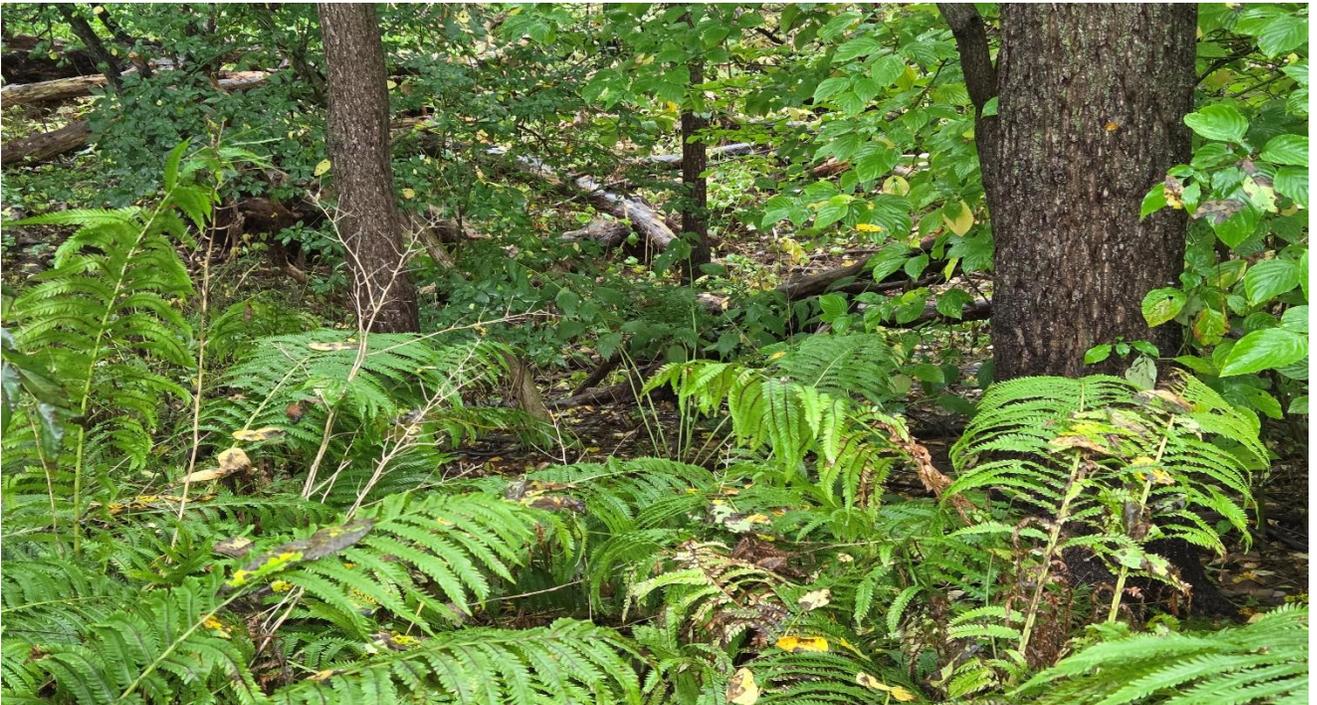
7. Section C-C' looking from east to west

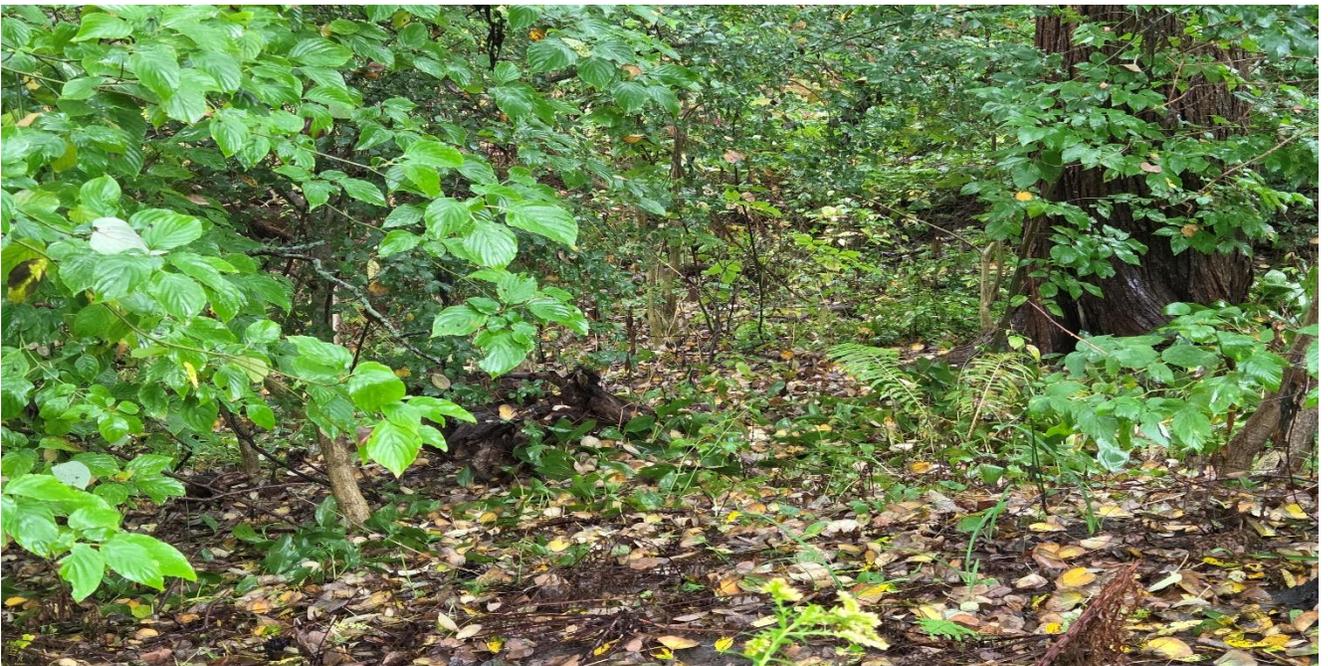
9. Section D-D' looking from west to east

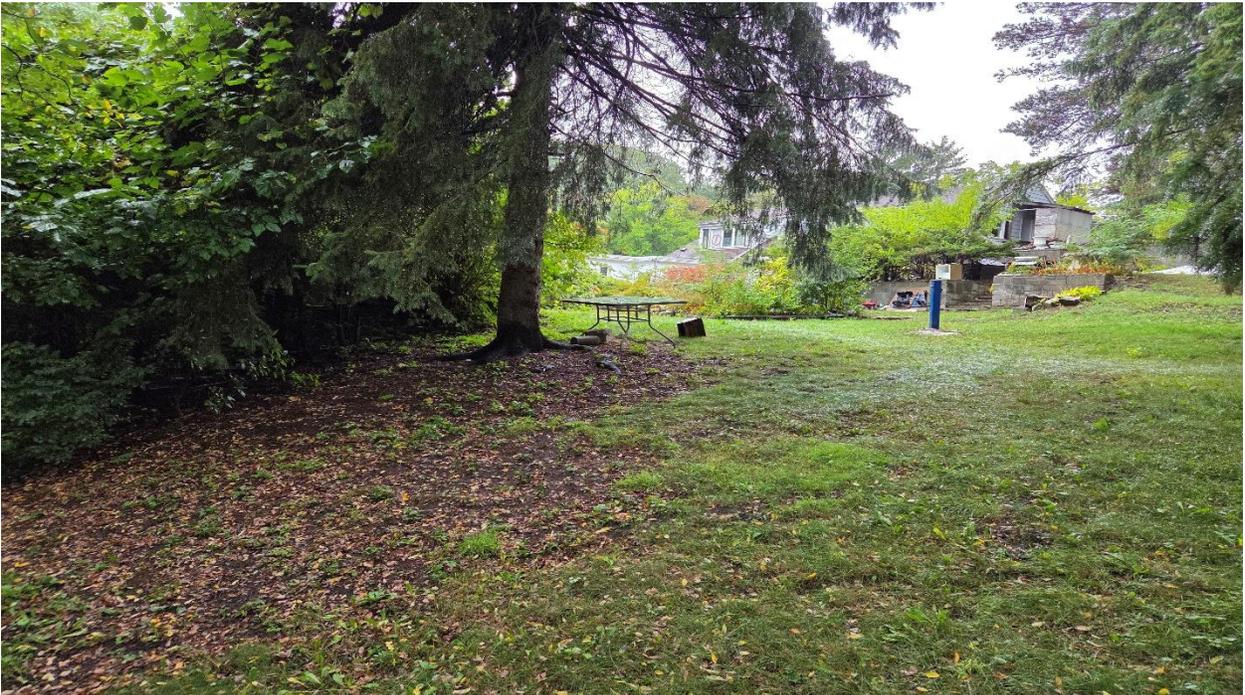
11. Section D-D' looking from south to north

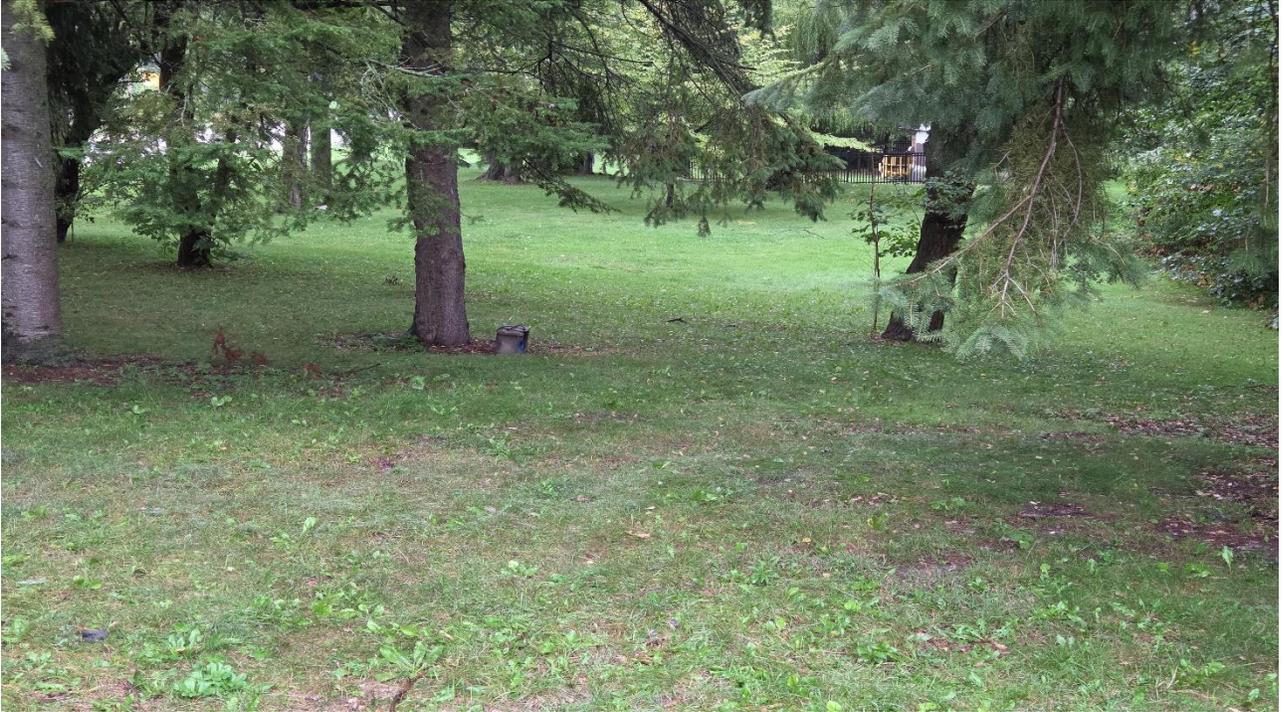
12. Section E-E' looking from east to west

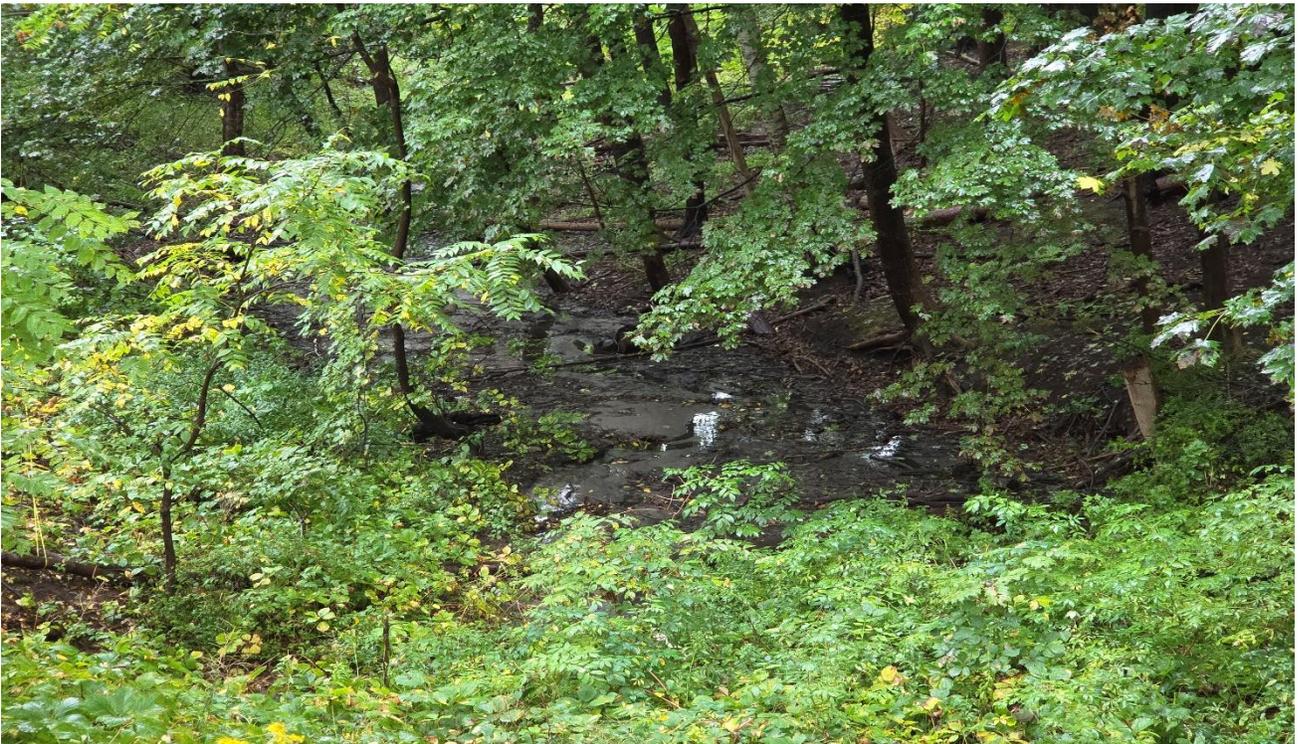
13. Section E-E' looking south to north showing mature trees and grasses on slope

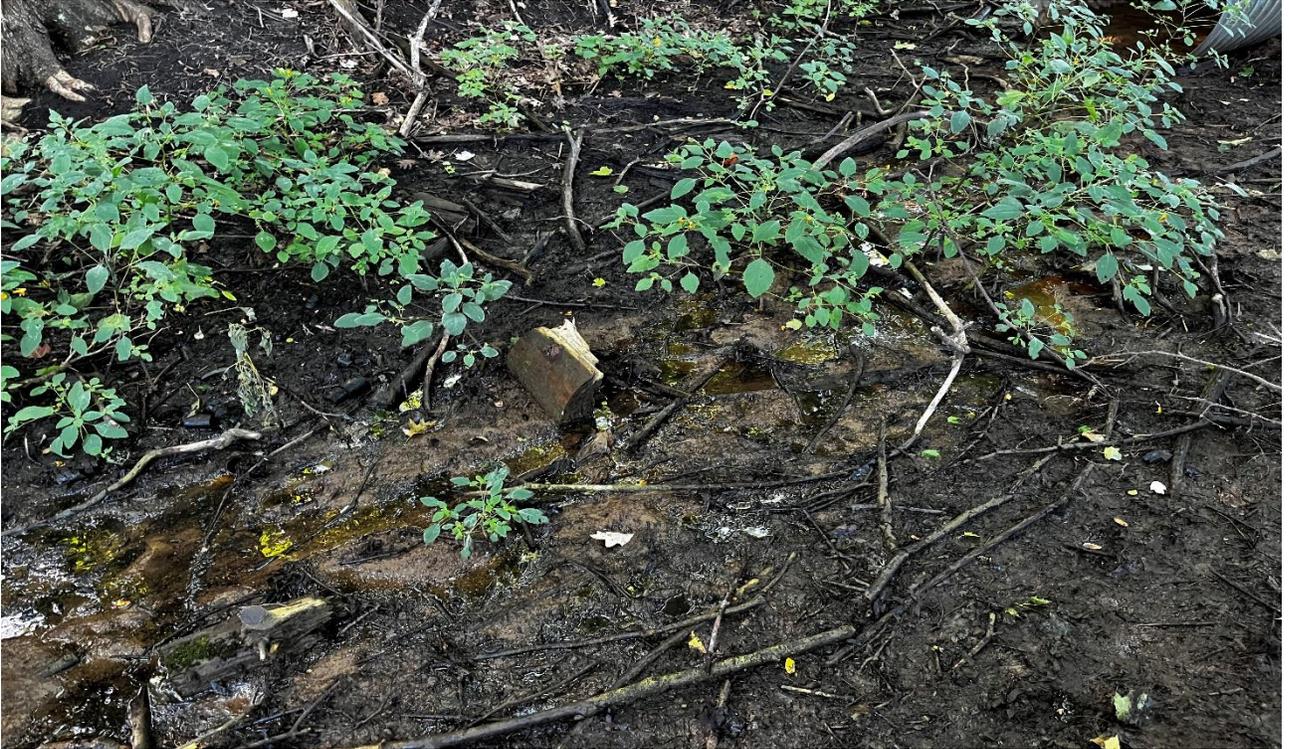
14. Creek and Mature trees and sapling growth on toe of the slope

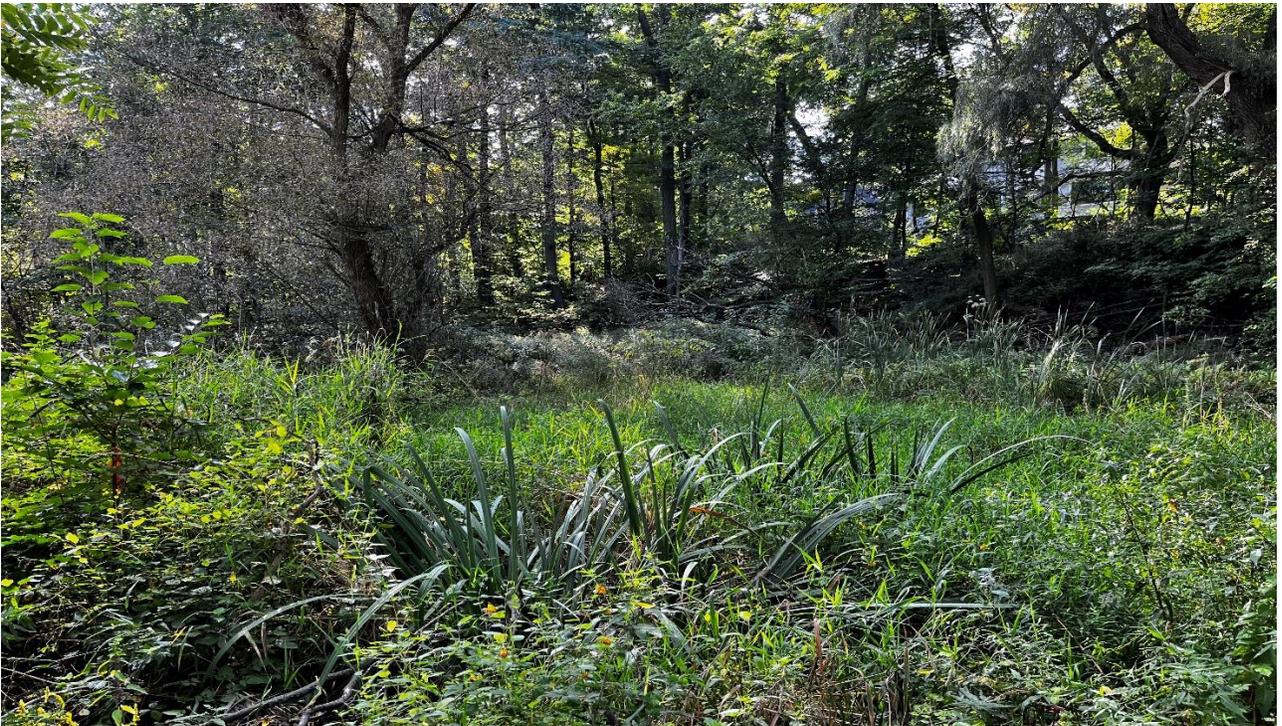
15. Bottom of Seasonal Creek

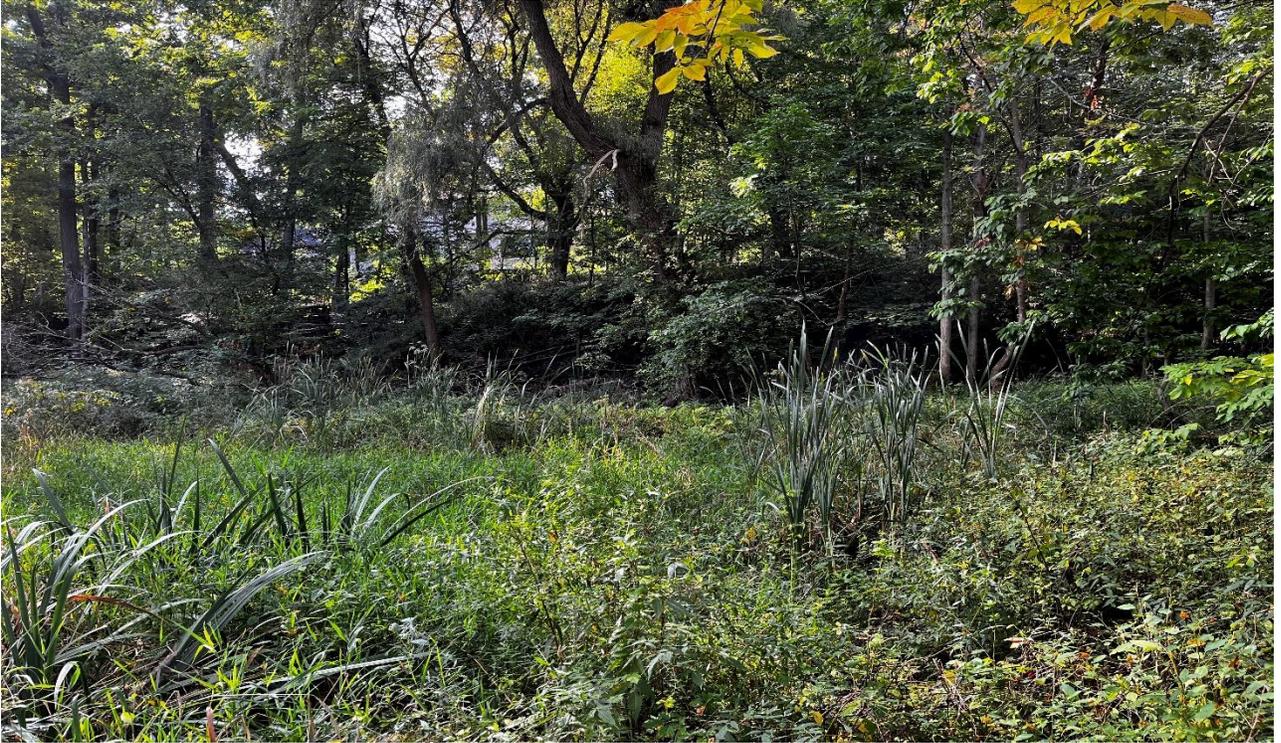
16. Wetland

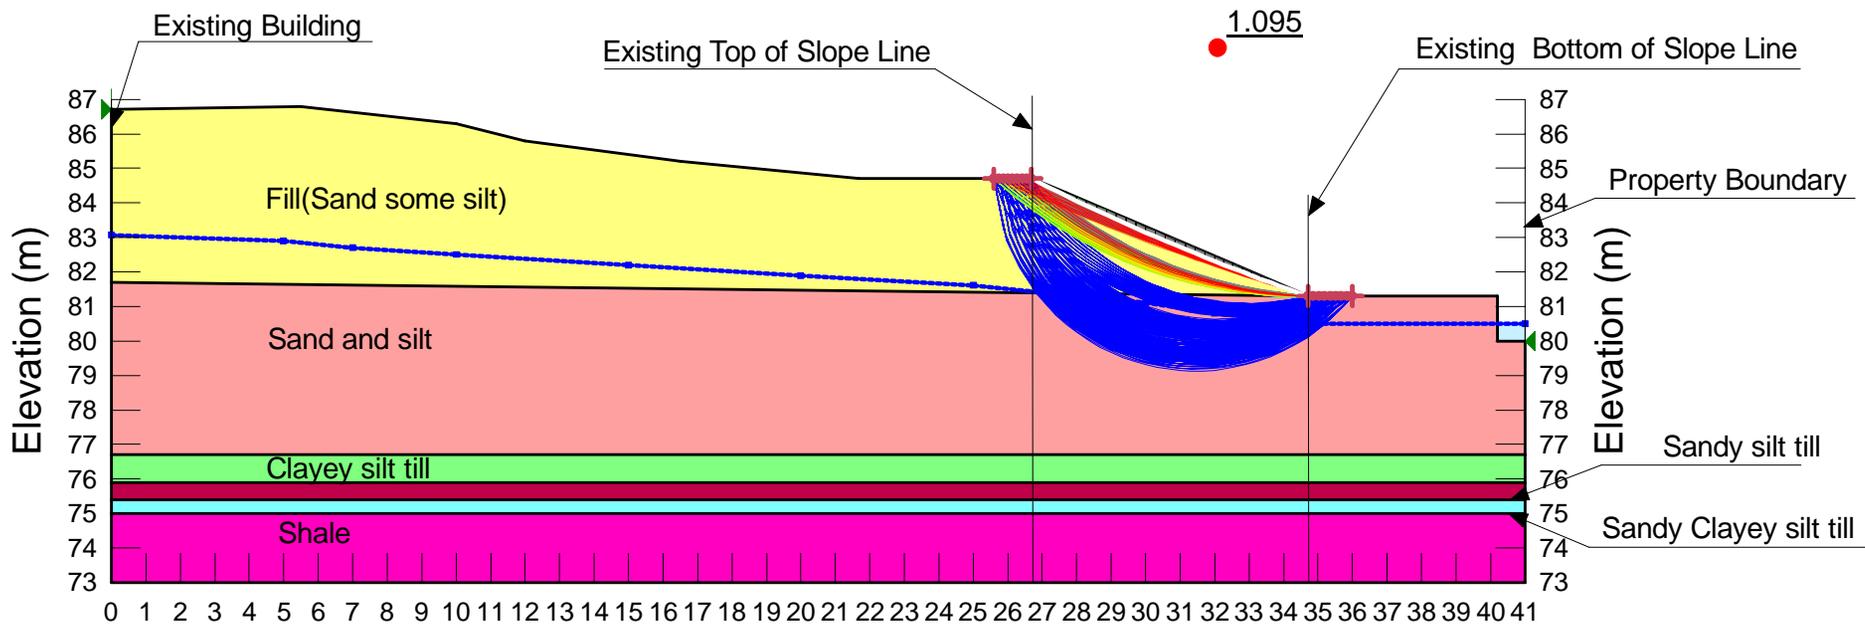
Fig 1: Section A-A' under static condition (existing)

1. The existing slope at Section A-A' has FOS less than 1.5 and 1.3 under static and seismic conditions. The slope inclination at Sections D-D' and E-E' is flatter than 3:1 (H:V).
2. The existing slopes at Sections B-B' and C-C' have FOS more than 1.5 and 1.3 under static and seismic conditions.
3. Design toe erosion allowances (TEA) of 0m to 2m are applicable.
4. The stability components of the LTSTOS are 5.70m, 0m, 0m, 0m and 0m at Sections A-A', B-B', C-C', D-D' and E-E'.
5. An access allowance of 6.0m is recommended. Overhanging of 2nd floor and above will not impact LTSTOS.
6. Deeper fill materials were observed in the area of BH102, covering Section A-A'. Engineering solutions are recommended to stabilize the slope in this area to reduce stable top of slope setback.
7. Figure E3 & E3a, in Appendix E, show total development setback prior to and after slope stabilization measures.

Section A-A'
Factor of Safety: 1.095
Radius of Circle: 65.808 m

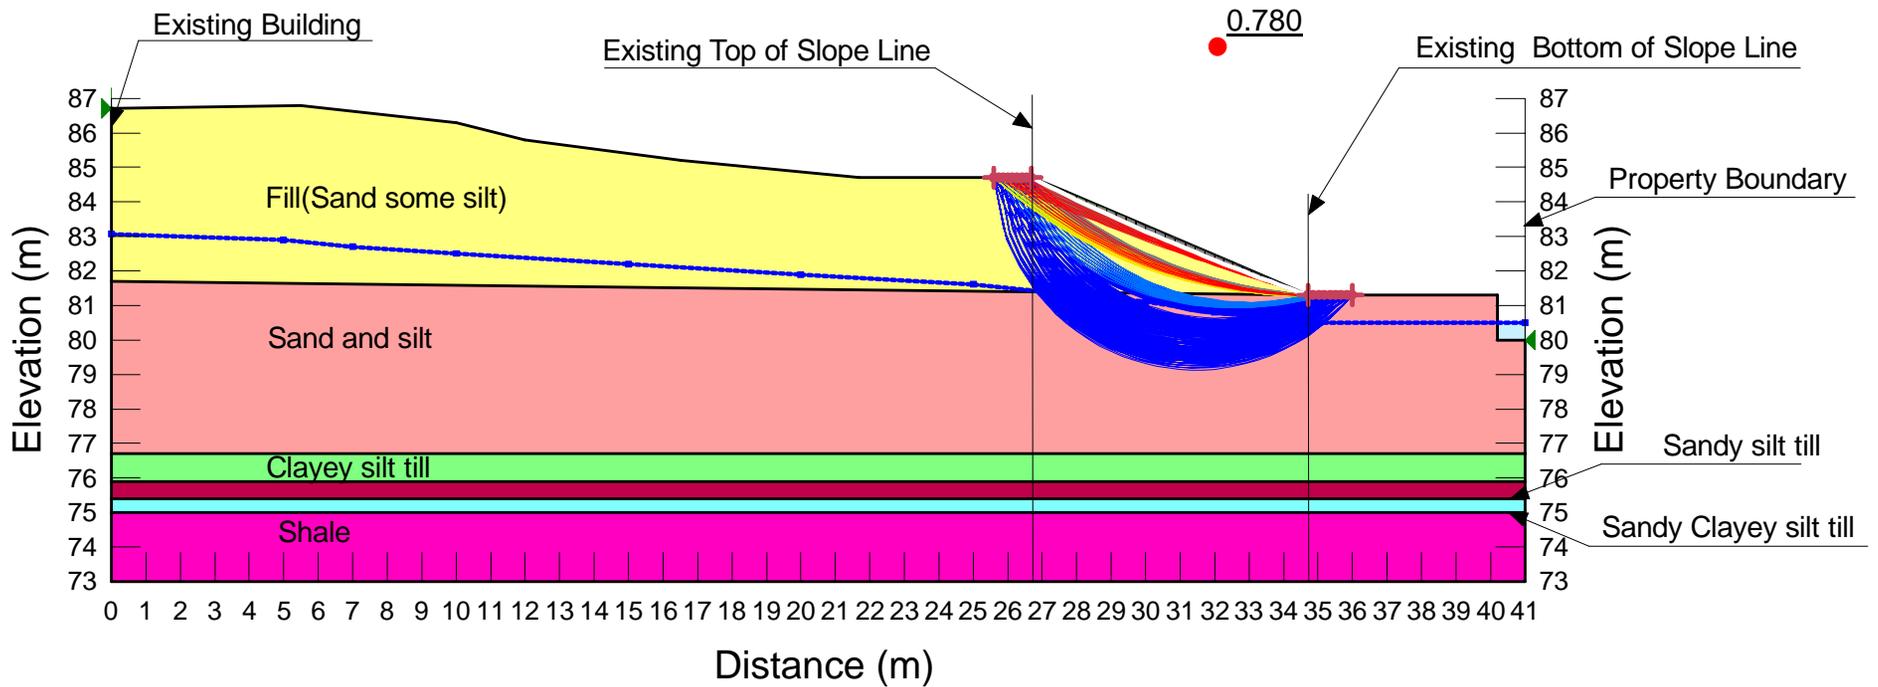
Fig 2: Section A-A' under seismic condition (existing)

Section A-A'
Factor of Safety:0.780
Radius of Circle:65.808 m

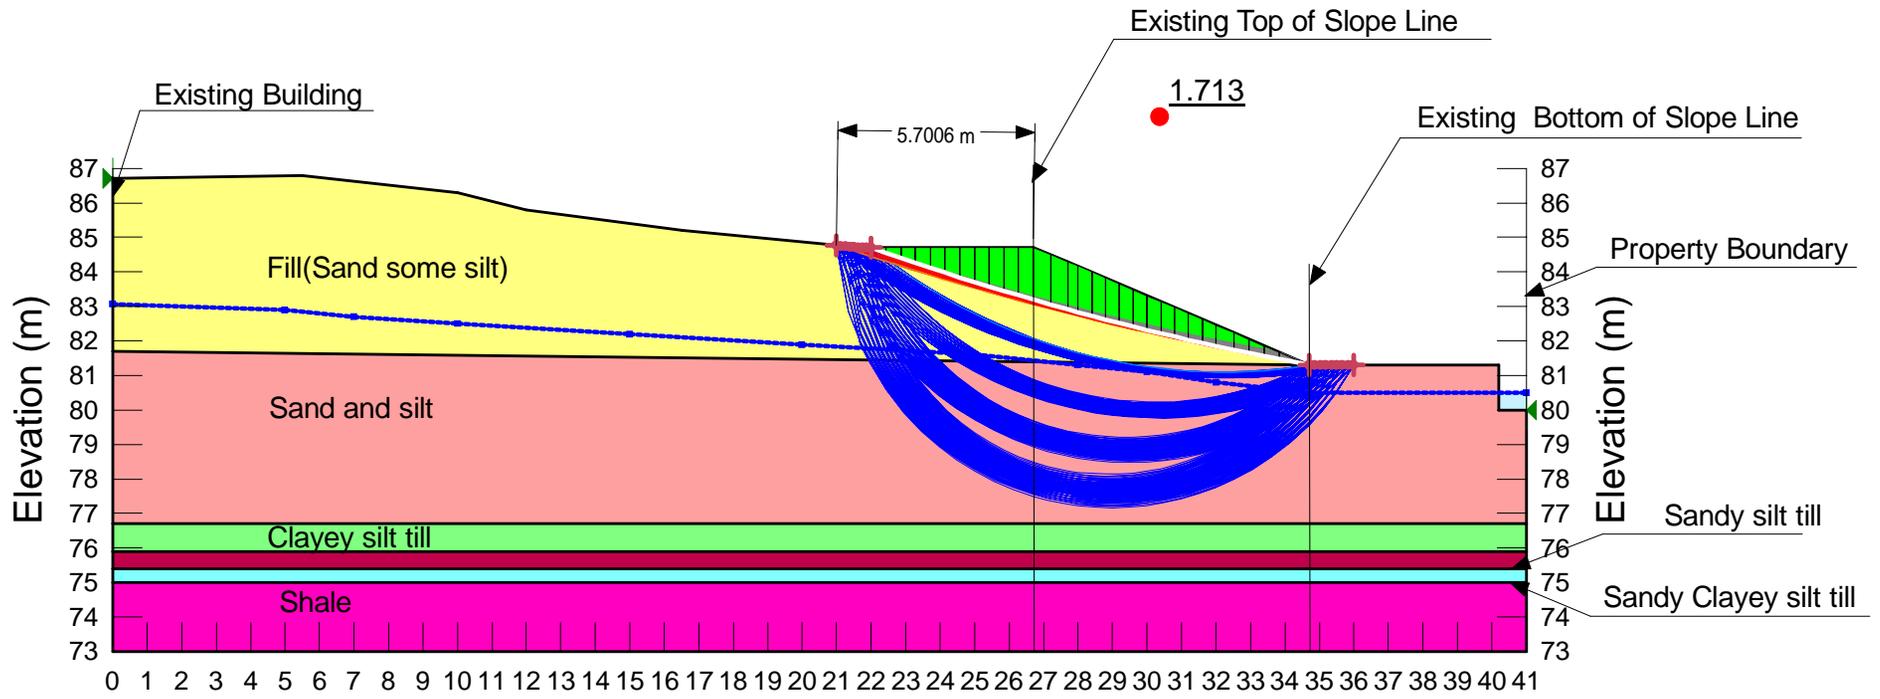
Fig 3: Section A-A' under static condition (FOS 1.713)

Sliding surfaces associated with FOS of 1.713 and 1.367, obtained under static and seismic conditions, daylight at approximately 5.7006m behind the top of slope line for Section A-A'.

Section A-A'
 Factor of Safety:1.713
 Radius of Circle:85.776m

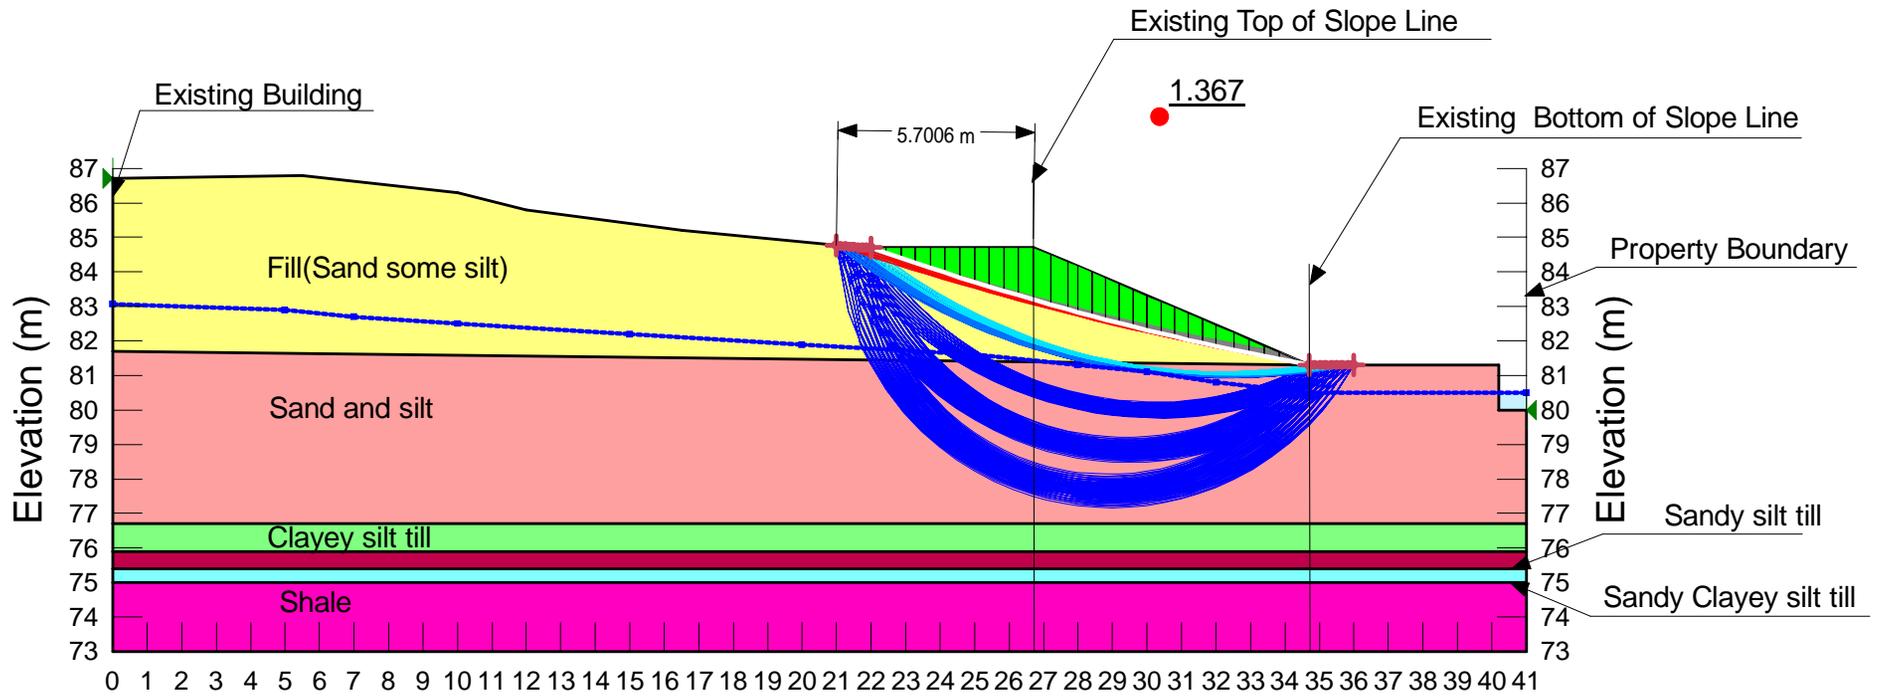
Fig 4: Section A-A' under seismic condition (FOS 1.367)

Section A-A'
Factor of Safety:1.367
Radius of Circle:85.776m

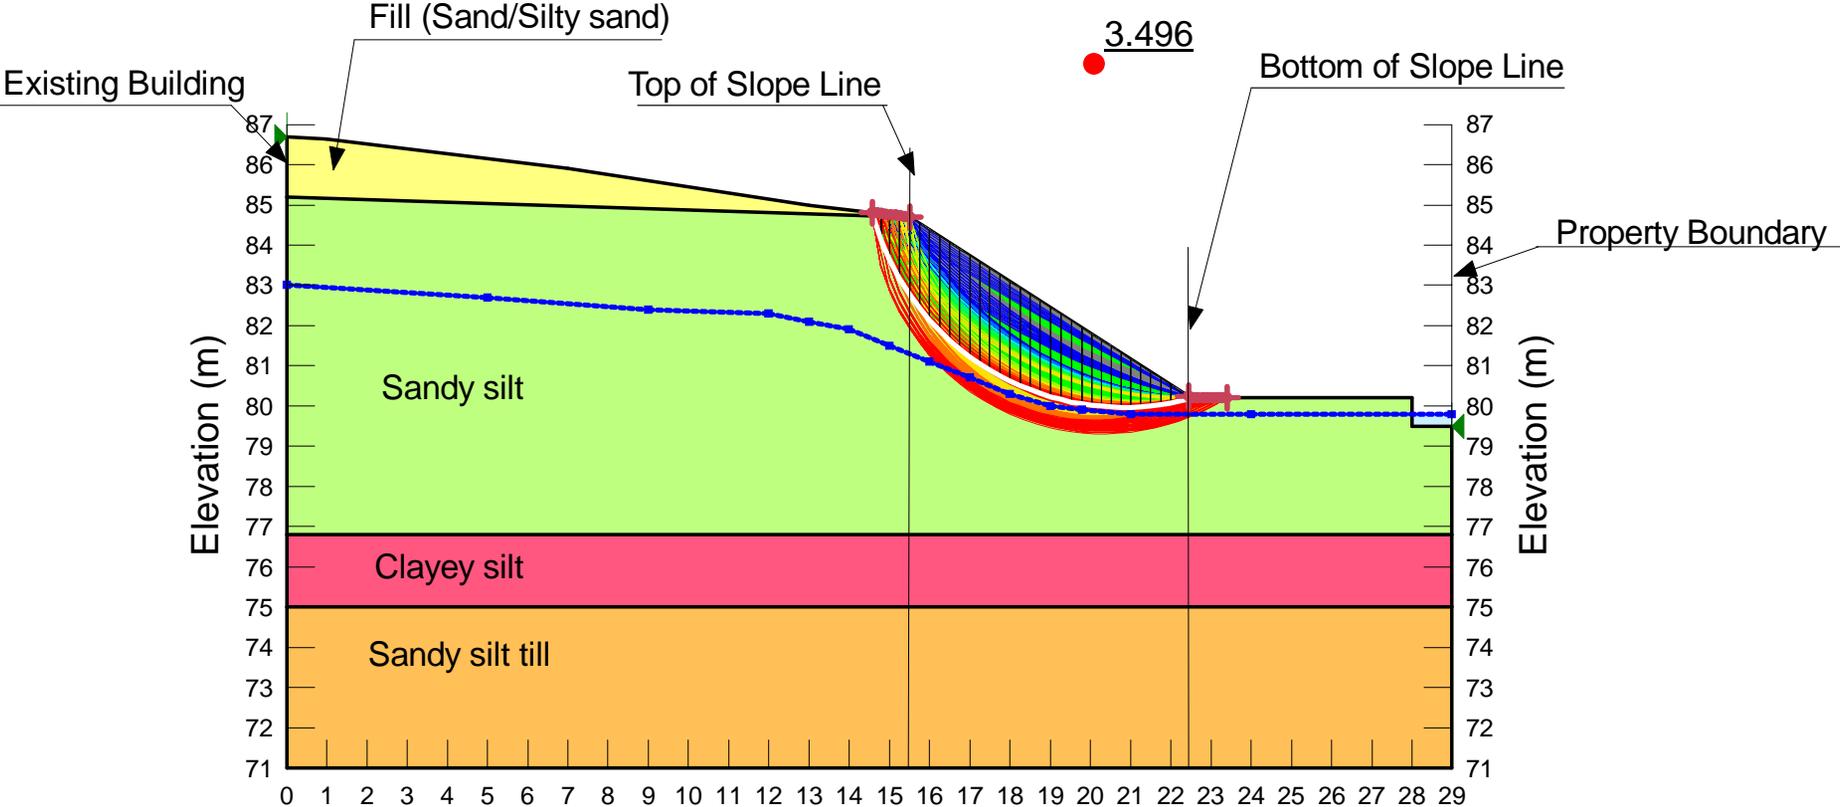
Fig 5: Section B-B' under static condition (existing)

Section B-B'
Factor of Safety:3.496
Radius of Circle:6.473 m

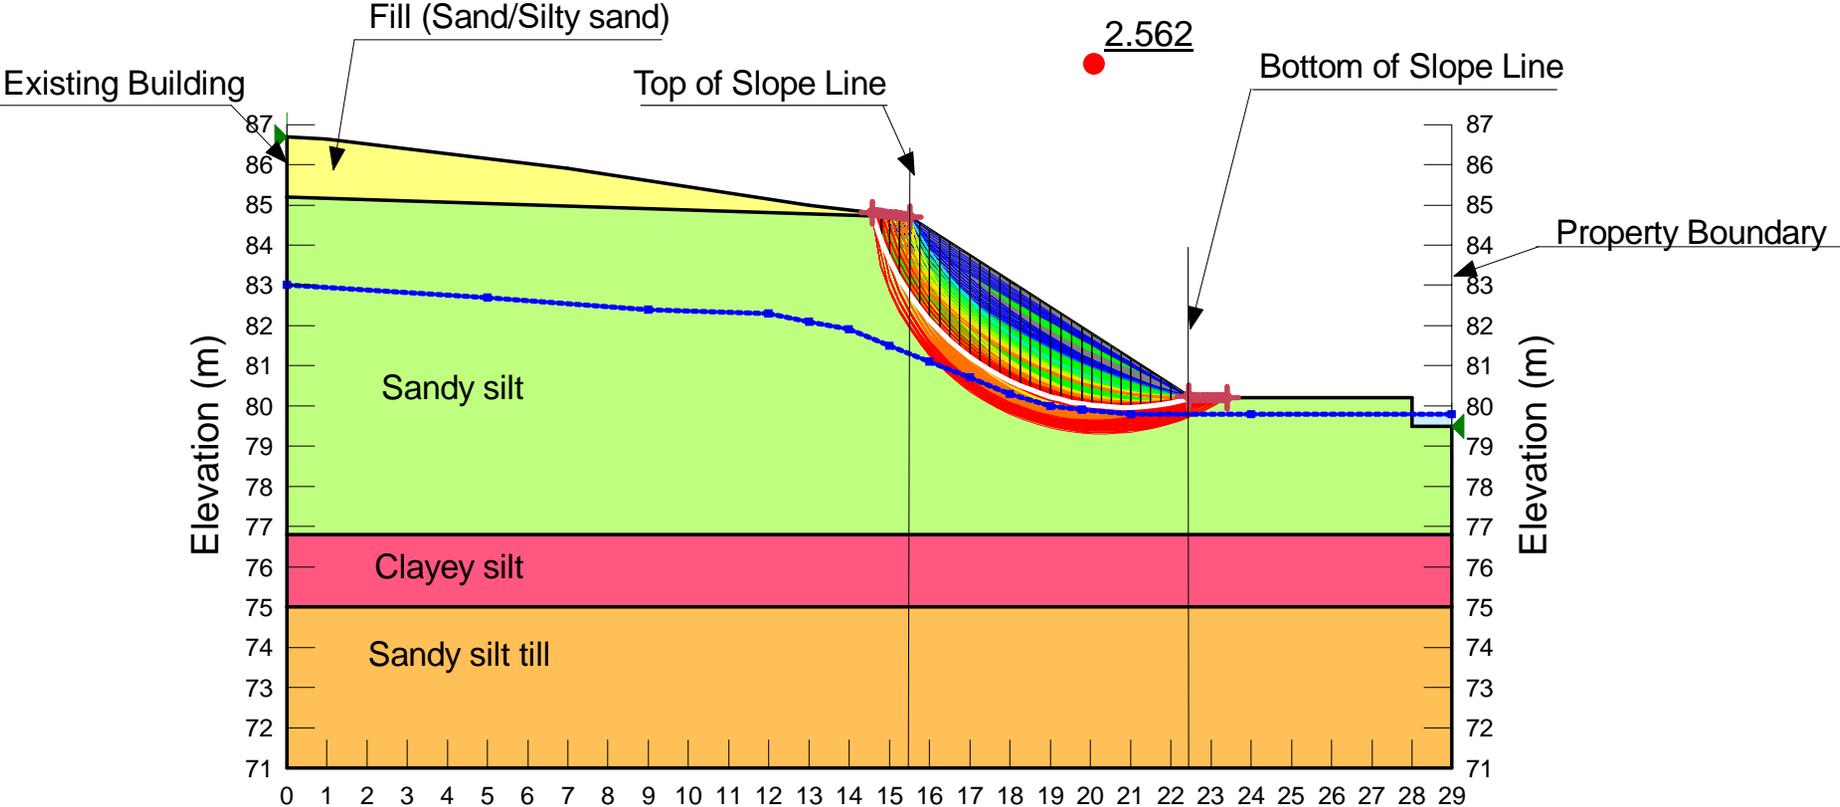
Fig 6: Section B-B' under seismic condtion (existing)

Section B-B'
Factor of Safety:2.562
Radius of Circle:6.473 m
