# ARBORIST REPORT

## Thorny Brae Residential

1765, 1775 Thorny Brae Place  
Mississauga, Ontario

Oct 15, 2025

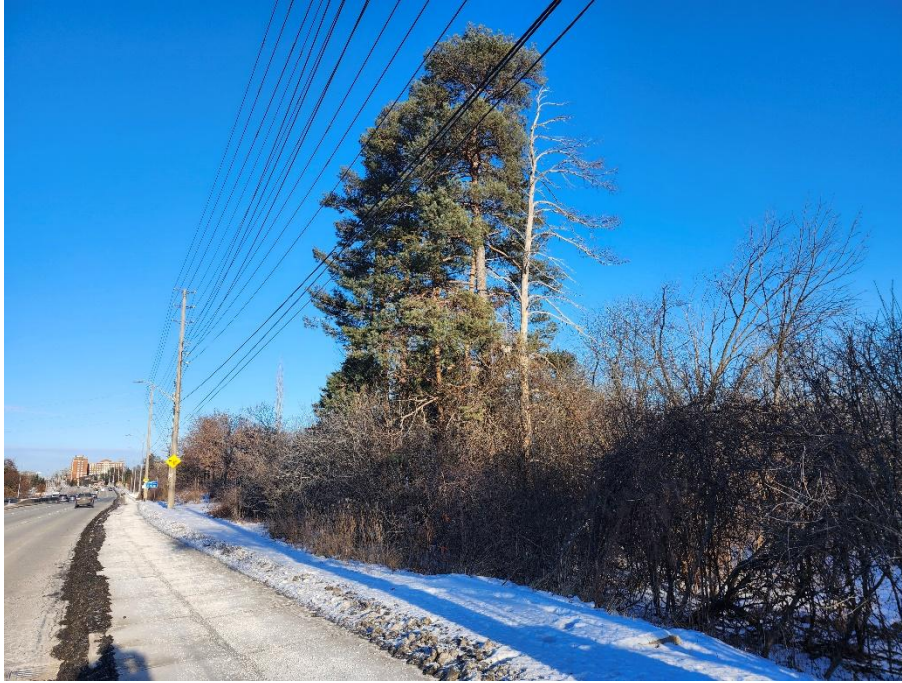
Figure 4: Looking east along Eglinton Ave. to row of Scots pine.

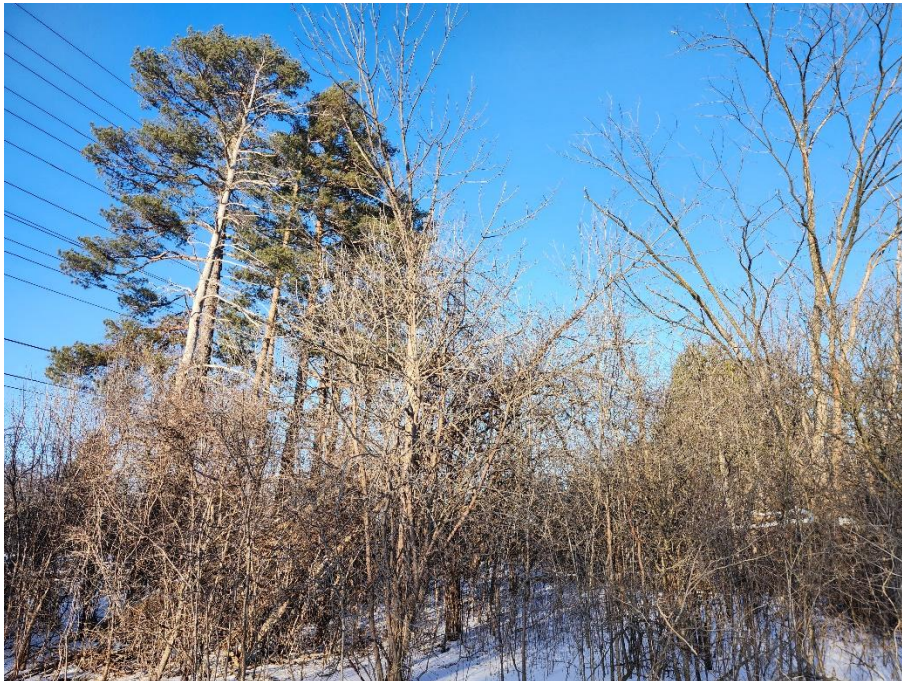
Figure 5: View of Scots pine row amongst understorey brush.

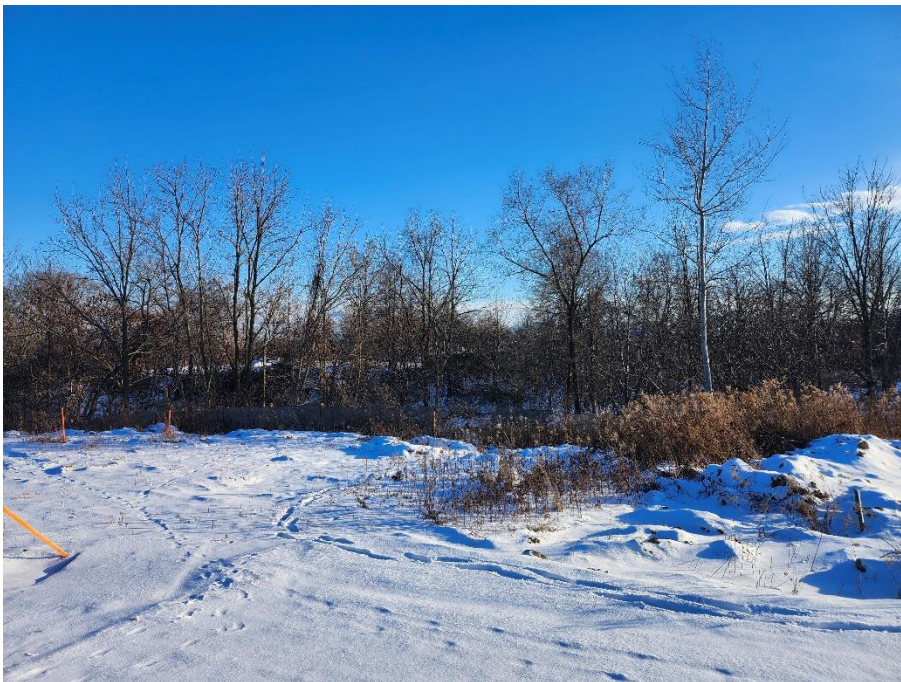
Figure 7: former Thorny Brae cul-de-sac looking south towards trees amongst scrubland.

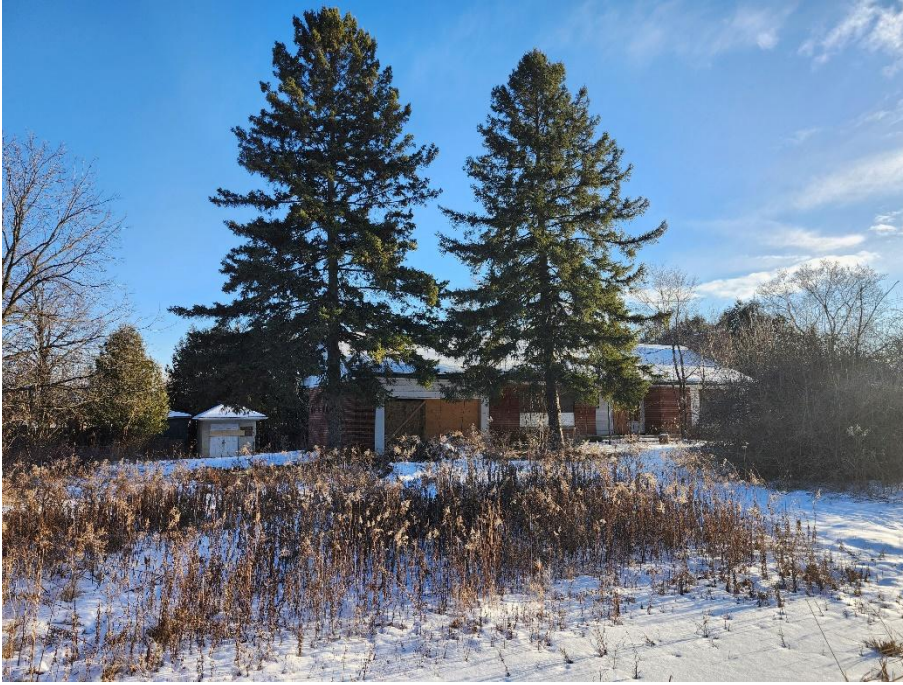
Figure 8: Trees along single-family house on south side of former Thorny Brae Pl.

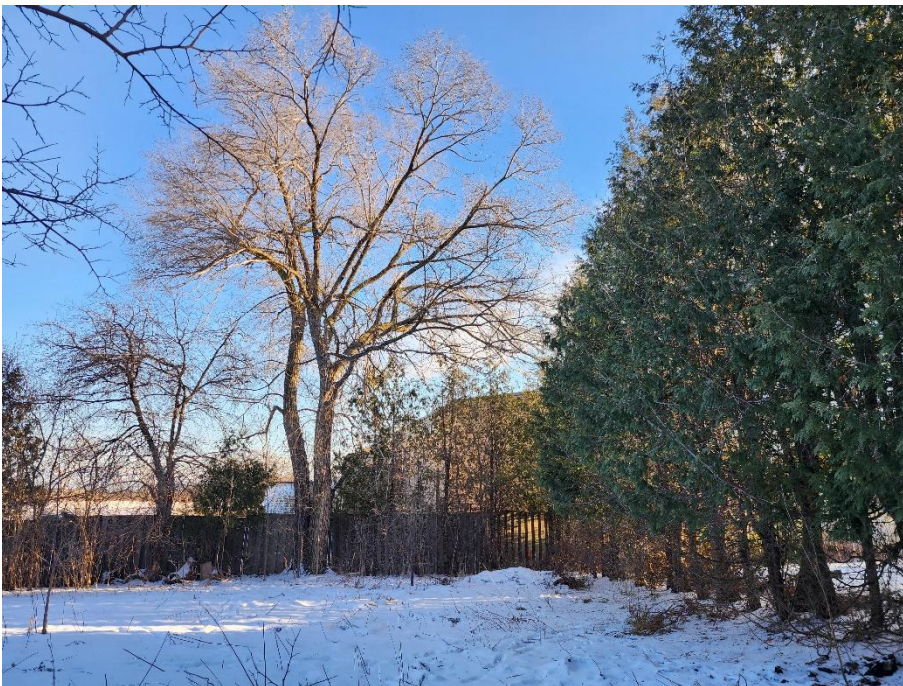
Figure 9: Trees and hedges at south side of property.
