June 23, 2022 [Revised August 7, 2024] [Revised July, 2025]

ARBORIST REPORT

1225 Dundas Street East, Mississauga, Ontario

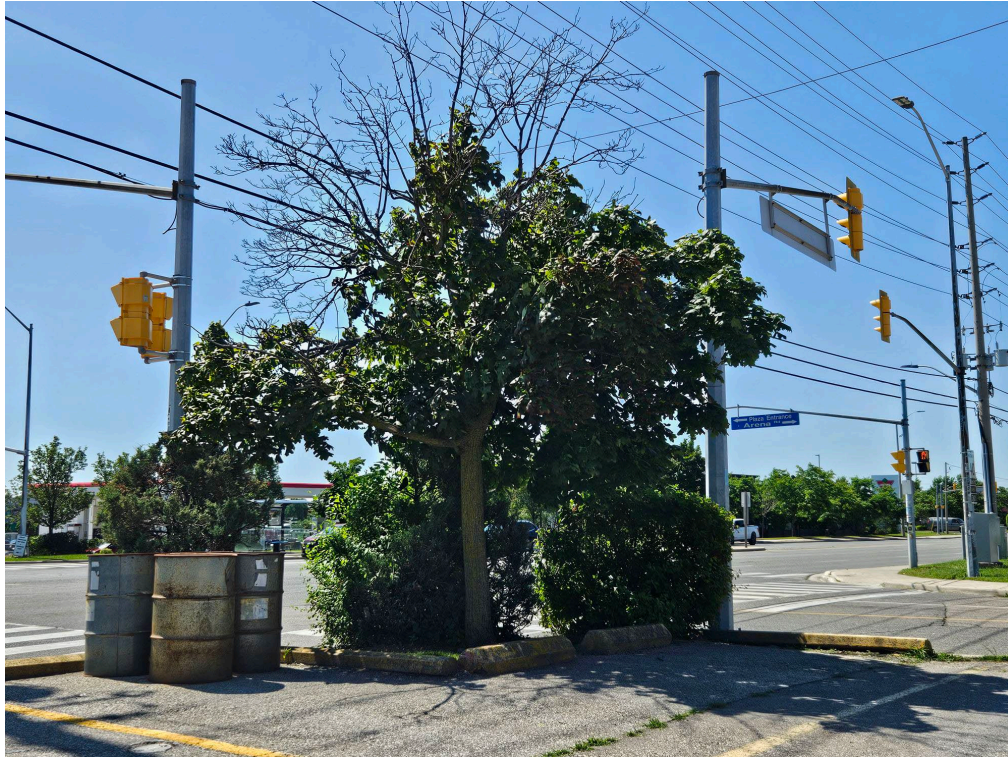
Tree 411

Tree #	Common Name	Botanical Name	DBH (CM)	Condition	Comments	Recommendation
411	Norway Maple	Acer platanoides	20	P	Significant crown die-back and leader die-back	Retain
412	Manitoba Maple	Acer negundo	37	P	Single stem of co-dominant pair remains, moderate to significant deadwood in canopy, signs of rot at base, epicormics throughout	Retain
413	Slippery Elm	Ulmus rubra	23	F/G	Evidence of leaf miner	Retain
414	Slippery Elm	Ulmus rubra	20	F	Evidence of leaf miner	Retain
415	Slippery Elm	Ulmus rubra	21	F	Evidence of leaf miner, slightly imbalanced crown	Retain
416	Slippery Elm	Ulmus rubra	21	F/P	Evidence of leaf miner, moderate/significant die-back on north side of crown	Retain
417	Slippery Elm	Ulmus rubra	24	F/G	Evidence of leaf miner	Retain
418	Slippery Elm	Ulmus rubra	23	F	Evidence of leaf miner	Remove due to construction
419	Slippery Elm	Ulmus rubra	24	F/G	Evidence of leaf miner	Remove due to construction

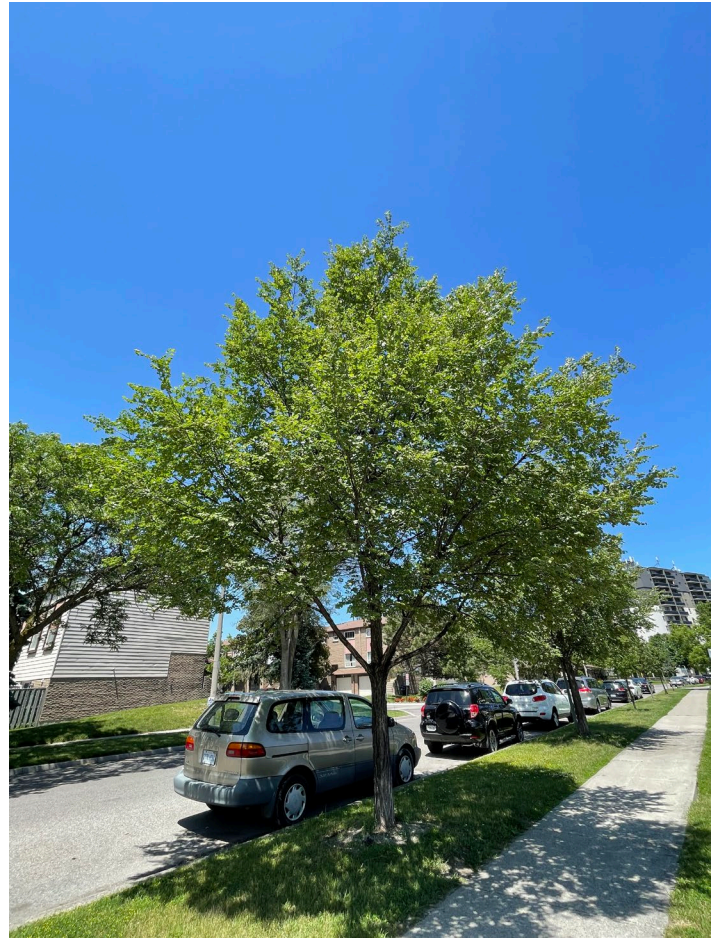
Tree 420

420	Slippery Elm	Ulmus rubra	23	F/G	Evidence of leaf miner	Retain
421	Slippery Elm	Ulmus rubra	26	F/G	Evidence of leaf miner	Retain
446	Honey Locust	Gleditsia triacanthos	16	F/G	Wound at trunk at 1.2 metres	Retain
447	Honey Locust	Gleditsia triacanthos	5	F/G	Newly planted, minor deadwood in canopy	Retain
448	Honey Locust	Gleditsia triacanthos	18	G	Good form, full canopy	Remove due to construction
449	Bradford Pear	Pyrus calleryana	8	F/G		Retain
450	Bradford Pear	Pyrus calleryana	9	F/G	Mild lean	Retain
