January 21, 2016

Reference No. 0803-S002

**Re: Supplementary Slope Stability Study Letter Report
Proposed Employment Lands
Dezen Industrial – Phase 2
Southwest Quadrant of Highway 407 and Hurontario Street
City of Mississauga**

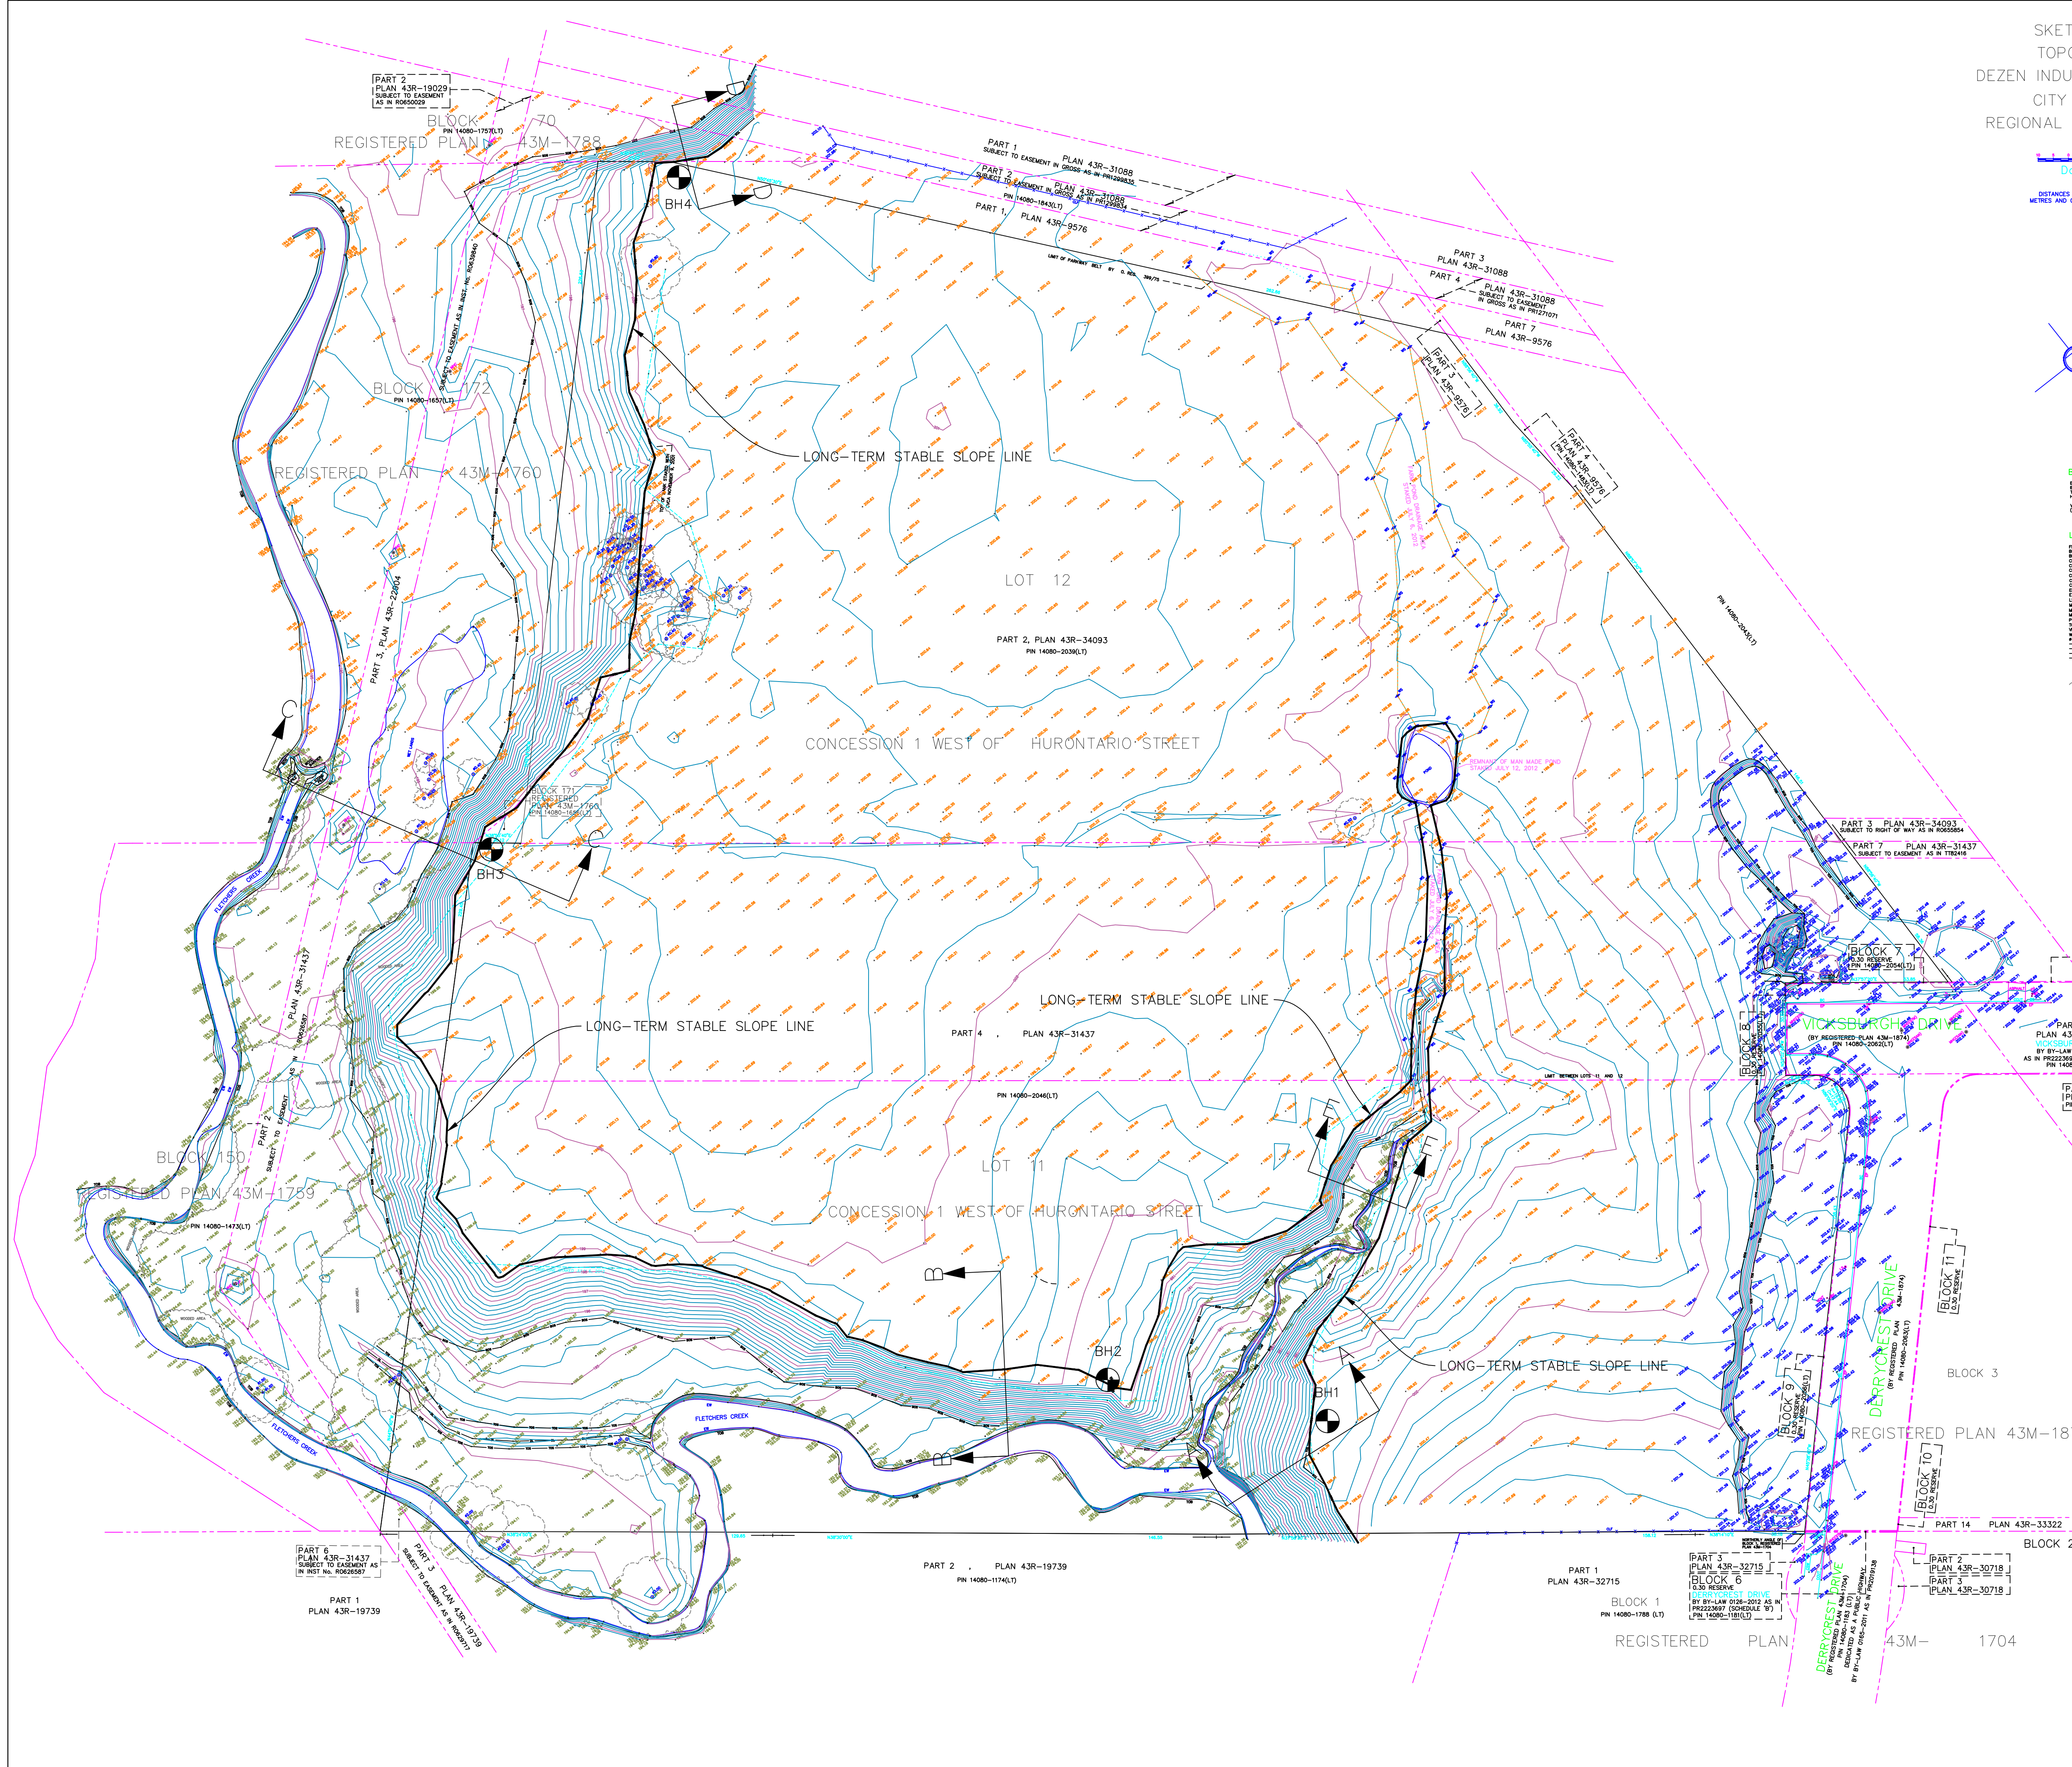
DESIGNED BY		CHECKED BY		DWG NO. 1	
SCALE 1:1000	REF. NO. 0803-S002	DATE JANUARY 2016	REV B

The long-term stable slope line (LTSSL), incorporating the geotechnically stable gradients and toe erosion allowance where applicable is established on the Borehole and Cross-Section Location Plan, Drawing No. 1. For the most part, the LTSSL coincides with the Top of Bank (staked with CVC on November 9, 2001) or the Farm Pond Drainage Area (staked July 6, 2012).

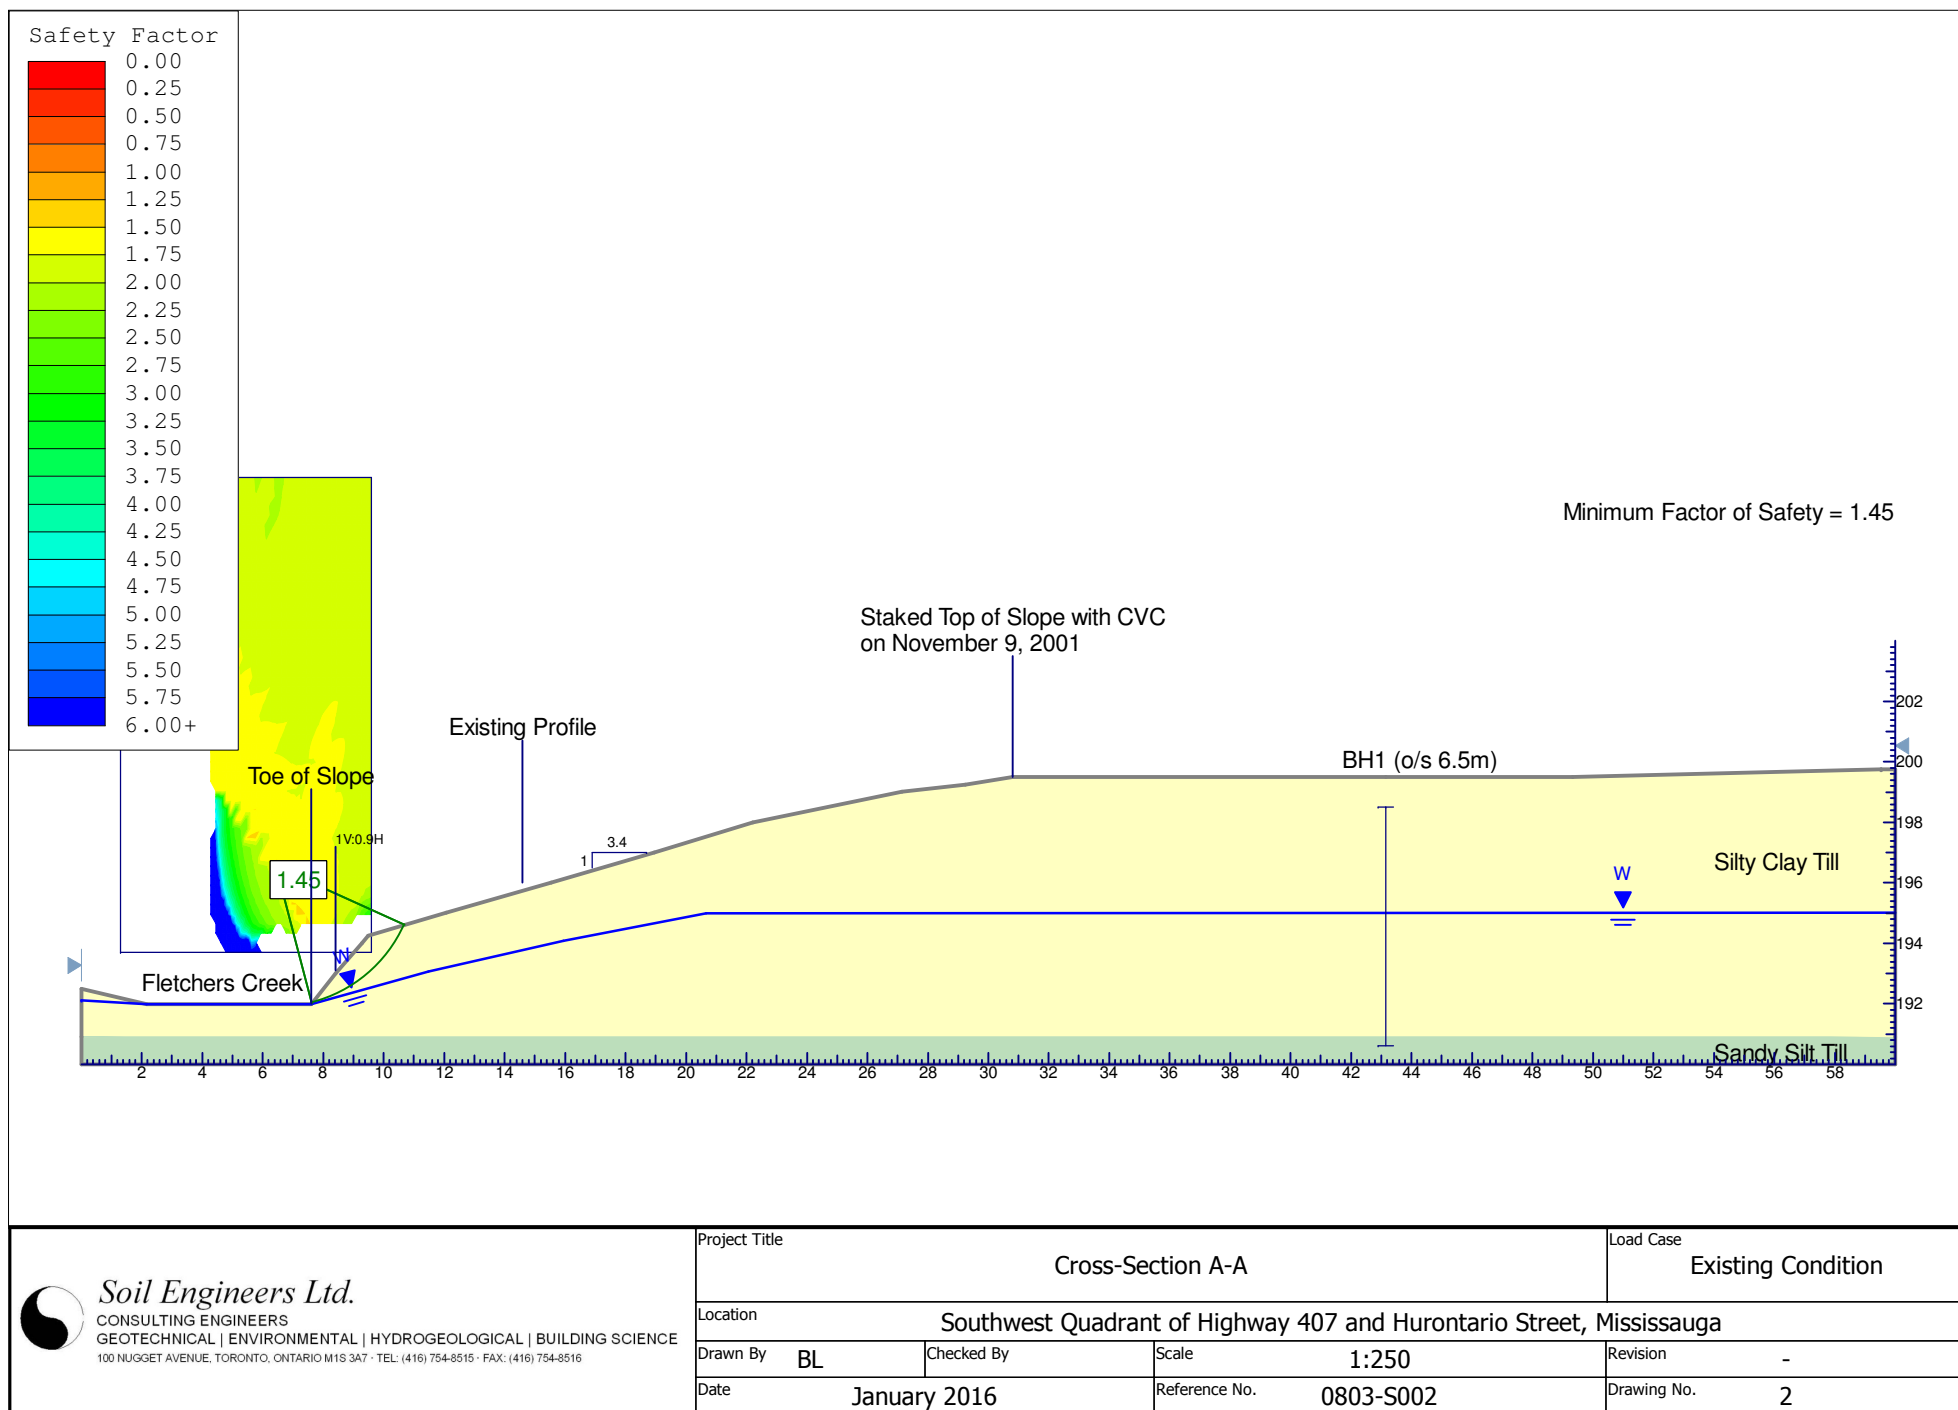
For Cross-Section A-A, the result shows that the existing slope has a FOS of 1.45, which fails to meet the OMNR requirements. The result is presented on Drawing No. 2. Therefore, the existing valley slope at this location is considered to be geotechnically unacceptable for the proposed development. A gradient of 1V:2.2H is recommended for use in sound native clay till. The remodelled slope, yielding a FOS of 1.55, which meets the OMNR requirements, is presented on Drawing No. 3.

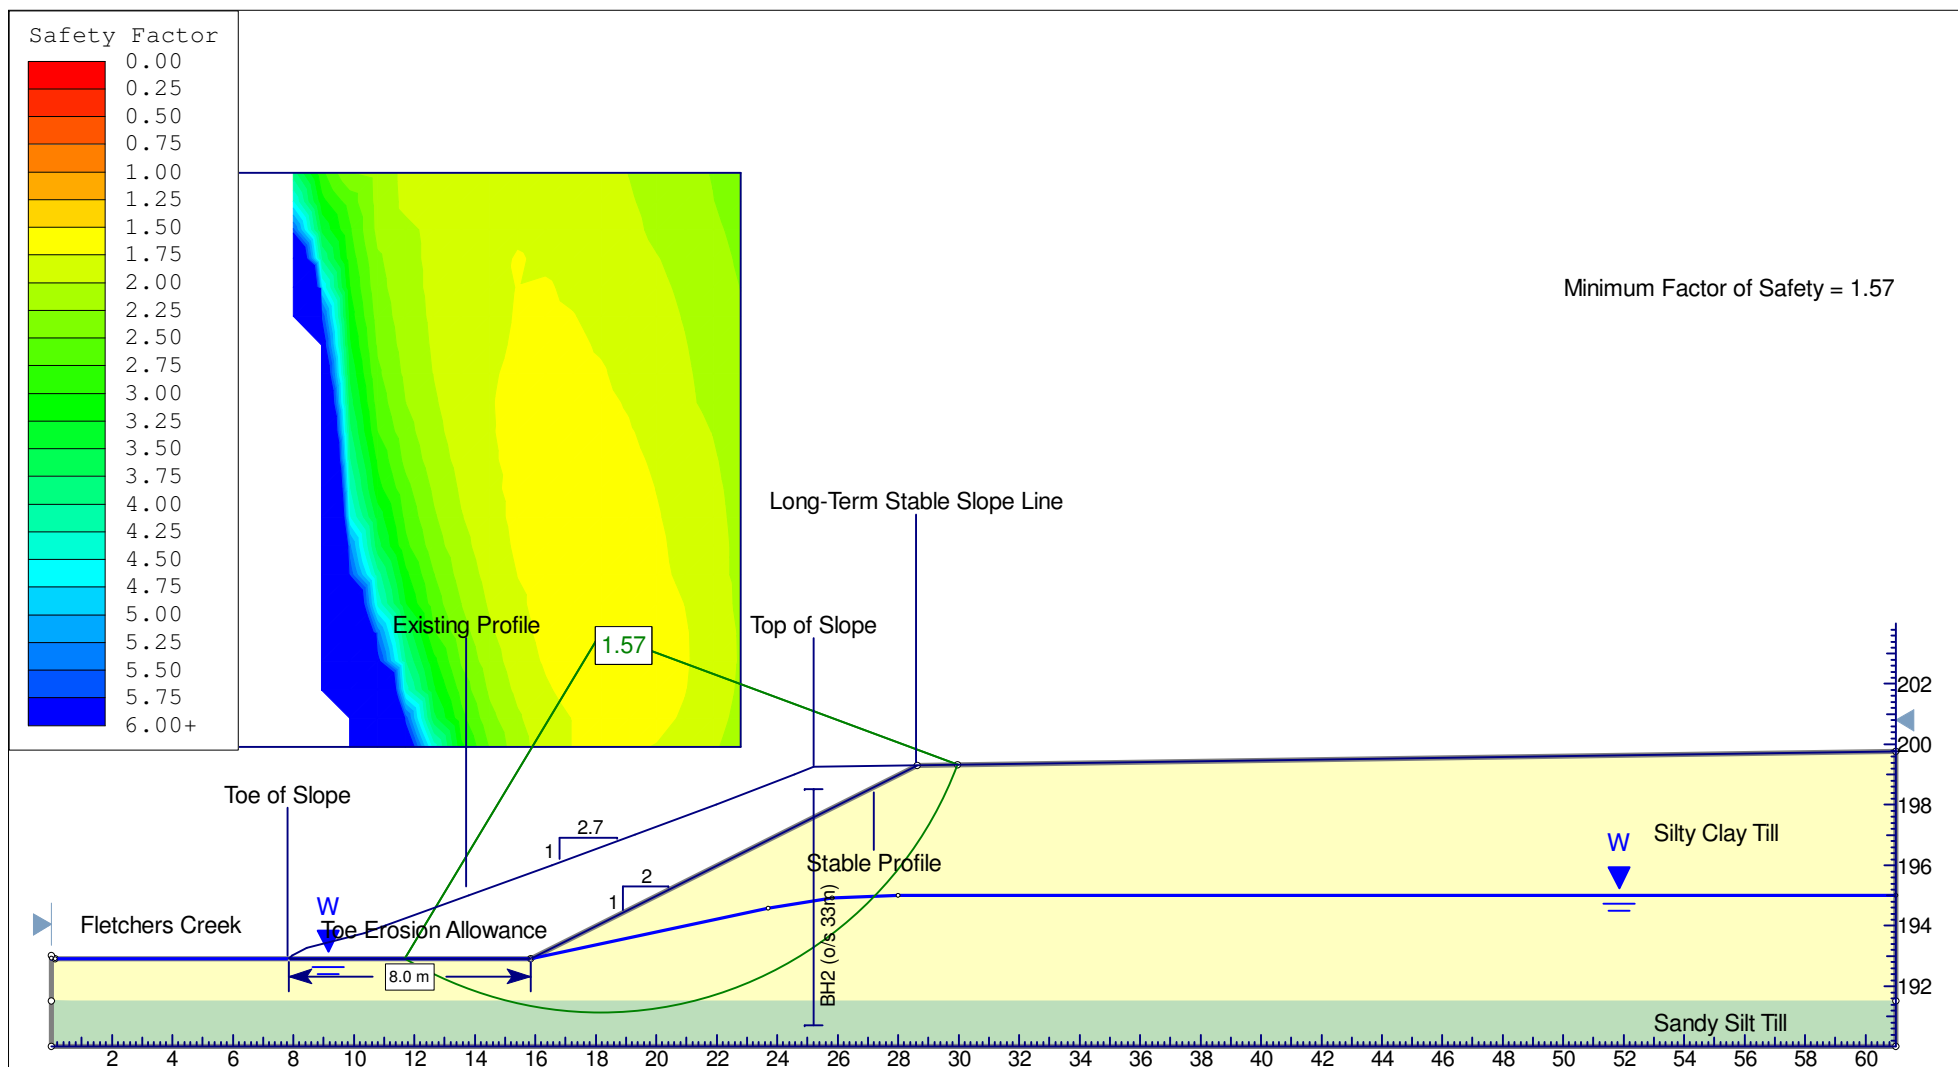
Project Title			Cross-Section B-B		Load Case	
					Stable Condition	
Location			Southwest Quadrant of Highway 407 and Hurontario Street, Mississauga			
Drawn By		BL	Checked By		Scale	Revision
					1:250	-
Date			January 2016		Reference No.	Drawing No.
					0803-S002	5

In the absence of an adequate flood plain, a toe erosion allowance of 8 m will be required where active erosion was observed. This is mainly applicable for Cross-Sections A-A and B-B and surrounding areas. For the latter, a geotechnically stable gradient of 1V:2H is used behind the toe erosion setback. The remodelled slope, with a FOS of 1.57, meets the OMNR requirements and is presented on Drawing No. 5.
