April 13, 2020  
(Revision of Report dated January 21, 2016)

Reference No. 0803-S002  
Page 1 of 4

**Re: Supplementary Slope Stability Study Letter Report  
Proposed Employment Lands  
Dezen Industrial – Phase 2  
Southwest Quadrant of Highway 407 and Hurontario Street  
City of Mississauga**

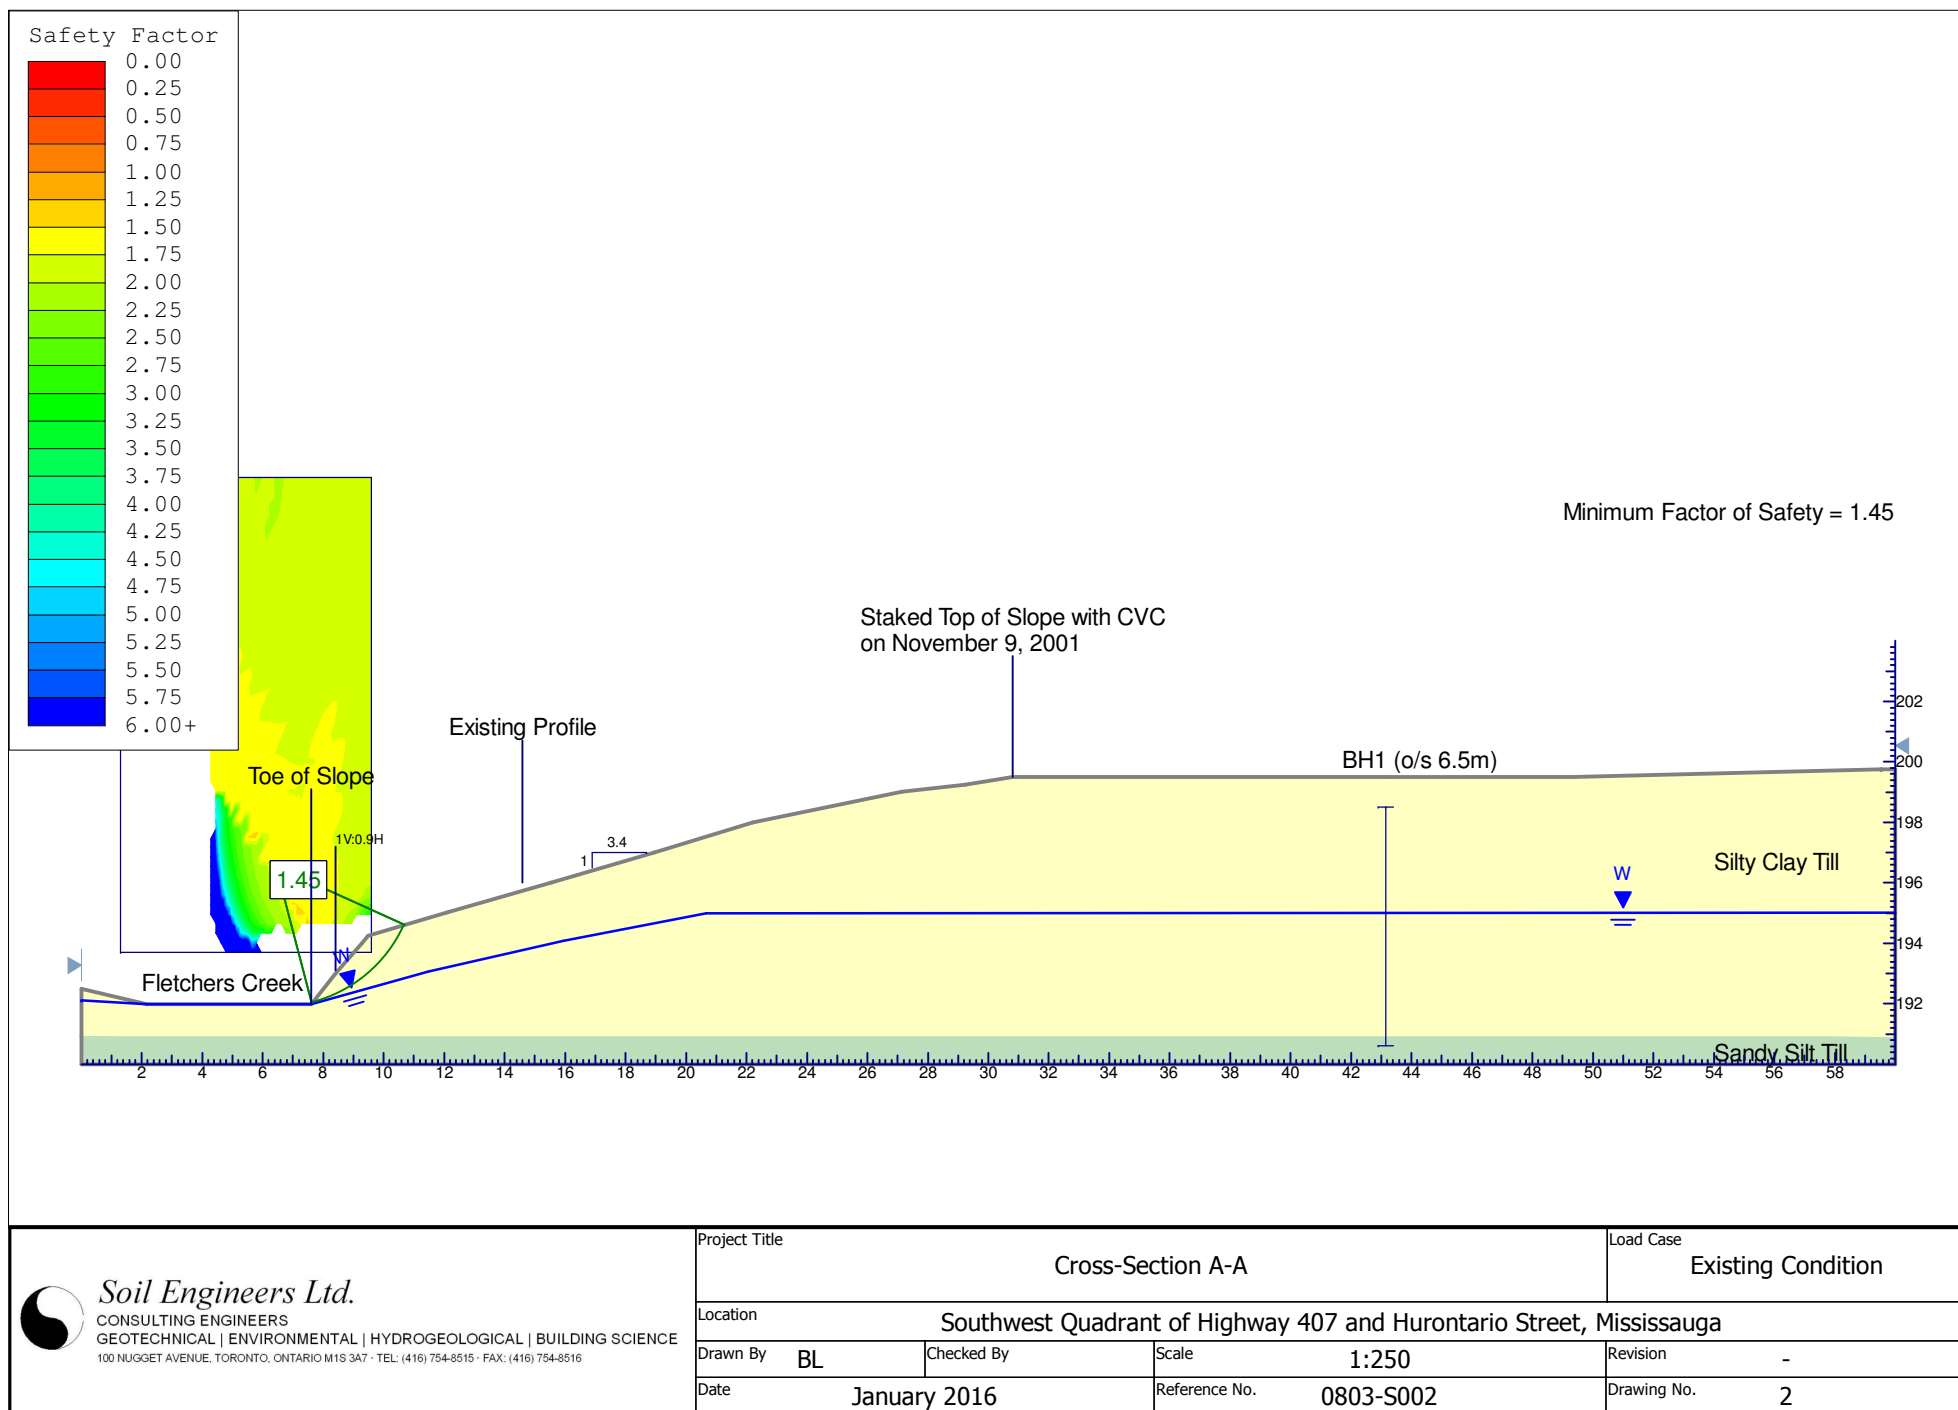
The long-term stable slope line (LTSSL), incorporating the geotechnically stable gradients and toe erosion allowance (where applicable) is established on the Borehole and Cross-Section Location Plan, Drawing No. 1. For the most part, the LTSSL coincides with the Top of Bank (staked with CVC on November 9, 2001) or the Farm Pond Drainage Area (staked July 6, 2012). Where the valley feature is not well defined east/opposite of Cross-Section E-E, the LTSSL follows the meander belt setback.

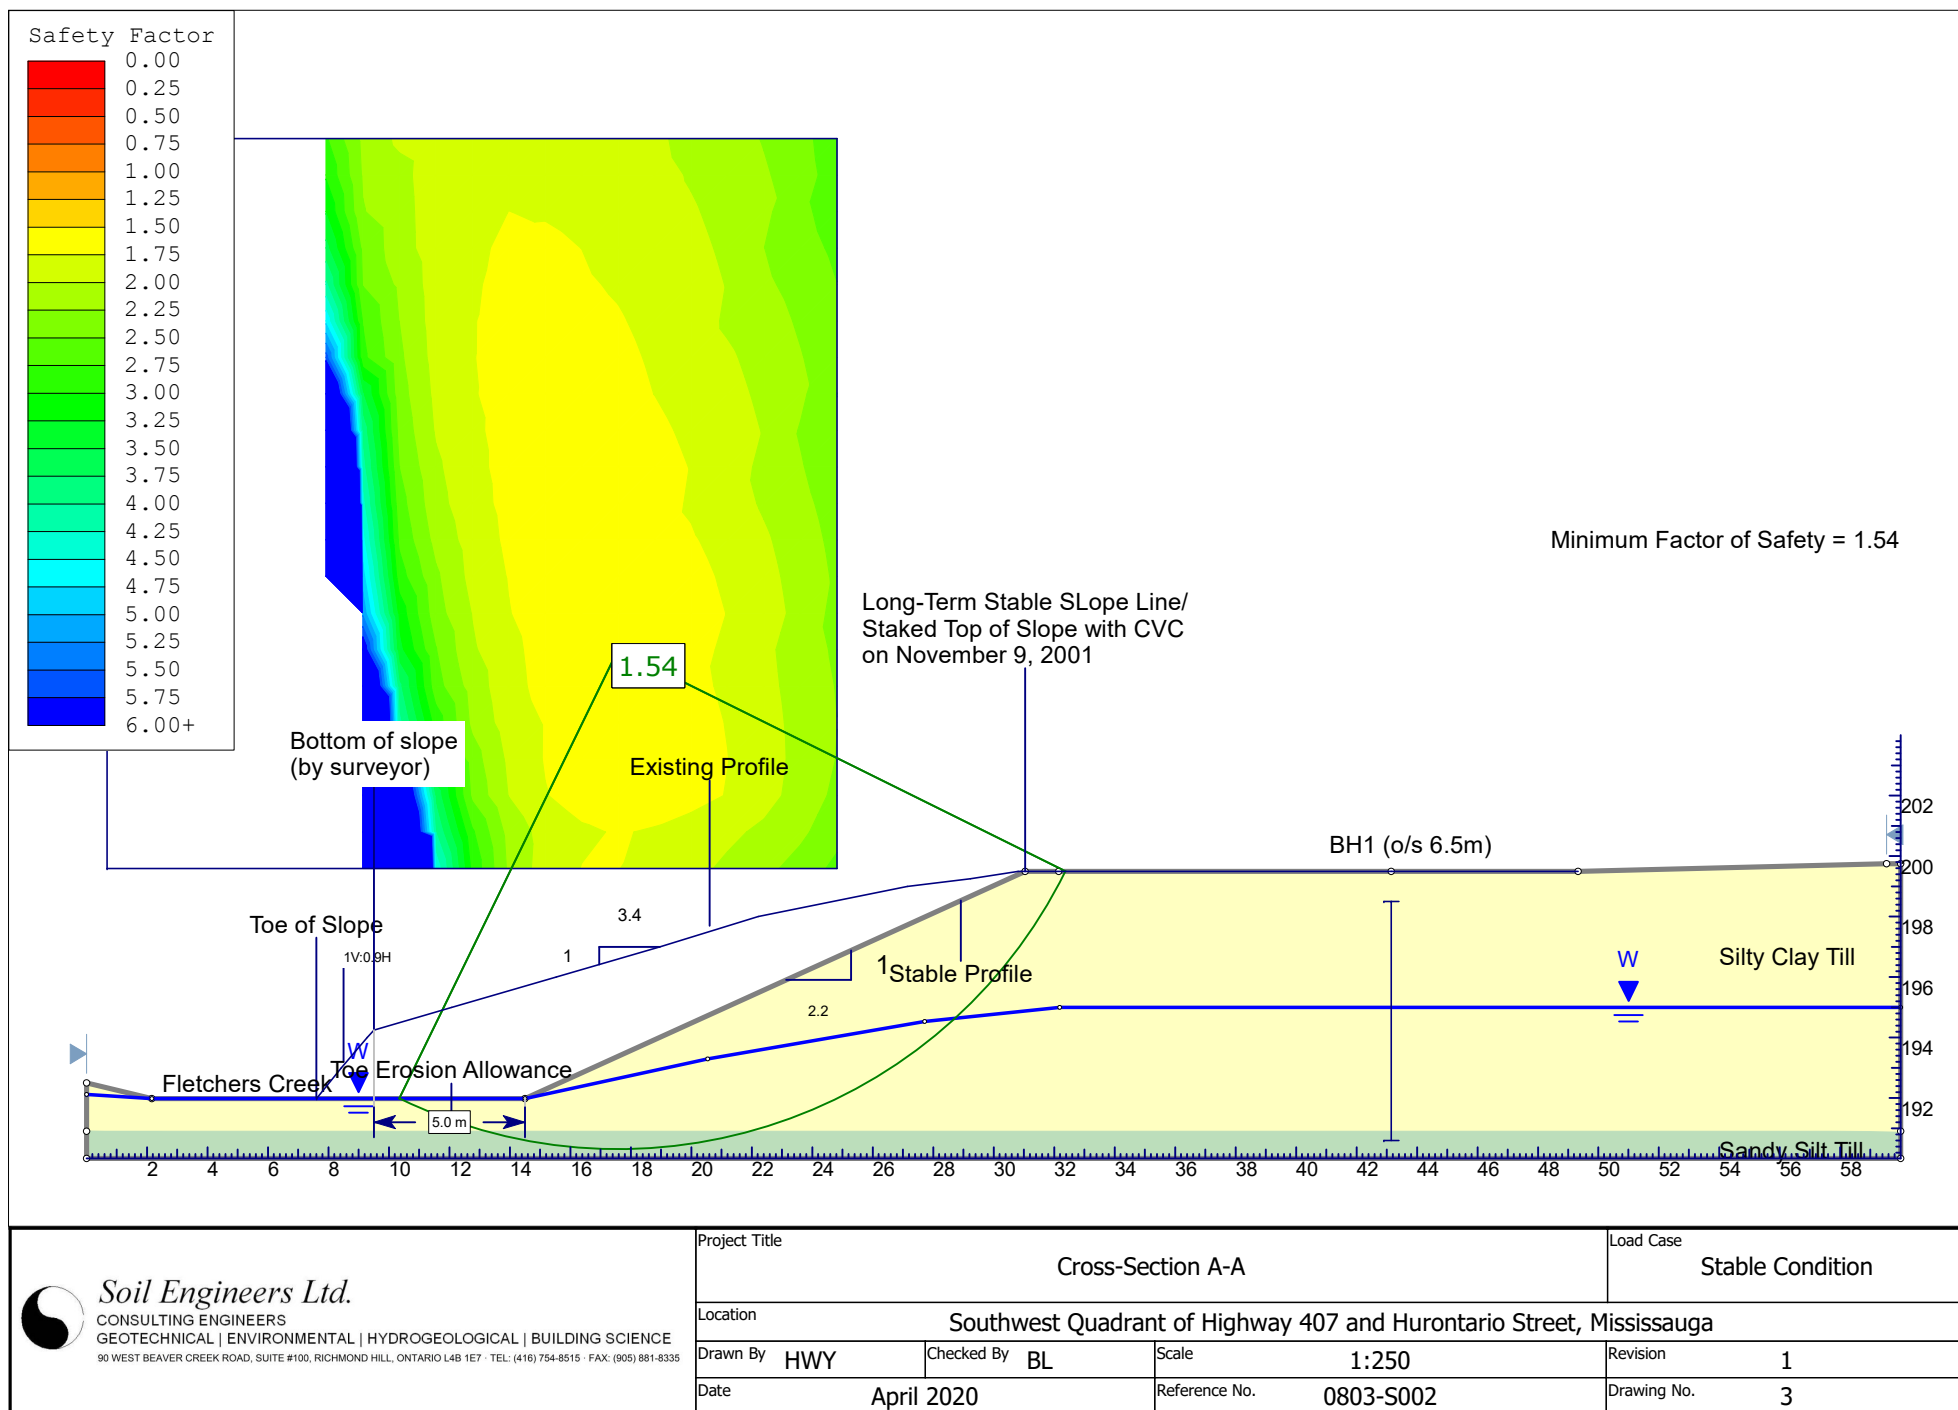
For Cross-Section A-A, the result shows that the existing slope has a FOS of 1.45, which fails to meet the OMNR requirements. The result is presented on Drawing No. 2. Therefore, the existing valley slope at this location is considered to be geotechnically unacceptable for the proposed development. A gradient of 1V:2.2H is recommended for use in sound native clay till. The remodelled slope, yielding a FOS of 1.54, which meets the OMNR requirements, is presented on Drawing No. 3.

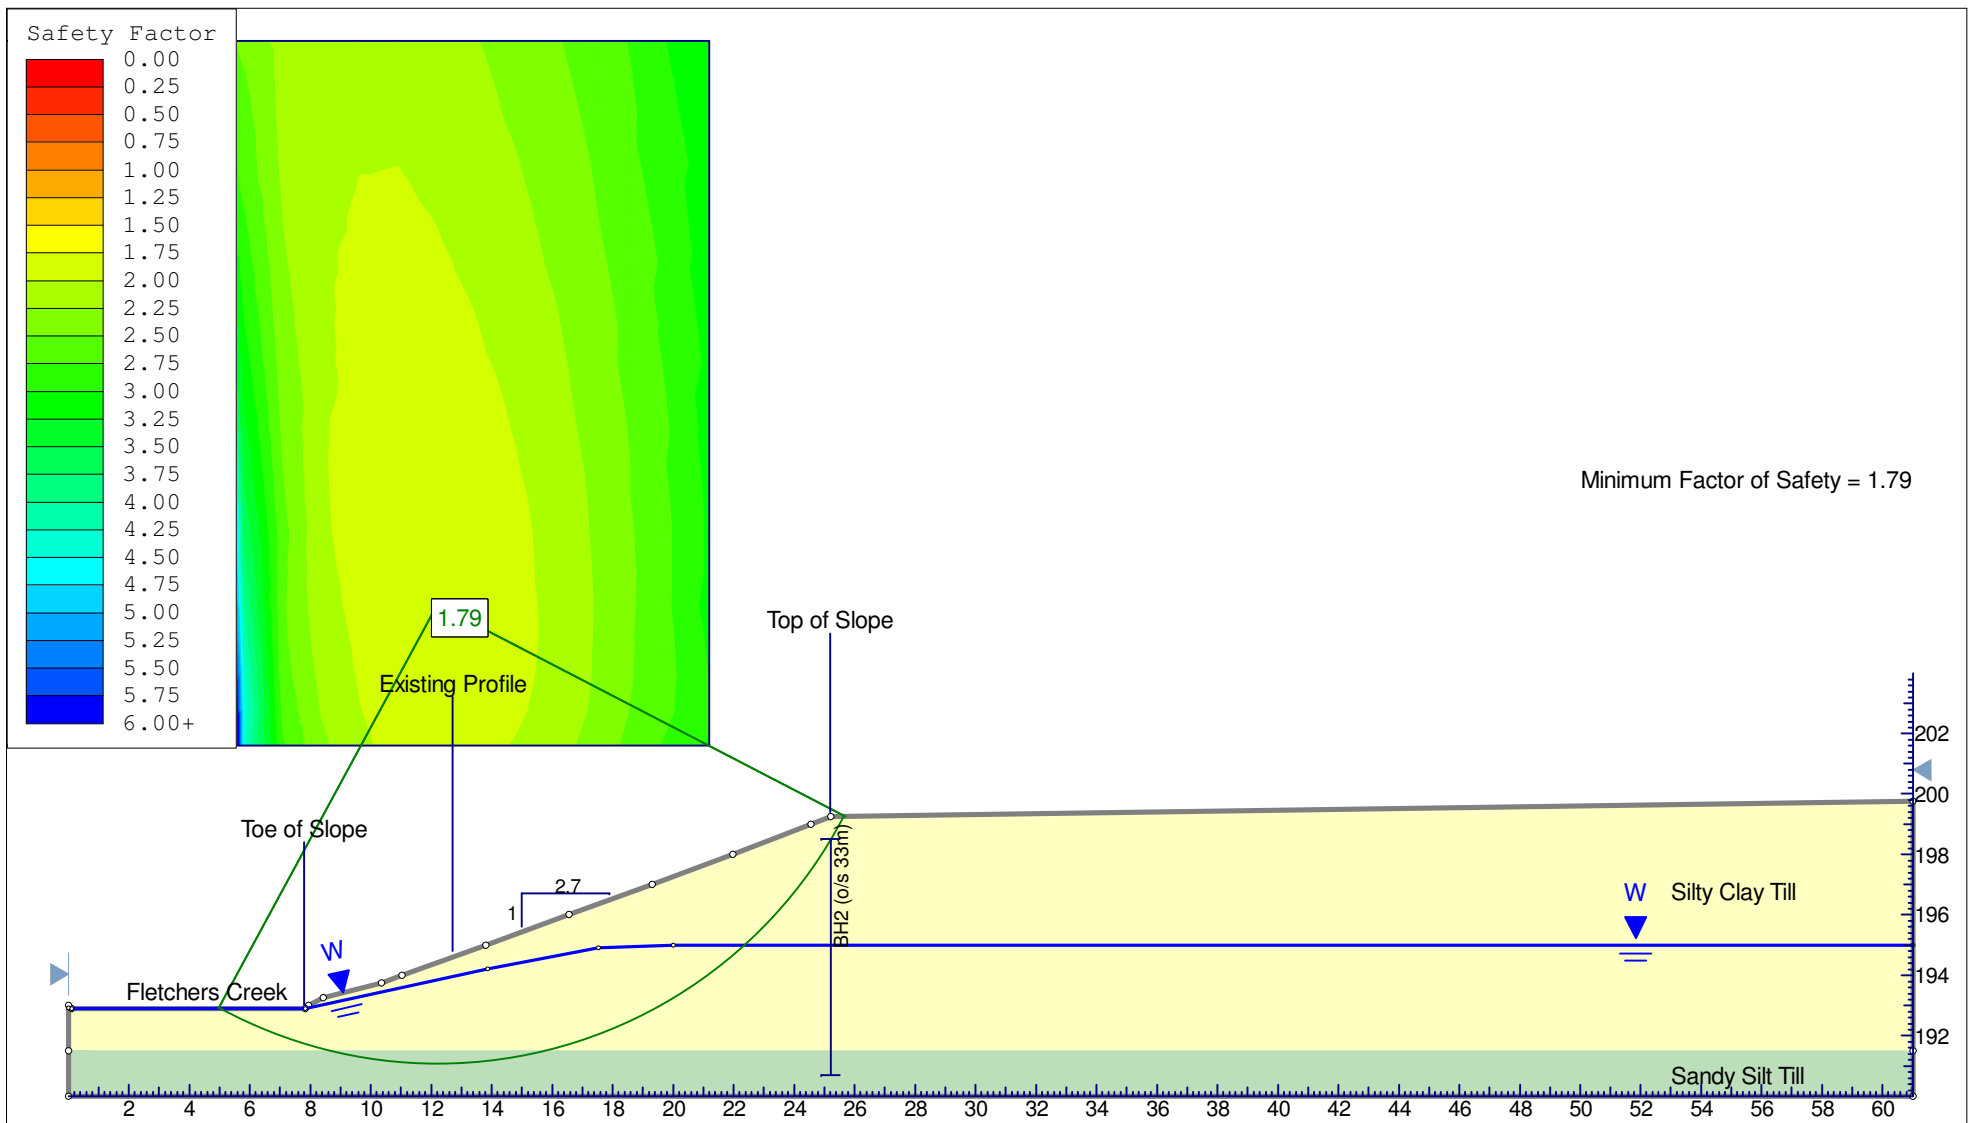
The result from the analysis indicates that the slope at Cross-Sections B-B to E-E has a factor of safety (FOS) ranging from 1.79 and 2.40, which satisfies the OMNR guideline requirements for infrastructure and public land uses (minimum FOS of 1.5). These existing slopes are therefore considered geotechnically stable. The results are presented on Drawing Nos. 4, 6, 7 and 8.

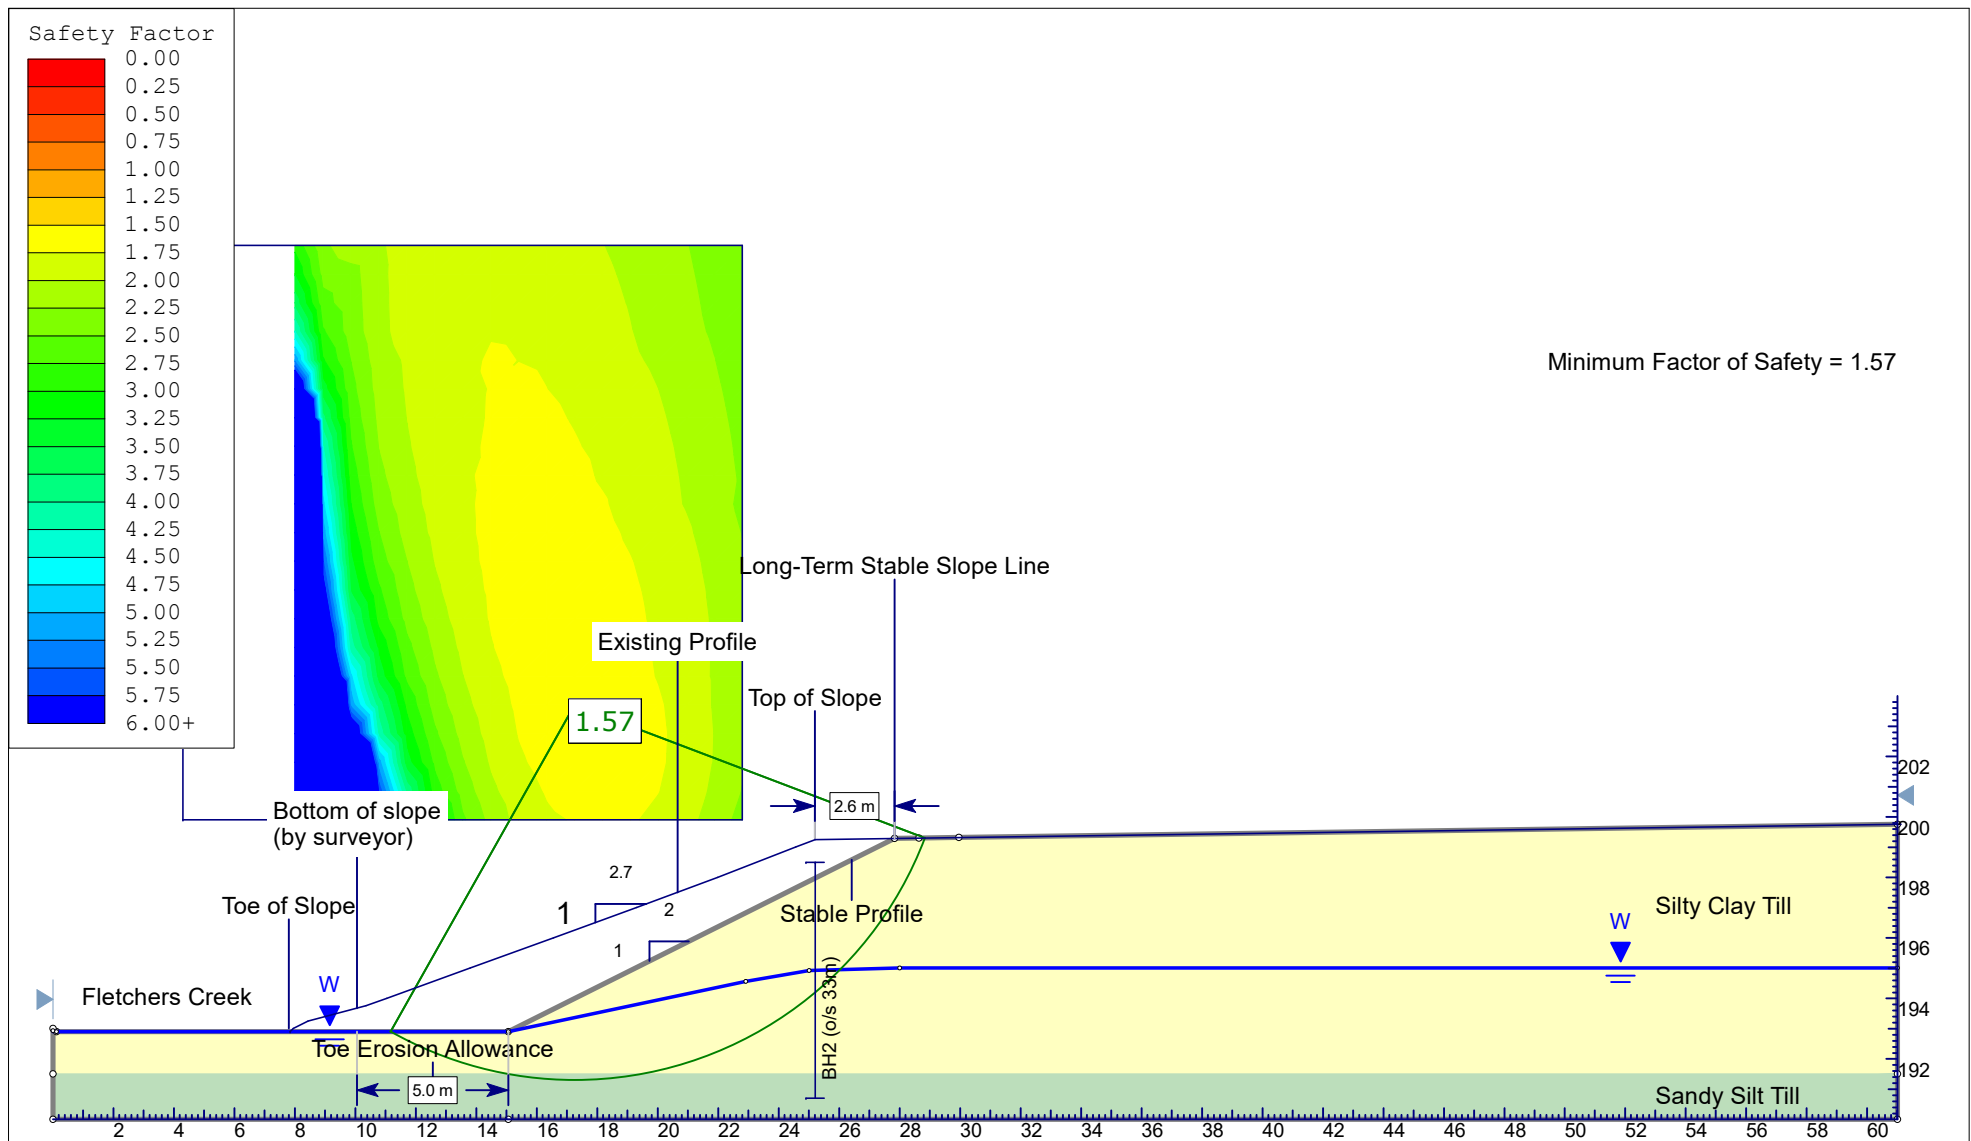
In the absence of an adequate flood plain (less than 15 m in width), a toe erosion allowance of 5 m has been recommended by GEO Morphix Ltd. In their study. This is mainly applicable for Cross-Sections A-A, B-B and E-E and surrounding areas. For Cross-Sections B-B and E-E, a geotechnically stable gradient of 1V:1.9H to 1V:2H is used behind the toe erosion setback. The remodelled slopes, with FOS of 1.57 and 2.12, meets the OMNR requirements and is presented on Drawing Nos. 5 and 9.
