September 18, 2025  
(Revision of Report dated April 13, 2020)

Reference No. 2507-S026  
Page 1 of 4

**Re: Supplementary Slope Stability Study Letter Report  
Proposed Employment Lands  
De Zen Industrial - Phase 2  
Southwest of Highway 407 and Hurontario Street  
City of Mississauga**

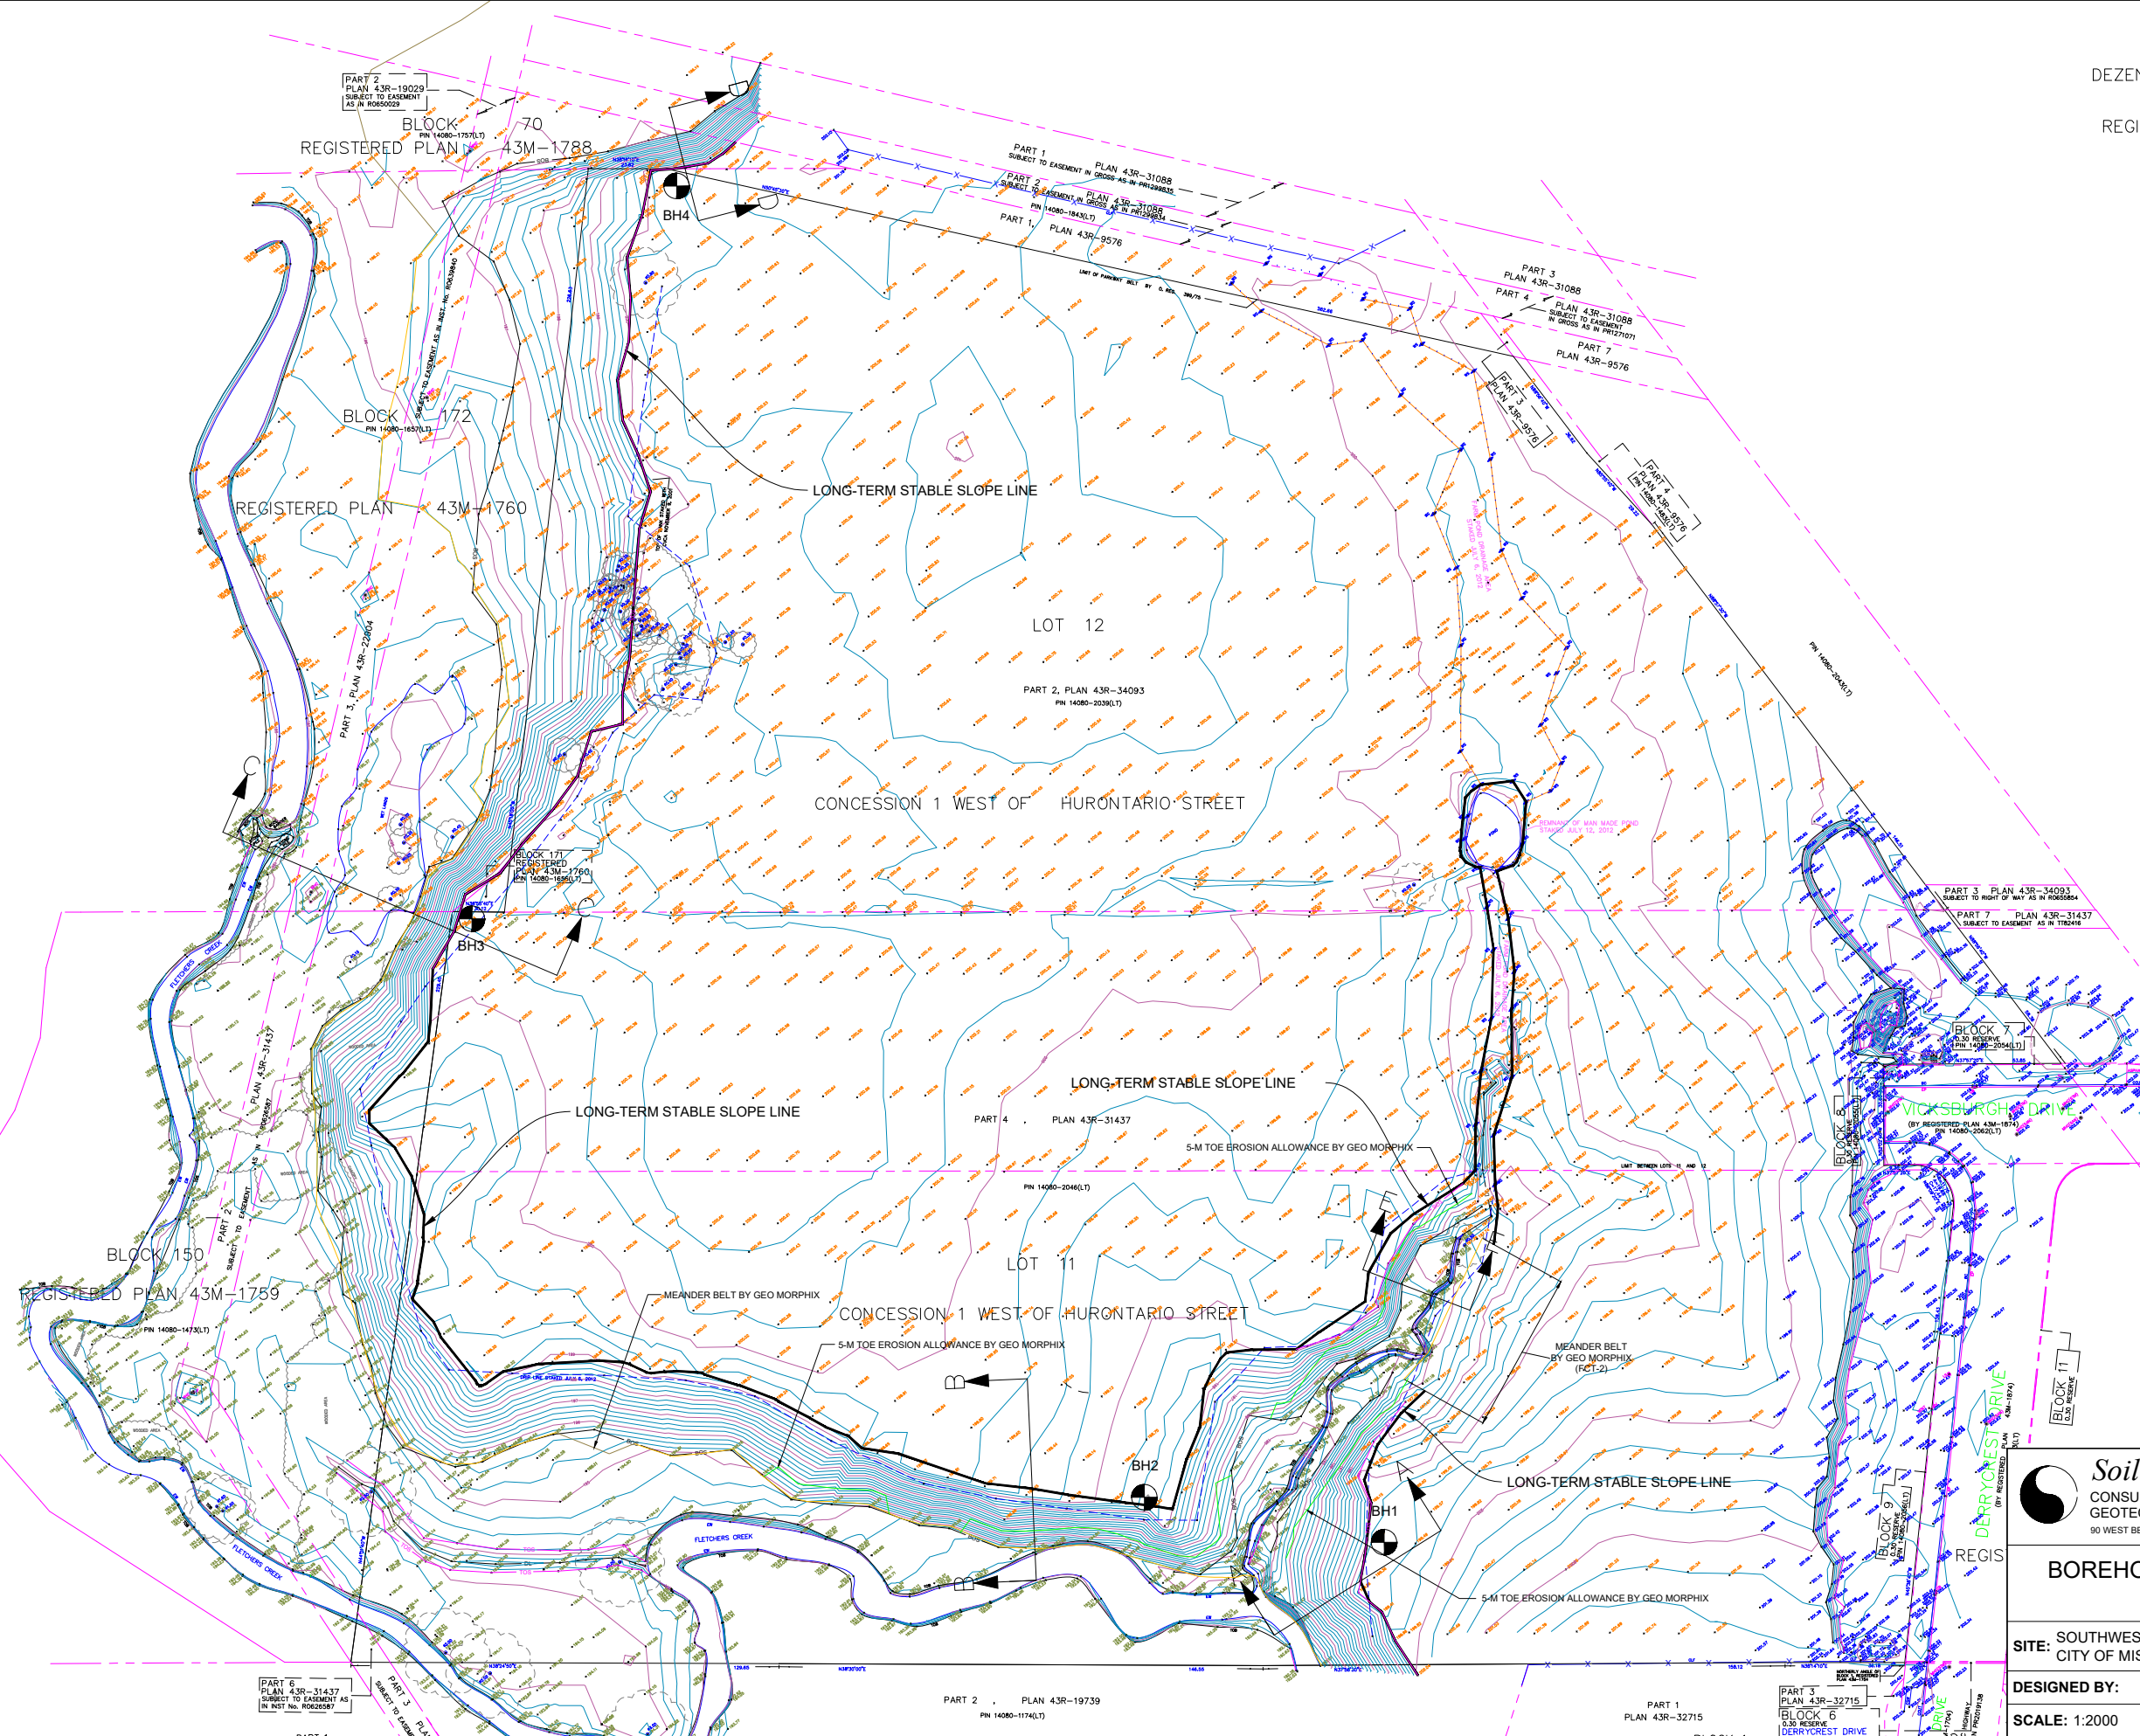
DESIGNED BY:		CHECKED BY:		DWG NO.: 1	
SCALE: 1:2000	REF. NO.: 2507-S026		DATE: SEPTEMBER 2025		REV D

The Long-Term Stable Slope Line (LTSSL), incorporating the geotechnically stable gradients and TEA, where applicable, is established on the Borehole and Cross-Section Location Plan, Drawing No. 1. For the most part, the LTSSL coincides with the Top of Bank (staked with CVC on November 9, 2001) or the Farm Pond Drainage Area (staked July 6, 2012). The LTSSL is not defined for the unconfined feature east/opposite of Cross-Section E-E (also known as Reach FCT-2); instead, the MBW will govern in this area.

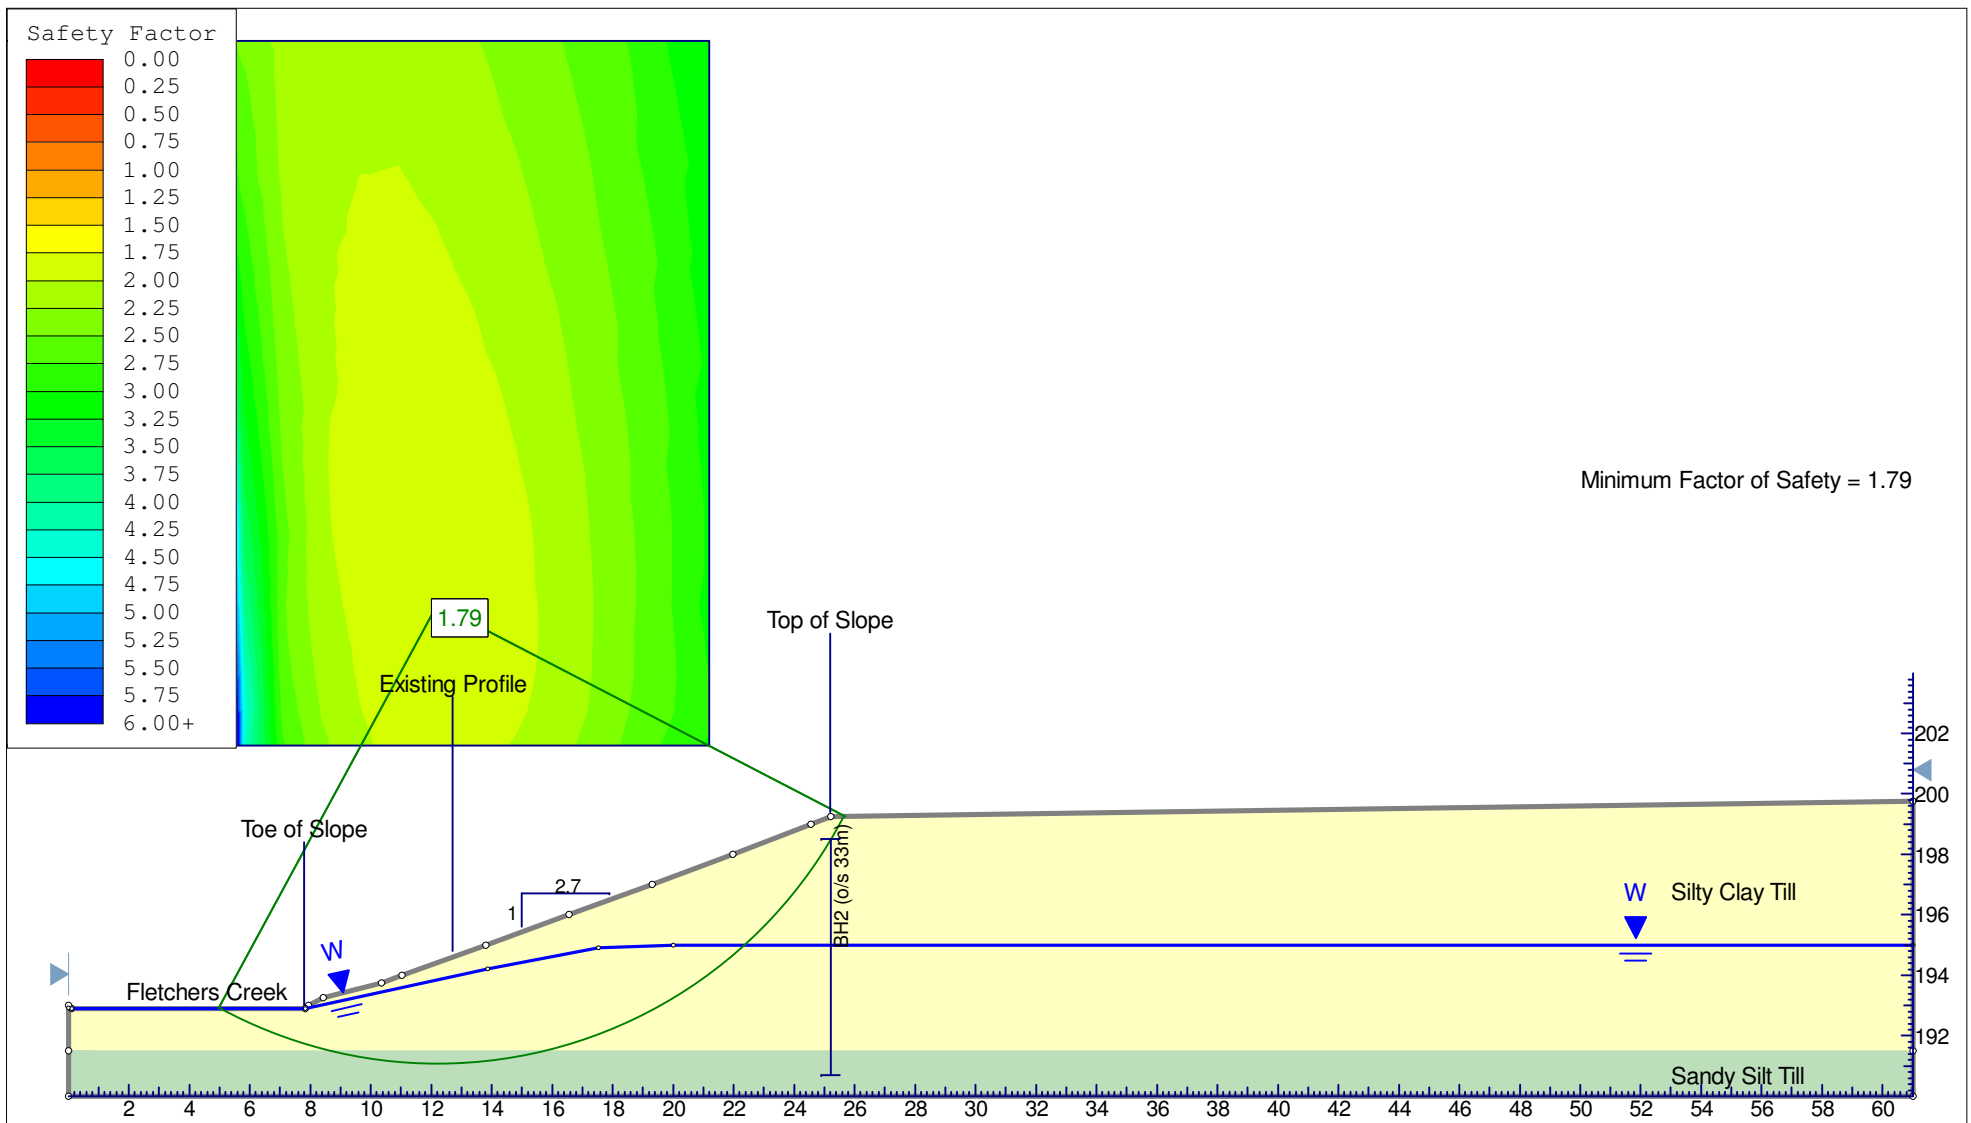
The result from the analysis indicates that the slope at Cross-Sections B-B to E-E has a factor of safety (FOS) ranging from 1.79 and 2.40, which satisfies the OMNR guideline requirements for infrastructure and public land uses (minimum FOS of 1.5). These existing slopes are therefore considered geotechnically stable. The results are presented on Drawing Nos. 4, 6, 7 and 8.

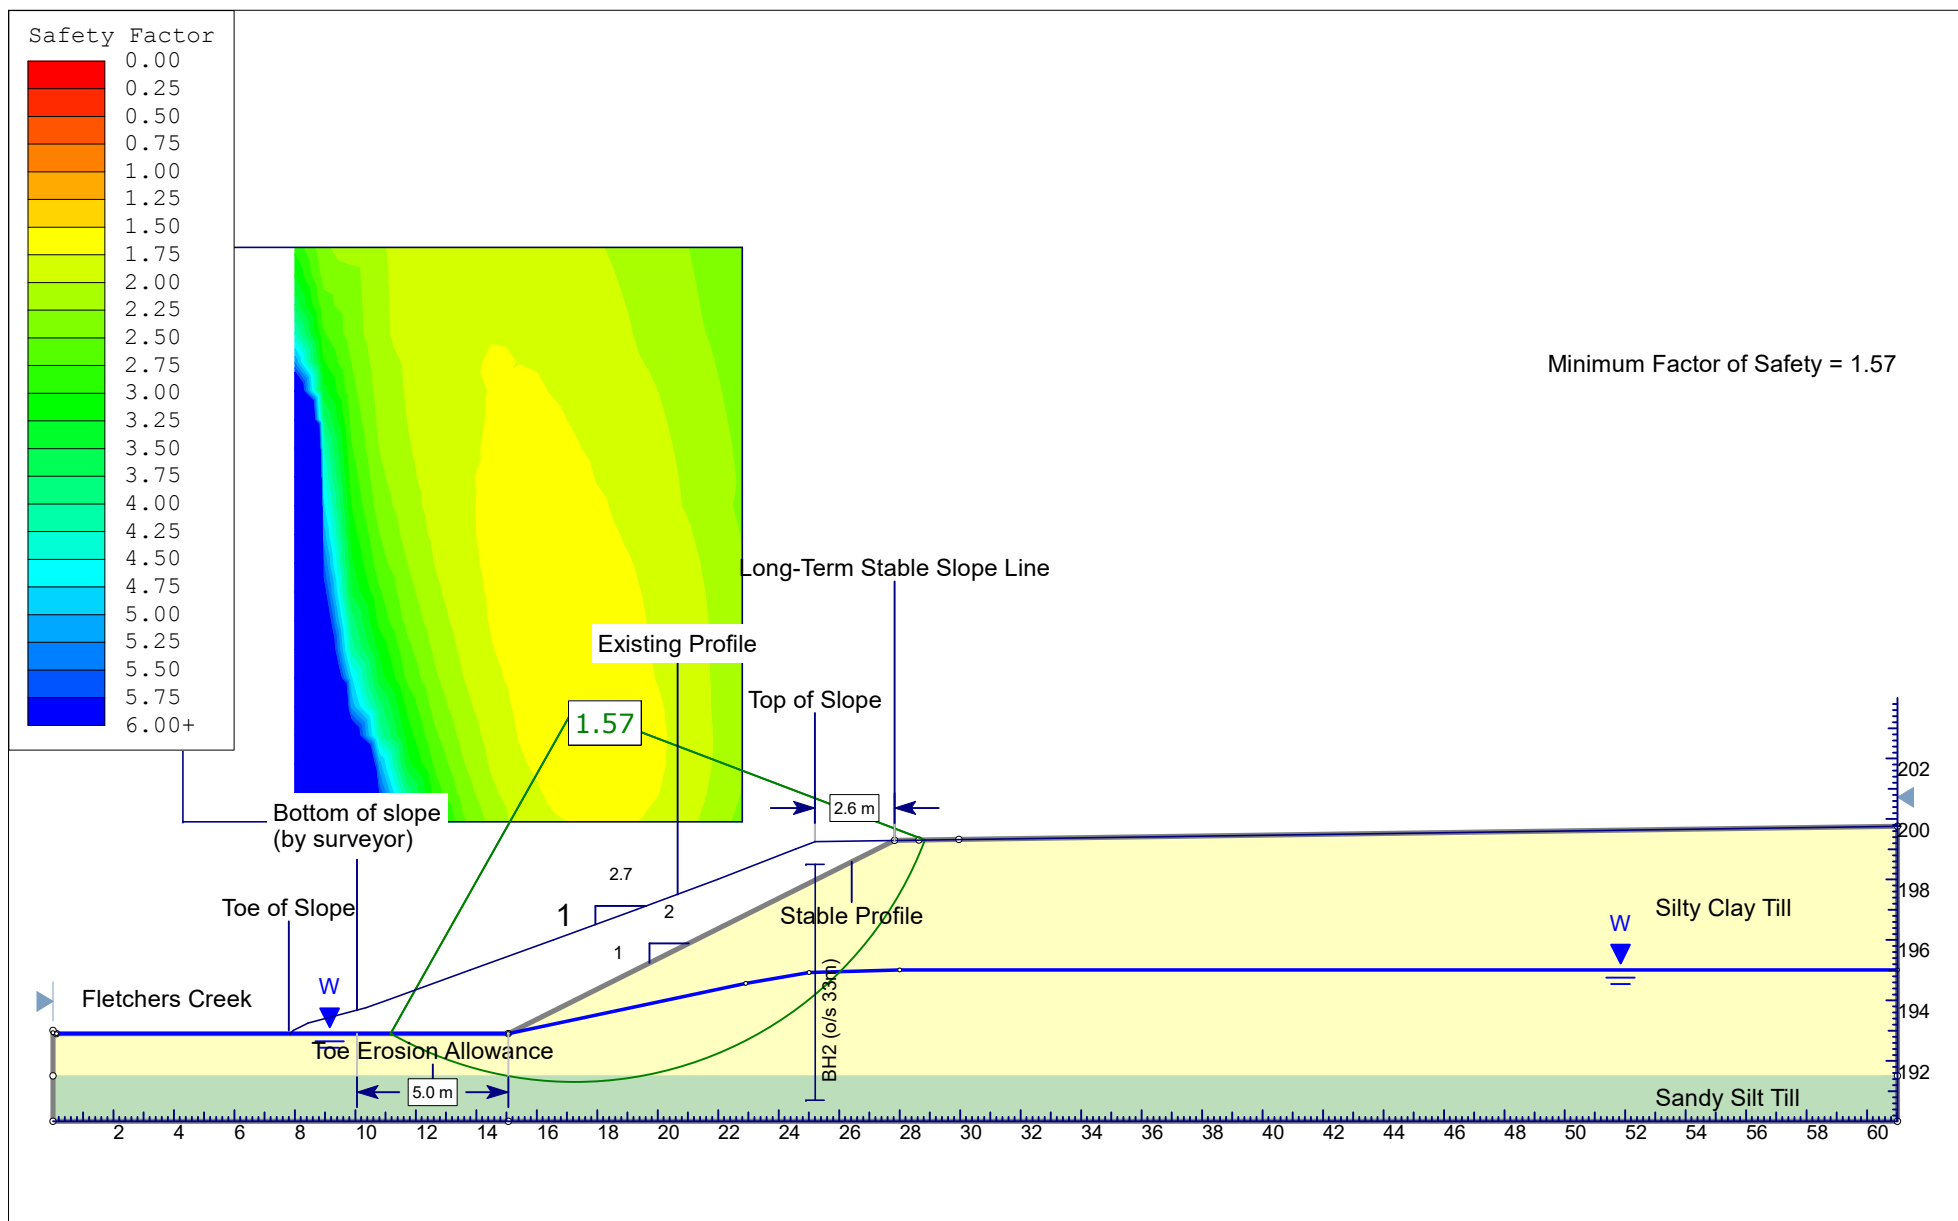
In the absence of an adequate flood plain (less than 15 m in width), a TEA of 5 m has been recommended by GEO Morphix Ltd. in their study. This is mainly applicable for Cross-Sections A-A, B-B and E-E and surrounding areas. For Cross-Sections B-B and E-E, a geotechnically stable gradient of 1V:1.9H to 1V:2H is used behind the TEA. The remodelled slopes, with FOS of 1.57 and 2.12, meets the OMNR requirements and is presented on Drawing Nos. 5 and 9.
