August 14, 2025

ARBORIST REPORT
7564 Tenth Line West, Mississauga, Ontario

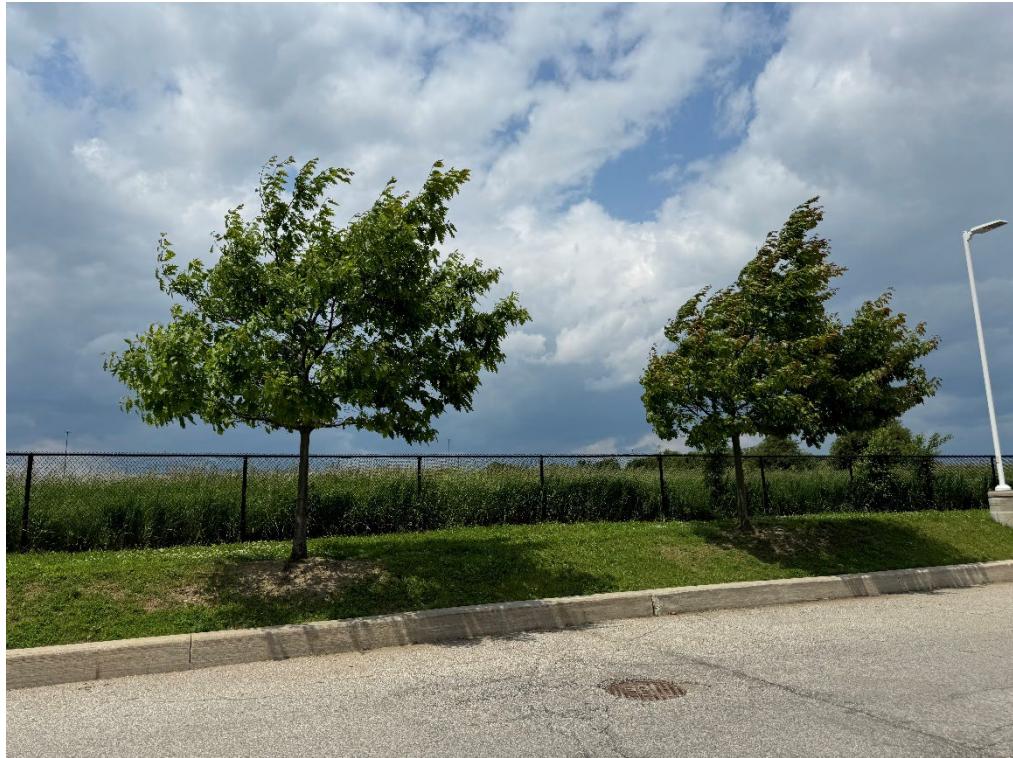
Trees 541, 542

Tree #	Common Name	Botanical Name	DBH (CM)	Condition	Comments	Recommendation
541	Red Oak	<i>Quercus rubra</i>	12	F	Minor deadwood in canopy	Retain
542	Red Oak	<i>Quercus rubra</i>	14	F	Minor deadwood in canopy	Retain
543	Red Oak	<i>Quercus rubra</i>	14	F	Moderate deadwood in canopy	Remove due to construction
544	Red Oak	<i>Quercus rubra</i>	16	F	Minor to moderate deadwood in canopy	Remove due to construction
545	Ash Sp.	<i>Fraxinus Sp.</i>	14	F		Remove due to construction
546	Ash Sp.	<i>Fraxinus Sp.</i>	6	F	2 stem at base	Remove due to construction
547	Black Walnut	<i>Juglans nigra</i>	40	F	Minor deadwood in canopy	Retain
548	Manitoba Maple	<i>Acer negundo</i>	64	F	Minor deadwood in canopy	Retain
549	Common Buckthorn	<i>Rhamnus cathartica</i>	26	F	Minor to moderate deadwood in canopy	Remove due to construction
550	Common Buckthorn	<i>Rhamnus cathartica</i>	27	F	Multi-stem at base, minor to moderate deadwood throughout	Remove due to construction

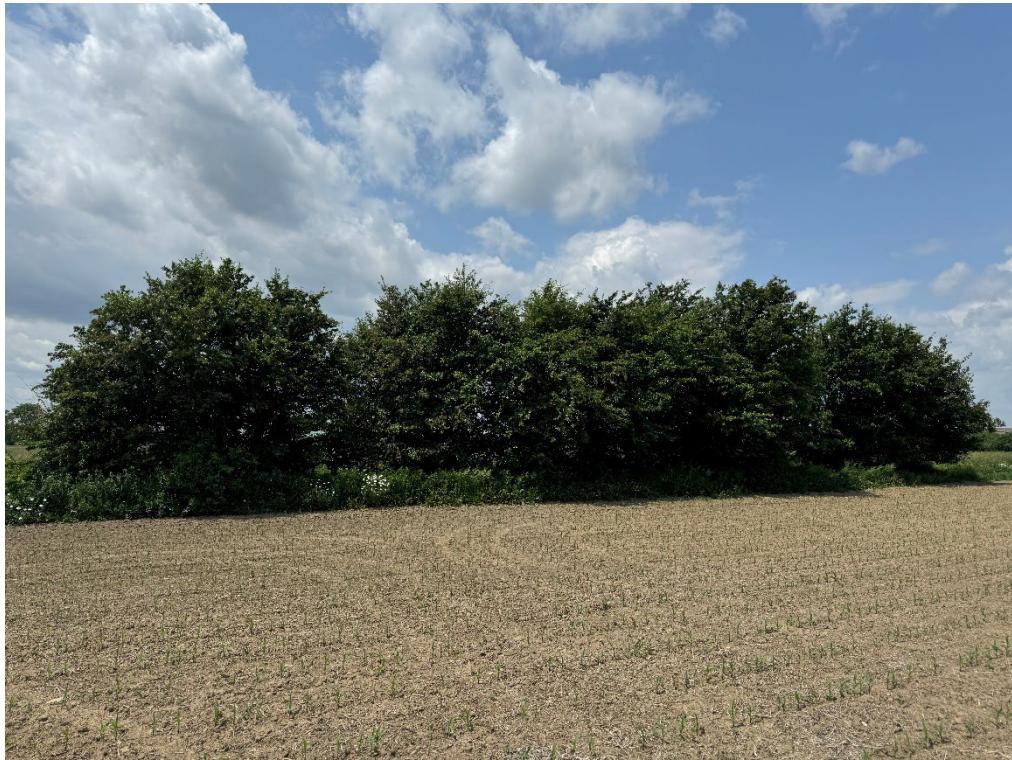
Trees 549 – 552

551	Common Buckthorn	<i>Rhamnus cathartica</i>	15	F	Multi-stem at 0.7 metres, minor deadwood in canopy	Remove due to construction
552	Common Buckthorn	<i>Rhamnus cathartica</i>	27	F	Multi-stem at base, minor deadwood in canopy	Remove due to construction
553	Common Buckthorn	<i>Rhamnus cathartica</i>	21	F	Multi-stem at base, minor to moderate deadwood in canopy	Remove due to construction
554	Common Buckthorn	<i>Rhamnus cathartica</i>	20	F	Minor deadwood in canopy	Remove due to construction
555	Common Buckthorn	<i>Rhamnus cathartica</i>	21	F	Minor deadwood in canopy	Remove due to construction
556	Flowering Crabapple Tree	<i>Malus Sp.</i>	26	F	Mild lean, bow at top, minor deadwood in canopy	Remove due to construction

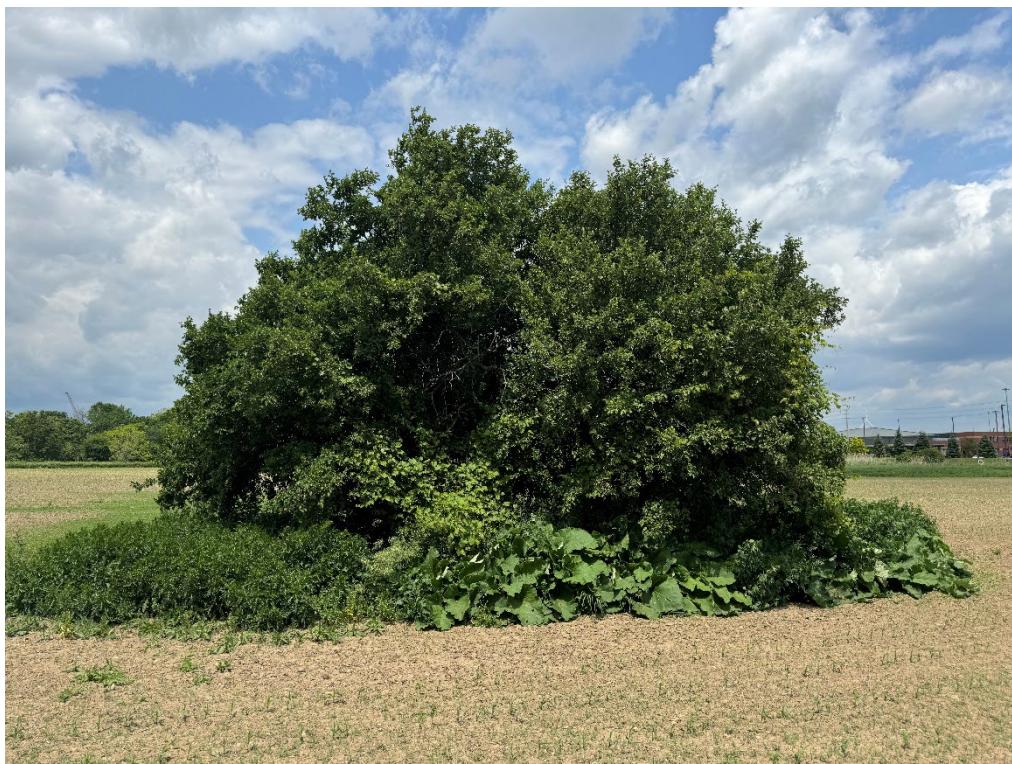
Trees 556 – 558

557	Flowering Crabapple Tree	Malus Sp.	31	F/P	Multiple bows throughout, contorted form, moderate deadwood in canopy	Remove due to construction
558	Flowering Crabapple Tree	Malus Sp.	47	F	Mild lean, minor deadwood in canopy	Remove due to construction
559	Shagbark Hickory	<i>Carya ovata</i>	34	F	Minor deadwood in canopy	Remove due to construction
560	Shagbark Hickory	<i>Carya ovata</i>	45	F/P	Moderate deadwood in canopy	Remove due to construction
561	Shagbark Hickory	<i>Carya ovata</i>	22	F	Minor deadwood throughout	Remove due to construction
562	Shagbark Hickory	<i>Carya ovata</i>	47	F	Moderate deadwood in canopy	Remove due to construction
563	Basswood	<i>Tilia americana</i>	15	F		Remove due to construction
564	Common Buckthorn	<i>Rhamnus cathartica</i>	19	F	3 stem at base, minor deadwood in canopy	Remove due to construction
565	Common Buckthorn	<i>Rhamnus cathartica</i>	21	F	Minor to moderate deadwood in canopy	Remove due to construction

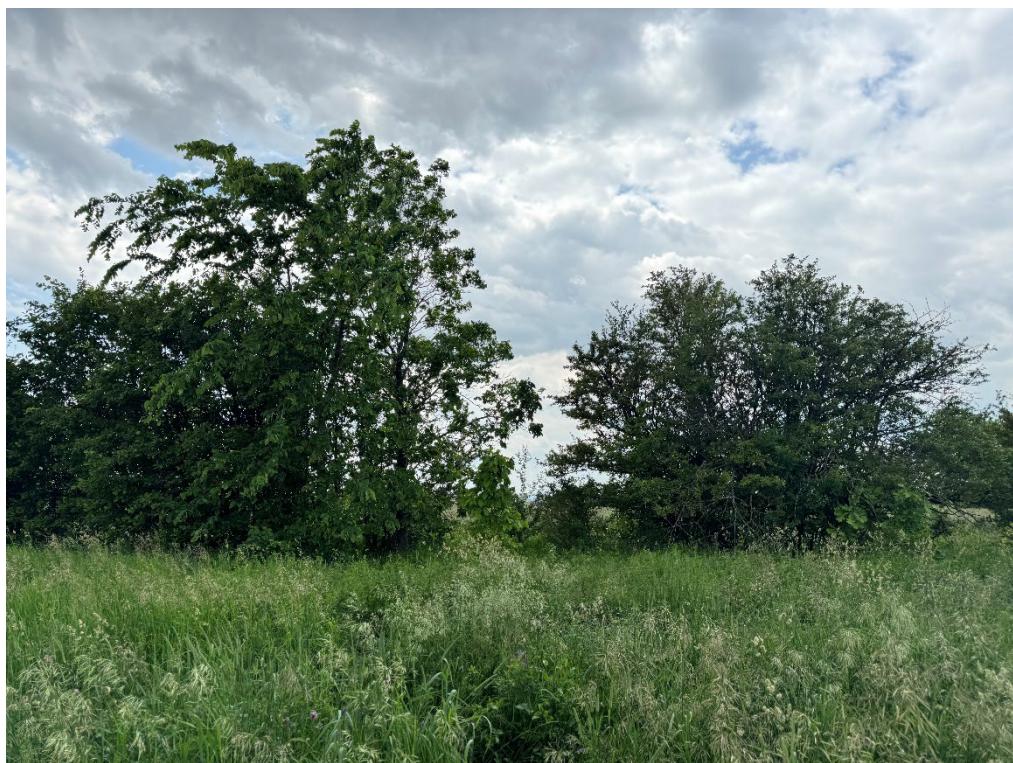
Trees 566 – 569

566	Common Buckthorn	<i>Rhamnus cathartica</i>	22	F	Multi-stem at base, minor to moderate deadwood in canopy	Remove due to construction
567	Shagbark Hickory	<i>Carya ovata</i>	22	F	Minor deadwood in canopy	Remove due to construction
568	American Elm	<i>Ulmus americana</i>	18	F		Remove due to construction
569	Common Buckthorn	<i>Rhamnus cathartica</i>	14	F	2 stem at base, minor deadwood in canopy	Remove due to construction
570	Shagbark Hickory	<i>Carya ovata</i>	59	F		Remove due to construction
571	Shagbark Hickory	<i>Carya ovata</i>	47	F	Mild lean	Remove due to construction
572	Shagbark Hickory	<i>Carya ovata</i>	22	F	Mild lean, minor deadwood throughout	Remove due to construction
573	Shagbark Hickory	<i>Carya ovata</i>	38	F	2 stem at 1.1 metres	Remove due to construction
574	Shagbark Hickory	<i>Carya ovata</i>	47	F		Remove due to construction
575	Shagbark Hickory	<i>Carya ovata</i>	48	F		Remove due to construction

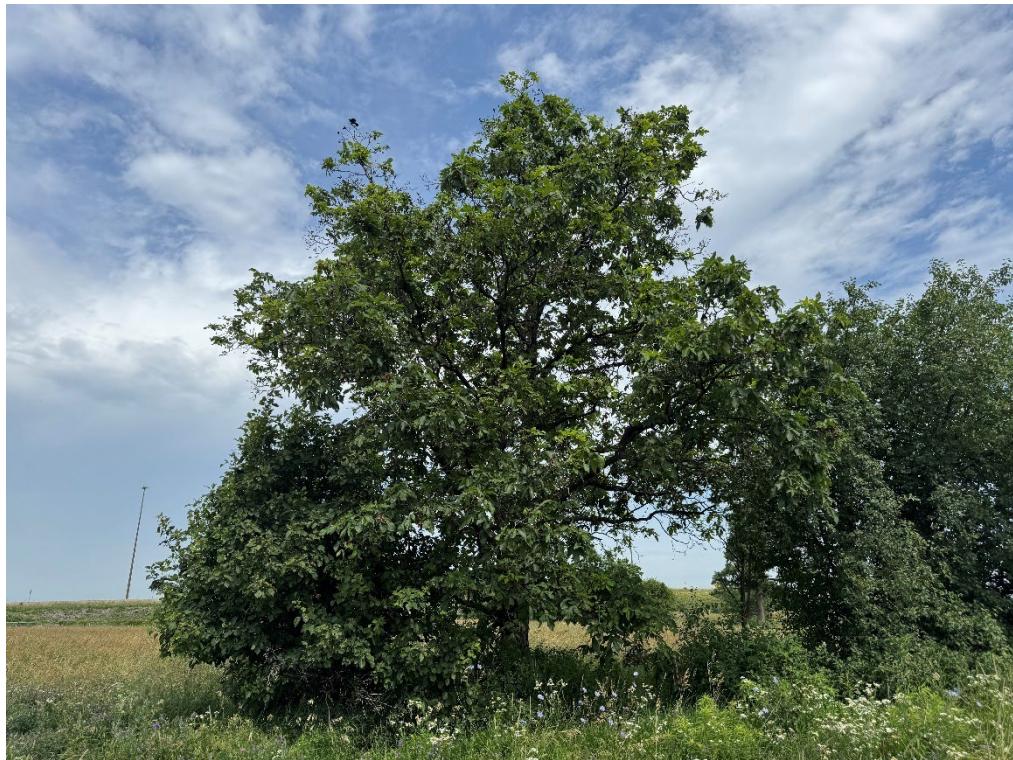
Tree 576

576	Shagbark Hickory	<i>Carya ovata</i>	50	F	Minor deadwood in canopy	Remove due to construction

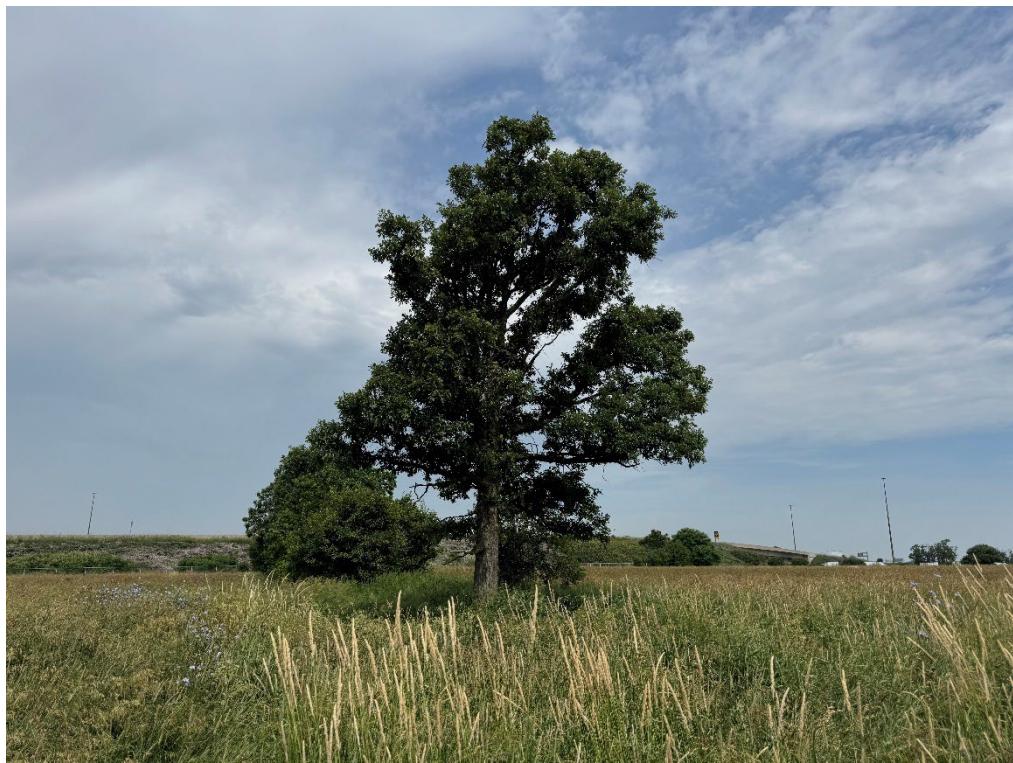
Tree 577

577	Burr Oak	<i>Quercus macrocarpa</i>	63	F	Minor deadwood throughout	Remove due to construction
578	Basswood	<i>Tilia americana</i>	23	F	Mild to moderate lean, 2 stem at 0.3 metres	Remove due to construction
579	Basswood	<i>Tilia americana</i>	18	F		Remove due to construction
580	Burr Oak	<i>Quercus macrocarpa</i>	19	F		Remove due to construction
581	Shagbark Hickory	<i>Carya ovata</i>	19	F		Remove due to construction
582	Shagbark Hickory	<i>Carya ovata</i>	31	F		Remove due to construction
583	Shagbark Hickory	<i>Carya ovata</i>	46	F		Remove due to construction
584	Shagbark Hickory	<i>Carya ovata</i>	43	F		Remove due to construction
585	Shagbark Hickory	<i>Carya ovata</i>	34	F	Minor deadwood throughout	Remove due to construction
586	Shagbark Hickory	<i>Carya ovata</i>	52	F	Minor deadwood throughout, 3 stem at base	Remove due to construction
587	Shagbark Hickory	<i>Carya ovata</i>	67	F	Minor deadwood throughout	Remove due to construction

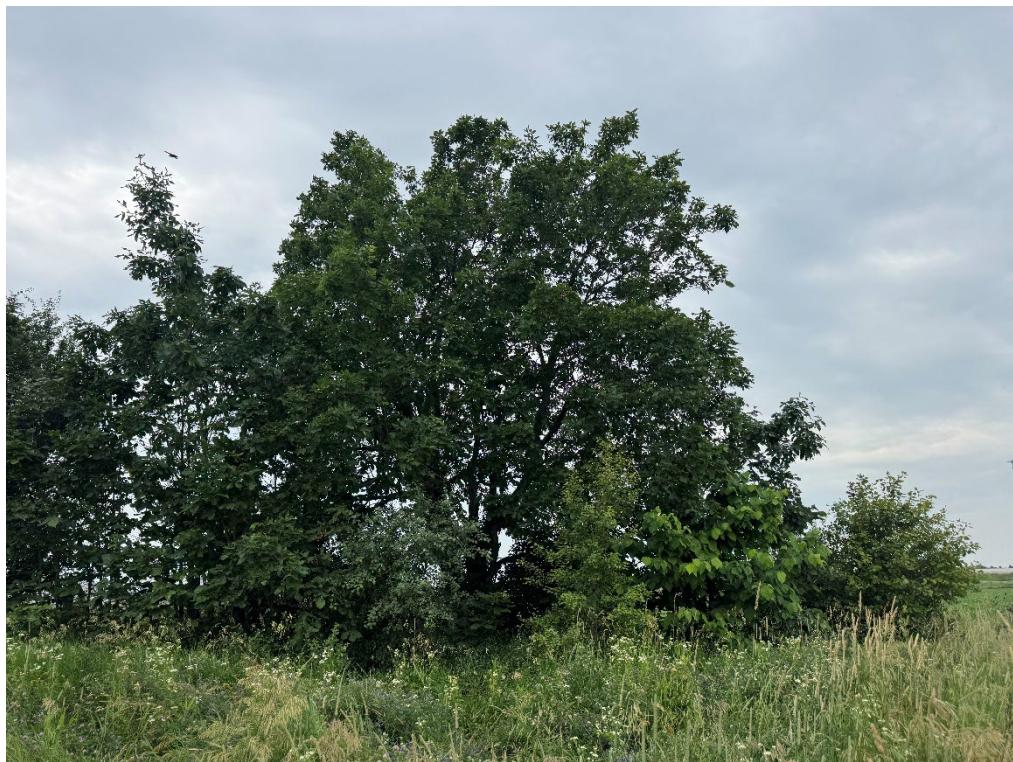
Tree 588

588	Shagbark Hickory	<i>Carya ovata</i>	43	F/P	Minor deadwood throughout, previous limb failures evident, 2 stem at 1.0 metre	Retain (injure)
589	Basswood	<i>Tilia americana</i>	19	F		Remove due to construction
590	Shagbark Hickory	<i>Carya ovata</i>	18	F		Remove due to construction
591	Shagbark Hickory	<i>Carya ovata</i>	15	F		Remove due to construction
592	Basswood	<i>Tilia americana</i>	15	F		Remove due to construction
593	Burr Oak	<i>Quercus macrocarpa</i>	23	F	Minor to moderate deadwood throughout	Remove due to construction
594	Shagbark Hickory	<i>Carya ovata</i>	31	F		Remove due to construction
595	Shagbark Hickory	<i>Carya ovata</i>	39	F	2 stem at 0.5 metres	Remove due to construction
596	Shagbark Hickory	<i>Carya ovata</i>	33	F		Retain
597	Shagbark Hickory	<i>Carya ovata</i>	44	F	Minor deadwood throughout	Remove due to construction
O1	Black Walnut	<i>Juglans nigra</i>	~48	F	Minor deadwood in canopy	Retain

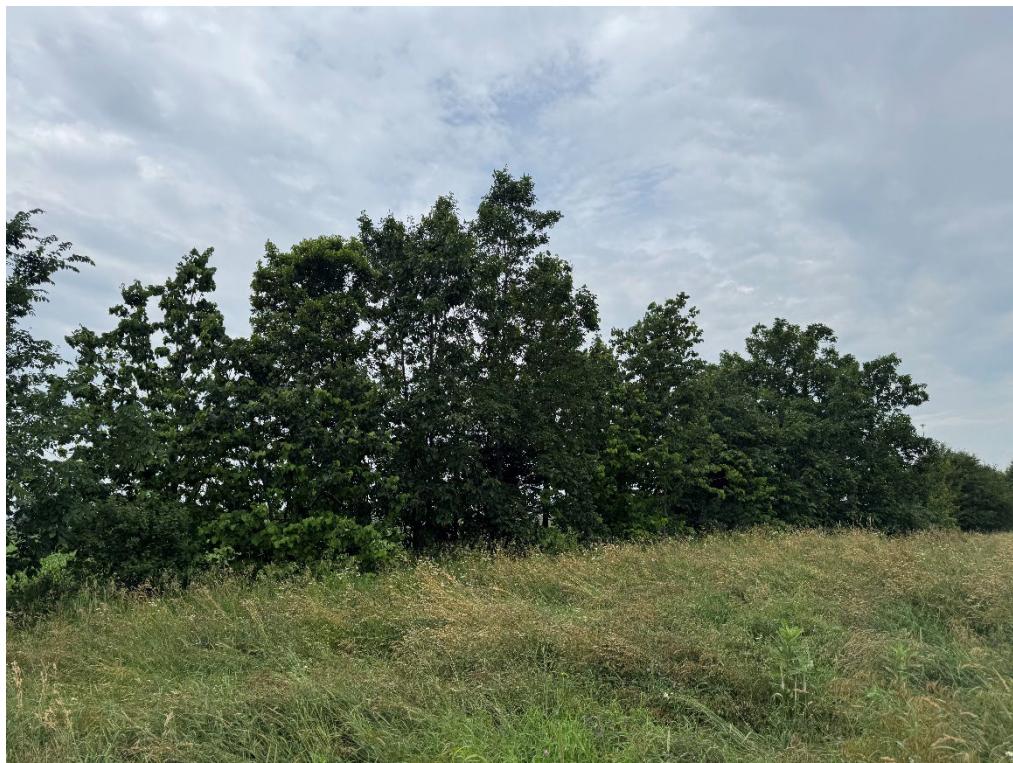
Trees 589 – 593, O6, O7

O2	Black Walnut	Juglans nigra	~26	F	Minor deadwood in canopy	Retain
O3	Black Walnut	Juglans nigra	~22	F	Minor to moderate deadwood in canopy	Retain
O4	Black Walnut	Juglans nigra	~33	F	Minor to moderate deadwood in canopy	Retain
O5	Black Walnut	Juglans nigra	~35	F	Minor to moderate deadwood in canopy	Retain
O6	Basswood	Tilia americana	~78	P	Suckers throughout, main leader previously failed, minor deadwood throughout	Retain (injure)
O7	Basswood	Tilia americana	18	F		Retain
O8	Burr Oak	Quercus macrocarpa	~72	F	Minor deadwood throughout	Retain (injure)
O9	Burr Oak	Quercus macrocarpa	~58	F/P	Moderate deadwood throughout	Retain (injure)
O10	Shagbark Hickory	Carya ovata	37	F		Retain
O11	Burr Oak	Quercus macrocarpa	84	F	Minor to moderate deadwood throughout, cavity at base on northwest side of tree	Retain (injure)
O12	Shagbark Hickory	Carya ovata	57	F	Minor to moderate deadwood throughout	Remove due to construction
