August 14, 2025 [Revised March 2, 2026]

ARBORIST REPORT
 7564 Tenth Line West, Mississauga, Ontario

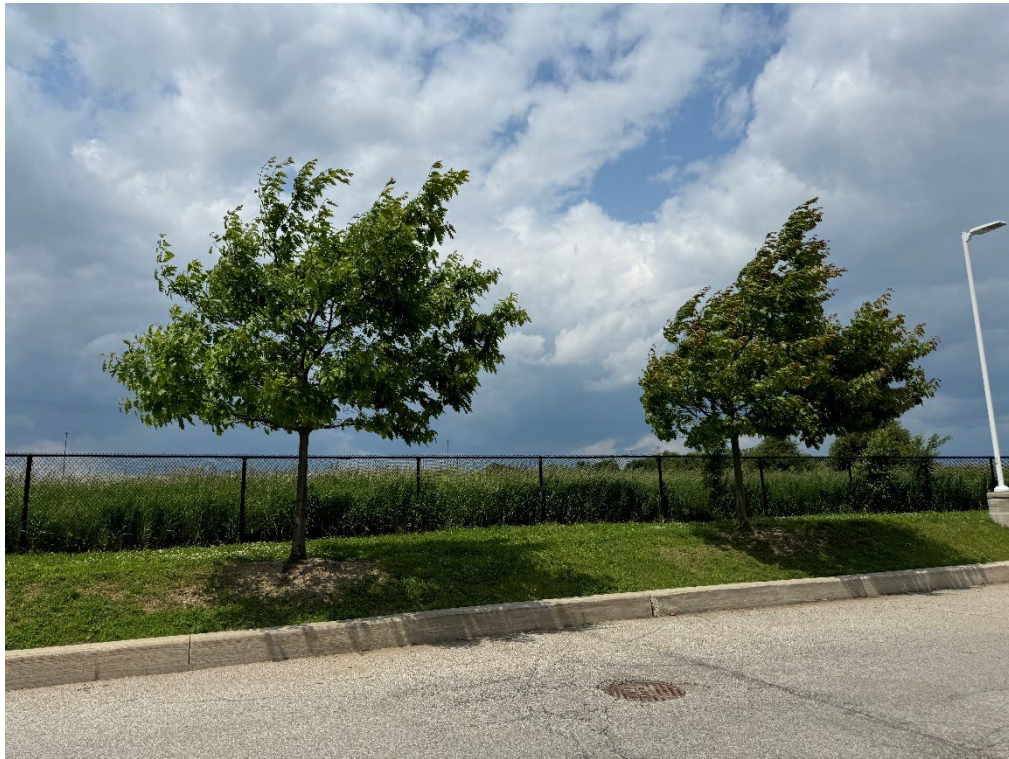
Trees 541, 542

Tree #	Common Name	Botanical Name	DBH (CM)	Condition	Comments	Recommendation
541	Red Oak	Quercus rubra	12	F	Minor deadwood in canopy	Retain
542	Red Oak	Quercus rubra	14	F	Minor deadwood in canopy	Retain
543	Red Oak	Quercus rubra	14	F	Moderate deadwood in canopy	Remove due to construction
544	Red Oak	Quercus rubra	16	F	Minor to moderate deadwood in canopy	Remove due to construction
559	Shagbark Hickory	Carya ovata	34	F	Minor deadwood in canopy	Remove due to construction
560	Shagbark Hickory	Carya ovata	45	F/P	Moderate deadwood in canopy	Remove due to construction
561	Shagbark Hickory	Carya ovata	22	F	Minor deadwood throughout	Remove due to construction
562	Shagbark Hickory	Carya ovata	47	F	Moderate deadwood in canopy	Remove due to construction
563	Basswood	Tilia americana	15	F		Remove due to construction
564	Common Buckthorn	Rhamnus cathartica	19	F	3 stem at base, minor deadwood in canopy	Remove due to construction

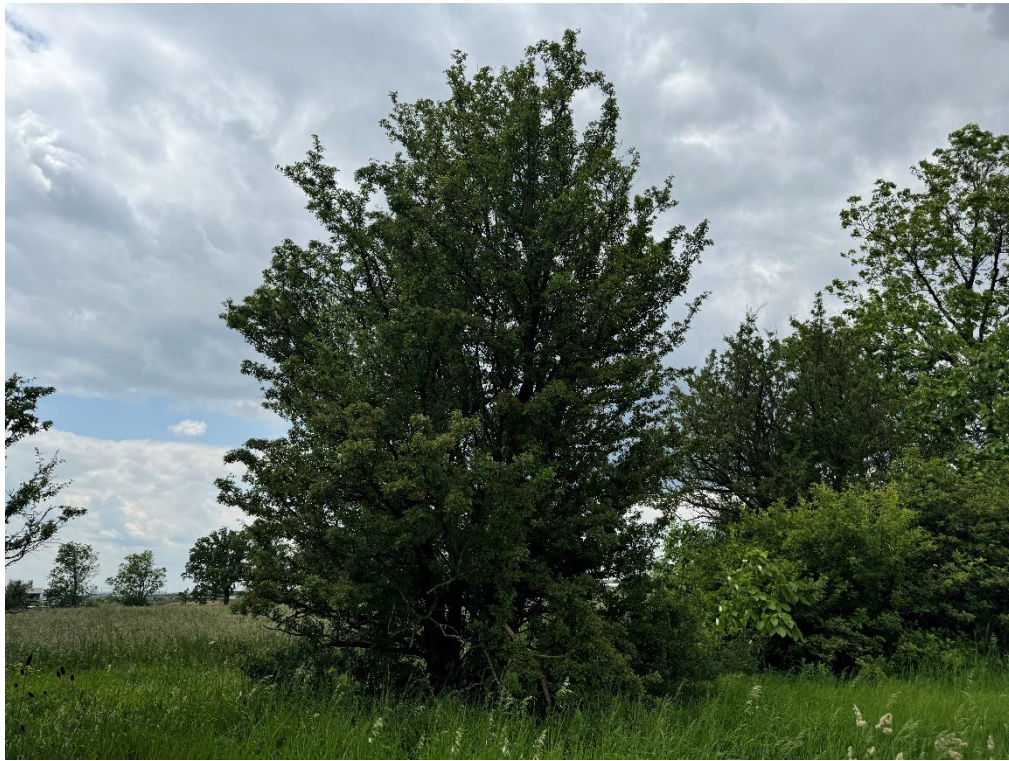
Tree 565

565	Common Buckthorn	Rhamnus cathartica	21	F	Minor to moderate deadwood in canopy	Remove due to construction
566	Common Buckthorn	Rhamnus cathartica	22	F	Multi-stem at base, minor to moderate deadwood in canopy	Remove due to construction
567	Shagbark Hickory	Carya ovata	22	F	Minor deadwood in canopy	Remove due to construction
568	American Elm	Ulmus americana	18	F		Remove due to construction
569	Common Buckthorn	Rhamnus cathartica	14	F	2 stem at base, minor deadwood in canopy	Remove due to construction

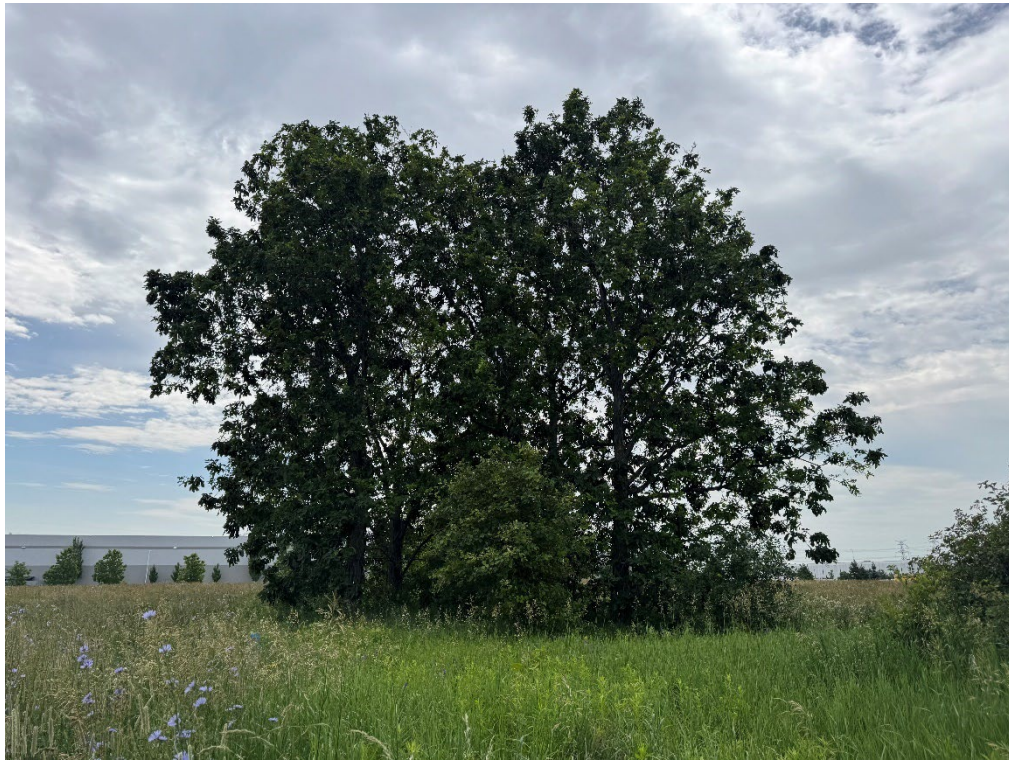
Trees 570 – 574

570	Shagbark Hickory	Carya ovata	59	F		Remove due to construction
571	Shagbark Hickory	Carya ovata	47	F	Mild lean	Remove due to construction
572	Shagbark Hickory	Carya ovata	22	F	Mild lean, minor deadwood throughout	Remove due to construction
573	Shagbark Hickory	Carya ovata	38	F	2 stem at 1.1 metres	Remove due to construction
574	Shagbark Hickory	Carya ovata	47	F		Remove due to construction
575	Shagbark Hickory	Carya ovata	48	F		Remove due to construction
576	Shagbark Hickory	Carya ovata	50	F	Minor deadwood in canopy	Remove due to construction
577	Burr Oak	Quercus macrocarpa	63	F	Minor deadwood throughout	Remove due to construction
578	Basswood	Tilia americana	23	F	Mild to moderate lean, 2 stem at 0.3 metres	Remove due to construction
579	Basswood	Tilia americana	18	F		Remove due to construction
580	Burr Oak	Quercus macrocarpa	19	F		Remove due to construction
581	Shagbark Hickory	Carya ovata	19	F		Remove due to construction

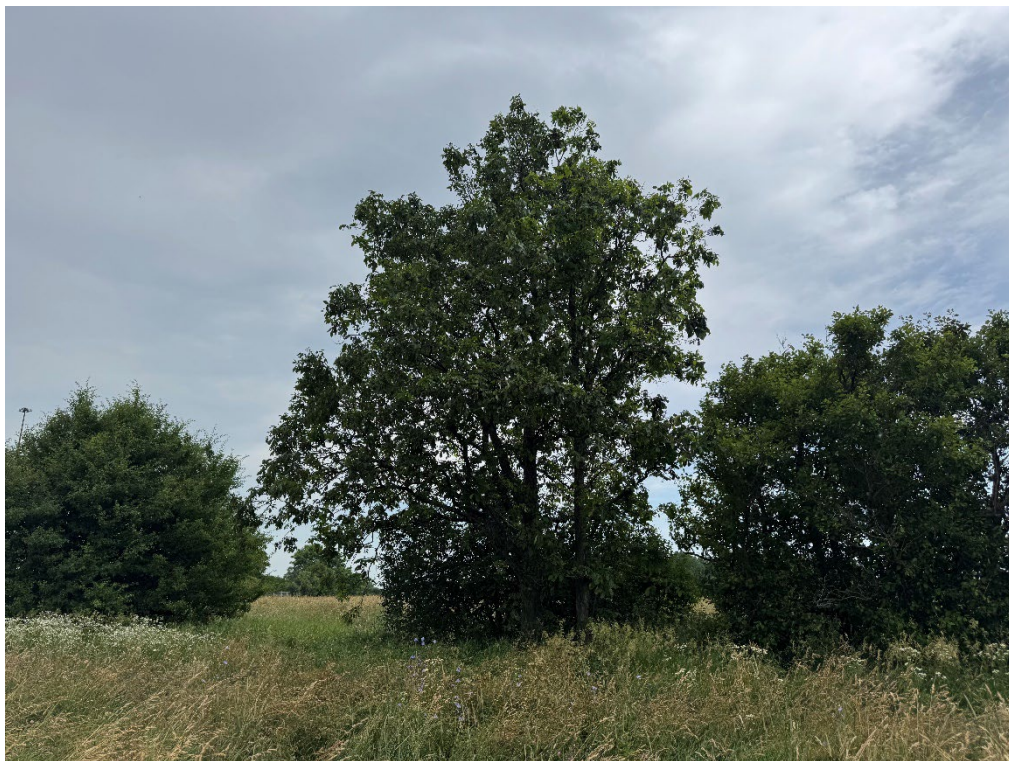
Trees 582, 583

582	Shagbark Hickory	Carya ovata	31	F		Remove due to construction
583	Shagbark Hickory	Carya ovata	46	F		Remove due to construction
584	Shagbark Hickory	Carya ovata	43	F		Remove due to construction
585	Shagbark Hickory	Carya ovata	34	F	Minor deadwood throughout	Remove due to construction
586	Shagbark Hickory	Carya ovata	52	F	Minor deadwood throughout, 3 stem at base	Remove due to construction
587	Shagbark Hickory	Carya ovata	67	F	Minor deadwood throughout	Remove due to construction
588	Shagbark Hickory	Carya ovata	43	F/P	Minor deadwood throughout, previous limb failures evident, 2 stem at 1.0 metre	Retain (injure)
589	Basswood	Tilia americana	19	F		Remove due to construction
590	Shagbark Hickory	Carya ovata	18	F		Remove due to construction

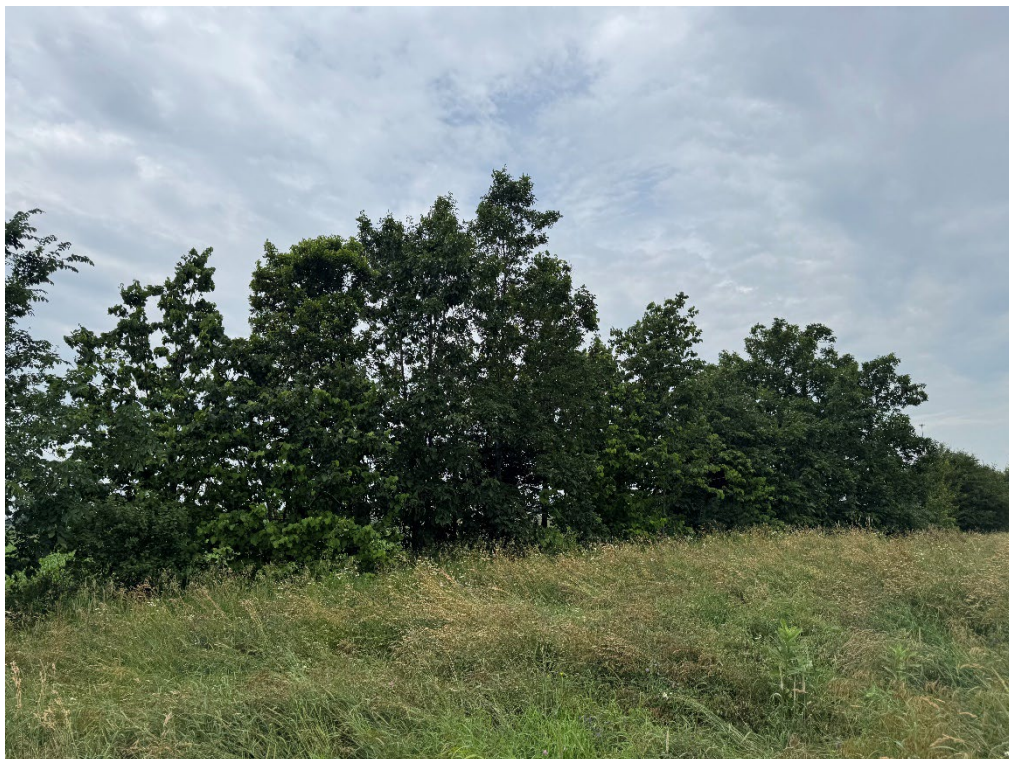
Trees 589 – 593, O6, O7

591	Shagbark Hickory	Carya ovata	15	F		Remove due to construction
592	Basswood	Tilia americana	15	F		Remove due to construction
593	Burr Oak	Quercus macrocarpa	23	F	Minor to moderate deadwood throughout	Remove due to construction
594	Shagbark Hickory	Carya ovata	31	F		Remove due to construction
595	Shagbark Hickory	Carya ovata	39	F	2 stem at 0.5 metres	Remove due to construction
596	Shagbark Hickory	Carya ovata	33	F		Retain
597	Shagbark Hickory	Carya ovata	44	F	Minor deadwood throughout	Remove due to construction
O6	Basswood	Tilia americana	~78	P	Suckers throughout, main leader previously failed, minor deadwood throughout	Retain (injure)
O7	Basswood	Tilia americana	18	F		Retain
O8	Burr Oak	Quercus macrocarpa	~72	F	Minor deadwood throughout	Retain (injure)
O9	Burr Oak	Quercus macrocarpa	~58	F/P	Moderate deadwood throughout	Retain (injure)
O10	Shagbark Hickory	Carya ovata	37	F		Retain
O11	Burr Oak	Quercus macrocarpa	84	F	Minor to moderate deadwood throughout, cavity at base on northwest side of tree	Retain (injure)
