ARBORIST REPORT AND TREE PRESERVATION PLAN

580 Hazelhurst Road, Mississauga, Ontario

Project No.: 25-1071

Date: November 12, 2025

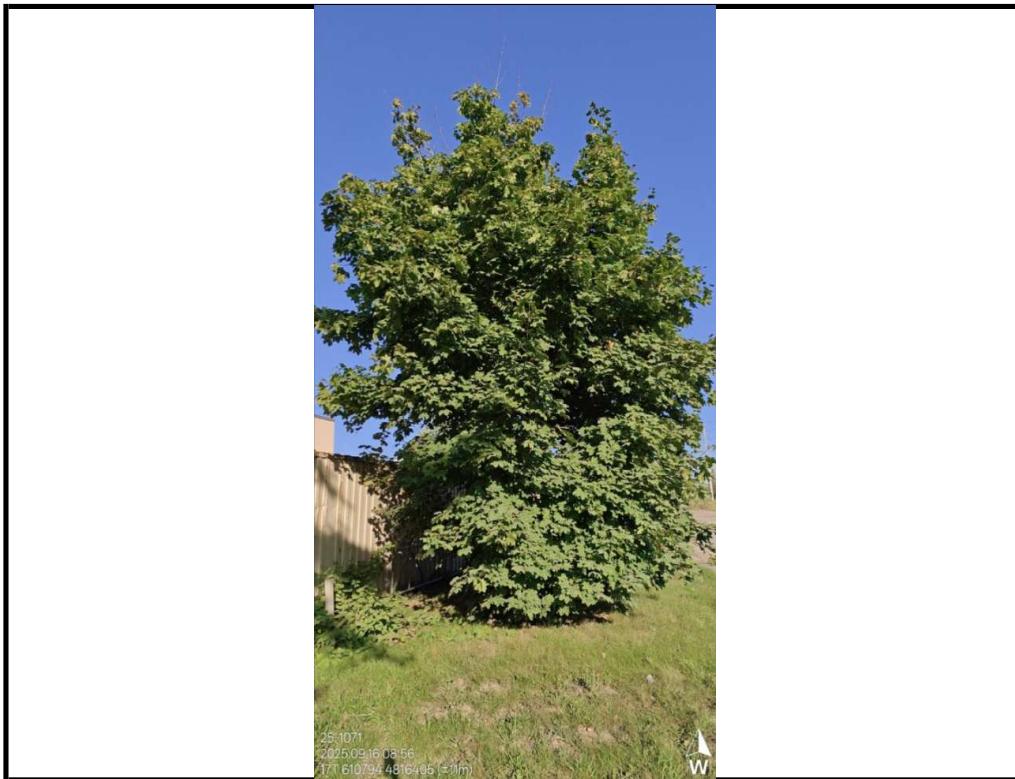
Tree # 119

119	ACERPLA	<i>Acer platanoides</i>	Norway Maple	3	38, 23, 11	46	F	F	G	G	Tar spots	<10%	8	4	3	0%	Pu	Boulevard	Retain	Frost crack										
120	ACERSAC	<i>Acer saccharinum</i>	Silver Maple	3	48, 20, 14	54	G	P	G	F		<10%	11	7	3.6	0%	Pu	Boulevard	Retain	Growing through fence										
121	FRAXAME	<i>Fraxinus americana</i>	White Ash	3	8, 6, 6	12	P	p	G	P		<10%	5	2	1.5	100%	Pu	Boundary	Remove	Growing through fence, lots of silt on leaves from trucks										
122	ACERSAC	<i>Acer saccharinum</i>	Silver Maple	3	26, 25, 24	43	F	G	G	G		<10%	13	7	3	54%	Pu	Boundary	Remove	Codominant trunk with weak Union										
123	ACERSAC	<i>Acer saccharinum</i>	Silver Maple	2	29, 9	30	G	G	G	G		<10%	14	5	3.6	100%	Pr	Development Site	Remove	100% encroachment, within proposed concept plan										
124	ACERSAC	<i>Acer saccharinum</i>	Silver Maple	2	37, 30	48	G	G	G	G		<10%	14	7	6	86%	Pr	Development Site	Remove	86% encroachment, within proposed concept plan

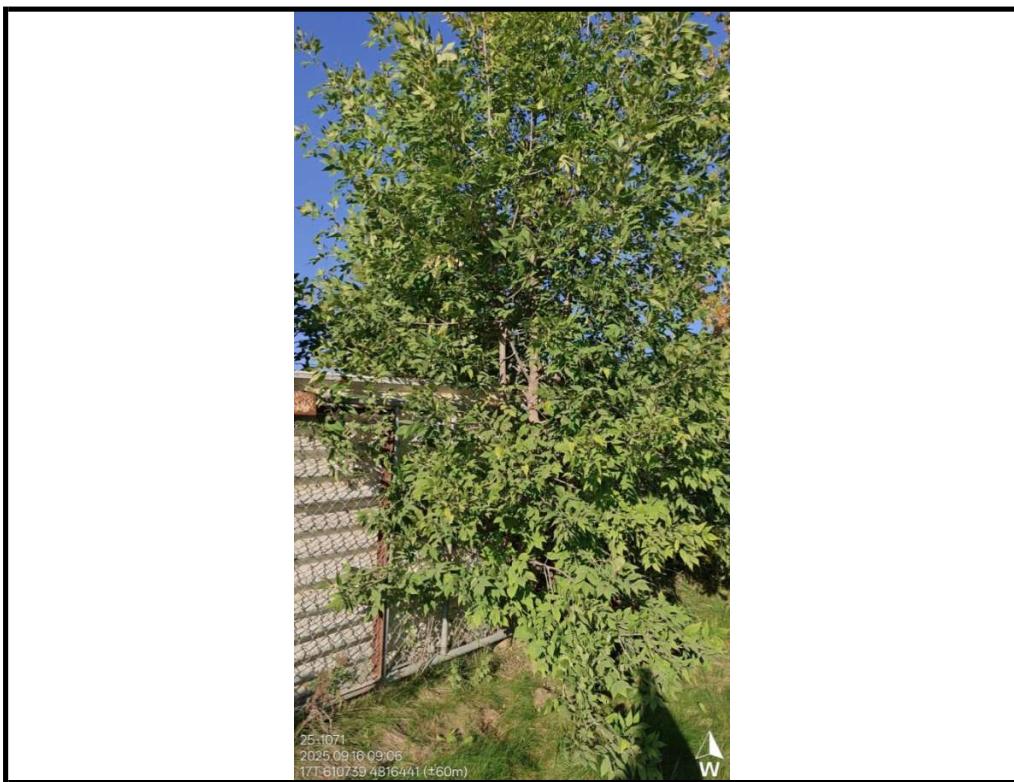
Tree # 121

TREE ID	DBH (CM)*	OVERALL TREE CONDITION	REPLACEMENT TREES REQUIRED
121	12	Poor	0
122	43	Good	3
123	30	Good	2
124	48	Good	4
125	23	Poor	2
126	20	Dead	0
128	22	Good	2
129	37	Good	3
130	16	Dead	0
145	62	Dead	0
161	10	Good	0
162	12	Poor	0
TOTAL:			16

Based on the location of trees relative to the proposed Concept Plan, 12 individual trees (Trees 121, 122, 123, 124, 125, 126, 128, 129, 130, 145, 161 and 162) are proposed for removal to permit construction activities. The trees proposed for removal are indicated on **Figure 2** and on the tree inventory chart in **Appendix A**. Of the 12 trees proposed for removal, three (3) are in poor condition, six (6) are in good condition and three (3) are dead. Tree 145 has an encroachment percentage of 15%; however, this tree is proposed to be removed due to its poor condition and potential to fall.

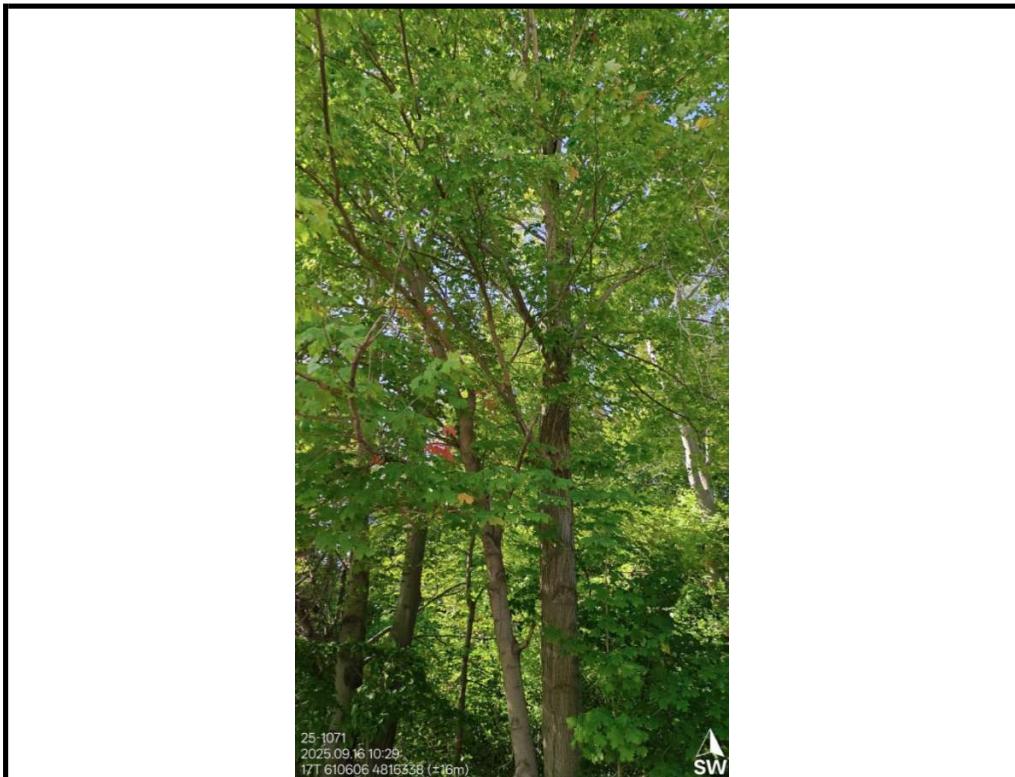
Tree # 133

TREE NO.	SPECIES	DBH (CM)	CONDITION	PERCENT ENCROACHMENT INTO TPZ	RECOMMENDED ACTION
133	Sugar Maple	49	The tree has two stems and is in good condition with less than 10% deadwood.	1%	Retain and protect with specific preservation methods #1 to 5 (Table 6-3).
137	American Beech	64	The tree has frost cracks and is in good condition with less than 10% deadwood with no indication of Beech Bark Disease.	1%	Retain and protect with specific preservation methods #1 to 5 (Table 6-3).
138	Eastern Hemlock	51	The tree is in good condition with less than 10% deadwood.	3%	Retain and protect with specific preservation methods #1 to 5 (Table 6-3).

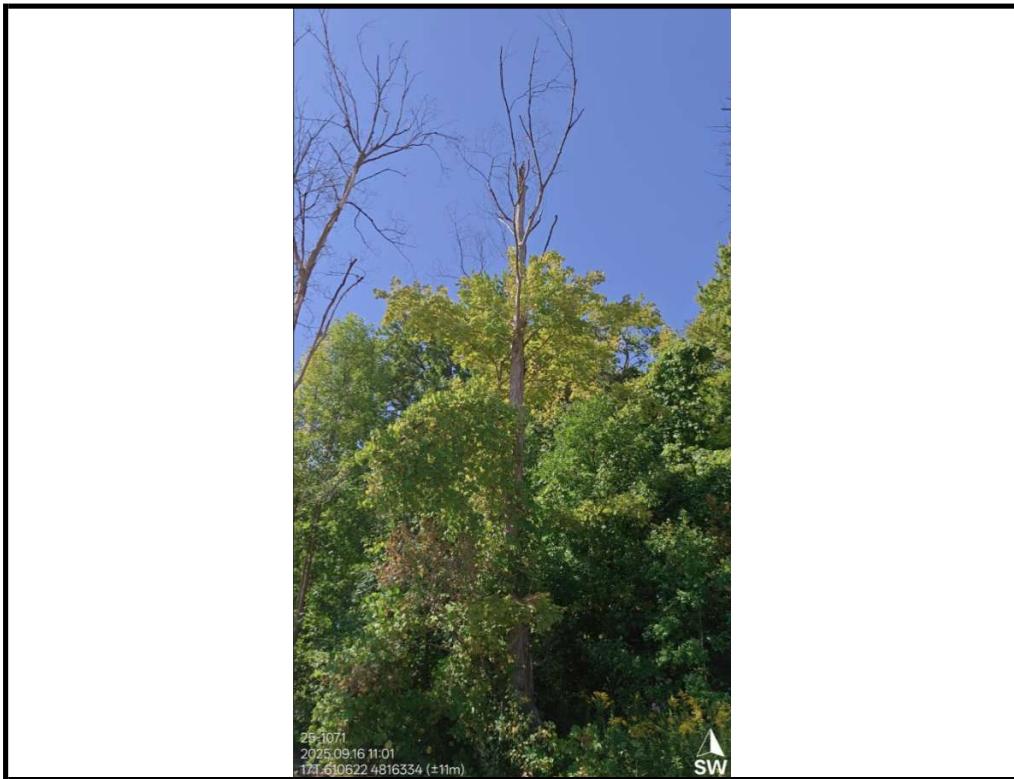
Tree # 143

TREE NO.	SPECIES	DBH (CM)	CONDITION	PERCENT ENCROACHMENT INTO TPZ	RECOMMENDED ACTION
143	Sugar Maple	44	The tree is in poor condition with a broken top and 30% deadwood. Gravel/grading is present at the base of the tree.	3%	Retain and protect with specific preservation methods #1 to 5 (Table 6-3).
148	Sugar Maple	41	The tree is in poor condition with a broken top and 25% deadwood. Equipment damage is present at the base of the trunk with gravel present at the base of the tree.	7%	Retain and protect with specific preservation methods #1 to 5 (Table 6-3).

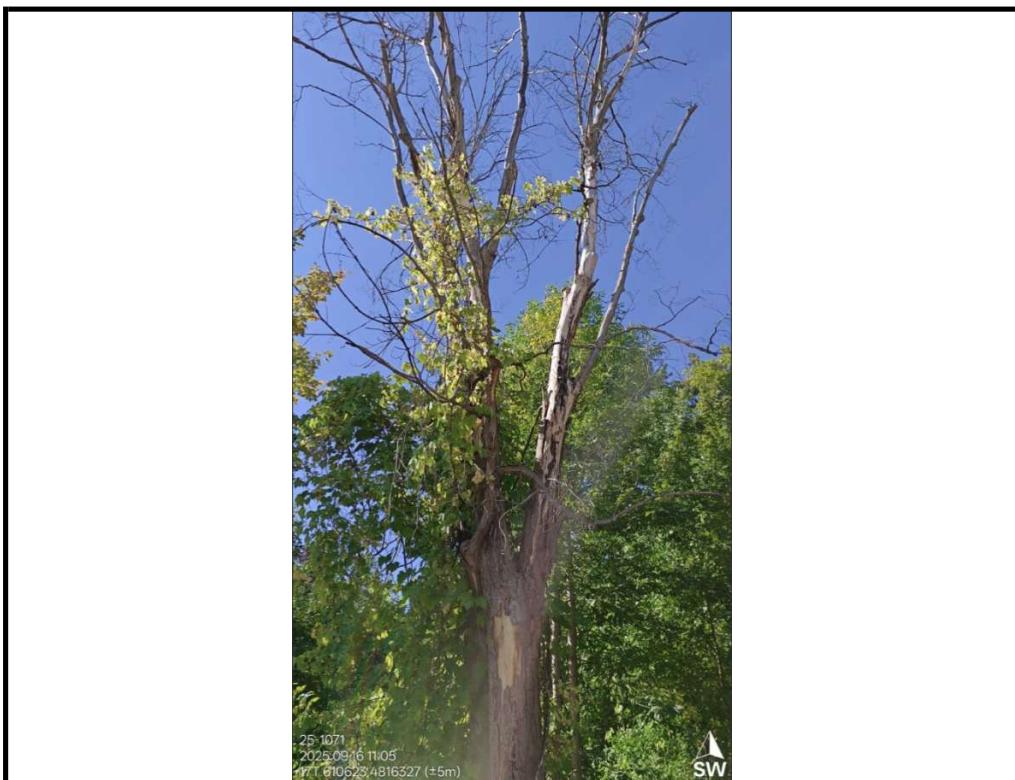
Tree # 145

145	ACERSAS	<i>Acer saccharum</i>	Sugar Maple	1	62	62	D	D	D	D		100%	20	8	8.4	15%	Pr	Boundary	Remove	Hazard to development due to potential to fall										
146	FRAXAME	<i>Fraxinus americana</i>	White Ash	2	17, 14	22	F	G	G	F		<10%	14	3	3.6	0%	Pr	Neighbouring Site	Retain	Trunk wound from deer browse										
147	FRAXAME	<i>Fraxinus americana</i>	White Ash	2	15, 9	18	G	G	G	G		<10%	14	3	2.4	0%	Pr	Neighbouring Site	Retain											
148	ACERSAS	<i>Acer saccharum</i>	Sugar Maple	1	41	41	P	P	F	P		25%	14	2	6	7%	Pr	Boundary	Retain with specific measures	Broken top with deadwood at top, equipment damage at base of trunk, gravel up to base of trunk										
149	FRAXAME	<i>Fraxinus americana</i>	White Ash	2	10, 9	14	P	F	G	P		<10%	10	2	2.4	0%	Pr	Neighbouring Site	Retain	Trunk grown into concrete cylinder, now a wound

- It is anticipated that written consent will be required for the proposed removal of Tree 145, located on the shared Site boundary and/or neighbouring property. Requirements for trees on neighboring properties are to be confirmed by the City of Mississauga.

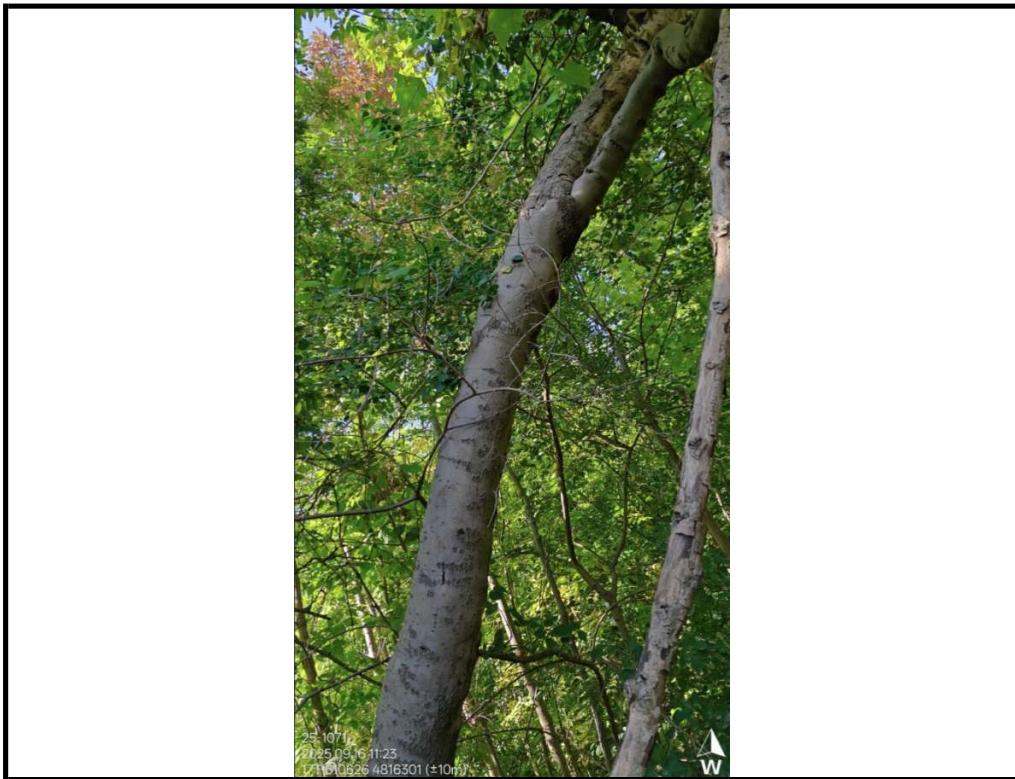
Tree # 151

150	FRAXAME	<i>Fraxinus americana</i>	White Ash	1	11	11	G	G	G	G	<10%	12	2	2.4	0%	Pr	Neighbouring Site	Retain														
151	FAGUGRA	<i>Fagus grandifolia</i>	American Beech	1	27	27	D	D	D	D	100%	5	0	3.6	0%	Pr	Neighbouring Site	Retain	Died Beech Bark Disease, falling over with a 40% lean to north													
152	TSUGCAN	<i>Tsuga canadensis</i>	Eastern Hemlock	1	22	22	G	G	G	G	<10%	12	3	3.6	0%	Pr	Neighbouring Site	Retain														
153	ACERSAS	<i>Acer saccharum</i>	Sugar Maple	1	54	54	G	P	P	P	70%	18	3	7.2	0%	Pr	Neighbouring Site	Retain	Dead, broken top, shedding bark, with Woodpecker cavities 14 m up													
154	FAGUGRA	<i>Fagus grandifolia</i>	American Beech	1	10	10	P	P	F	P	20%	7	2	2.4	0%	Pr	Neighbouring Site	Retain	Deformed branching grape on trunk													
155	FAGUGRA	<i>Fagus grandifolia</i>	American Beech	1	23	23	G	F	F	F	20%	15	7	3.6	0%	Pr	Neighbouring Site	Retain	30% lean to the east (into the site)
