Soil Engineers Ltd.

Reference No. 2006-S167

**Re: A Slope Stability Assessment for
Proposed Residential Development
44-45 Longview Place
City of Mississauga**

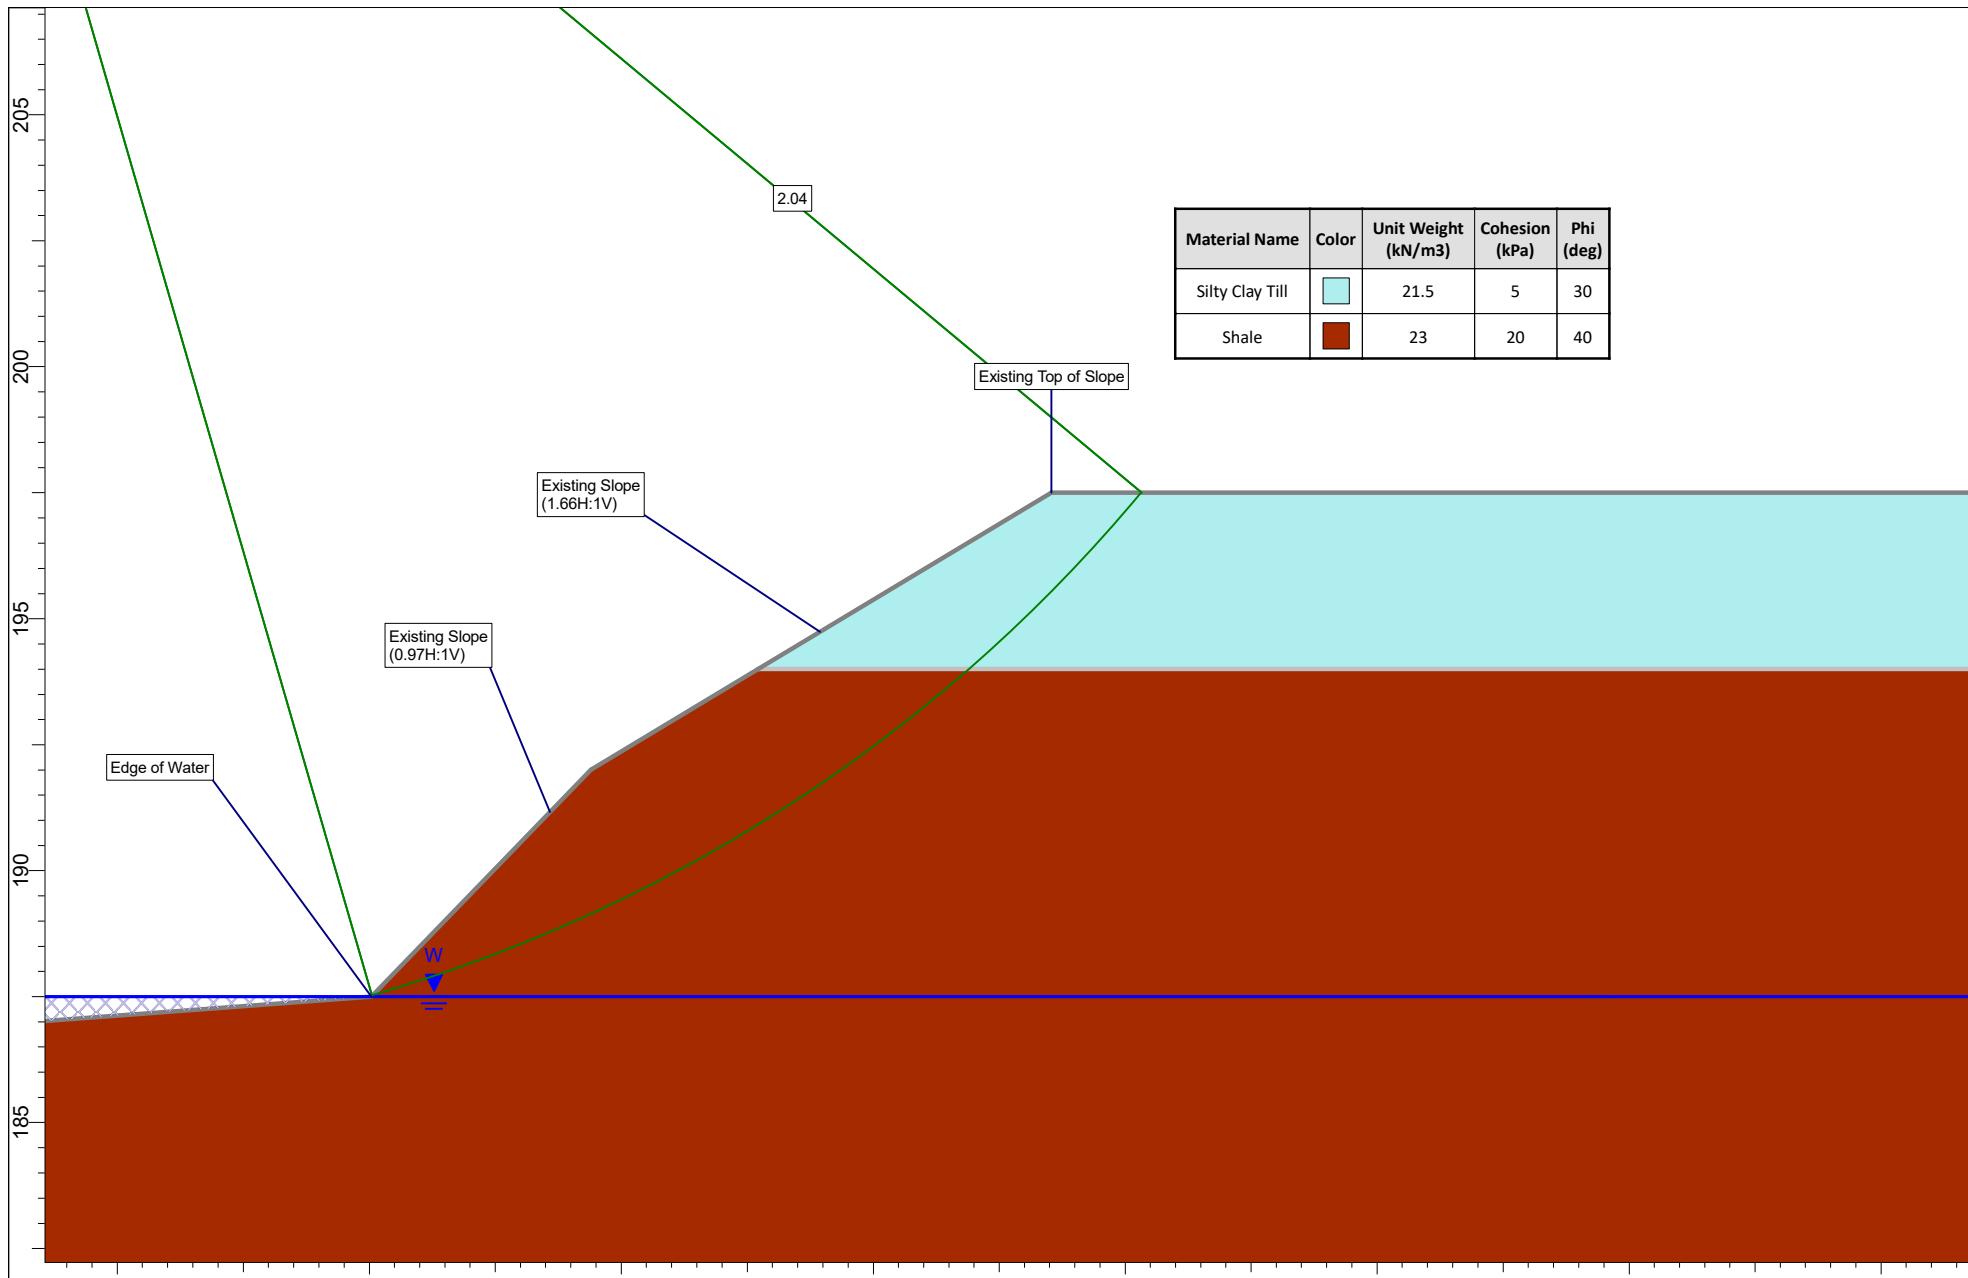
Project Title			Load Case
Slope Stability Assessment - Cross Section A-A			Existing Condition
Location			44-45 Longview Place, City of Mississauga
Drawn By	P.K.	Checked By	Scale
		K.L.	1:150
Date	April 2025	Reference No.	Revision
		2006-S167	-
			Drawing No.
			2

The resulting FOS of the analyses at Cross-Sections A-A, B-B and C-C at existing conditions meet the Ontario Ministry of Natural Resources (OMNR) and the Credit Valley Conservation (CVC) guideline requirements (minimum FOS of 1.5). In addition, the resulting FOS for all cross-sections also meet the required FOS under elevated groundwater condition (minimum FOS of 1.3). The results are presented in Drawing Nos. 2 to 7.

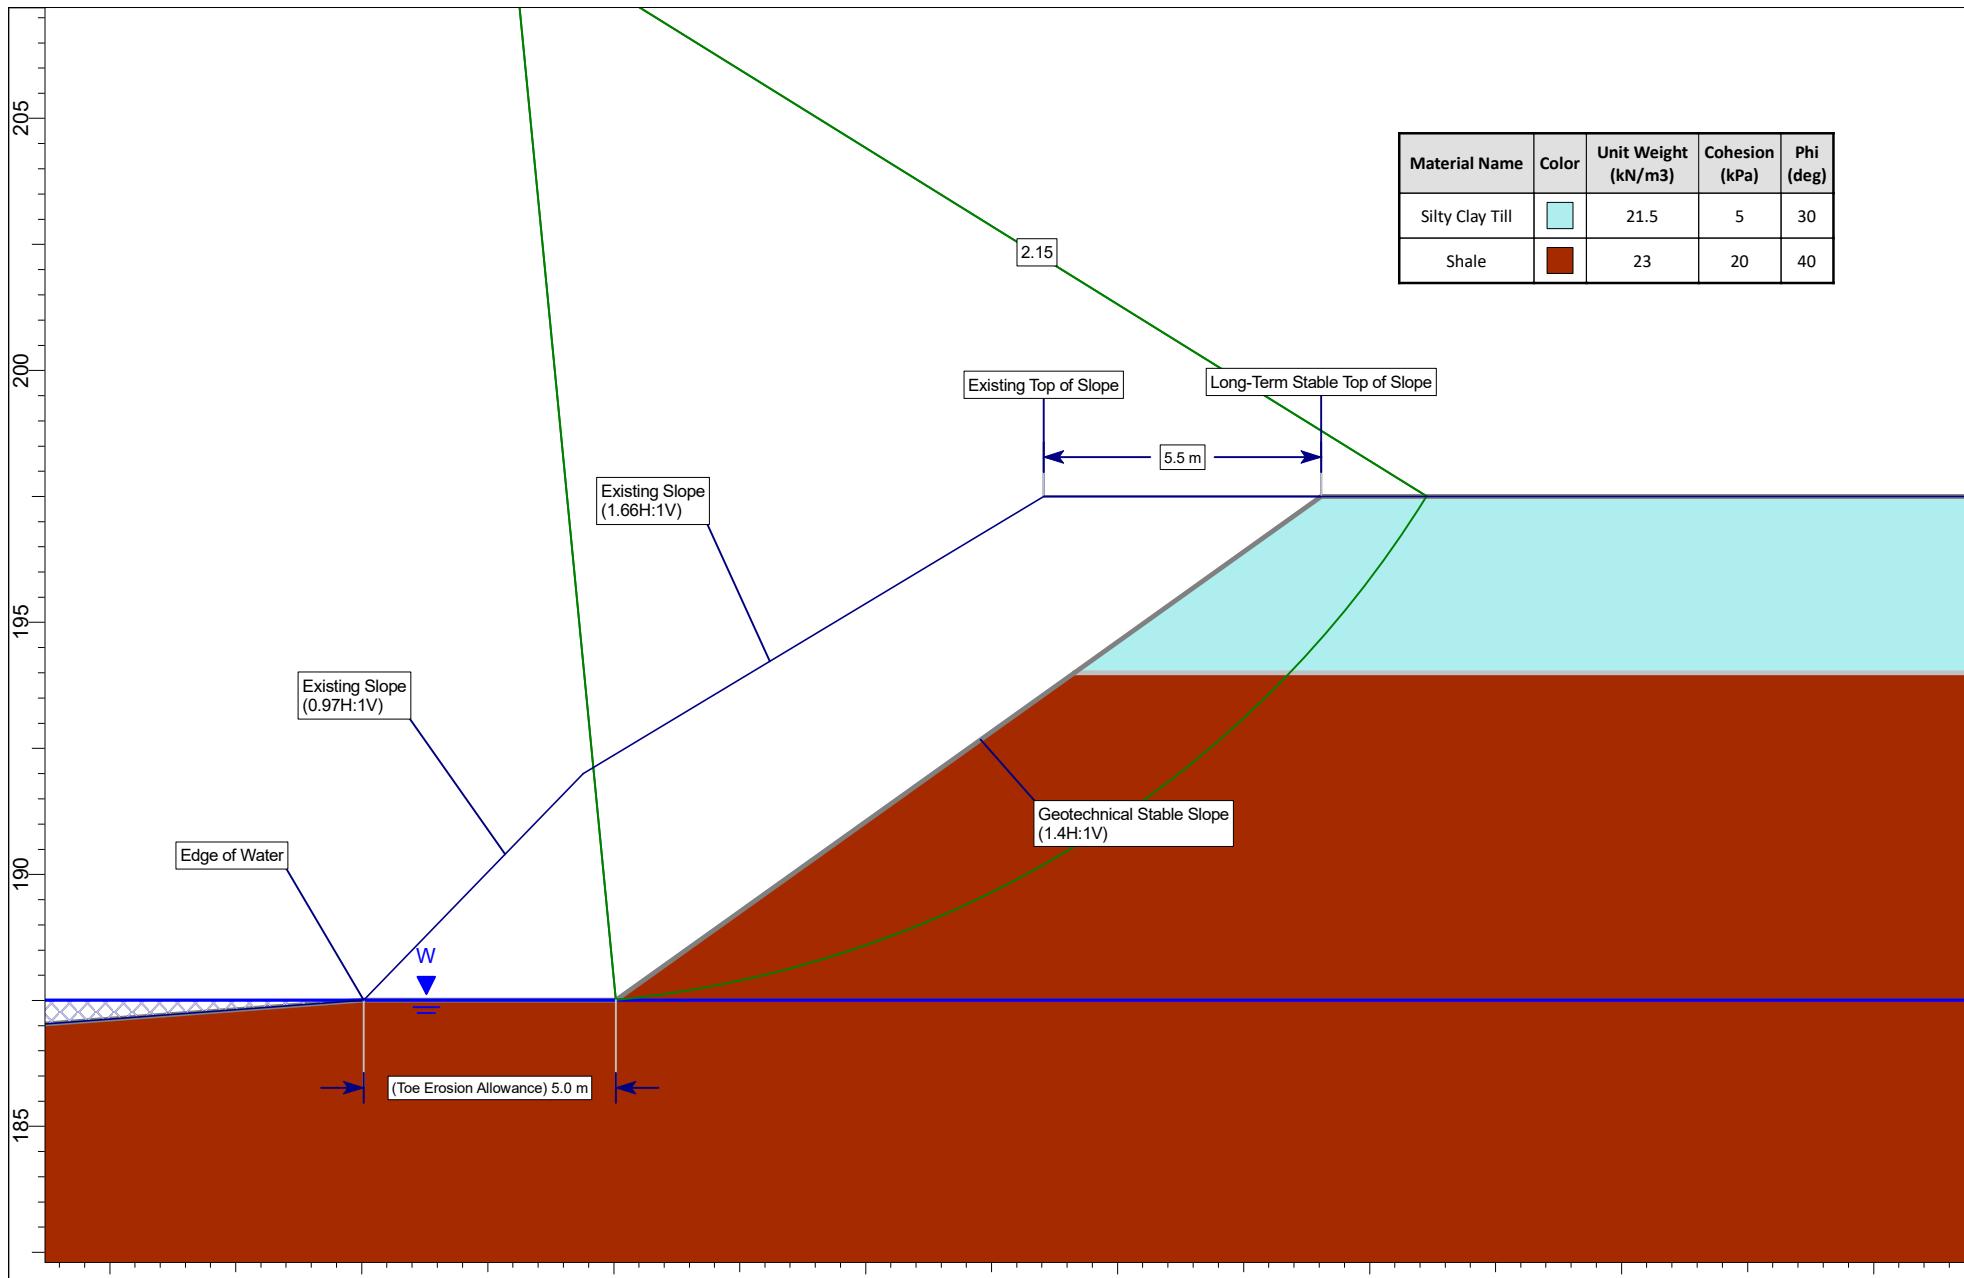
Based on the OMNR guideline requirement, a T.E.A. of 5.0 m will be required from the edge of water for the disclosed soil/rock types. After applying the T.E.A., the cross-sections were subsequently re-analysed using remodelled stable slope gradient of 1.4H:1V for both the shale bedrock and the silty clay till. The resulting FOS of Cross-Sections A-A, B-B and C-C meet the OMNR guideline requirement (min FOS of 1.5 and 1.3) under normal water condition and elevated groundwater condition, respectively. The analytical results for the geotechnically stable condition are presented on Drawing Nos. 8 to 13 and are summarized in the following table. The resulting LTSTOS is also illustrated on Drawing No. 1.

Cross-Sections	FOS (normal water condition)	FOS (elevated water condition)
A-A	2.15	1.63
B-B	2.28	1.73
C-C	2.13	1.58
