# Credit River Erosion Control Project Behind Kenninghall Blvd and Plainsman Rd

Municipal Class Environmental  
Assessment

**Public Information Centre**

Date: February 2026

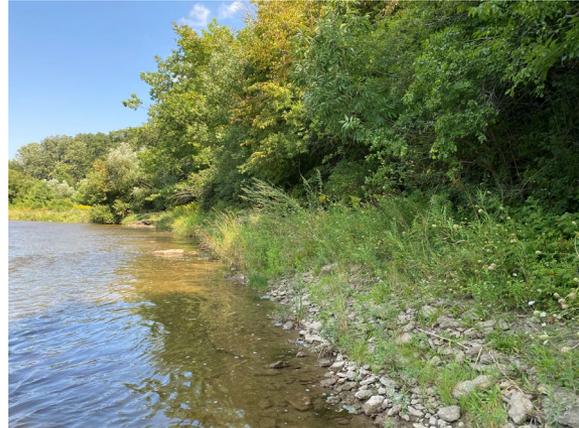
Stable toe of valley slope behind St. Ives Way.

- Previously identified as CRAMS Erosion Site 7
- ES-1 is located along the outside of a meander bend where it contacts the valley wall
- Approximately 250 m in length
- No erosion protection
- No evidence of active erosion
- Secondary channel in upstream portion of site that travels along the toe of valley wall, but potential hazard is apparently decreasing over time as suggested by the channel width decrease from 14 m to <3 m between 1954 and 2022

**Hazard Level: 2**

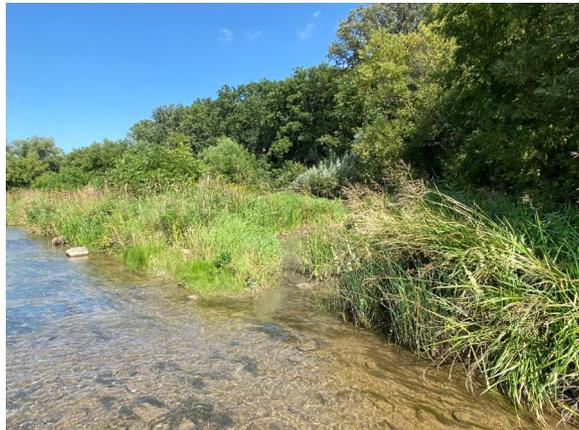
Outlet of secondary channel near toe of valley slope

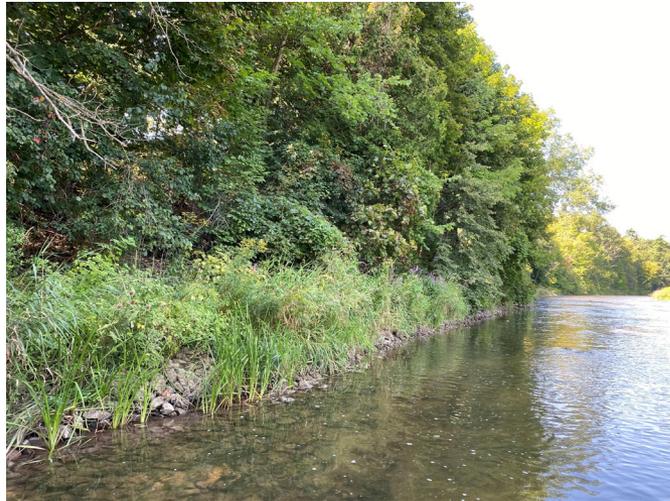
Gabion protected toe of valley wall behind properties along Shady Lawn Court

- Previously identified as CRAMS Erosion Site 6A
- Straight section of channel with gabion installed along toe of valley wall
- Gabion wire in frequent contact with flow was mostly missing, but there was no notable displacement of gabion stone
- Erosion protection continues to be effective

**Hazard Level: 2**

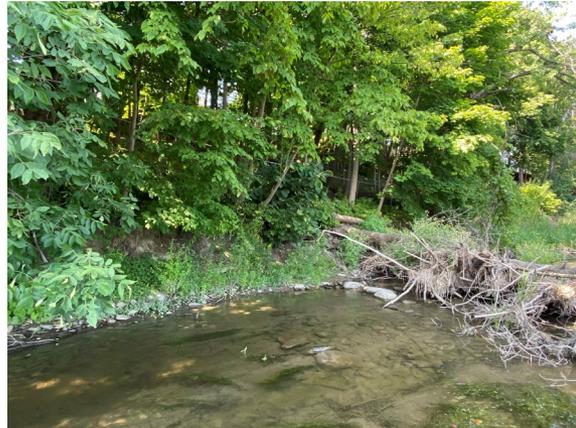
Eroding toe of valley wall at 19  
Plainsman Road

- Previously identified as CRAMS Erosion Site 6B
- Located along the outside of a low-radius meander bend
- Observations limited to two properties as most are non-participating properties along Plainsman Road
- Erosion and toe instability were observed at 19 Plainsman Road

**Hazard Level: Not assessed  
due to limited observations**

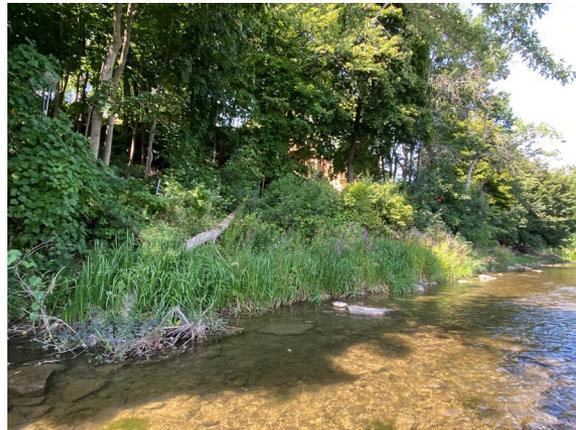
Natural toe protection with  
vegetated shale shelf at 21  
Plainsman Road

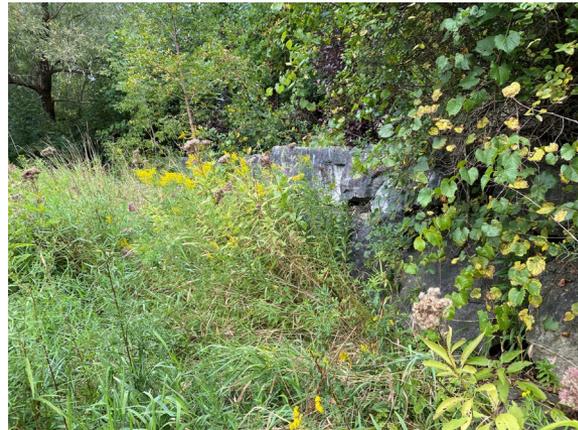
Armourstone retaining wall  
between secondary channel and  
Culham Trail

- Previously identified as CRAMS Erosion Site 5B
- 50 m long, ~1.5 m high armourstone retaining wall to support Culham Trail
- Minimum separation of 2 m between wall and secondary channel
- Width of secondary channel has decreased from 11 m to 3.0 between 1954 and 2022, suggesting decreasing hazard over time

**Hazard Level: 3**

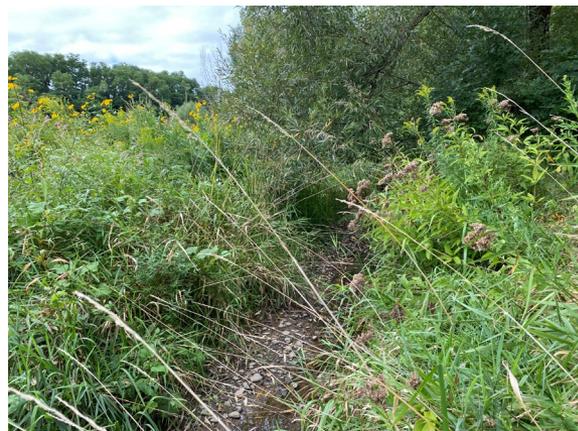
Secondary channel adjacent to  
armourstone wall

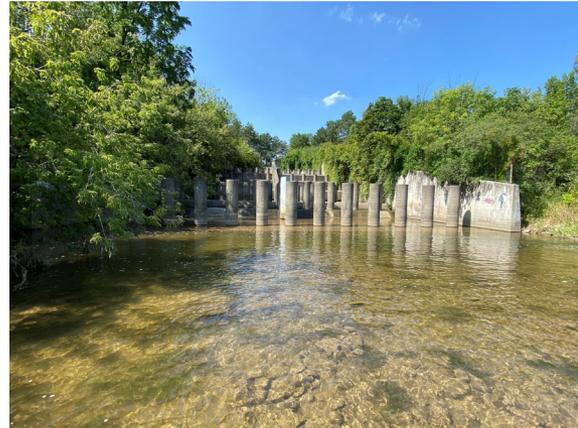
Mullet Creek diversion outlet structure in Riverrun Park

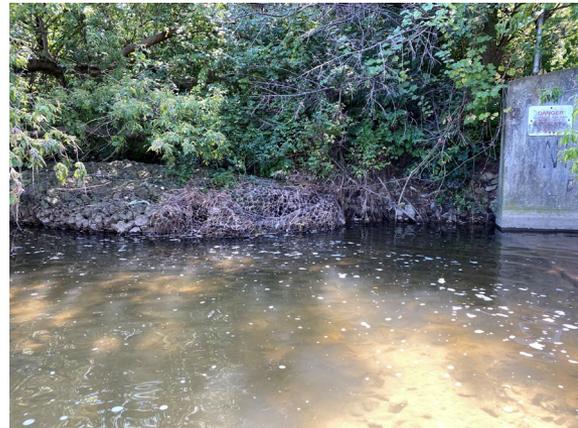
Failed gabion on south bank at end of outlet structure

- Previously identified as CRAMS Erosion Site 5A
- Undermined gabion erosion protection due to bed scouring resulting in collapse

**Hazard Level: 4**

- Erosion Site 5 - a failed gabion at the outlet of the Mullet Creek diversion structure
- Erosion Site 8 - 100 m of failing gabion at the toe of an armoured valley wall behind the residential properties at the end of Rapallo Mews
- Erosion Site 12 – a failed bed scour protection at a storm sewer outfall in Pinecliff Park

- Bioengineering in the form of a vegetated rock buttress will be constructed to protect the exposed toe of valley wall at Erosion Site 7 and to replace the failing erosion protection measures along the storm sewer outfall channel at Erosion Site 9 and failing gabion at Erosion Site 5.
- At Erosion Sites 9 and 12, the armourstone at Erosion Site 9 will be re-used to construct a drop structure at the end of each outfall structure to prevent bed scouring and headwall undermining.
- At Erosion Site 8, the gabion at the toe of the armoured valley wall will be repaired with the installation of new gabion wire on the damaged face to contain the gabion stone. If any displaced gabion stone needs to be replaced, it can be sourced from Erosion Site 9 or Erosion Site 5.

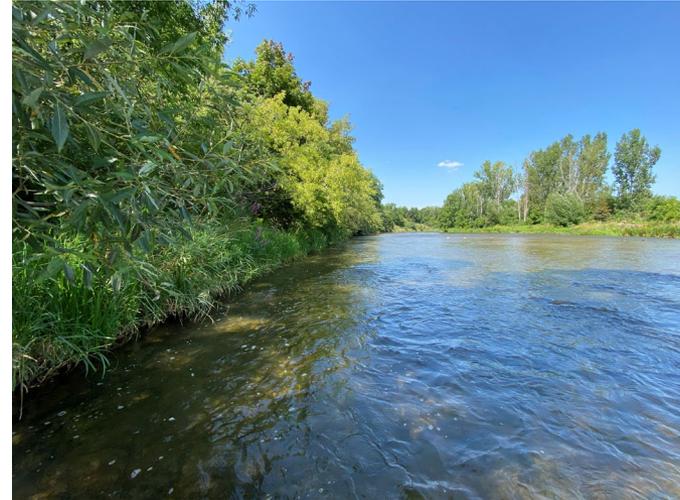
Gabion and vegetation along toe of valley wall behind Hyde Mill Crescent

- Straight section of channel with 130 m of gabion installed along toe of valley wall
- Gabion wire in frequent contact with flow was partially missing, but there was no notable displacement of gabion stone
- Erosion protection continues to be effective

**Hazard Level: 2**

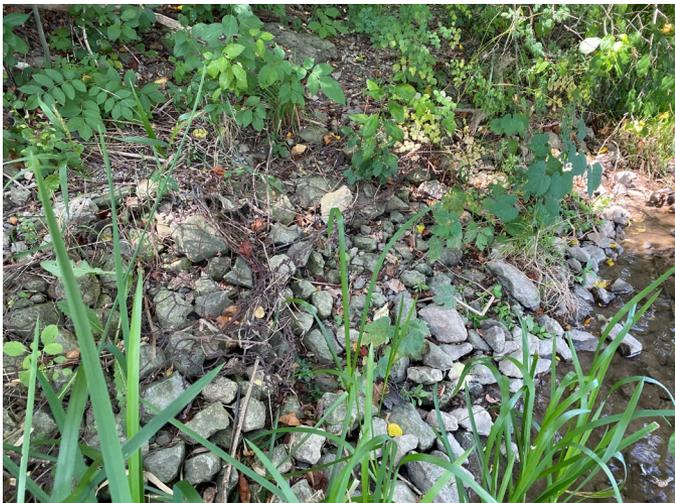
Gabion wire in poor to good condition at toe of valley wall

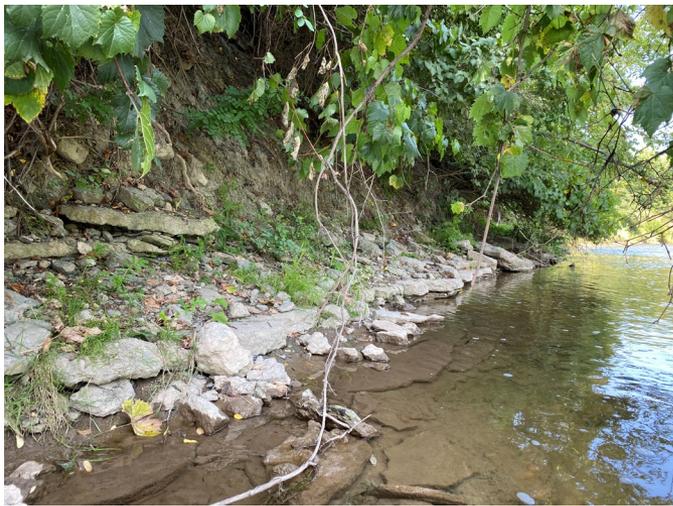
- Unprotected valley wall approximately 35 m in length behind Hyde Mill Crescent
- Toe is eroded and steepened
- Lower portion of toe is comprised of shale, which offers erosion protection only during periods of low-flow
- Less than 20 m between Hyde Mill Crescent properties and toe of valley wall

**Hazard Level: 5**

Eroded toe of valley wall

- Erosion Site 7 - 33 m of eroded toe of valley wall creating a risk to residential properties along Hyde Mill Crescent
- Erosion Site 9 - a storm sewer outfall and channel, between Rapallo Mews and Colbert Gardens, with failed bank armoring that has resulted in erosion into private property

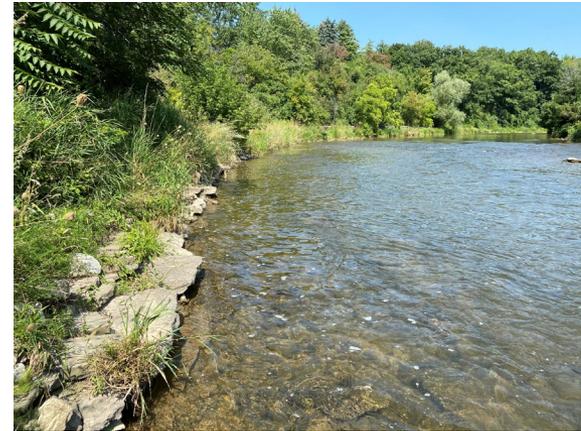
Exposed shale under gabion toe

- Existing City monitoring site
- 100 m of gabion protecting valley wall near apex of meander bend
- Gabion at toe in poor condition with stone loss
- Gabion sits atop shale which provides erosion resistance

**Hazard Level: 4**

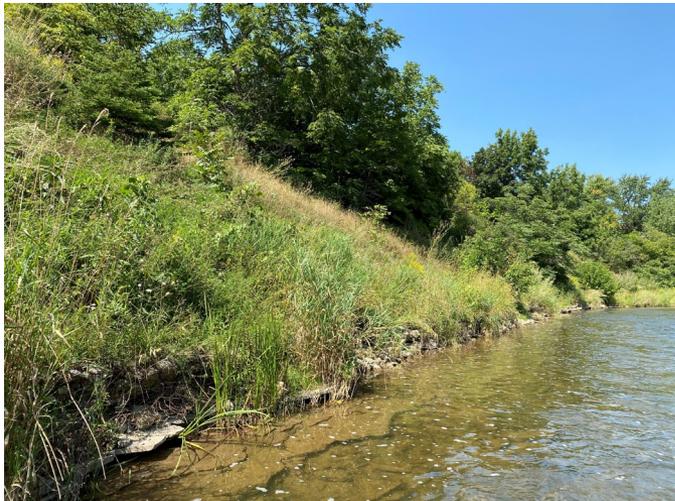
Gabion protected valley wall behind Rapallo Mews

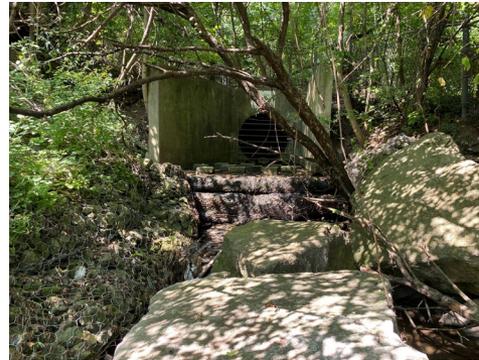
- Existing City monitoring site
- Bed scouring of storm sewer outfall channel resulted in armourstone wall undermining and failure
- The armourstone wall protected the adjacent private property
- Outfall channel is in generally poor condition

**Hazard Level: 5**

Storm sewer outfall and failed armourstone wall

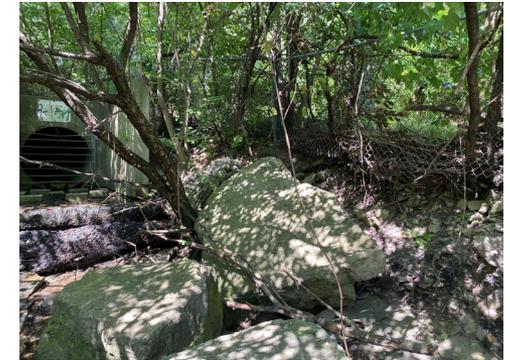
Failed armourstone wall at private property line

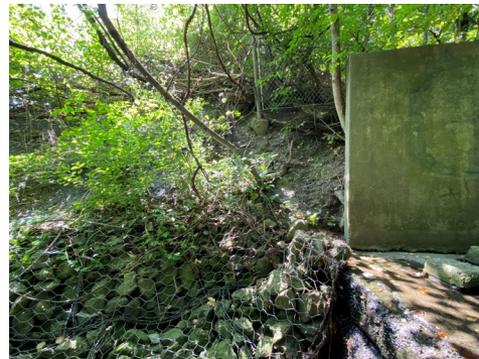
Erosion behind gabion slope protection

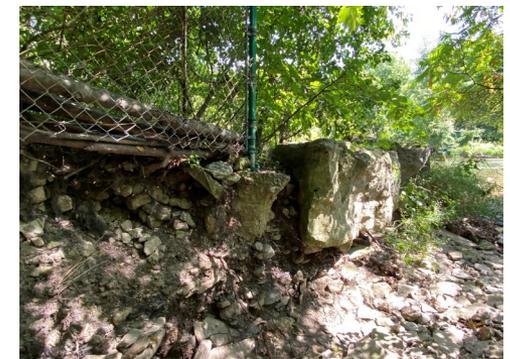
Failed armourstone wall and undermined fence

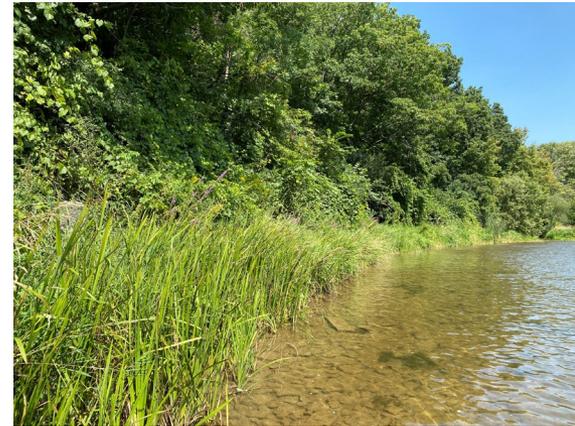
Unprotected valley wall behind  
Kenninghall Boulevard

- Previously identified as CRAMS Erosion Site 4
- Armourstone along the toe of valley wall was in good condition with no contact with flow
- The unprotected portion of valley wall just upstream of the meander bend apex shows no evidence of erosion

**Hazard Level: 1**

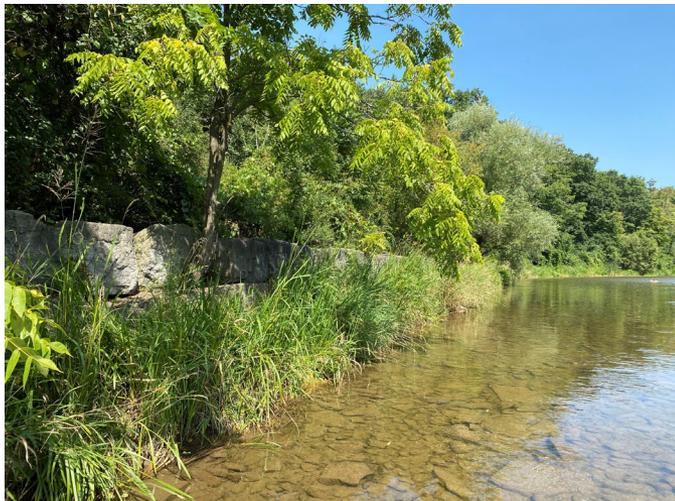
Armourstone toe protection behind  
Colbert Gardens

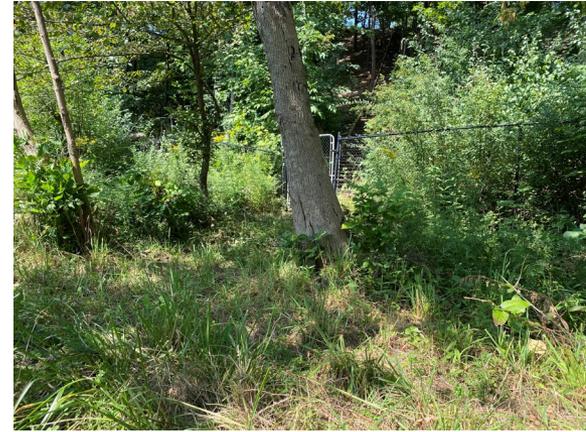
Vegetated buffer between channel and toe of slope

- Existing City monitoring site
- Secondary channel width decreased from 8.5 m to 5.5 m between 2005 and 2022 suggesting decreasing hazard to properties
- Fine bed materials in secondary channel indicates low erosive forces

**Hazard Level: 2**

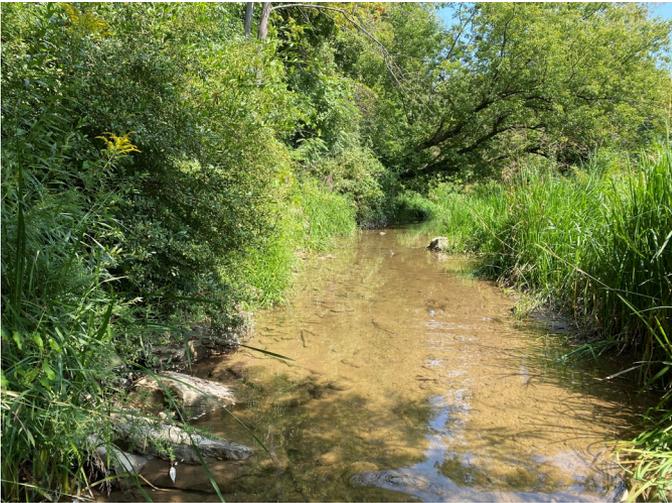
Low-energy secondary channel behind Kenninghall Boulevard

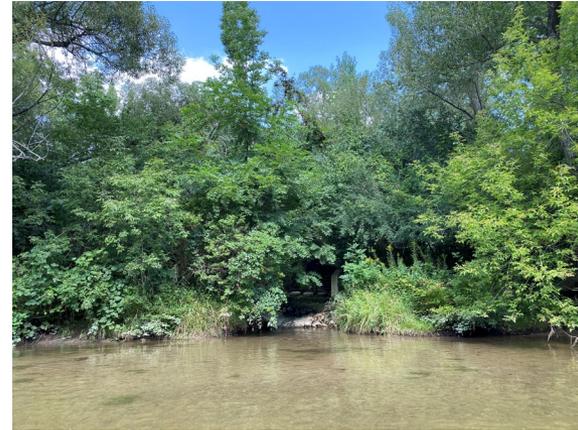
Storm sewer outfall structure at main channel

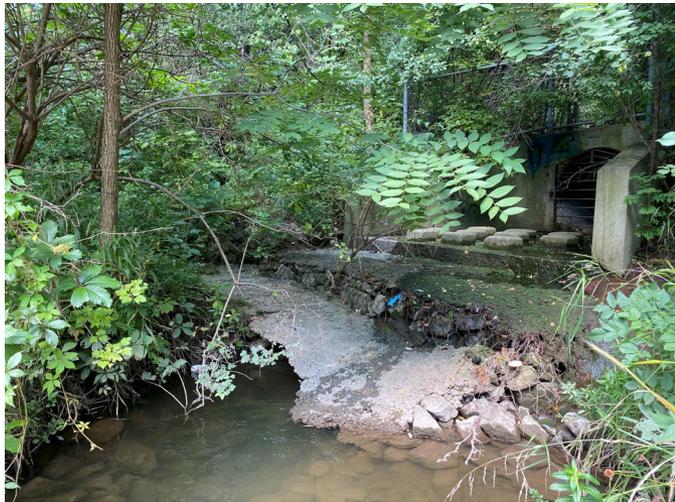
Storm sewer outfall with failed bed scour protection and possible undermining

- Existing City monitoring site
- Bed scour protection at the end of the storm sewer outfall structure has failed
- Potential for structure undermining with further deterioration of bed scour protection

**Hazard Level: 4**

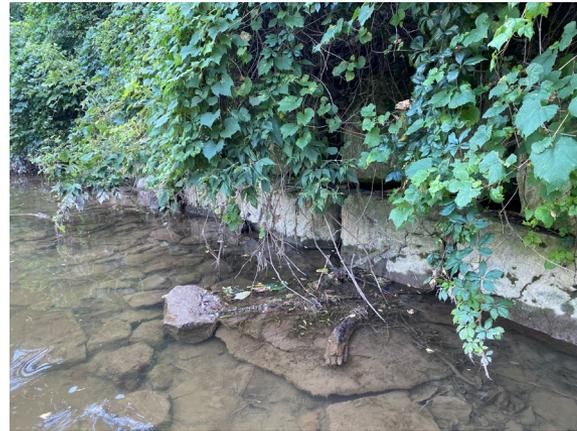
Armourstone in good, stable condition

- Previously identified as CRAMS Erosion Site 3
- Approximately 300 m of armourstone was installed to protect properties along Hollywell Avenue
- There was no apparent armourstone displacement

**Hazard Level: 1**

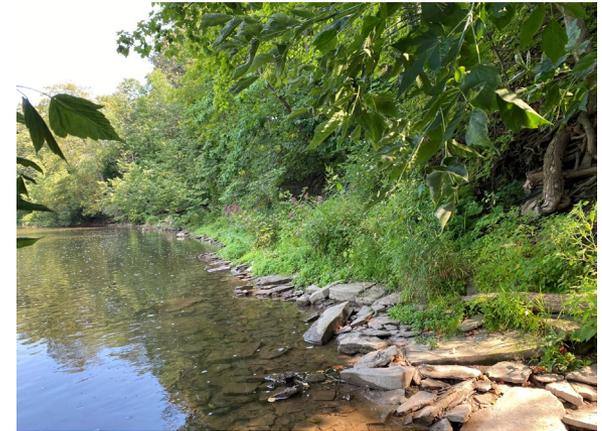
Toe of valley wall upstream of armourstone

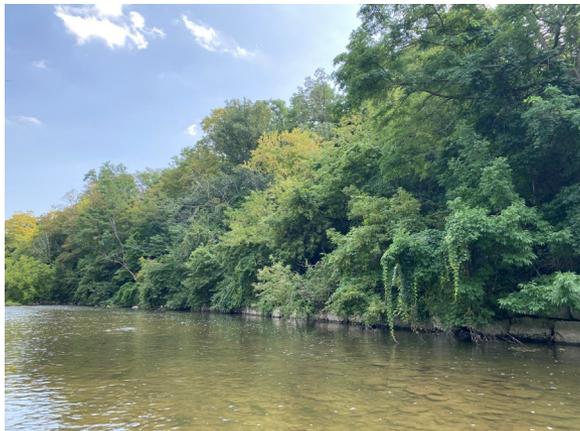
Armourstone toe protection along valley wall
