ARBORIST REPORT

Chelsea on the Green | Limited Partnership PHASE 2

4100 Pony Trail Drive and 1850 Rathburn Road East
Mississauga, Ontario

December 3, 2025

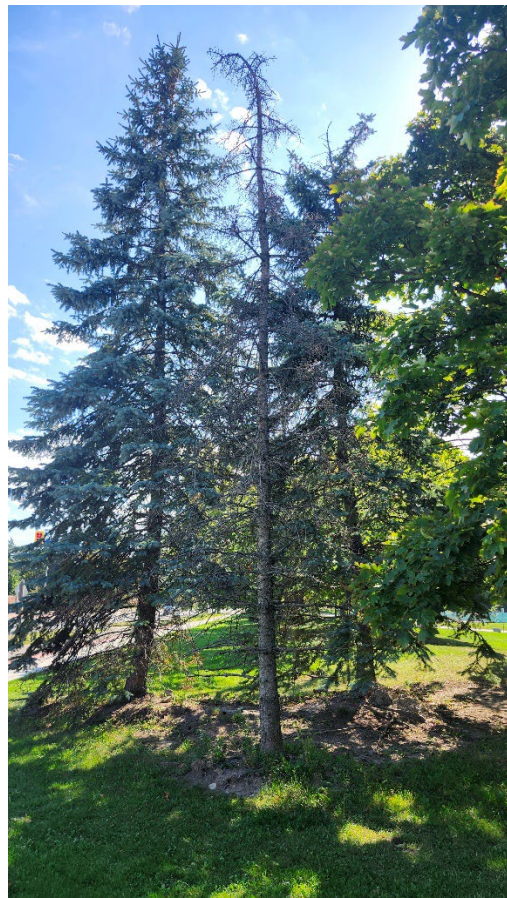
Figure 8: Trees 36 to 38.

#36, 39, 49, 71, 109, 119, 132 and 135. A total of 8 trees.

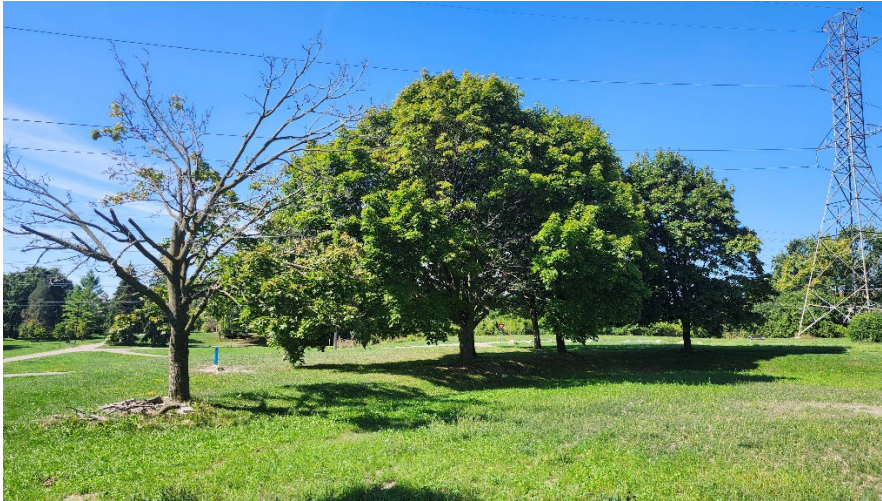
108	Acer platanoides (Norway Maple)	42.3	11	M	M	RC	Multi-branch node and wounds on surface roots.	S
109	Acer platanoides (Norway Maple)	34.5	7.5	L	L	R	Backfilled, canopy 80% dead and large limbs dead throughout.	S
110	Acer platanoides (Norway Maple)	56.7	14	M	M	RC	Approximately 10 medium-sized dead branches, wounds on surface roots, small girdling roots, large wound below main branch union of 30% trunk circumference, multi-branch node and wound at main branch union.	S
111	Acer platanoides (Norway Maple)	40.9	8	M	M	RC	Multi-branch node, girdling roots, approximately 3 medium-sized dead branches and tight branch union.	S

Figure 22: Tree 109 on left and trees 110 to 114 on right.

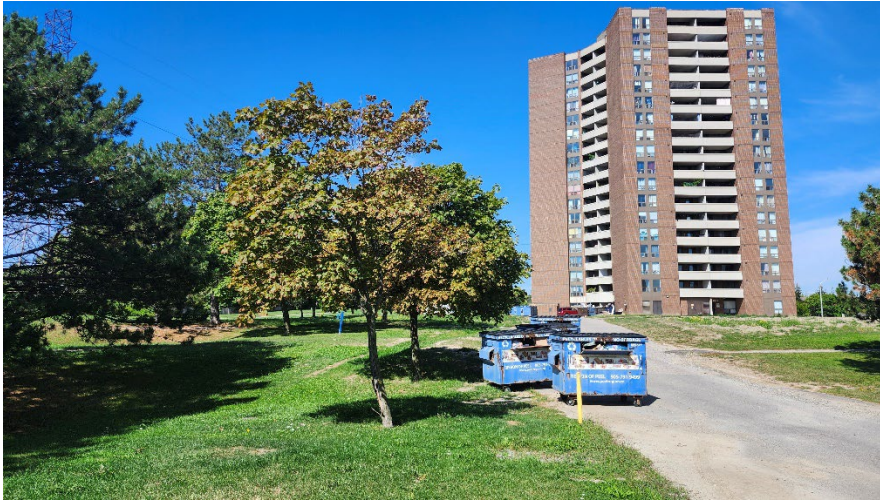
119	Acer platanoides (Norway Maple)	14.5	4	L	L	R	Multi-branch node, one dead leader, canopy 40% dead, backfilled, wound on trunk of 50% trunk circumference, and large crack at base to main union.	S
120	Acer platanoides (Norway Maple)	20.5	5	M	M	Ph1 RC	Backfilled, wound at 1m height over 30% of trunk circumference, multi-branch node and large wound on lowest branch over 30% of branch circumference.	S
121	Pinus nigra (Austrian Pine)	30.2	6	M	M	Ph1 RC	Dieback on older growth of 15%, lean 10° at base, backfilled, and wounds on surface roots.	S
122	Pinus nigra (Austrian Pine)	24.4	5.5	M	M	Ph1 RC	Backfilled.	S
123	Pinus nigra (Austrian Pine)	31	6	MH	ML	Ph1 RC	30° lean to north at base then straightens.	S
124	Pinus nigra (Austrian Pine)	31.7	7	MH	M	Ph1 RC	10° lean to north and backfilled.	S

Figure 25: Trees 119 and 120 along garbage disposal bins.

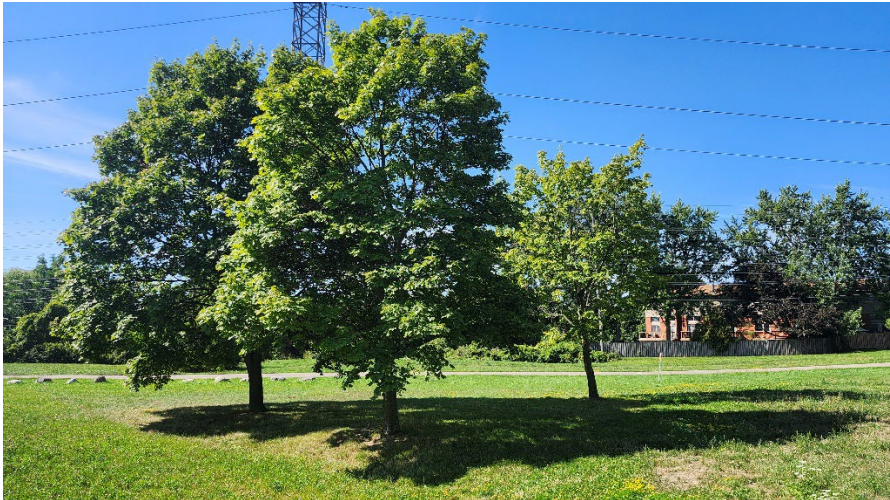
132	Acer platanoides (Norway Maple)	23.2	7	ML	L	R	Trunk wounded at base to 1m height over 40% of trunk circumference includes rot in trunk core, canopy 30% dead and multi-branch node.	S
133	Pinus nigra (Austrian Pine)	44	9	M	M	RC	Backfilled, dieback over 5% of older needle growth.	S
134	Pinus nigra (Austrian Pine)	37.5	7	ML	M	RC	Backfilled, and canopy 25% dead.	S
135	Pinus nigra (Austrian Pine)	20.3, 20.8 [29]	4.5	ML	L	R	co-dominant leaders, included bark, one dead leader and canopy 50% dead.	S
136	Pinus nigra (Austrian Pine)	37.6	11	M	M	RC	Backfilled, canopy with 10% dieback of older needles.	S
137	Acer platanoides (Norway Maple)	29.5	8	M	ML	RC	Co-dominant leader, multi-branch node, small girdling roots, potentially large girdling root below grade and one leader with wound over 50% trunk circumference.	S

Figure 28: Trees 130 to 132.

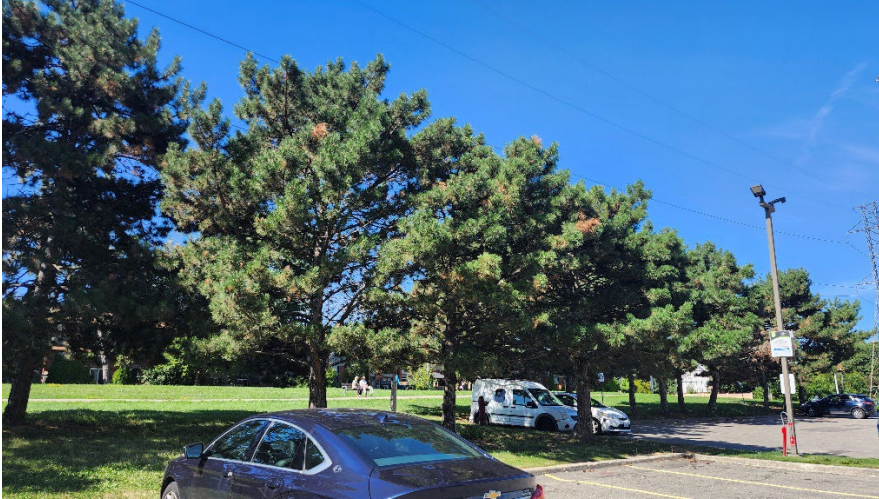
Figure 30: Neighbour's trees along south west property line to be preserved.
