# ***Soil Engineers Ltd.***

Reference No. 2404-S012A

**Re: Slope Stability Assessment  
Proposed Townhouse Development  
50 and 60 Harborn Road  
City of Mississauga**

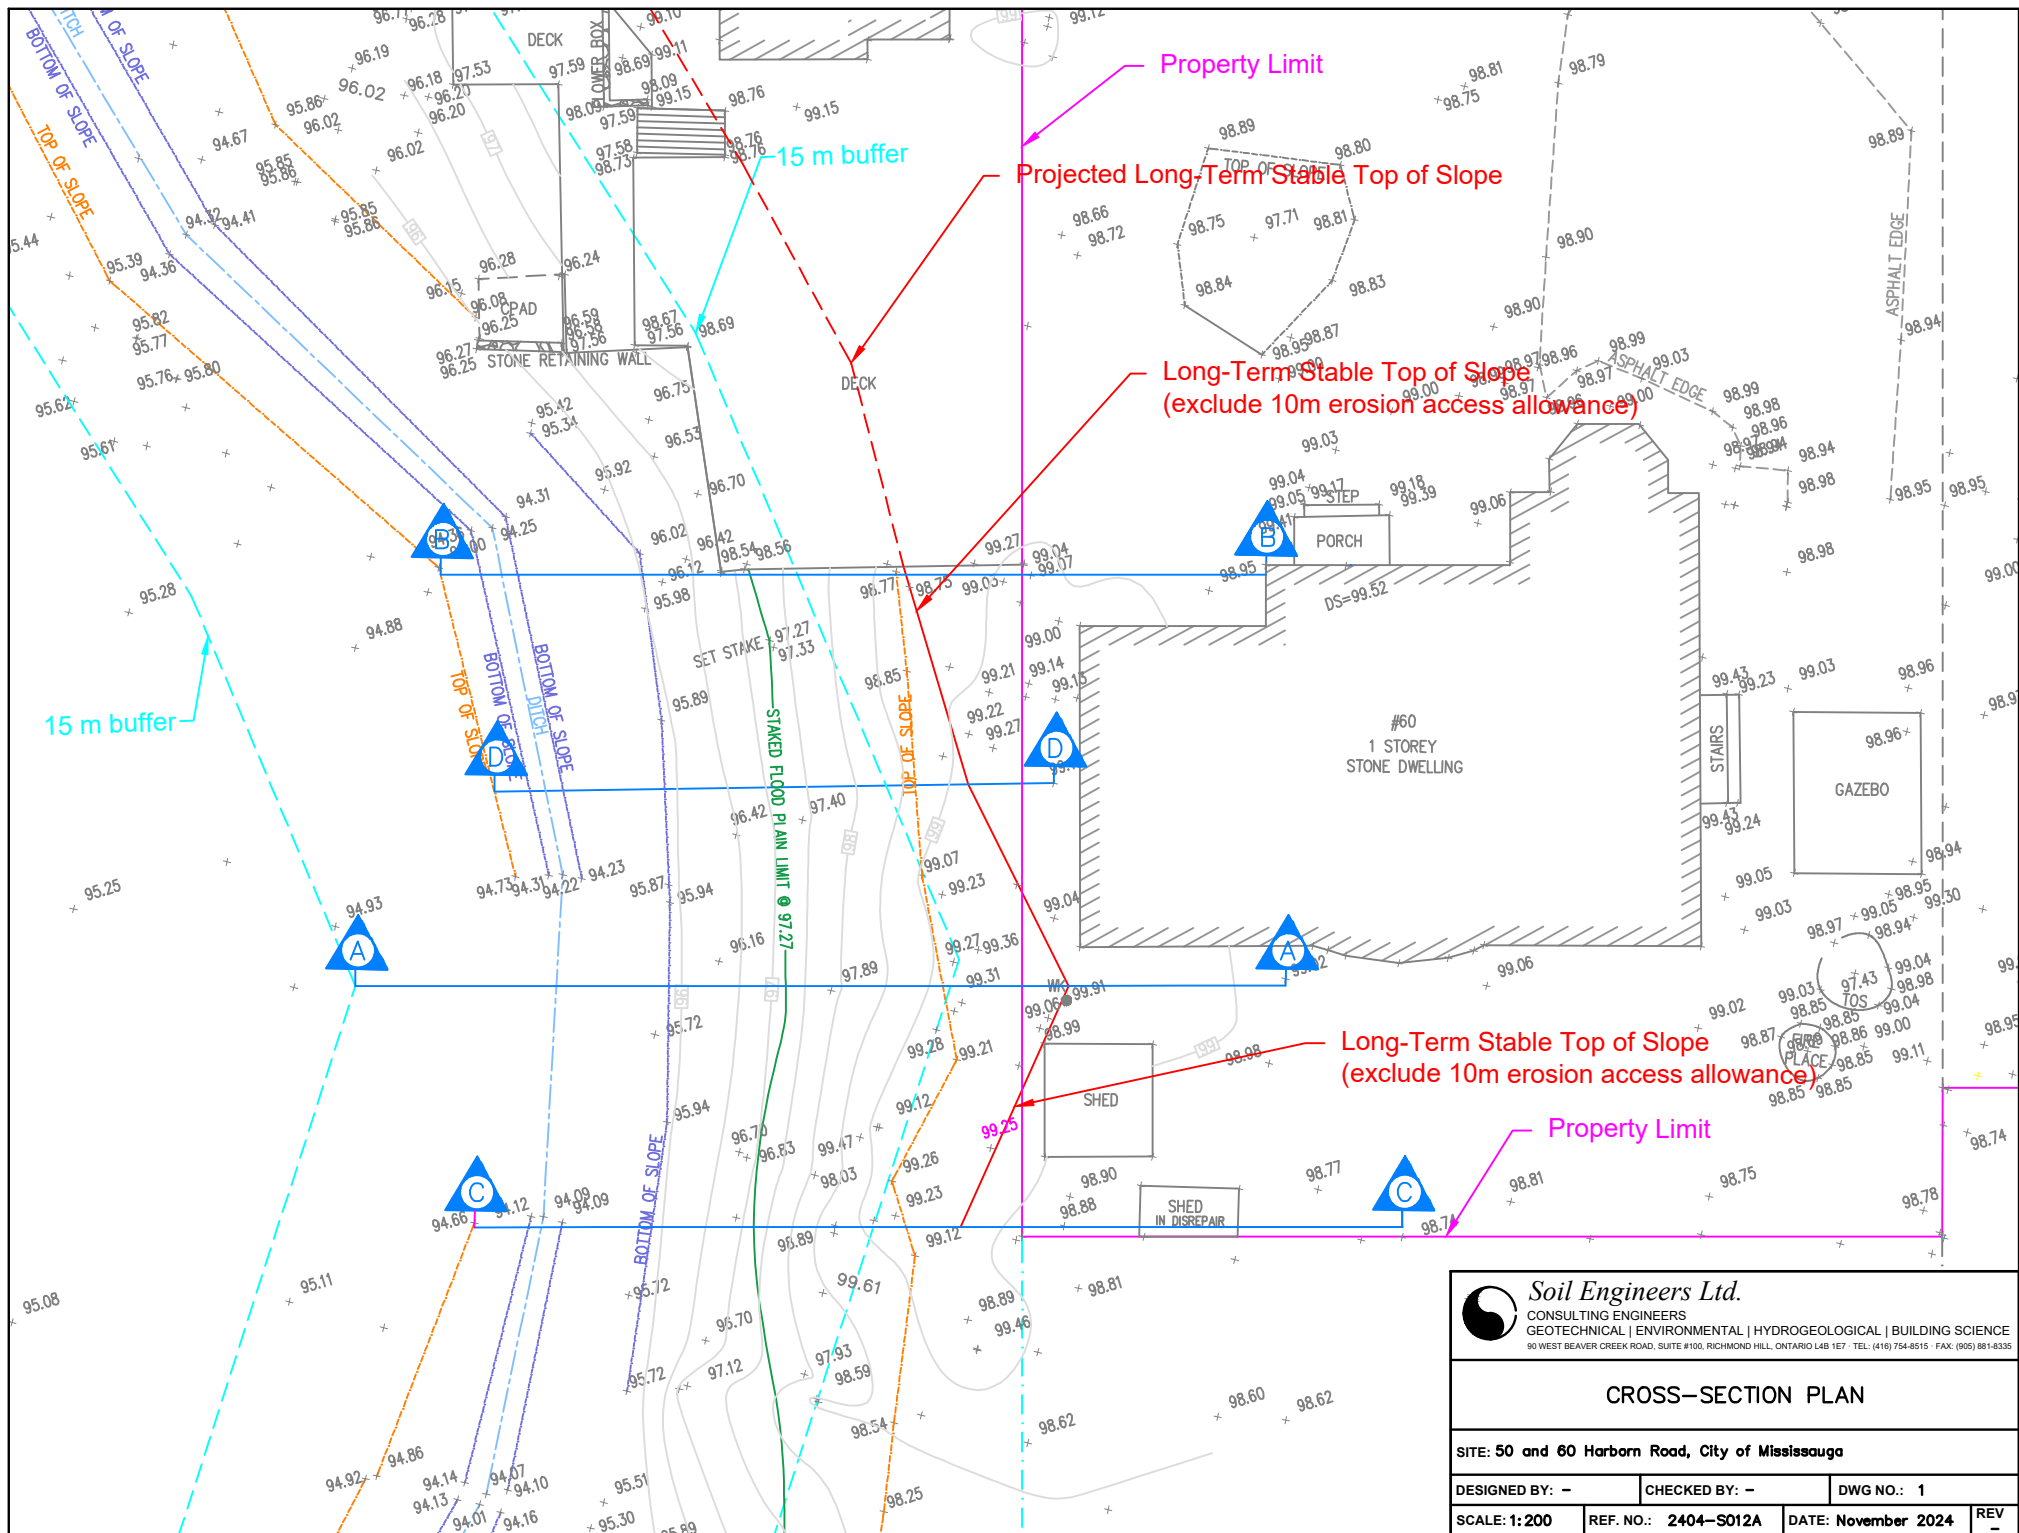
**CROSS-SECTION PLAN**

The survey details indicate that the valley land is approximately 2.7 to 4 m in height. Based on the available topographic information, the estimated gradients of the valley slope range between 1 vertical (V): 1.7 to 2.4 horizontal (H), with local gradient as steep as 1V:1.3H. The details from the topographic survey are presented on Drawing No. 1.

Since the topographic survey does not contain the full elevation contour of the entire extent of the valley land, the LTSTOS has been established where the elevation contours are available and a Projected Long-Term Stable Top of Slope is extrapolated into the area where the elevation contours are not available. The LTSTOS is plotted on Drawing No. 1.

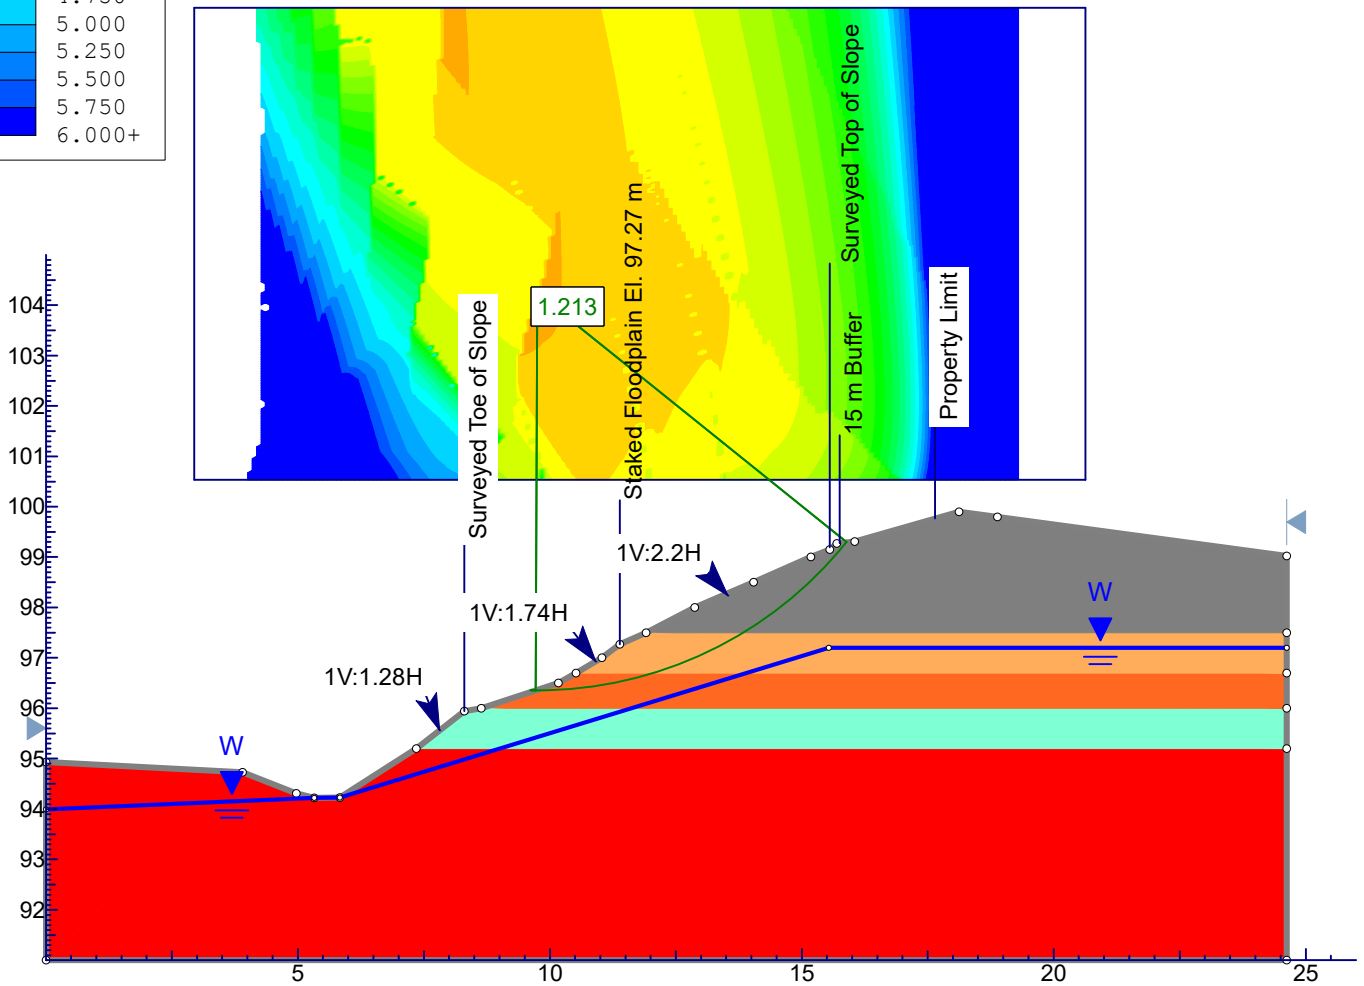
2

| <b>Slope Section</b> | <b>Height of Slope (m)</b> | <b>Slope Gradient</b> | <b>Factor of Safety</b> |
|---|---|---|---|
| A-A | 3.3 | 1V:1.28 to 2.2H | 1.213 |

The analytical results indicate that all cross-sections are less than the minimum FOS of 1.5 required by the CVC and OMNR for active land uses. Accordingly, a stable slope gradient, with a FOS exceeding 1.5, will need to be determined for the slope sections.

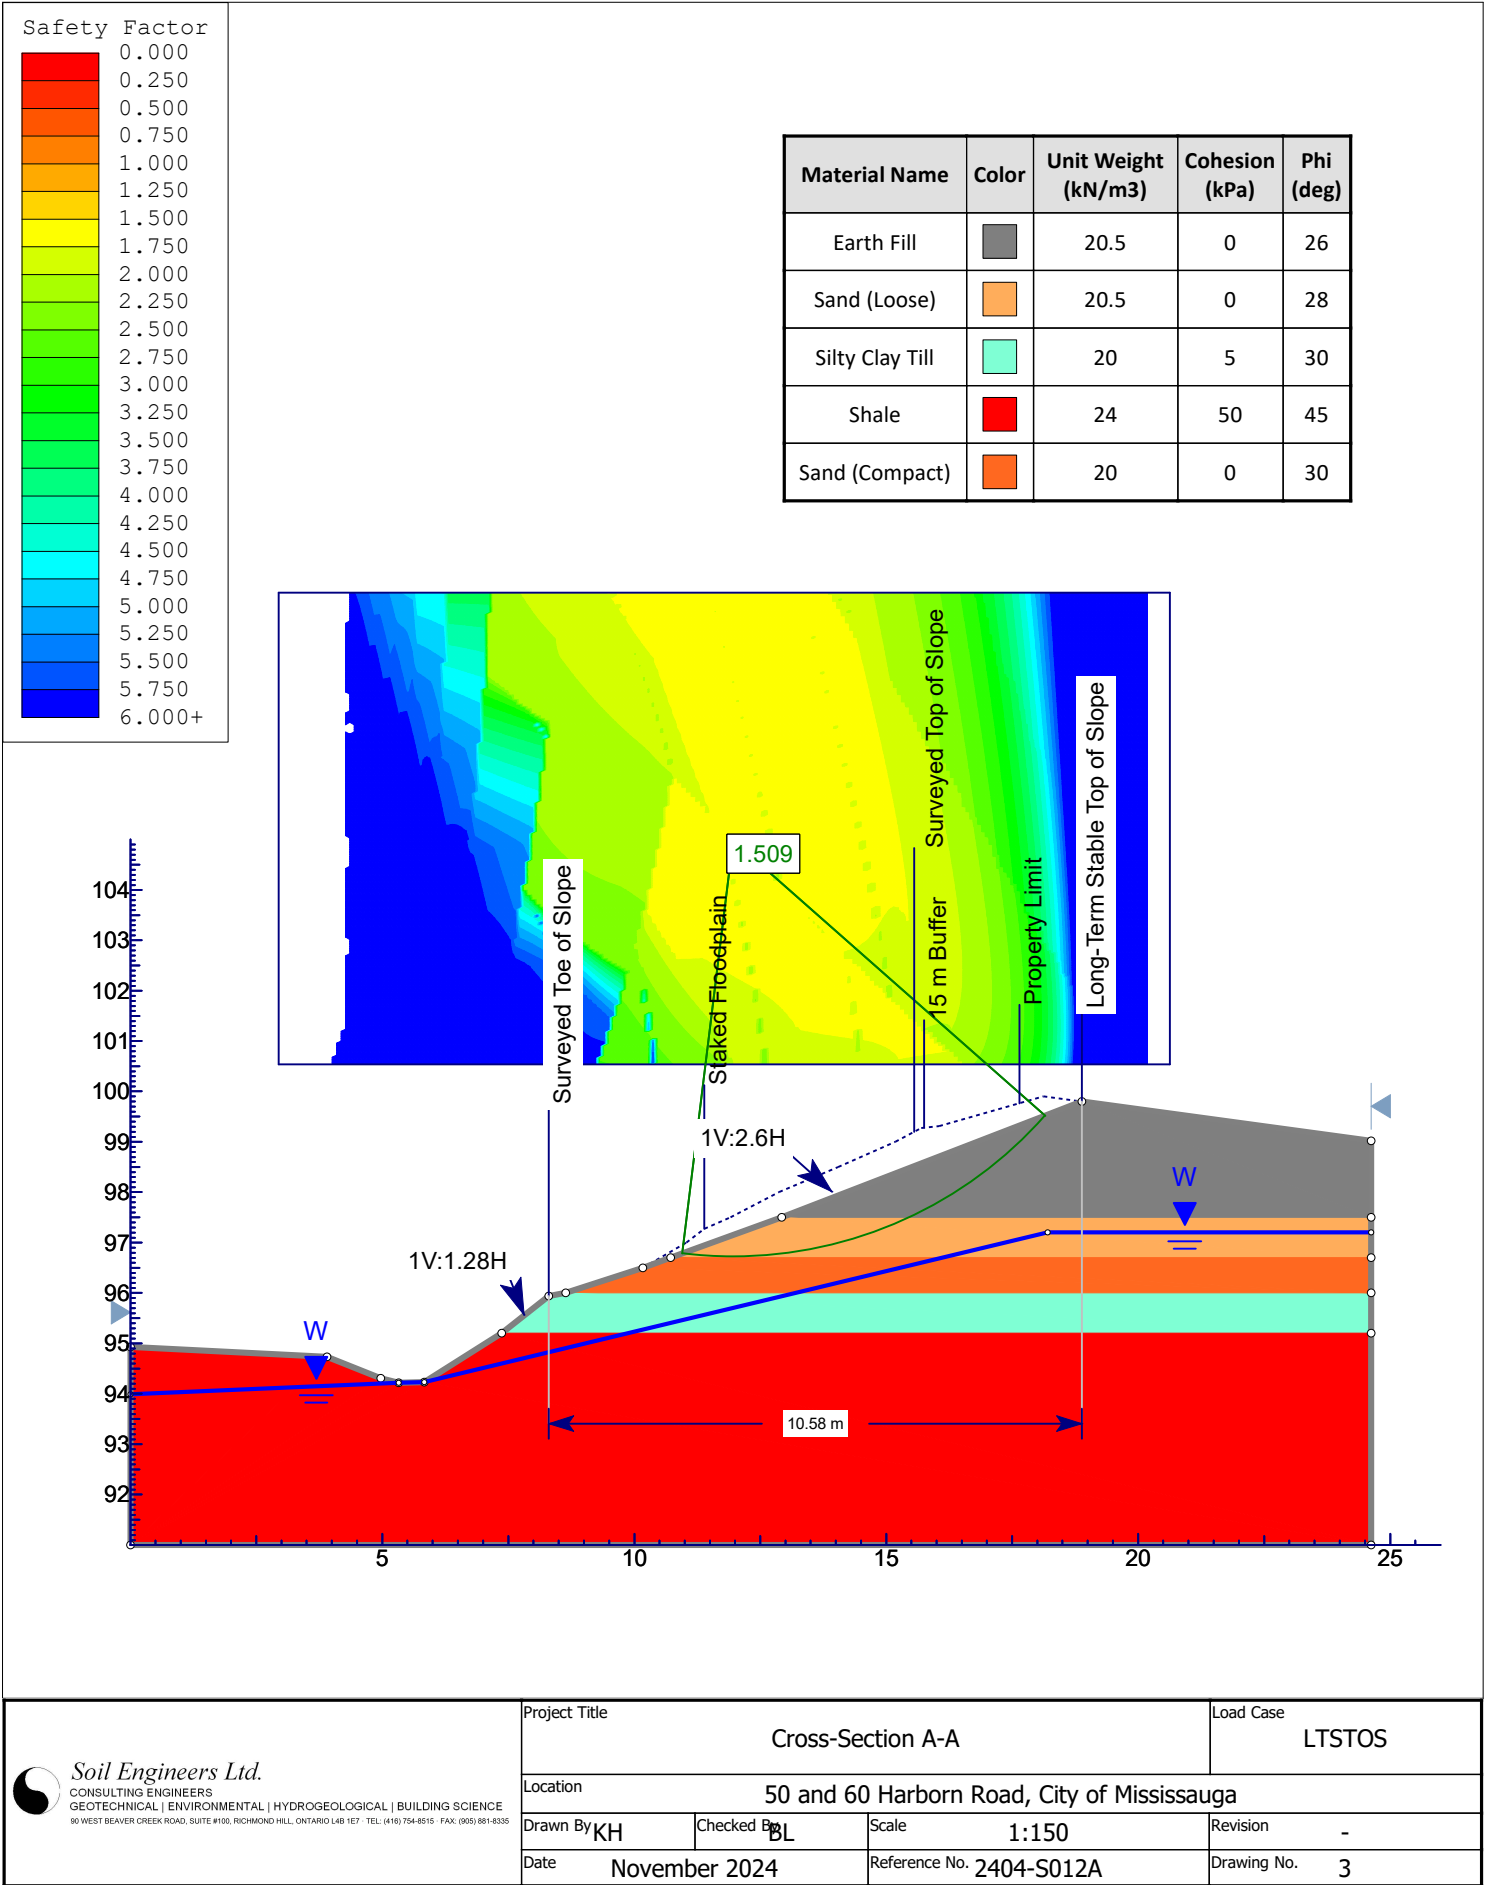
| | | | | Drawing No. | 3 |

| Slope Section | Height of Slope (m) | Slope Gradient | Factor of Safety |
|---|---|---|---|
| A-A | 3.9 | 1V:2.60H | 1.509 |

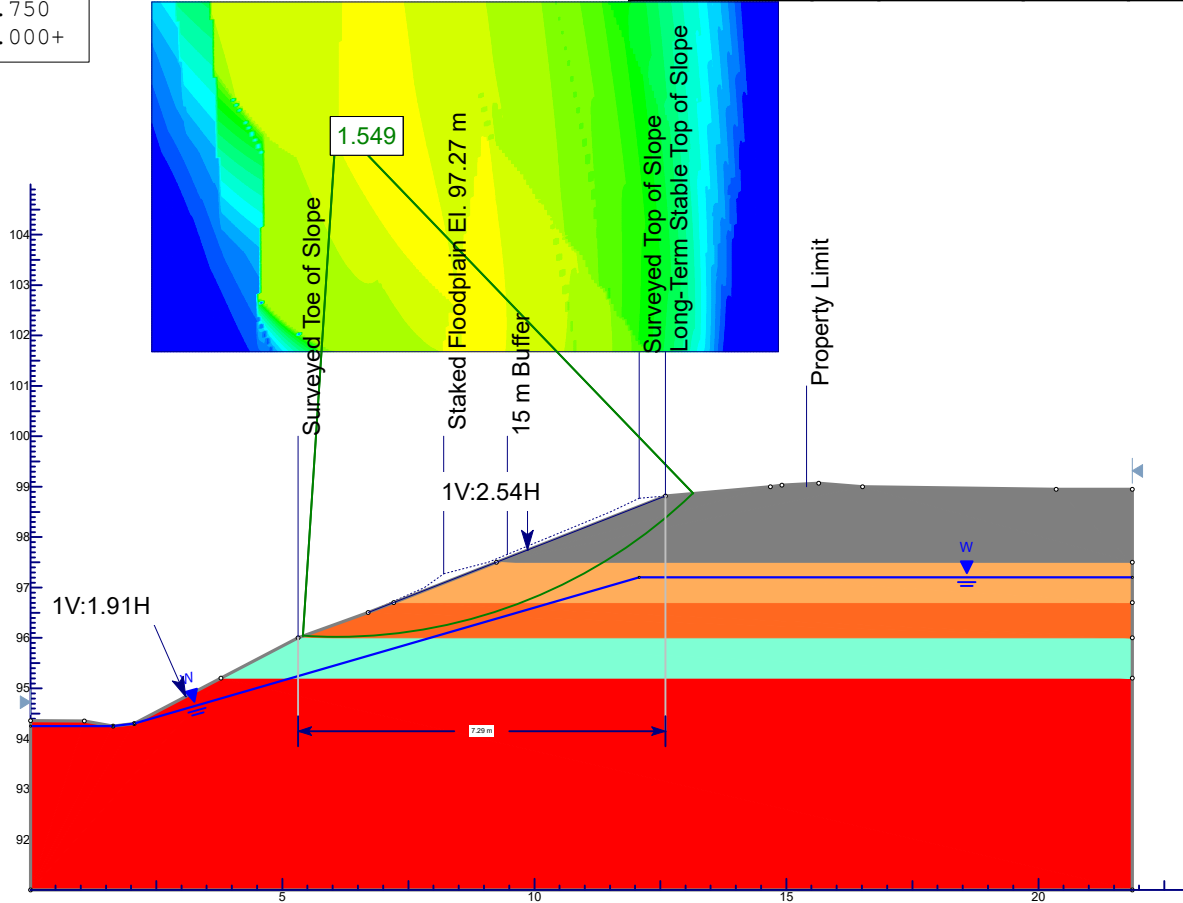
| Reference No. 2404-S012A | | | | Drawing No. 4 | |

| <b>Slope Section</b> | <b>Height of Slope (m)</b> | <b>Slope Gradient</b> | <b>Factor of Safety</b> |
|---|---|---|---|
| B-B | 2.8 | 1V:1.91 to 2.4H | 1.492 |

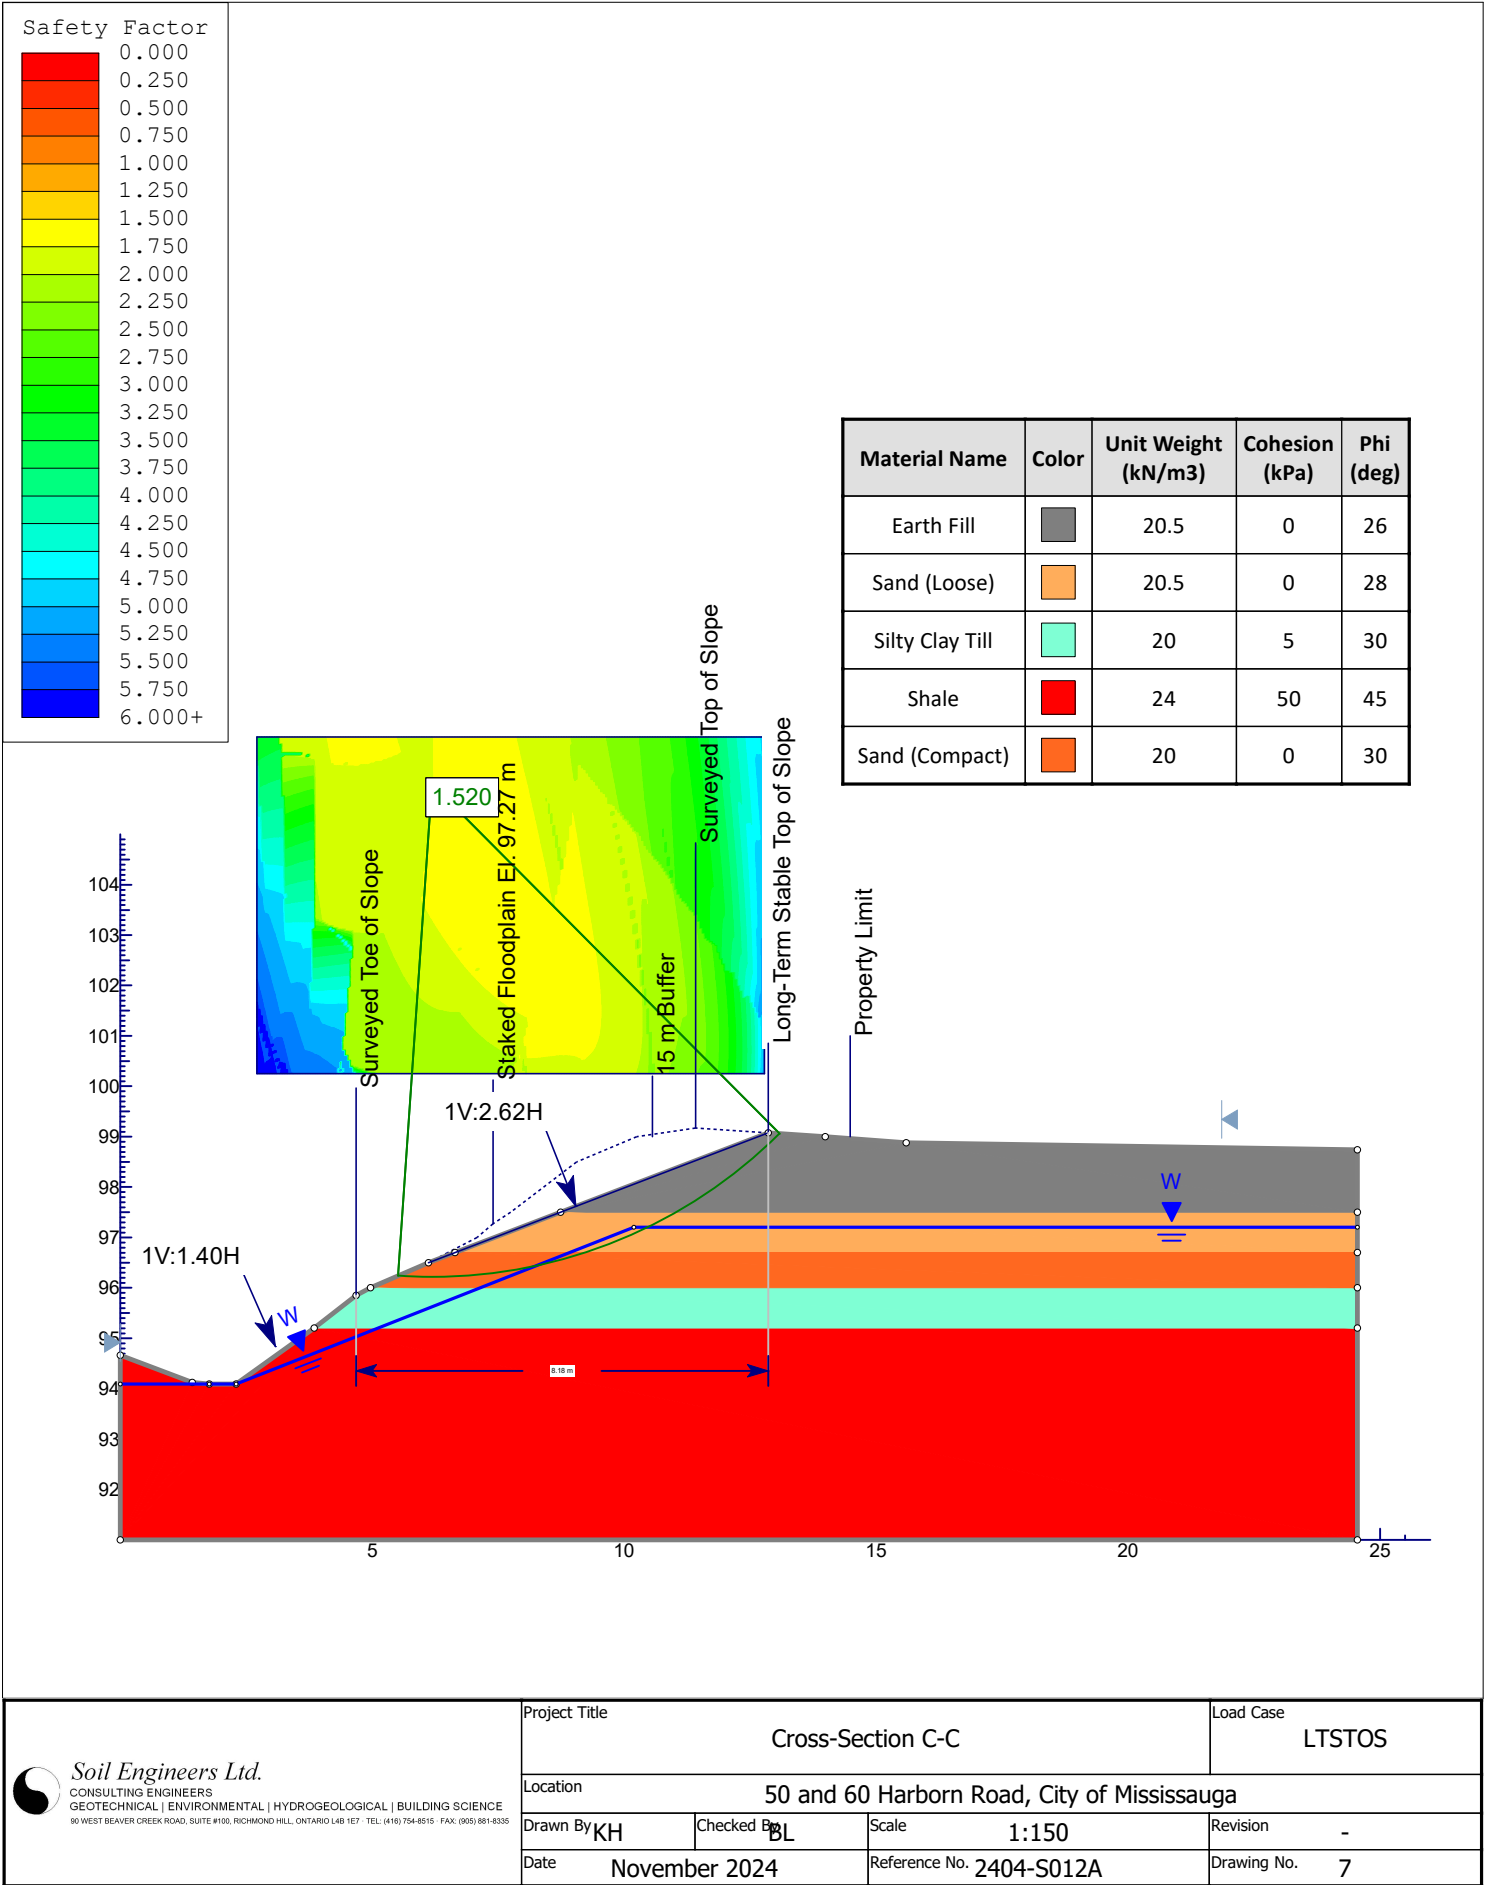
6

| <b>Slope Section</b> | <b>Height of Slope (m)</b> | <b>Slope Gradient</b> | <b>Factor of Safety</b> |
|---|---|---|---|
| C-C | 3.4 | 1V:1.40H to 1.47H | 0.962 |

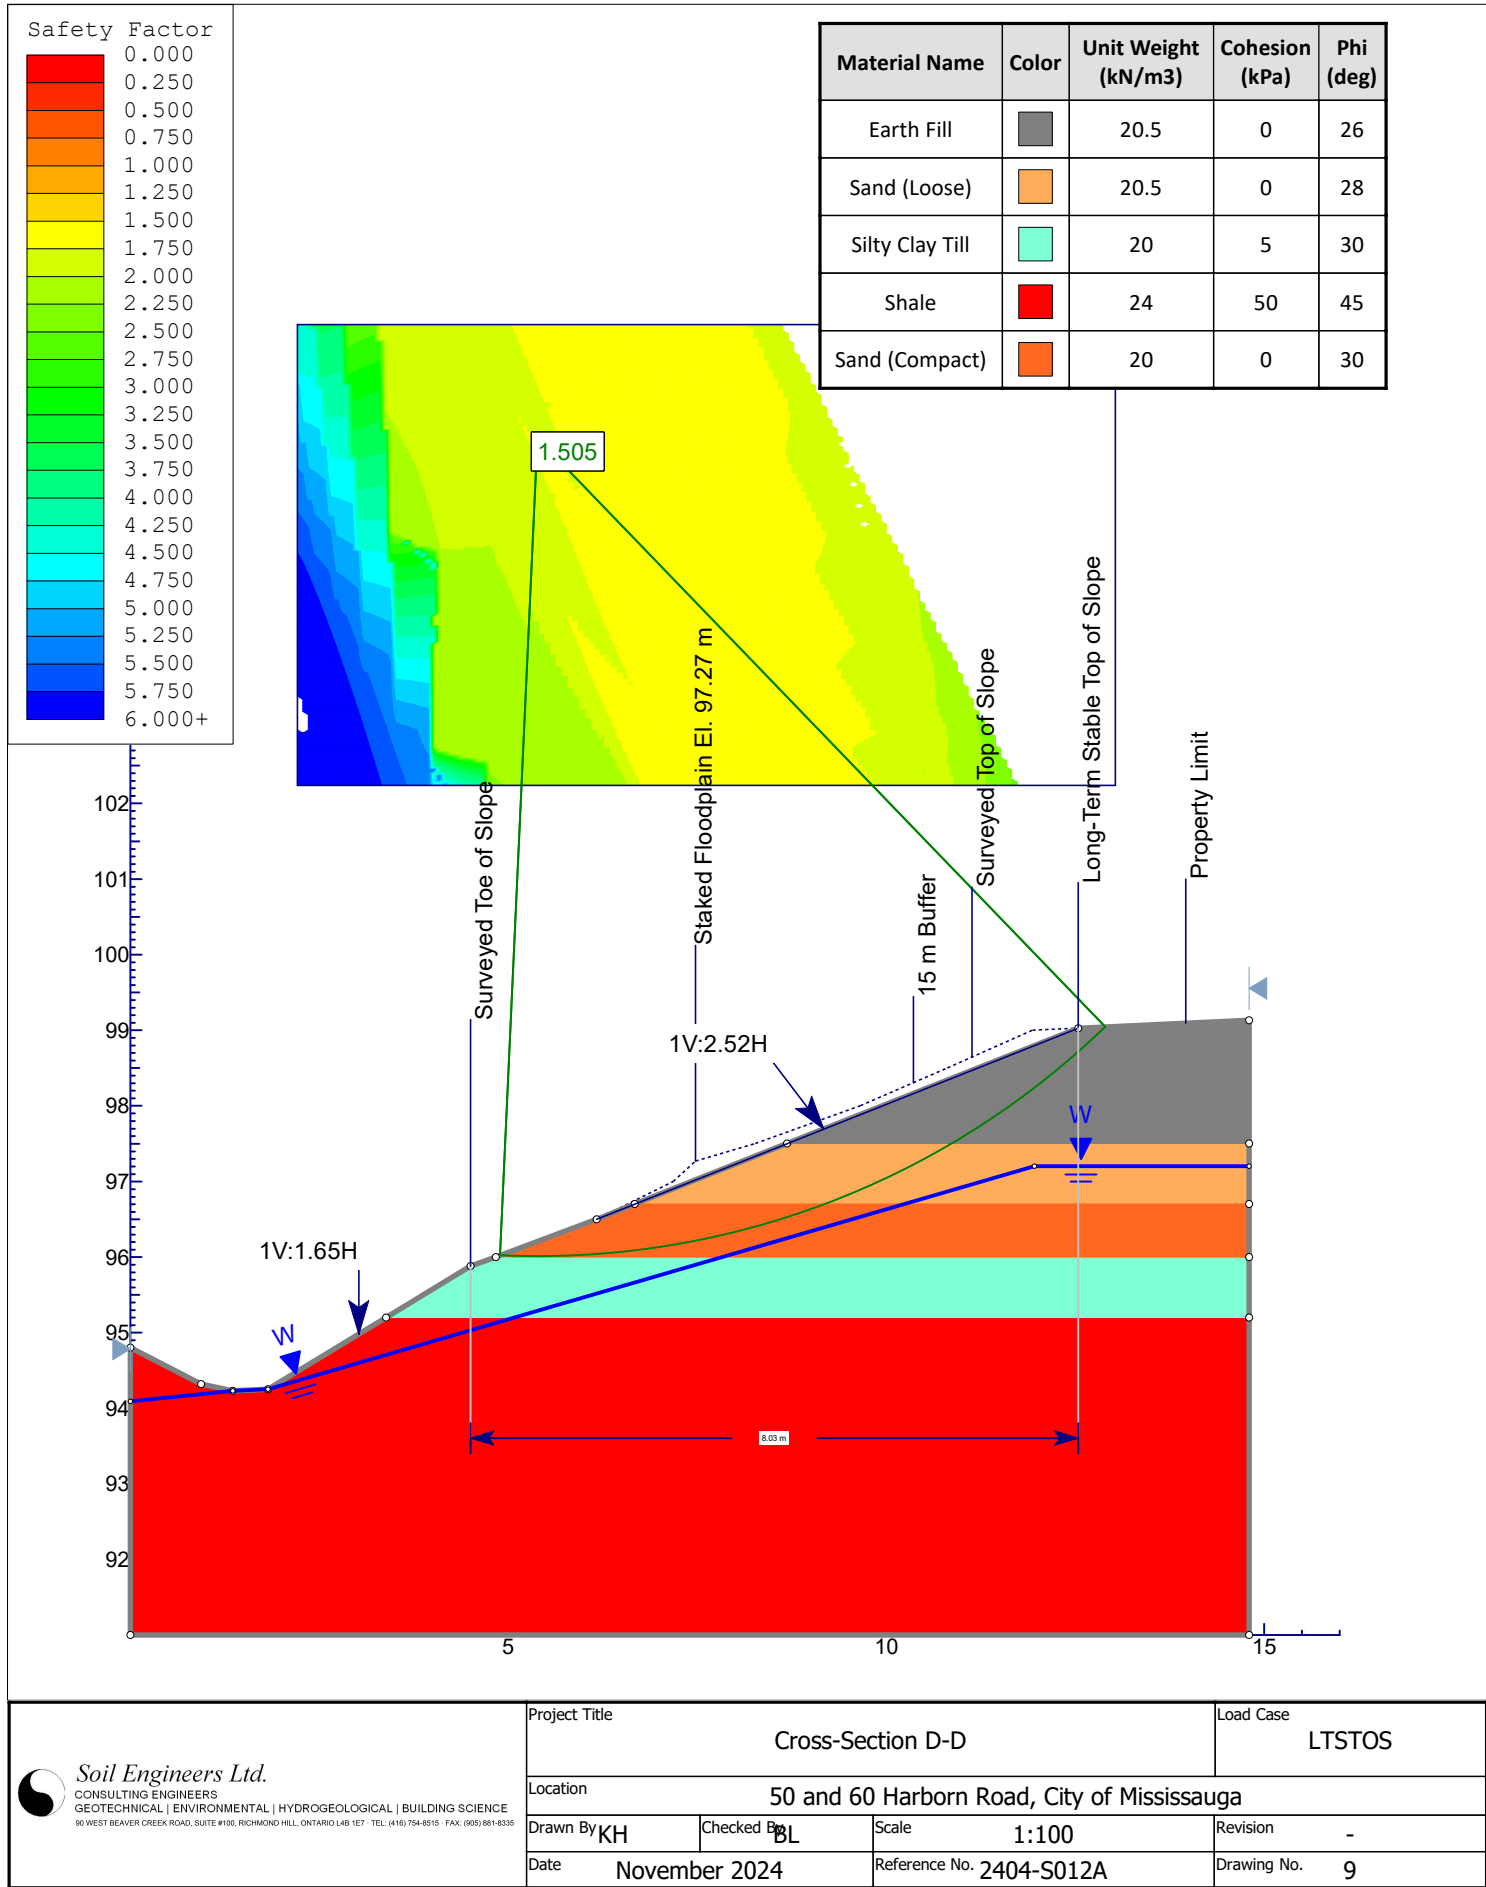
| | | | | Drawing No. | 9 |

| Slope Section | Height of Slope (m) | Slope Gradient | Factor of Safety |
|---|---|---|---|
| D-D | 3.1 | 1V:2.52H | 1.505 |
