**Arborist Report  
Proposed Development of 3415 Ninth  
Line, Mississauga**

**The Diocese of Mississauga,  
Vancouver and Western Canada,  
2188 Robinwood Court,  
Mississauga, ON L5M 3B9**

**February 21, 2020  
300044049.0000**

TREE PRESERVATION PLAN

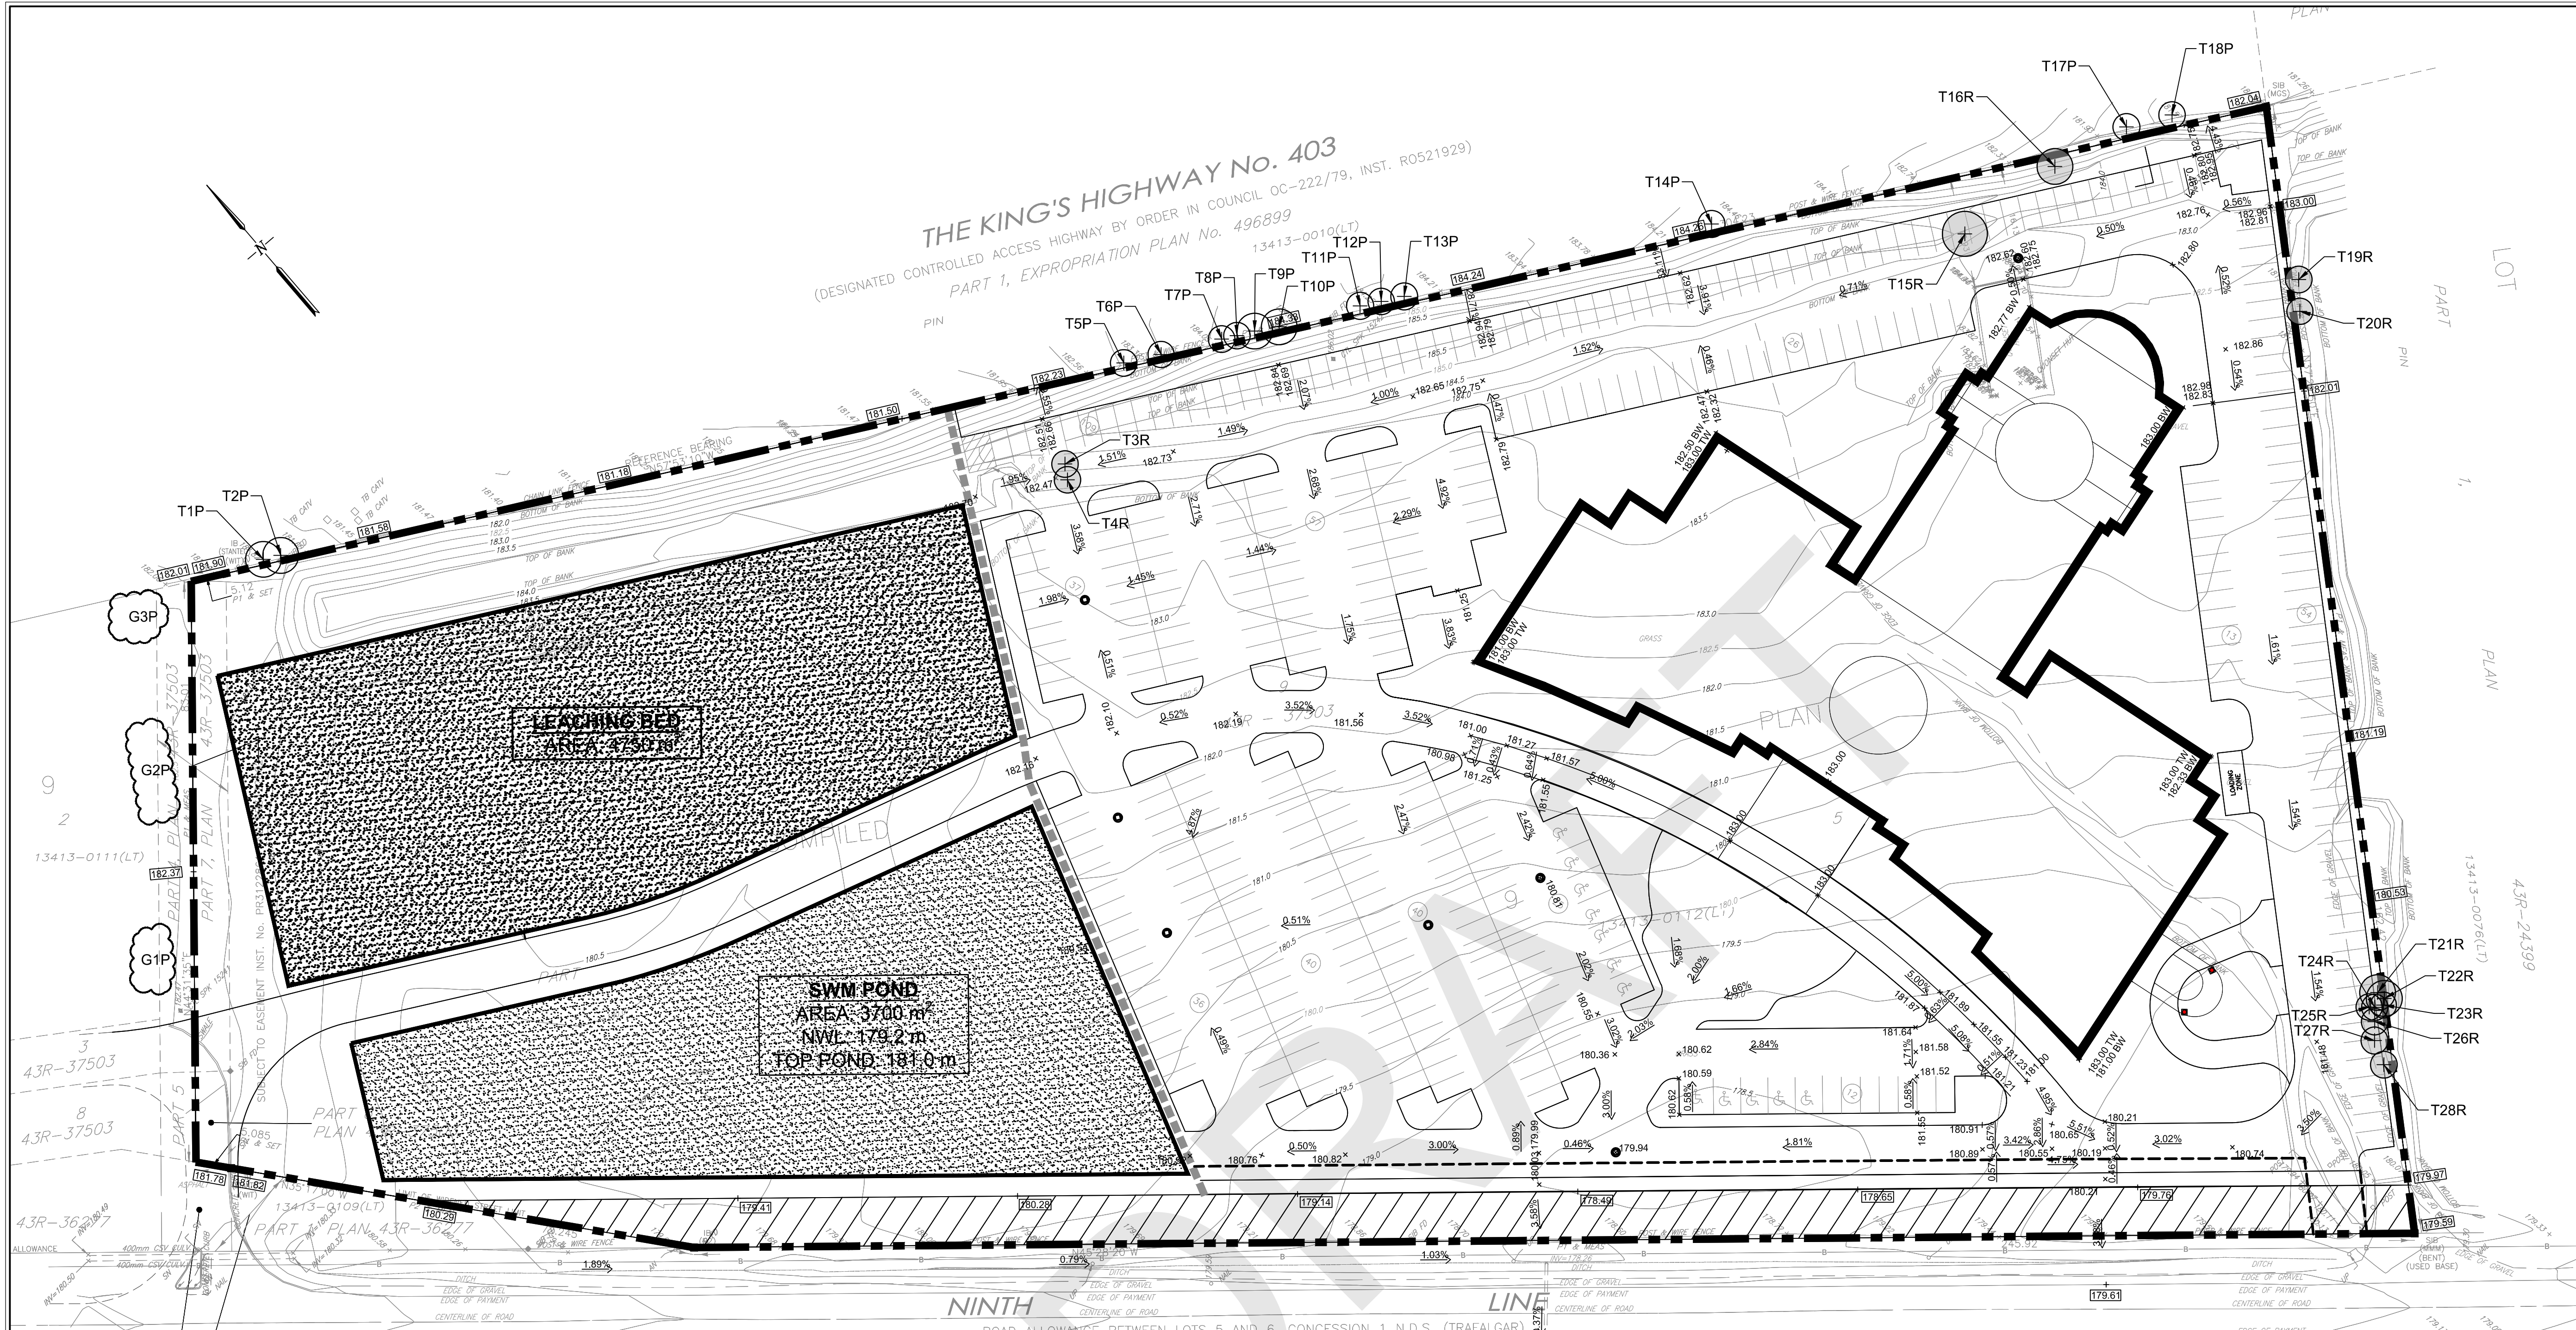
**T1**

A total of 28 trees were individually assessed within and immediately adjacent to the subject property. Furthermore, three groupings of newly planted trees are represented on Figure T1, north of the subject property.

There are 14 Trees recommended for preservation that are adequately setback from the proposed development (including grading) or can be reasonably protected and have a good or fair condition.

There are 20 trees found in three small groupings north of the subject property. These trees have recently been planted and are generally in good condition. All 20 trees in the groupings are recommended for preservation.

Removal of 14 trees is recommended due to their conflict with the proposed development elements or significant expected impacts to the root zones (i.e., root severance and compaction). The associated Tree Preservation Plan identifies the locations of trees to be removed.

Two trees (T19 and T20) are located immediately east of the subject property that are recommended for removal. These two trees will be removed subject to an agreement with the adjacent landowner based on the grading encroachment needs of the project.

| TREE ID | COMMON NAME | BOTANICAL NAME | CONDITION | DBH(CM) | MTPZ(M) | COMMENTS | RECOMMENDATION |
|---|---|---|---|---|---|---|---|
| T15 | WHITE WILLOW | SALIX ALBA | GOOD-FAIR | 13,15,12,14,18,22,20,12 | 6.44 | MULTI STEMMED BASE, INDUSTRIAL DEBRIS AND LUMBER STACKED AT BASE. INJURY TO LATERAL BRANCHES (LOW) EPICORMICK GROWTH (LOW) | REMOVE |
| T16 | SIBERIAN ELM | ULMUS PUMILA | POOR | 32 | 5.12 | 10% CROWN REMAINING, SIGNIFICANT DECAY AND SLOUGHING BARK | REMOVE |
| T19 | APPLE | MALUS PUMILA | FAIR | 15,10,10,4,2 | 3.81 | MULTI-STEMMED BASE, INJURIES TO LATERAL BRANCHES (MODERATE), DEBRIS PILES AT NORTHERN EDGE OF TRUNK | REMOVE |

Erosion and Sediment Control Fencing (ESC) will be installed along the limits of the development to reduce impacts to off-site trees recommended for preservation. All construction related activities (i.e. site alteration, excavation, and equipment storage) are not acceptable beyond the limits of the ESC fencing.

A landscape plan should be prepared to include the new plantings required to compensate for the removals. Any additional compensation will be completed via Cash in Lieu payments as per the City's most recent Fees and Charges Document.
