# ARBORIST REPORT

4553-4561 Hurontario Street  
Mississauga, Ontario

File: 11193-5513  
Date: Dec. 2, 2020  
Last Revised: May 17 2021

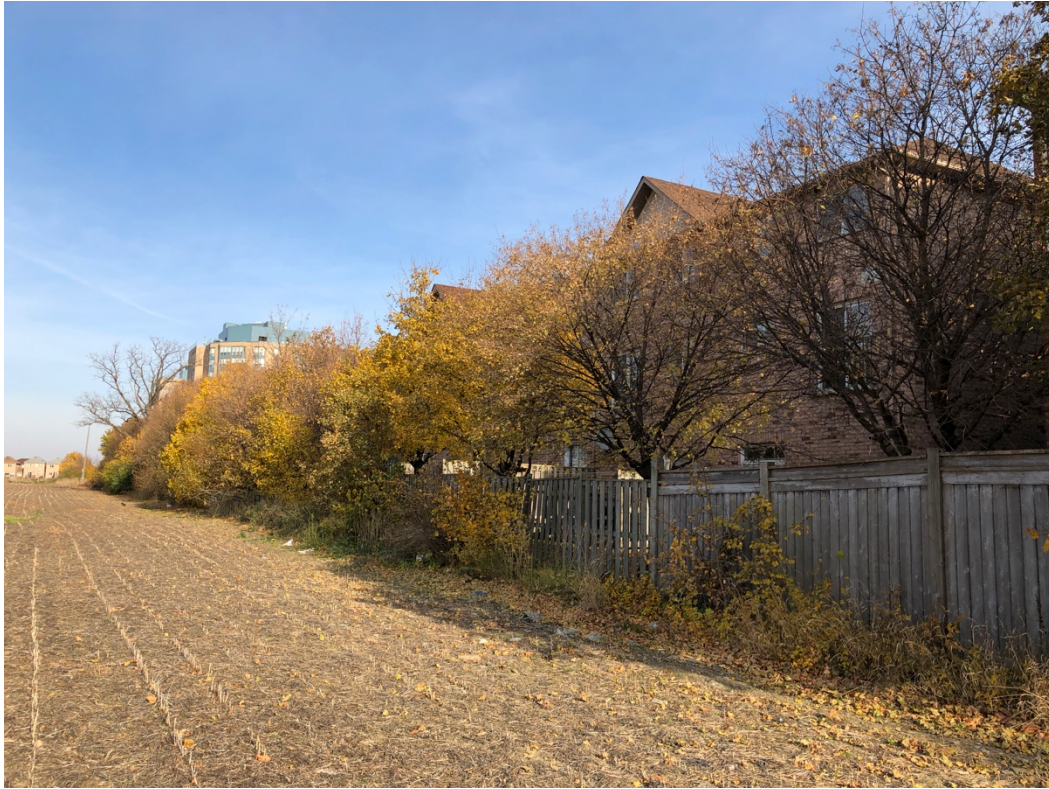
Photo I. Block 4: Trees in adjacent properties south of the subject site and wind-seeded suckers growing against fence.

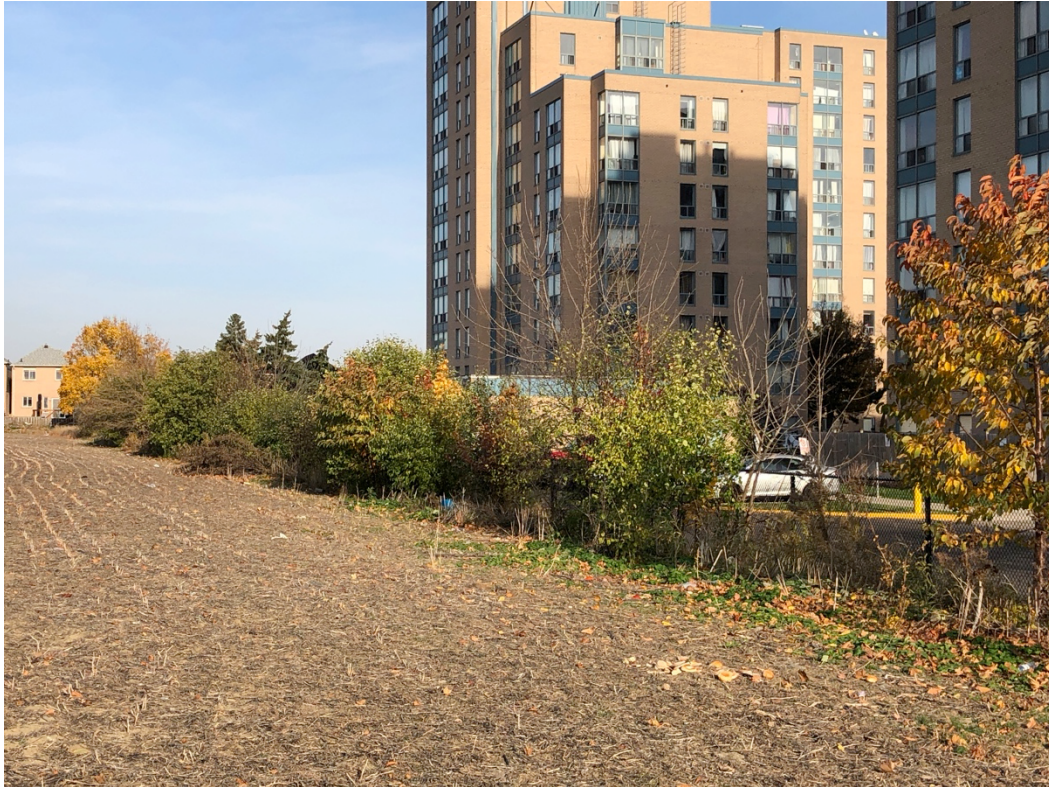
Photo 2. Block 5: Trees along south fence line, predominantly wind-seeded suckers and buckthorn.

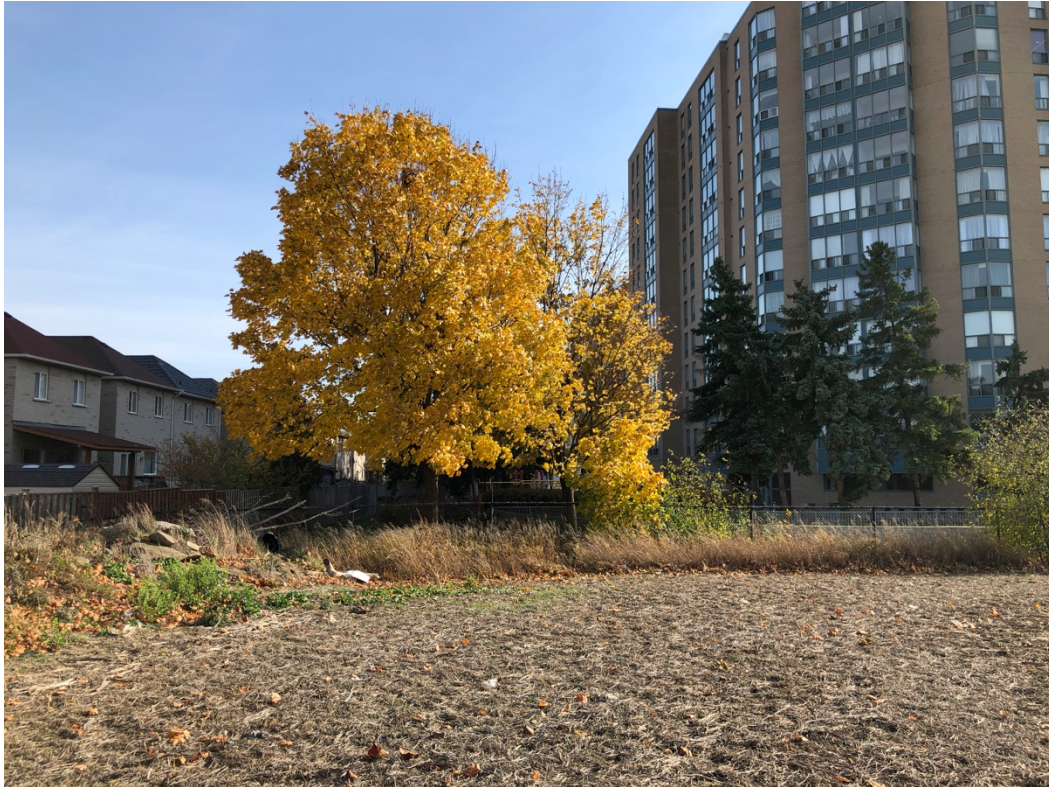
Photo 3. Trees 47 and 48 on adjacent property.

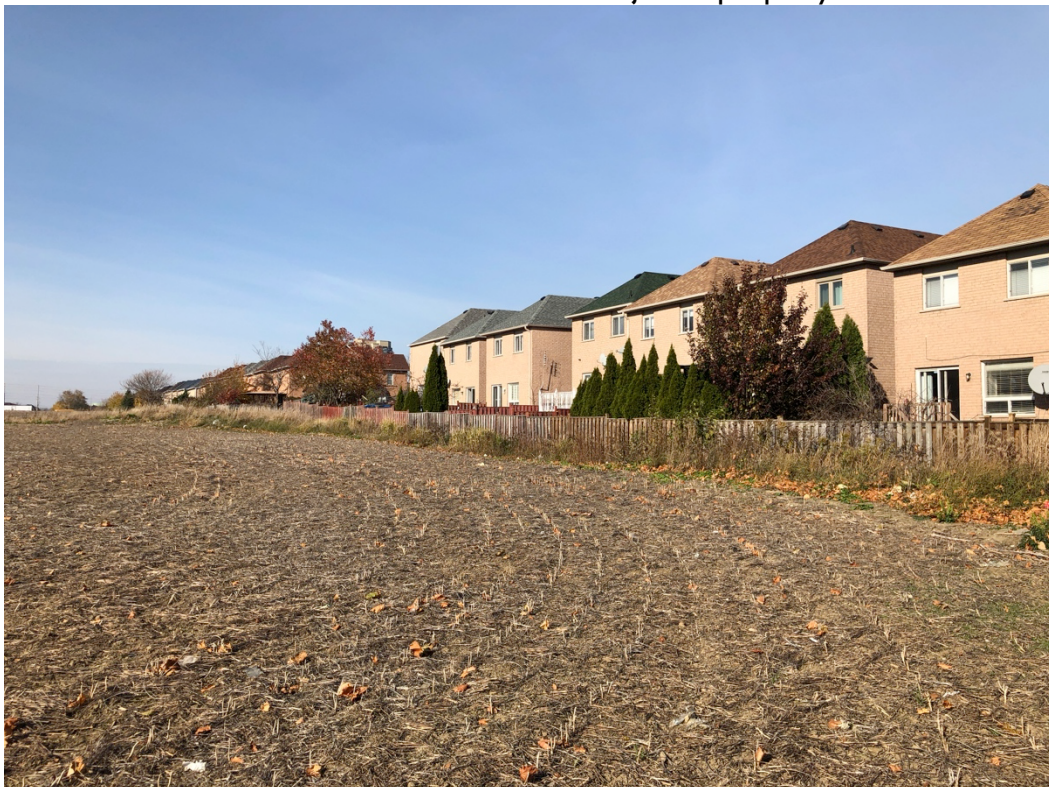
Photo 4. Block 3: Trees in backyards of adjacent private properties.

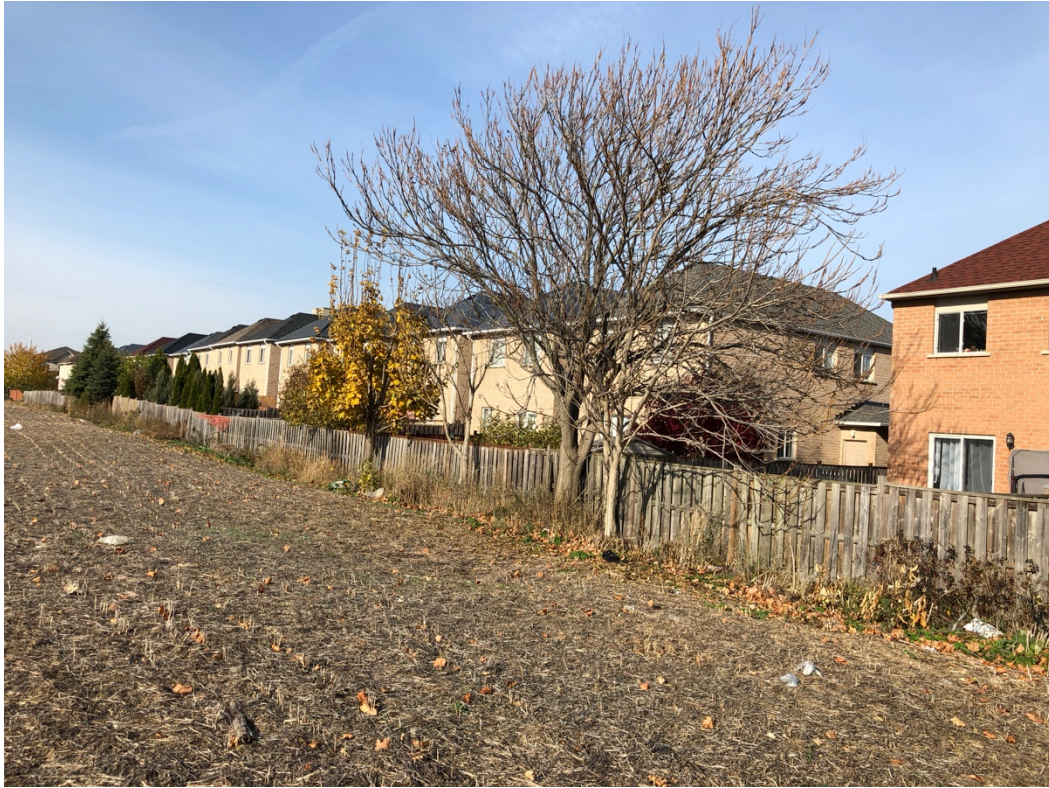
Photo 5. Block 3: Trees 56-60 on subject site to be removed.

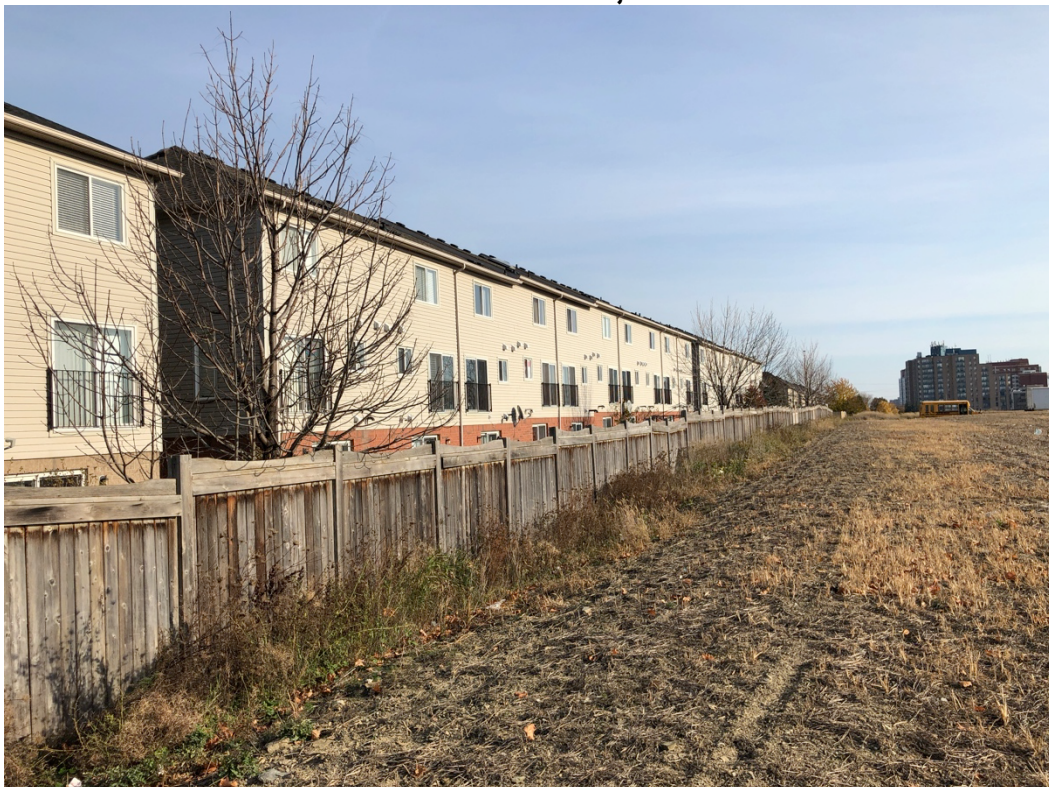
Photo 6. Block 2: Ash trees on adjacent properties east of subject site.

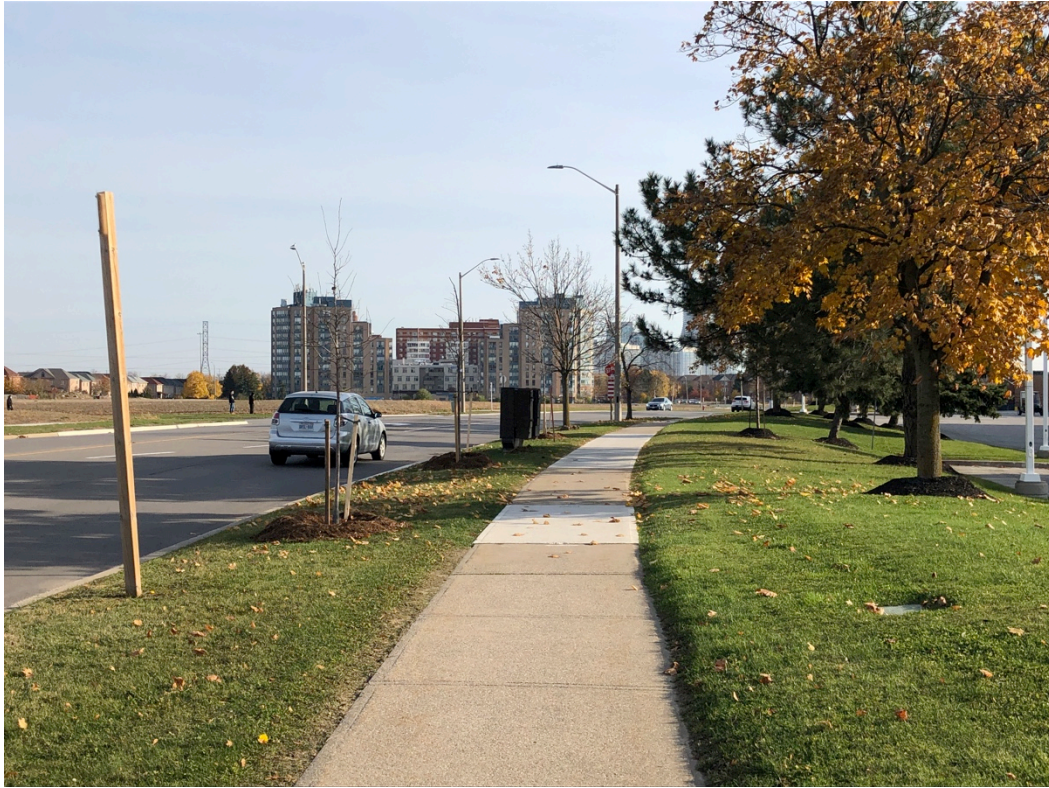
Photo 7. West side of Sorrento Dr. looking south. Newly planted trees in boulevard.

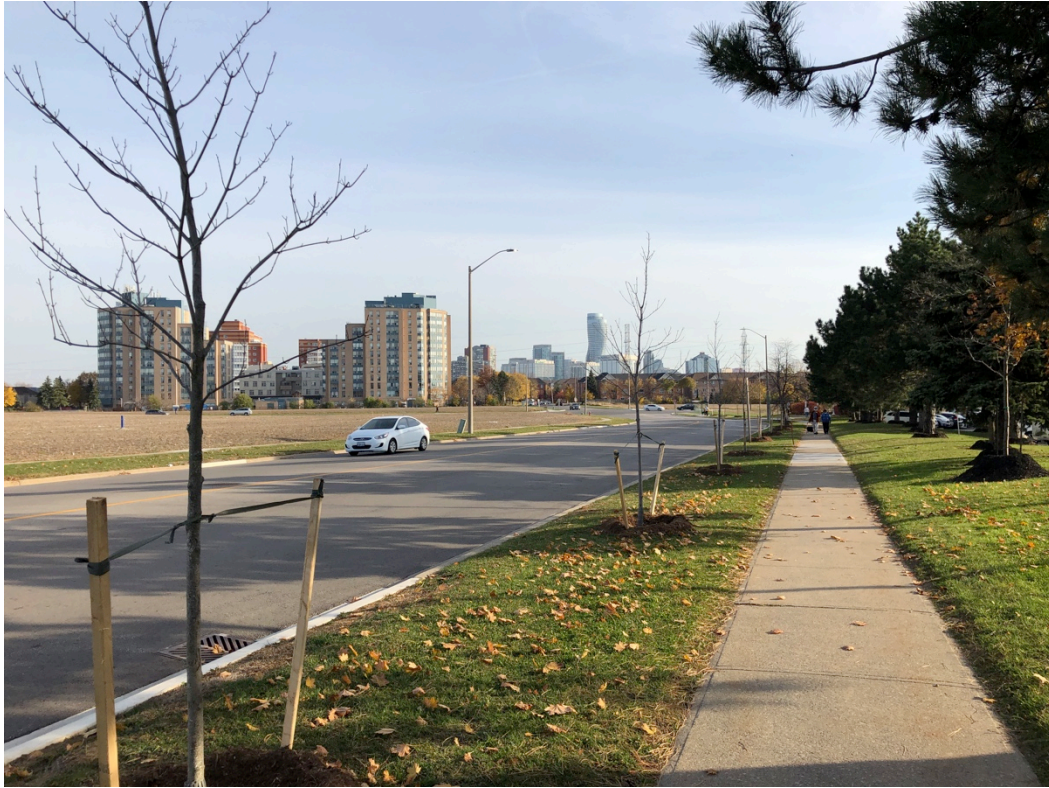
Photo 8. West side of Sorrento Dr. looking south. Newly planted trees in boulevard

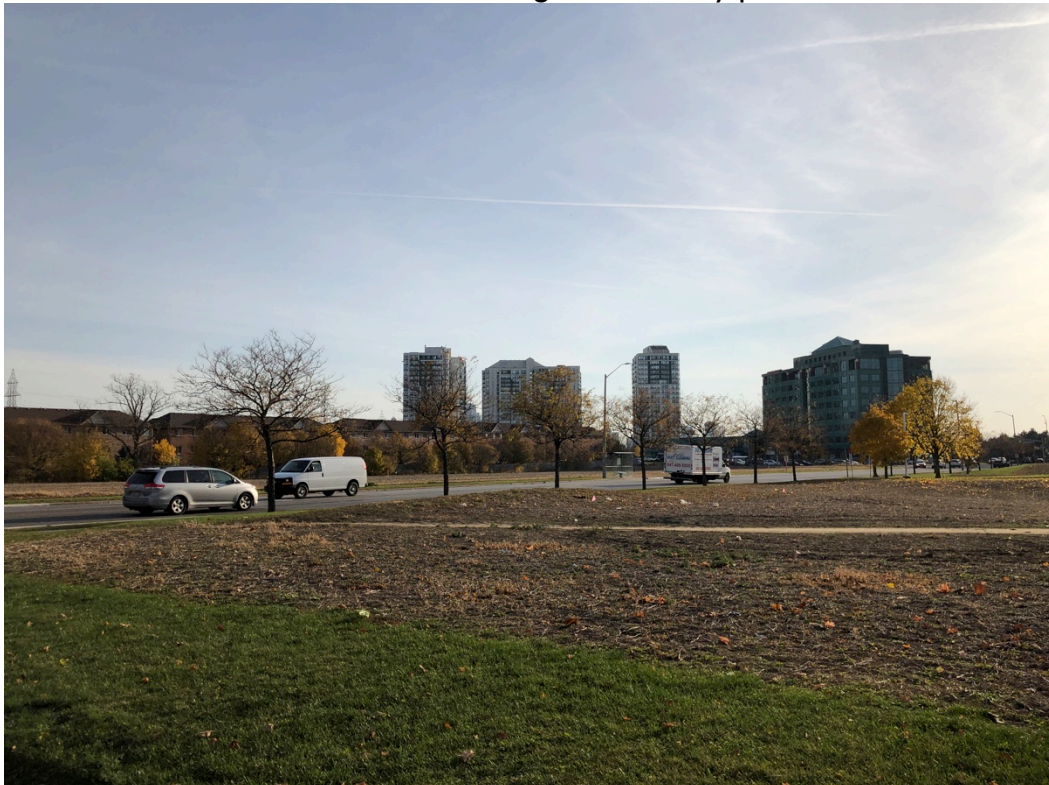
Photo 9. Block 1: Honey locust row along south side of block.
