→ **Sheridan Creek Erosion Control
Study – Lushes Avenue to Clarkson
Road South**

Purpose of the Virtual Public Information Centre

Introduction to the Study

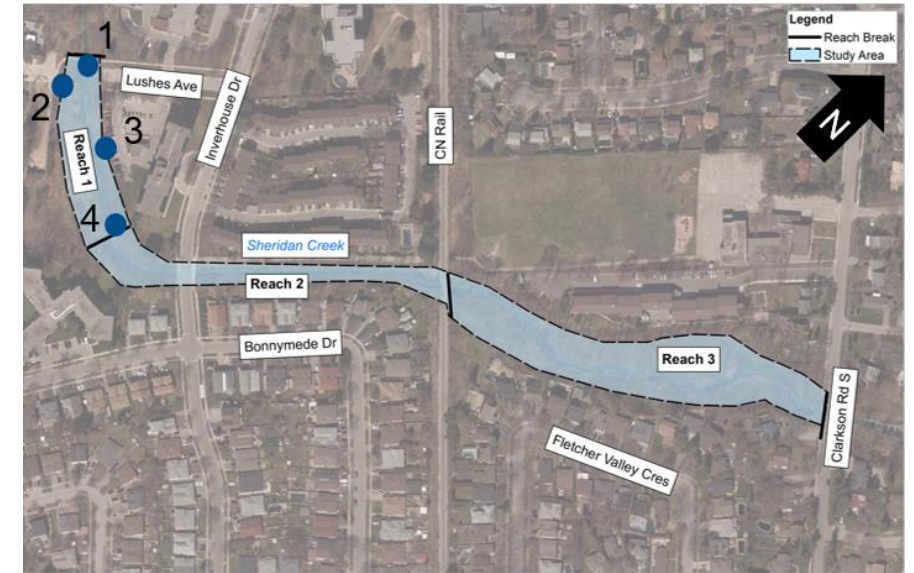
Under the Lushes crossing

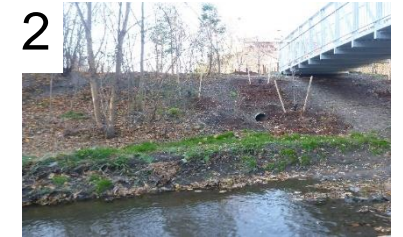
Minor bank erosion

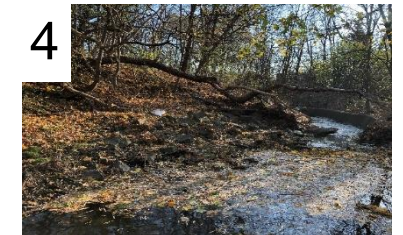
Transition to the downstream concrete channel

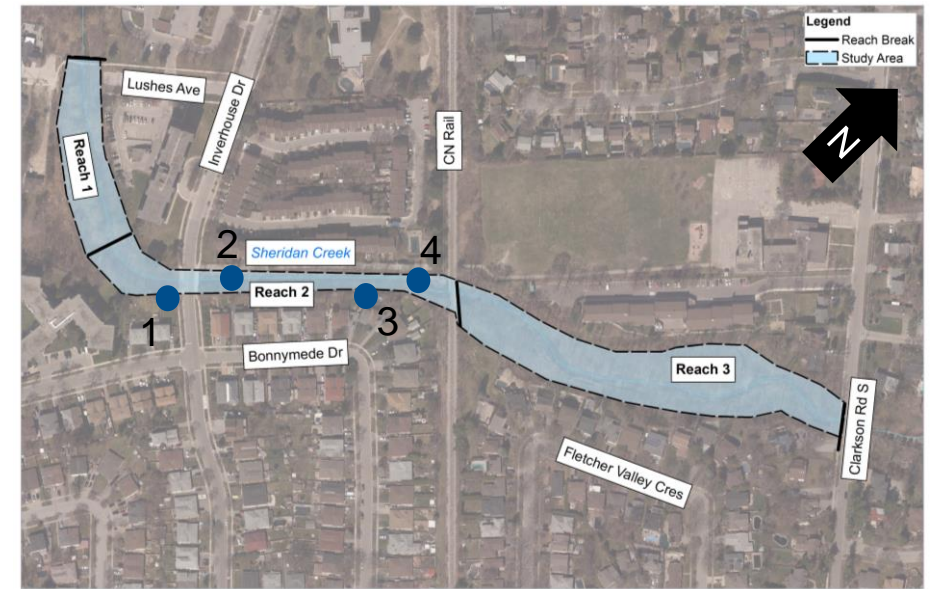
- Completely hardened channel with concrete bed and banks and gabion-lined valley slopes
- Concrete protection is cracked, displaced, and failing in segments along both the channel bed and bank
- Two stormwater outfalls within the reach in poor condition with displaced and failed concrete protection; subsurface infrastructure (sanitary and watermain) crossings under the channel
- Two concrete drop structures at the downstream limit of the reach
- Inverhouse Drive and CN rail bridge crossings within reach

Broken concrete bank

- Protect stormwater infrastructure and structural integrity of CN rail bridge abutments and Inverhouse Drive crossing through bed and bank protection
- Restore fish passage through removal of barriers and grade control
- Restore aquatic habitat and channel functions, including hydraulic function and sediment transport, through re-establishing a more natural but stable channel

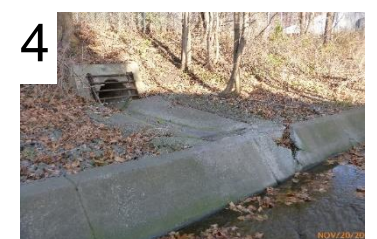
Cracked concrete bank

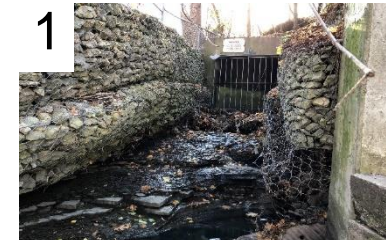
1
Scour of bed and damaged gabion baskets

- Remove failing bank protection and debris and stabilize banks with alternative treatments to protect stormwater infrastructure and private property from erosion and reduce hazard to public safety
- Restore fish passage through removal of barriers and grade control
- Enhance geomorphic stability and aquatic habitat of the channel through establishment of natural watercourse features

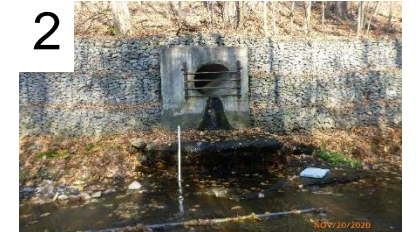
2
Downcutting of the channel bed

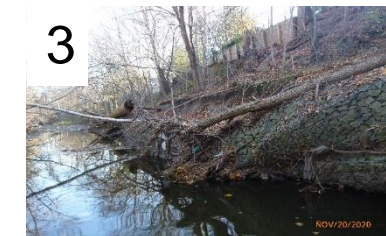
3
Failed gabion baskets

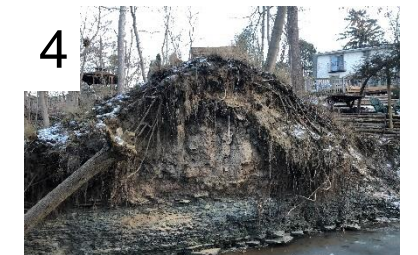
4
Bank erosion and downcutting
