**Tree Inventory and Preservation Plan Report
128 Lakeshore Road East
Mississauga, Ontario**

29 October 2021

KUNTZ FORESTRY CONSULTING Inc. Project P2995

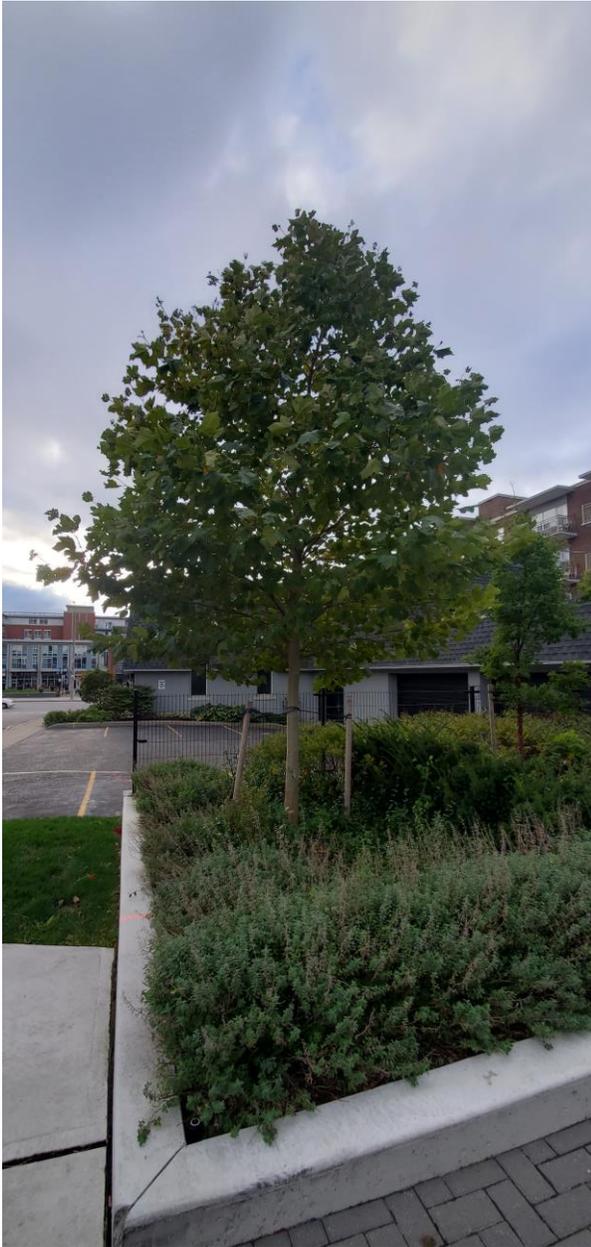
Image 1. Tree 1

The preservation of Tree 1 will be possible. Given that the dripline of Tree 1 is completely within the neighbouring property, tree preservation fence will not be required. Refer to Figure 1 for the proposed tree preservation and general Tree Protection Plan Note.

The findings of the study indicate a total of two trees on and within six metres of the subject property. The removal of one tree is required to accommodate the proposed development. The remaining one tree can be saved. No tree preservation fence will be required for Tree 1.

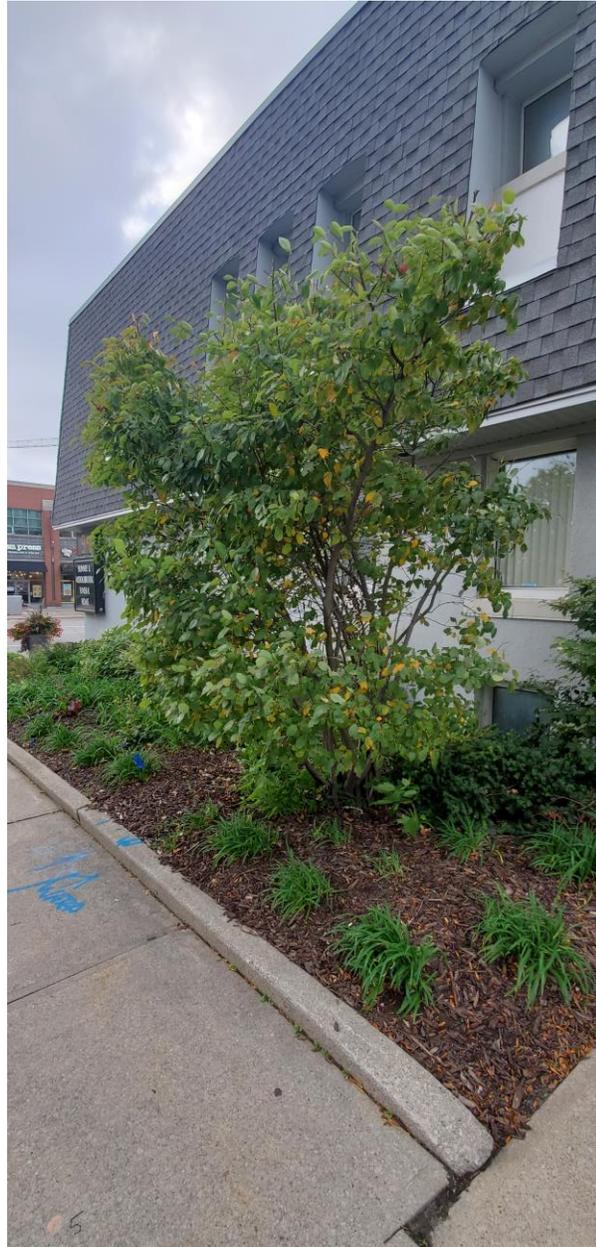
Image 2. Tree 2

The removal of Tree 2 is required as shoring for the underground parking is required at the property boundary. Tree 2 is a shrubby, multi-stemmed serviceberry tree planted in a small flower garden in front of the subject property – the tree is likely planted by the previous owner/tenants and not a city standard street tree. Refer to Figure 1 for the locations of the proposed tree removals.
