Memorandum

Project #: 1903701

Re: Fluvial Geomorphology Review
2935 & 2955 Mississauga Road

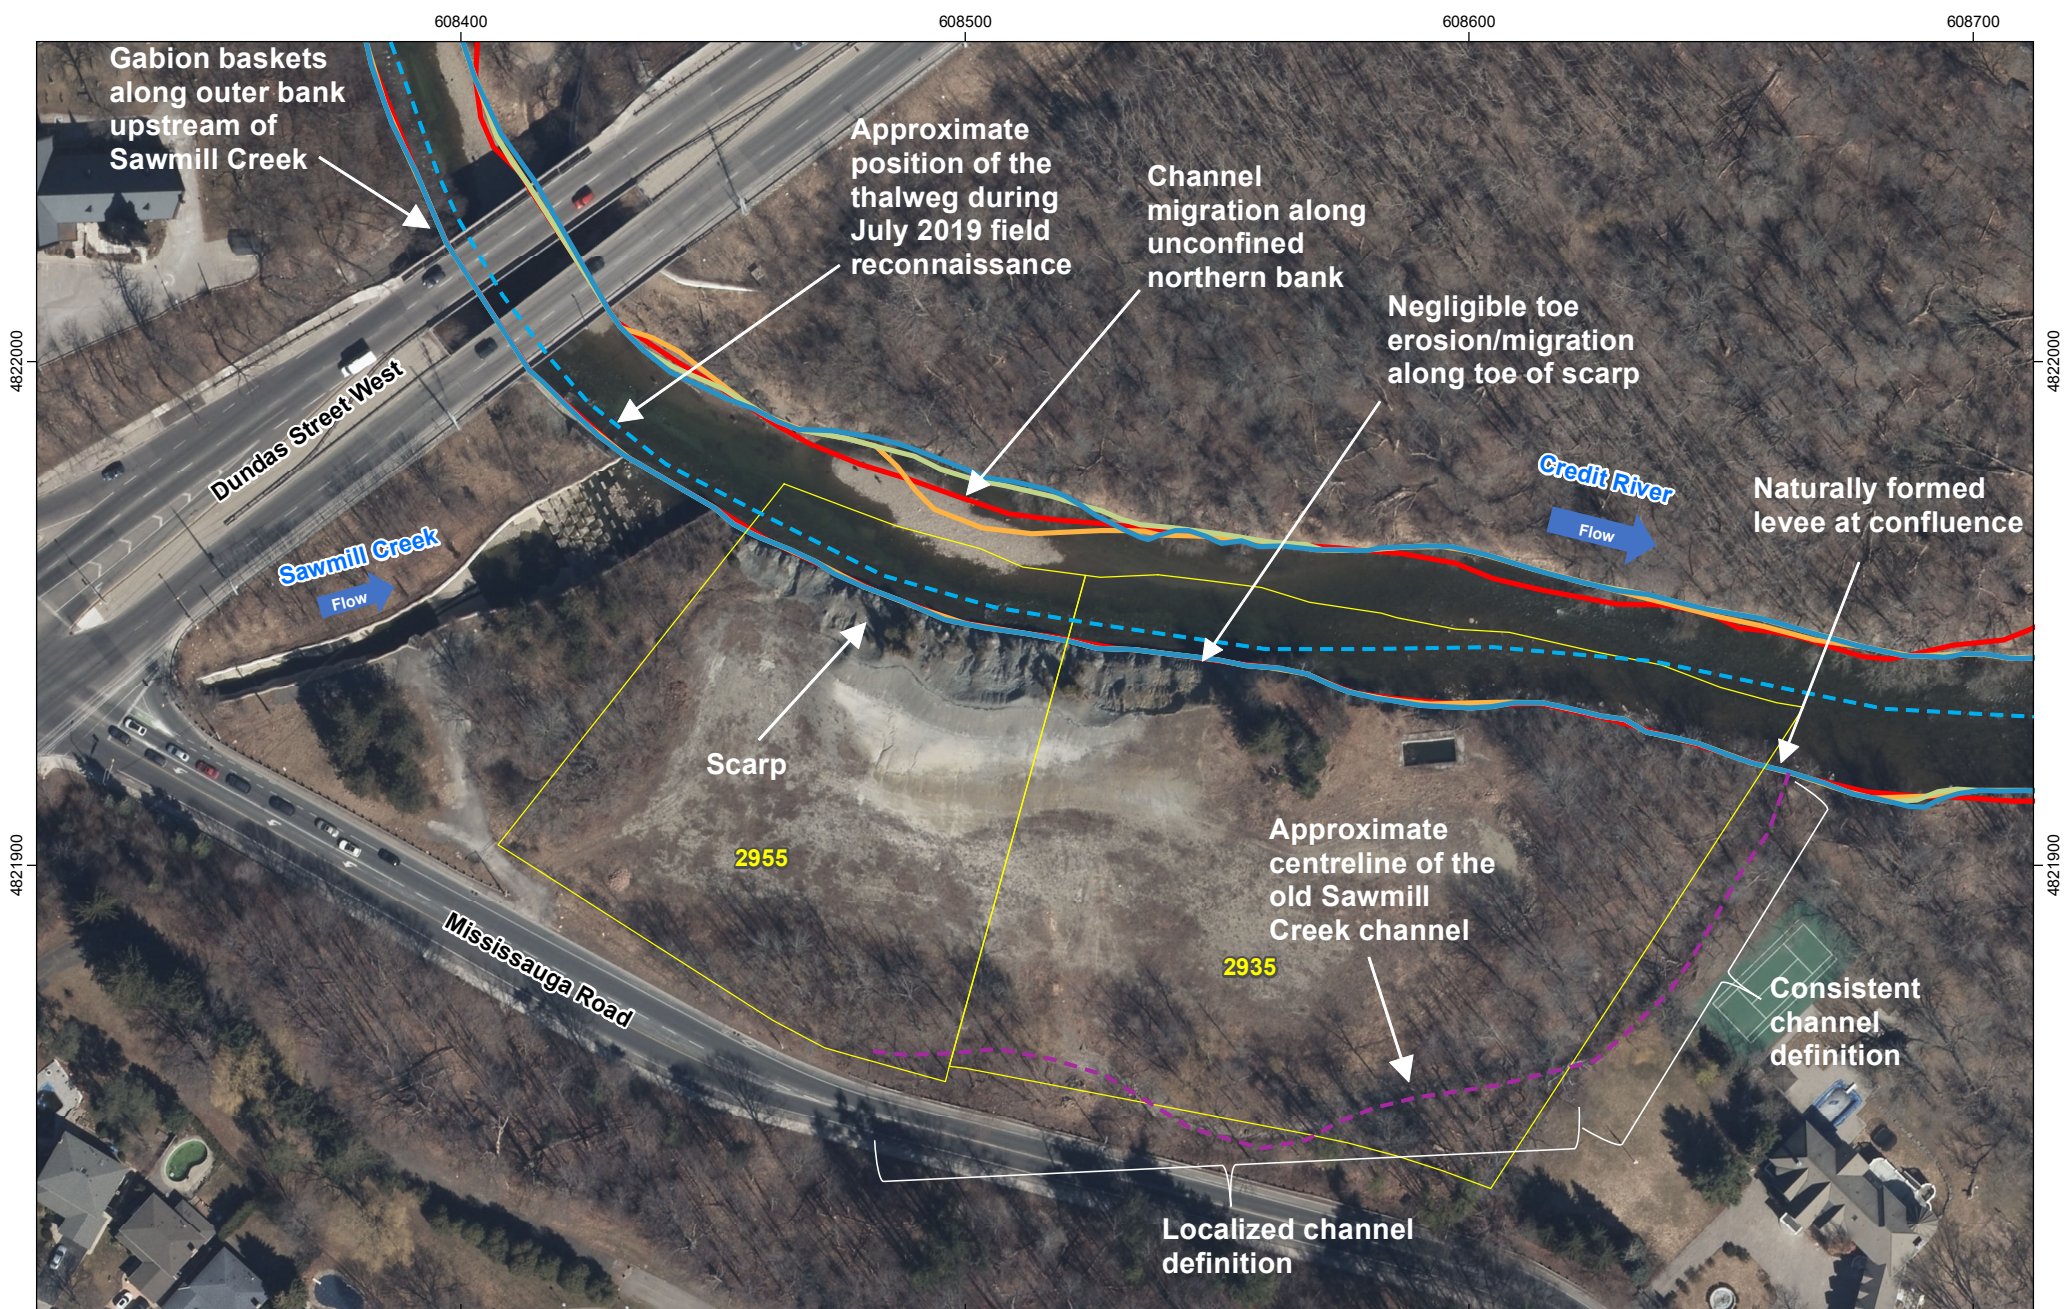
Figure 1

Since 1977, Sawmill Creek discharged into Credit River through a concrete flume structure immediately west of the subject properties (**Figure 1**). Prior to 1977, Sawmill Creek flowed through the subject properties and discharged into Credit River near the eastern property limit (**Figure 1**). Between 1954 and 1977, Sawmill Creek was realigned and straightened on several occasions. Following the construction of the concrete flume, the old Sawmill Creek channel within 2955 Mississauga Road was infilled. The old Sawmill Creek channel within 2935 Mississauga Road conveys storm water from a small catchment (approximately 2 ha) along Mississauga Road. During large flood events on Credit River, the downstream portion of the

Along the scarp, the exposed shale is nearly vertical and extends approximately 2 m to 3 m up the bank (**Photo 7**). Till overlies the shale. Locally, an alluvial 'cap' of gravel, cobbles and boulders was observed atop the till. The alluvial material would have been deposited when the bottom of Credit River was roughly coincident with the top of the terrace in the early Holocene (i.e. before the channel incised and the scarp was formed). Based on overlay analyses, the position of toe of the scarp has remained consistent since 1975 (**Figure 1**).

The southern bank of Credit River has not migrated over 43 years of photographic record (**Figure 1**). In this case, however, the 5 m toe erosion allowance used by Terraprobe (2008) in association with its long-term stable slope assessment is appropriately conservative based on CVC (1992) and MNR (2001) protocols. The exposed face of shale comprising the lower bank is actively weathering and vulnerable to fluvial and colluvial erosion. Furthermore, if the error inherent in riverbank linework is assumed to be approximately 2 m, then a 43-year record of 'unmeasurable erosion' could equate to as much as 4.7 m (~5 m) of migration over a 100-year period.

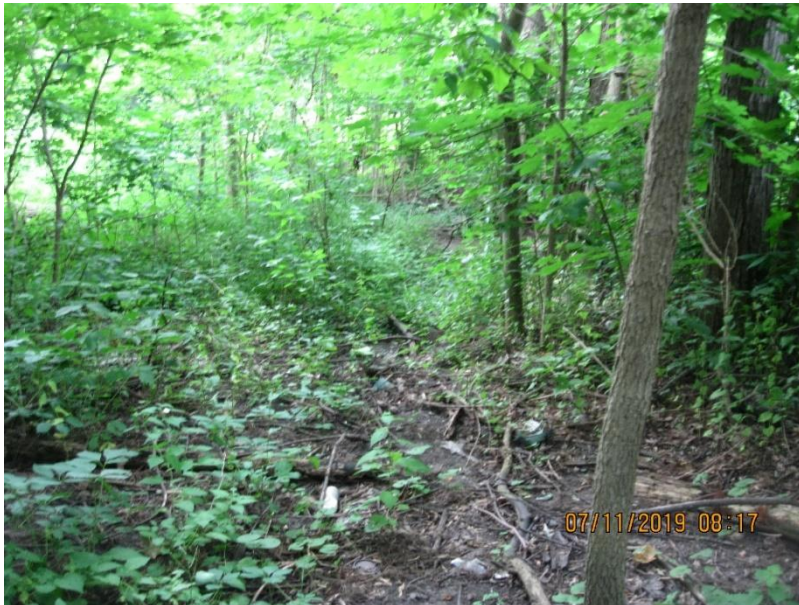
Within 2955 Mississauga Road, the old Sawmill Creek alignment is anthropogenically infilled and/or lacked channel definition (**Figure 1**). Localized channel definition is present within the 2935 Mississauga Road property where the channel parallels Mississauga Road (**Photo 1**). Localized scour has occurred downstream of three separate storm water culverts that drain beneath Mississauga Road. Consistent channel definition is present along the eastern property limit, immediately upstream of the confluence with Credit River (**Photo 2**). Along this section, the channel cross-section is trapezoidal and the bed and banks are locally armoured with cobble, boulders and concrete rubble. The top of bank width (16 m) and top of bank depth (2 m) is considerably wider and deeper than along the upstream section parallel to Mississauga Road. It is also abnormally large for the drainage area (9.9 km²) of Sawmill Creek prior to the realignment to the concrete flume in 1977. The trapezoidal shape, unnaturally large cross-sectional dimensions, and local hardening is likely a result of previous anthropogenic realignment and straightening prior to 1977.

Photo 1. *Looking downstream along the Old Sawmill Creek channel adjacent to Mississauga Road in 2935 Mississauga Road. The channel lacks consistent definition.*

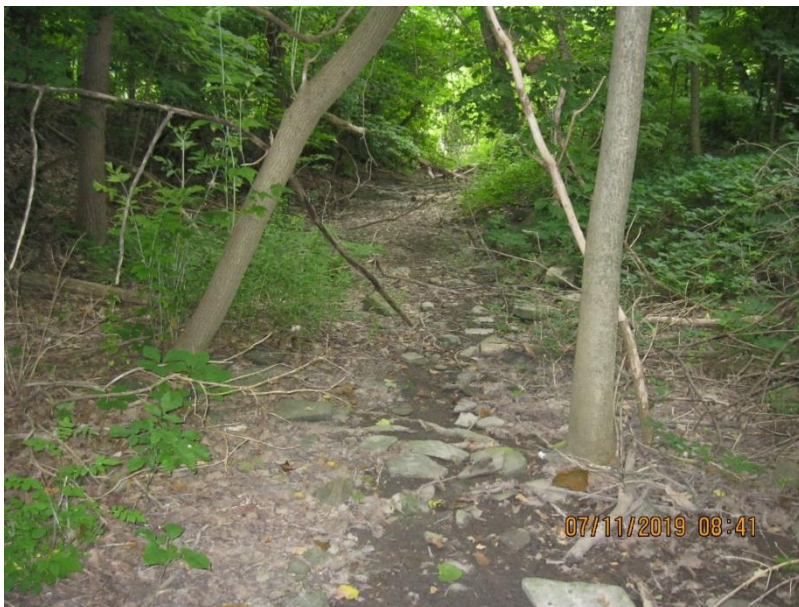
Photo 2. *Looking upstream in the Old Sawmill Creek channel along the eastern extent of 2935 Mississauga Road, just upstream of the confluence with Credit River. Remnants of localized bed and bank armouring are present. Trees and shrubs have grown along the periphery of the engineered channel.*

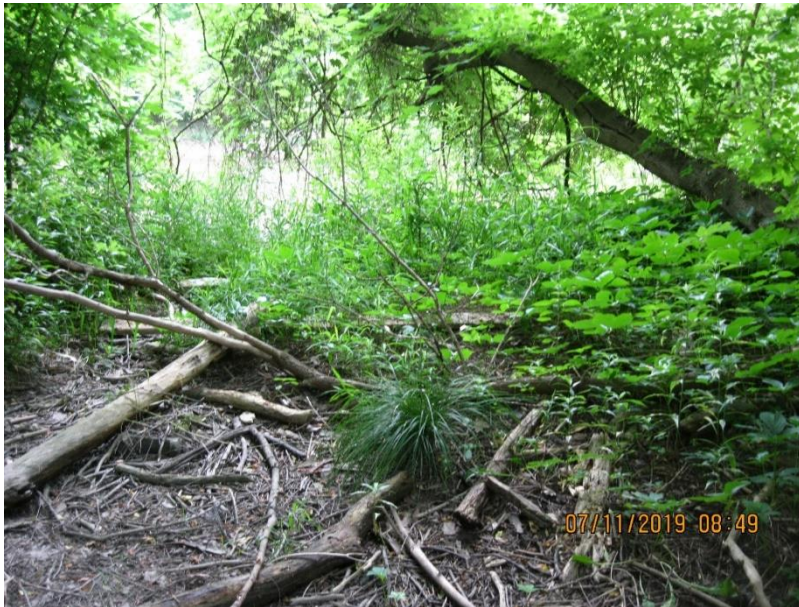
Photo 3. *Looking downstream at a naturally formed levee along Credit River that has blocked the mouth of the old Sawmill Creek channel. Rafted woody debris has accumulated on the berm and upstream into the old Sawmill Creek channel.*

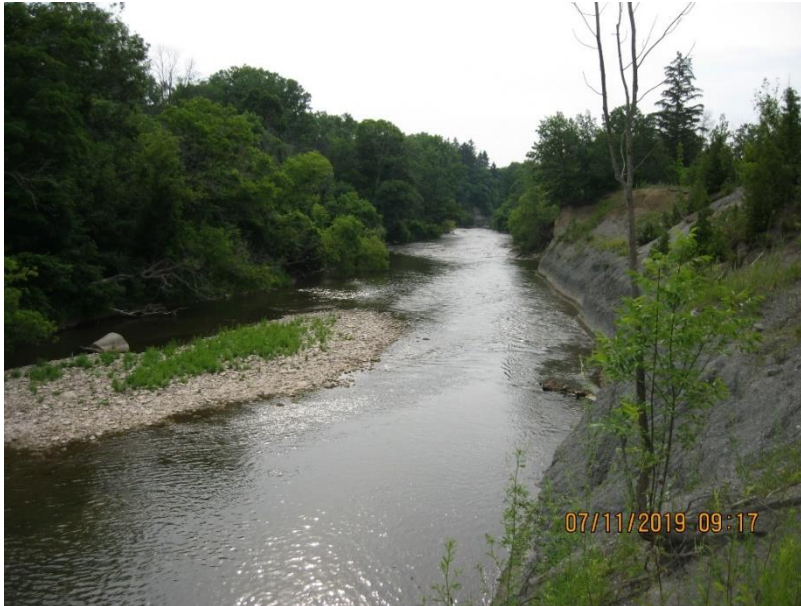
Photo 4. *Looking downstream from the existing confluence of Sawmill Creek and Credit River. The thalweg of Credit River is positioned against or near the terrace scarp for approximately 170 m before being deflected towards the eastern bank.*

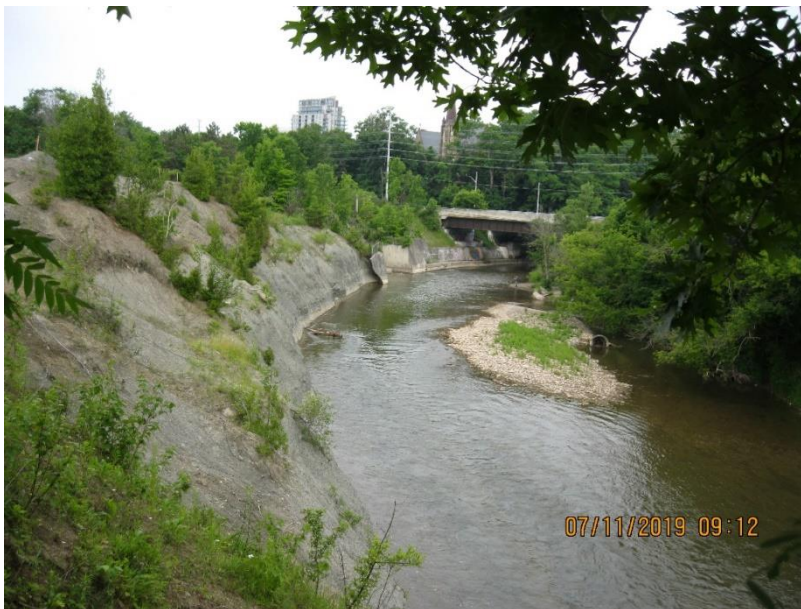
Photo 5. *Looking upstream along Credit River from 2935 Mississauga Road.*

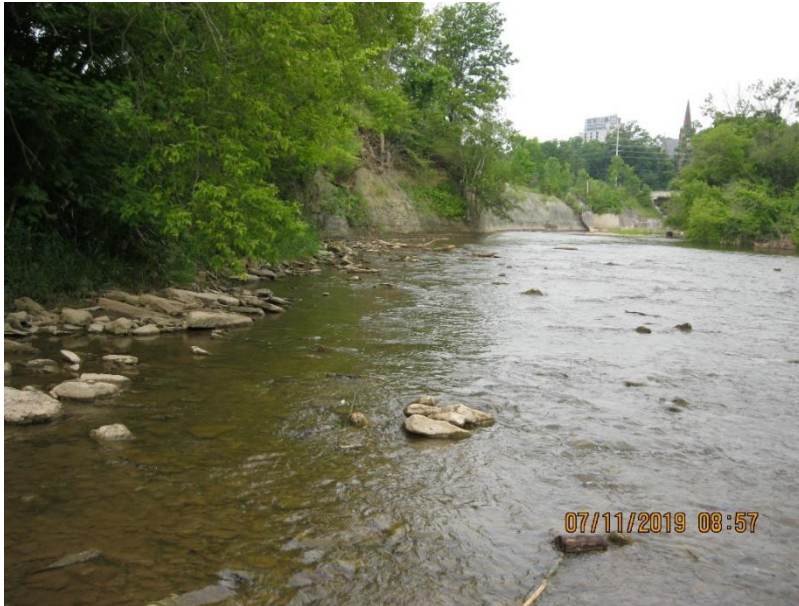
Photo 6. *Looking upstream along Credit River from the confluence with the old Sawmill Creek channel. Downstream of the exposed scarp the thalweg is deflected towards the opposite bank.*

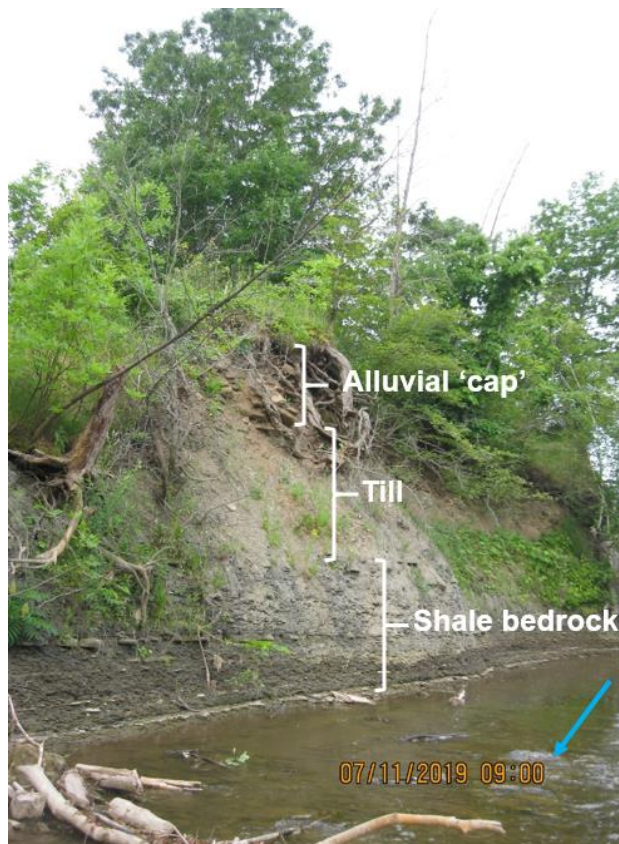
Photo 7. *Generalized stratigraphy of the terrace scarp within the 2935 Mississauga Road property.*
