Applicant:
Bousfield Inc.
P. Stewart
DARC 22-255

Arborist Report and Tree Protection Plan for 1580 and 1650 Dundas St. E Mississauga, Ontario

September 2021

July 2022

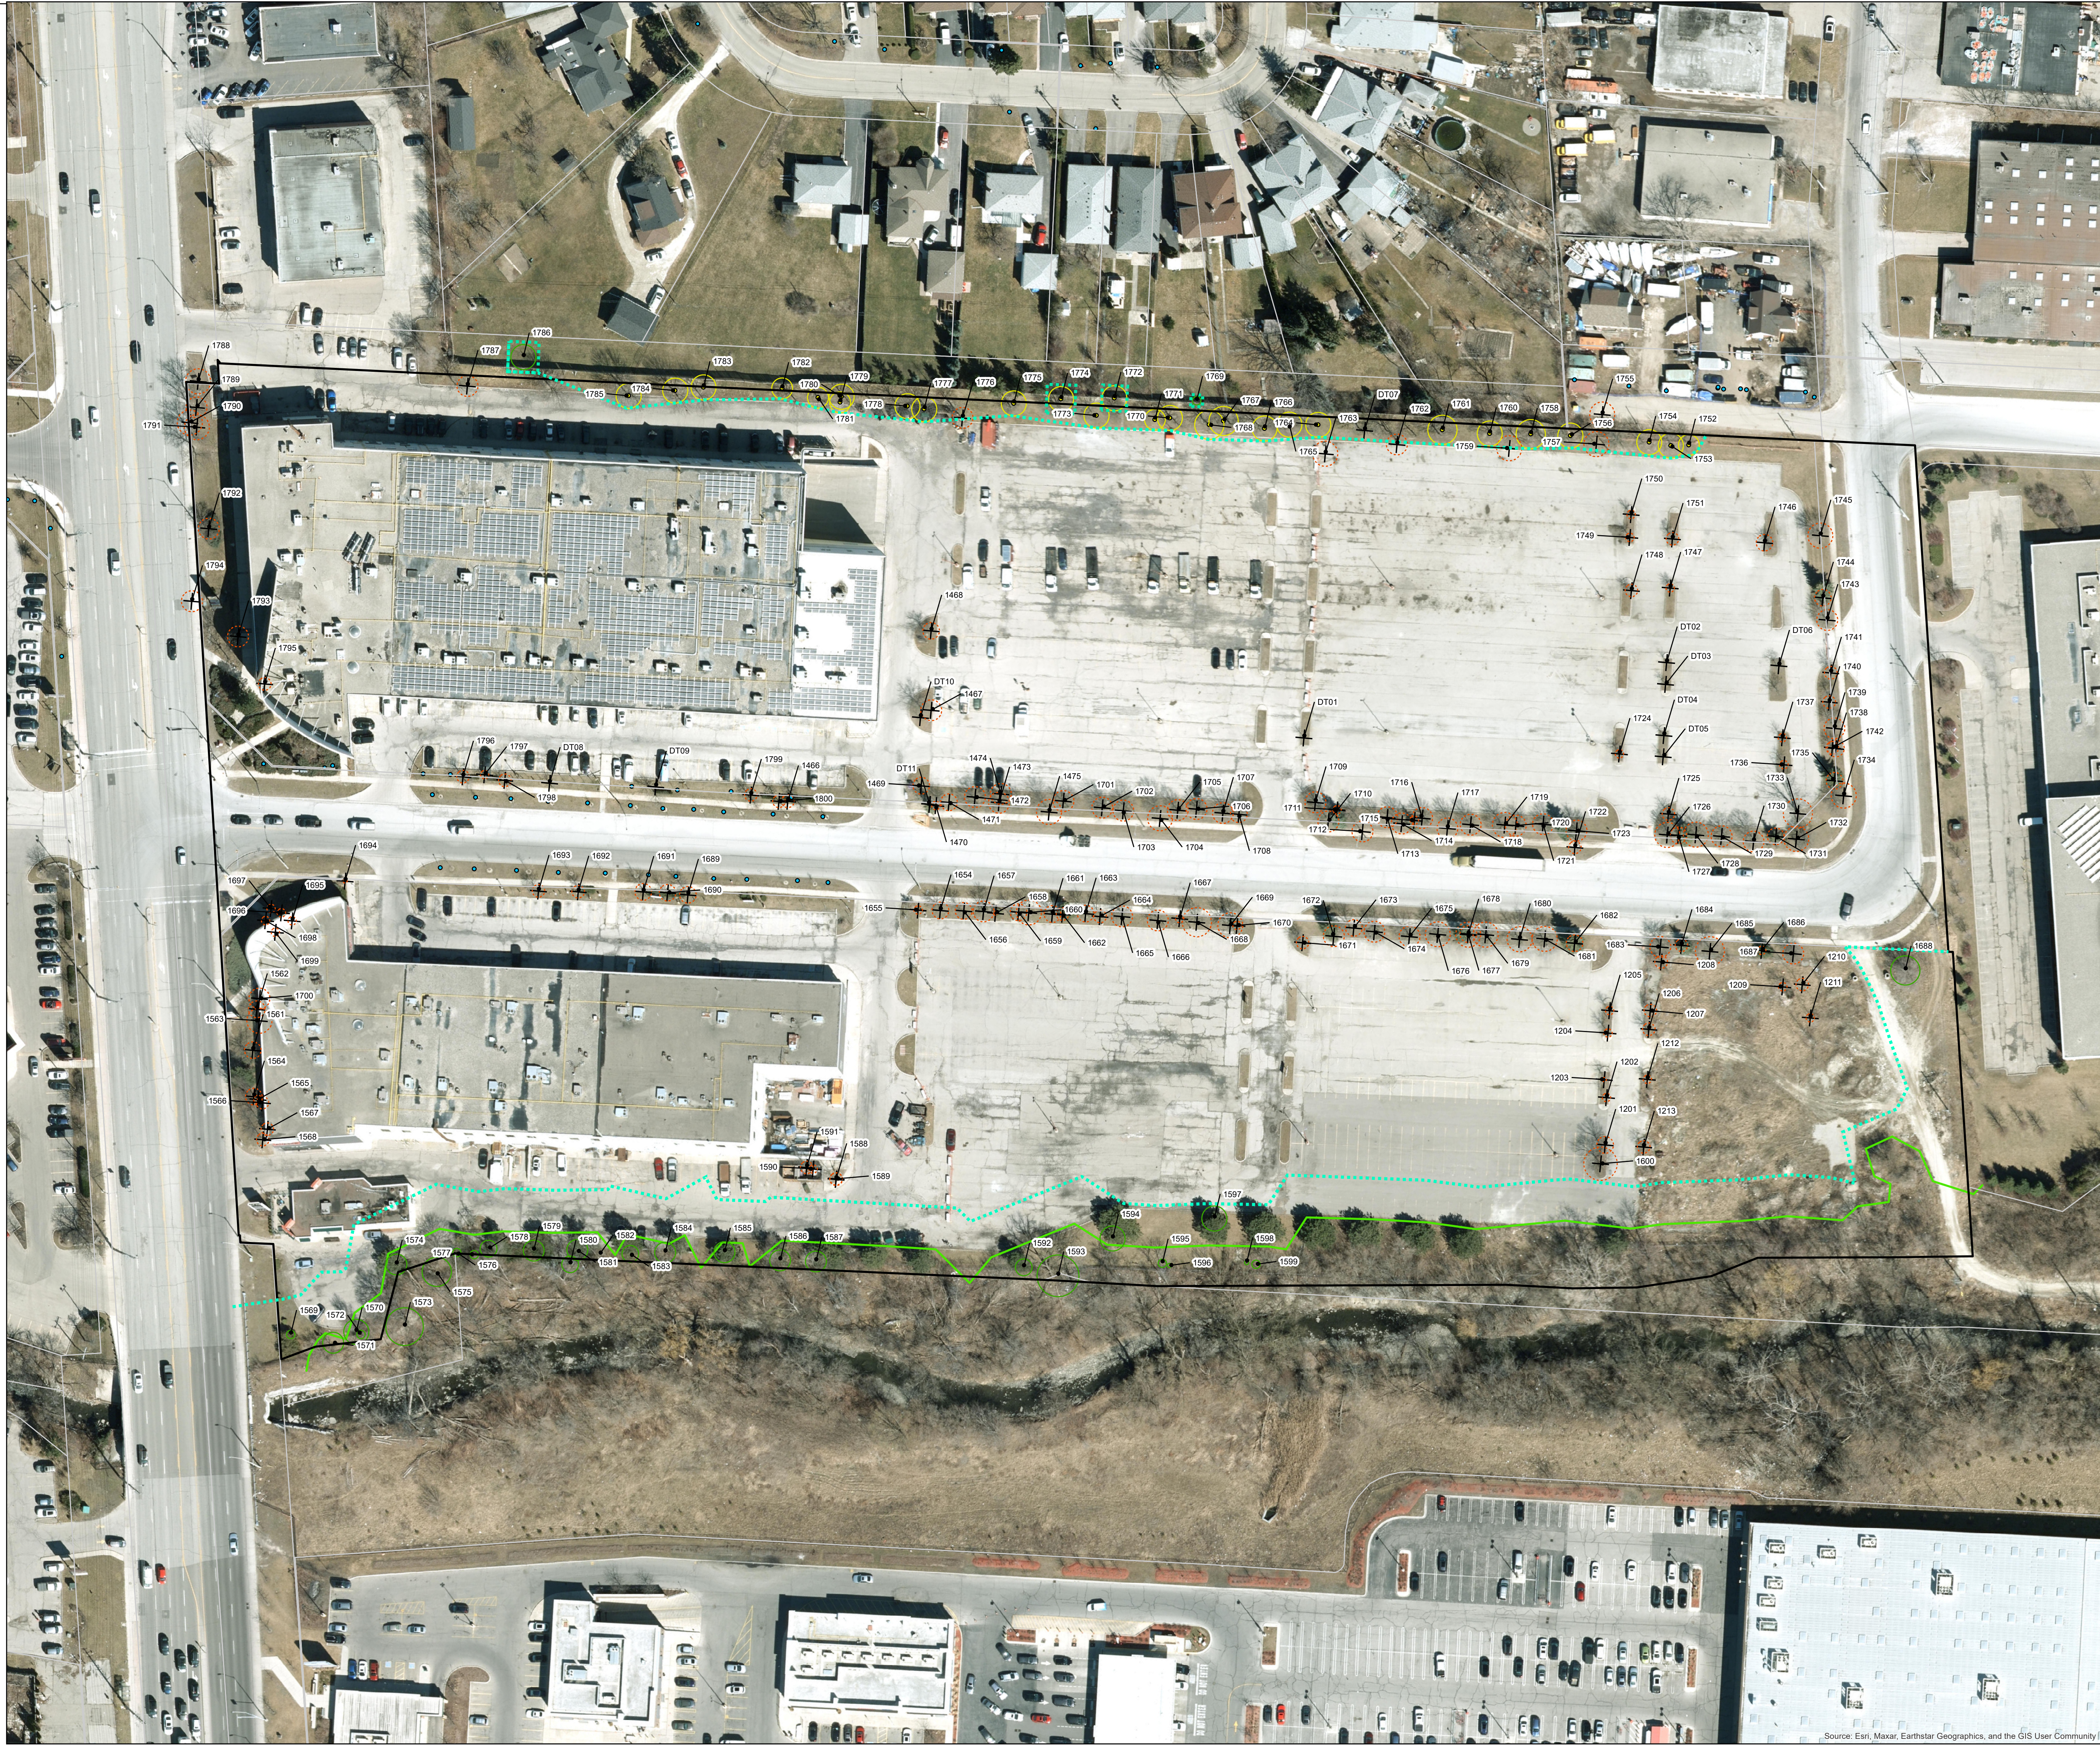
location in relation to the proposed works and areas of disturbance. As illustrated on the Tree Protection Plan (**Appendix A**), **164 trees with a DBH greater than 10 cm have been identified for removal and an additional 27 will be impacted. 201 of the tallied trees under 10 cm DBH are also to be removed. All trees recommended for removal are not compatible with construction of the proposed development.**

- **All trees shown as Impact require root pruning** as proposed works are likely within the root zone of these trees. It is recommended that roots hand dug and pruned according to standard arboricultural practices before excavation to minimize damage to tree roots. Exposed roots should be backfilled with native soil as soon as possible to prevent desiccation and to promote root growth. Exposed roots should not be allowed to dry out. Backfill should be clean, and if possible, from within graded areas within the work site. Backfilled soil must come into contact with existing soil cleanly (e.g. no sod, air pockets removed, etc.).

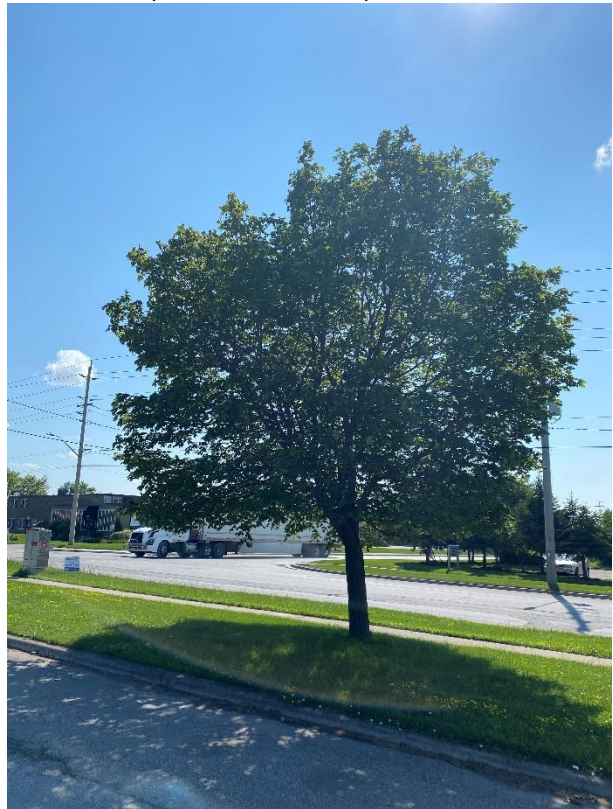
Tree #1746 (1650 Dundas St E)
