**Tree Inventory and Preservation Plan Report
49 South Service Road
Mississauga, Ontario**

15 September 2022, Revised 14 October 2022

KUNTZ FORESTRY CONSULTING Inc. Project P3402

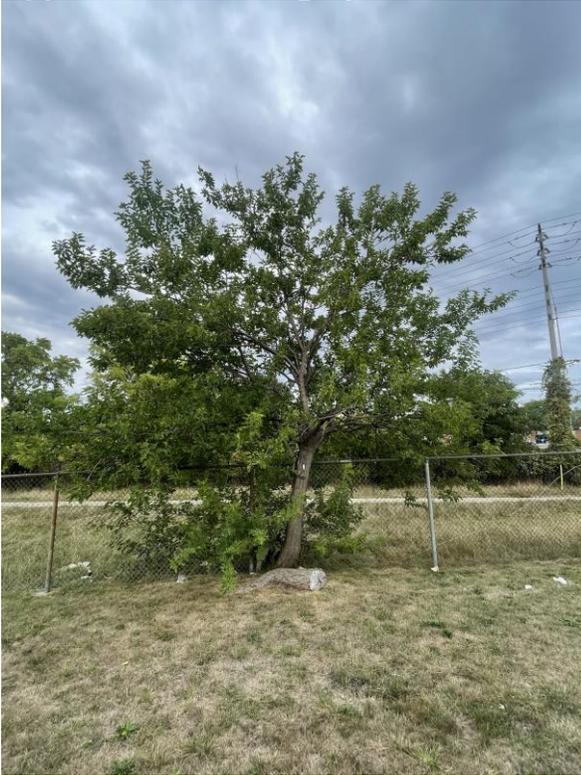
Image 1. Tree 168

The removal of Tree 168 is required to accommodate the proposed underground parking. Tree 168 is greater than 15cm DBH and is therefore protected by the City of Mississauga Private Tree By-law; a permit will be required prior to its removal. Refer to Figure 1 for the required tree removal.

Tree #	Common Name	Scientific Name	DBH	TI	CS	CV	CDB	DL	mTPZ	Ownership	Comments	Action	Comp.
168	White Mulberry	<i>Morus alba</i>	23.5	F	F	F	-	4	1.8	Subject Property	Included fence (L), Fluxing seam (M), Interfering branches (L), Lost stem (H)	Remove	2
A	Honey Locust	<i>Gleditsia triacanthos</i>	~10	G	F-G	G	-	2	1.5	MTO	~5m from fence	Preserve	-
B	Honey Locust	<i>Gleditsia triacanthos</i>	~10	F-G	F-G	F-G	-	3	1.5	MTO	~5m from fence	Preserve	-
C	Honey Locust	<i>Gleditsia triacanthos</i>	~12	F-G	F-G	F	-	3	1.5	MTO	~4m from fence, Grape vine competition (H)	Preserve	-
D	Honey Locust	<i>Gleditsia triacanthos</i>	~10	F	F	F	-	2	1.5	MTO		Preserve	-
E	Honey Locust	<i>Gleditsia triacanthos</i>	~12	F	F	F	-	3	1.5	MTO	Grape vine competition (H)	Preserve	-
F	Honey Locust	<i>Gleditsia triacanthos</i>	~10	F-G	F-G	F-G	-	3	1.5	MTO	Grape vine competition (H)	Preserve	-
G	Honey Locust	<i>Gleditsia triacanthos</i>	~8	G	G	G	-	2	1.2	MTO		Preserve	-

As such, a total of two (2) replacement trees are required on the subject property. Refer to the Landscape Plan for the proposed plantings. If the required replacement trees cannot be planted on the subject property, cash-in-lieu payments may be accepted at the City's discretion. Refer to Table 1 for the number of replacement trees required per individual tree removal.

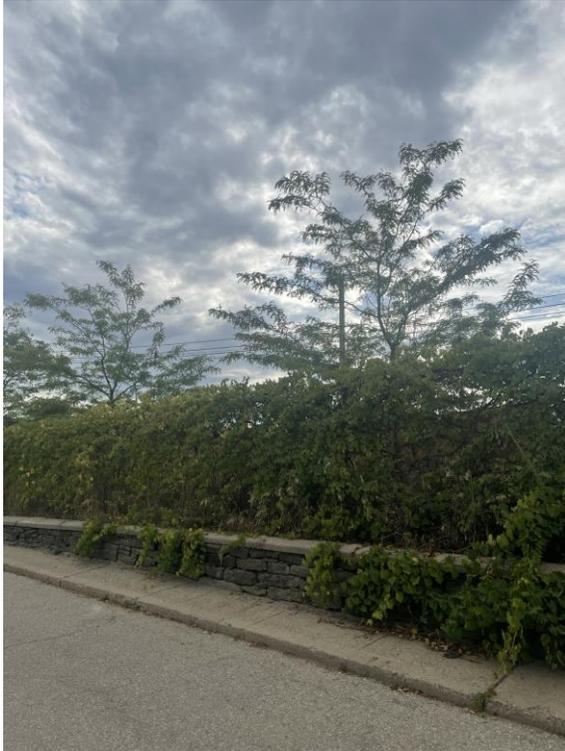
Image 5. Trees G and H (Right to left)

H	Honey Locust	<i>Gleditsia triacanthos</i>	~12	G	G	G	-	3	1.5	MTO		Preserve	-
I	Honey Locust	<i>Gleditsia triacanthos</i>	~10, 9, 6, 6, 5	F	P	F	-	3	1.5	MTO	Multi-stem @ ~1m, Weak unions (M)	Preserve	-
J	Honey Locust	<i>Gleditsia triacanthos</i>	<10	P-F	P	F	10	3	1.2	MTO	12 stems <10cm, Multi-stem @ ~1m, Grape vine competition (H)	Preserve	-
K	White Elm	<i>Ulmus americana</i>	~14	G	F	P	80	2	1.5	MTO	~7m from fence, Grape vine competition (H), Near death	Preserve	-
												TOTAL	2
