**Tree Inventory and Preservation Plan Report
3115 Hurontario Street
Mississauga, Ontario**

11 July 2022

KUNTZ FORESTRY CONSULTING Inc. Project P3292

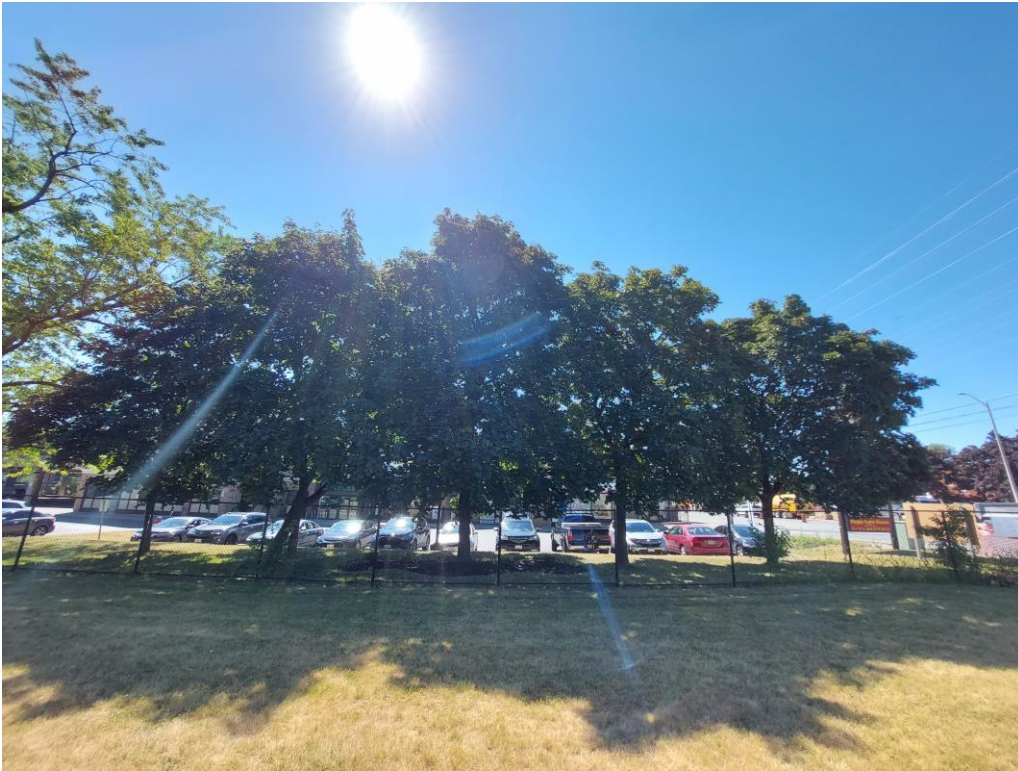
Image 1. Trees 1-6 (from right)

Tree #	Common Name	Scientific Name	DBH	TI	CS	CV	CDB	DL	mTPZ	Ownership	DL in SP	Comments	Action	Comp.
1	Norway Maple	<i>Acer platanoides</i>	30	G	G	G		4	1.8	Neighbour	0.5m	Exposed roots (L), growth deficit (L), pruning wounds (L), epicormic branches (L)	Preserve	
2	Norway Maple	<i>Acer platanoides</i>	31	FG	G	FG		4	2.4	Neighbour	1m	Co-dominance at 2.5m with included bark (L), exposed roots (L), pruning wounds (L), exposed roots (L)	Preserve	
3	Norway Maple	<i>Acer platanoides</i>	35	FG	G	FG		4.5	2.4	Neighbour	1.5m	Previously tagged 469, co-dominance in crown, pruning wounds (L), exposed roots (L), epicormic branches (L)	Preserve	
4	Norway Maple	<i>Acer platanoides</i>	25	FG	G	FG		3.5	1.8	Neighbour	1.5m	Co-dominance at 3.5m, pruning wounds (L), sweep (L)	Preserve	
5	Manitoba Maple	<i>Acer negundo</i>	36	F	G	FG		3.5	2.4	Neighbour	None	Co-dominance at 1.8m, lean (M) to southwest, pruning wounds (M), epicormic branches (M)	Preserve

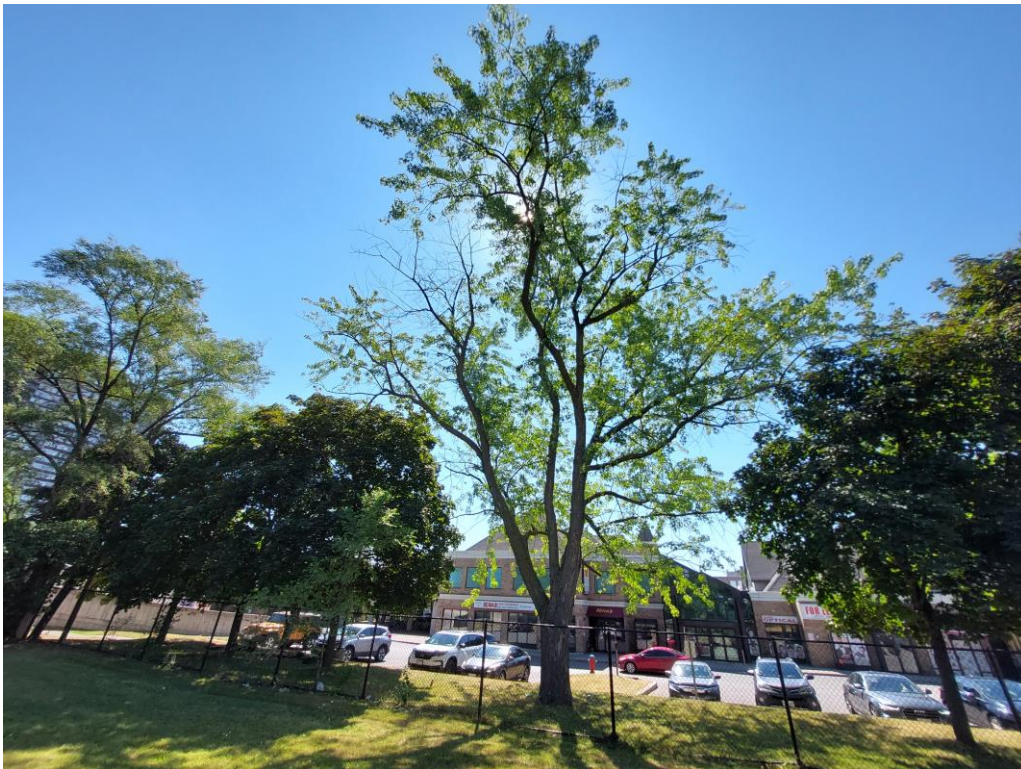
Image 2. Tree 7

6	Norway Maple	<i>Acer platanoides</i>	23	F	G	FG		3	1.8	Neighbour	None	Co-dominance at 4m, sweep (L), pruning wounds (M) with cavity	Preserve	
7	Silver Maple	<i>Acer saccharinum</i>	78.5	F	PF	PF	40	8	4.8	Neighbour	6m	Cavity at 1.6m, union at 2m, 3.5m, and 4m with 4 stems, deadwood, dead branches (M), epicormic branches (M), 1 stem has dead leader	Remove	6
8	Norway Maple	<i>Acer platanoides</i>	28	G	G	G		4	1.8	Neighbour	0.5m	Previously tagged 474, pruning wounds (L), exposed roots (L)	Preserve	
9	Norway Maple	<i>Acer platanoides</i>	27.5	FG	G	G		4	1.8	Neighbour	1m	Previously tagged 475, exposed roots (M), crook (L), growth deficit (L)	Preserve	
10	Siberian Elm	<i>Ulmus pumila</i>	15.5, 15, 14, 11.5, 9.5	F	F	PF	29	3	1.5	Neighbour	None	Previously tagged 476, union at 1m, bow (L) to south, chlorosis (M), pruning wounds (L)	Preserve	
11	Norway Maple	<i>Acer platanoides</i>	23.5	G	G	G		3.5	1.8	Neighbour	None		Preserve

The removal of 23 trees is required to accommodate the proposed development. Required tree removals include Trees 7, 13-16, 18-29, and 31-36. All trees that require removal are greater than 15cm DBH and protected by the City of Mississauga Private Tree By-law; a permit will be required prior to their removal. Trees 7, 13-16, and 18 are located on the adjacent property; written consent from the respective property owner is required prior to their removal. Refer to Figure 1 for the required and recommended tree removal.

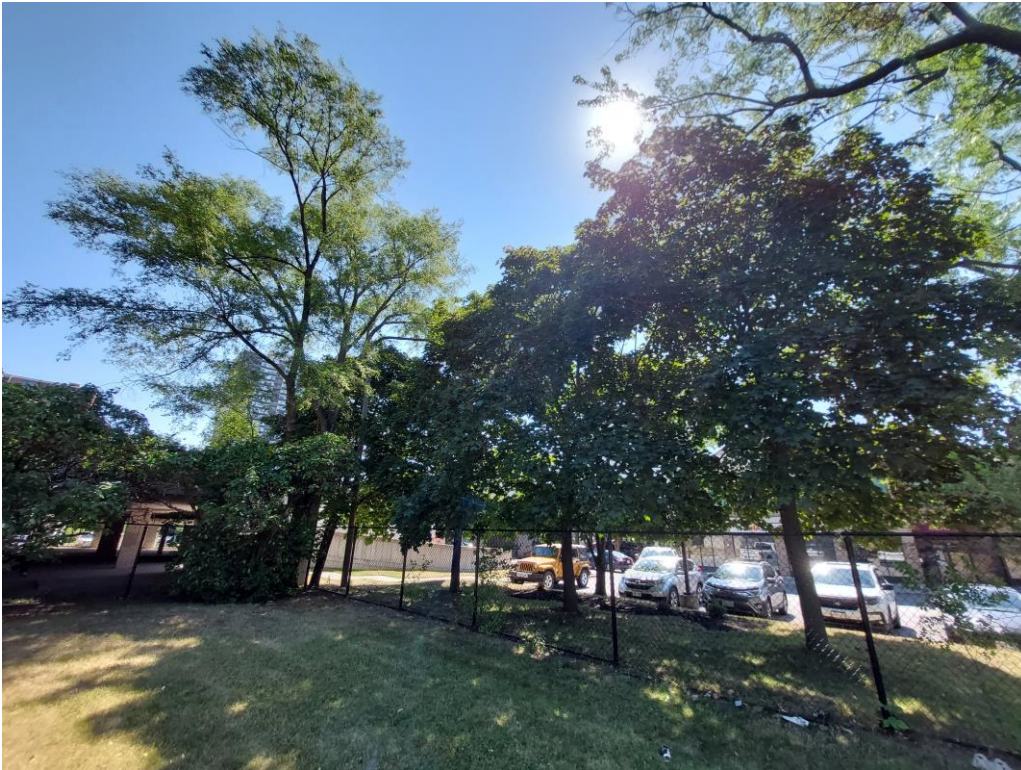
Image 3. Trees 8-12 and 18 (from right)

Minor encroachment into the minimum Tree Protection Zone (mTPZ) of Tree 12 is required to accommodate the proposed development. Given that encroachment is limited to outer edge of the mTPZ, long-term adverse impacts are not anticipated to the tree.

12	Norway Maple	<i>Acer platanoides</i>	29.5	F	FG	FG		4	1.8	Neighbour	1m	Seam (L) - closed, spiral stem, lean (L) to south, crook (M)	Preserve	
13	Norway Maple	<i>Acer platanoides</i>	46.5	P	G	G		5	3	Neighbour	4m	Hazard , co-dominance at 3m with split from union to 0.5m from ground	Remove	4
14	Norway Maple	<i>Acer platanoides</i>	33.5	FG	FG	PF	20	5	2.4	Neighbour	4m	Previously tagged 480, exposed roots (L), co-dominance at 3.5m, broken branches (L)	Remove	3
15	Norway Maple	<i>Acer platanoides</i>	26.5	FG	FG	FG		4	1.8	Neighbour	4m	Previously tagged 481, co-dominance at 4m, asymmetrical crown (M)	Remove	2
16	Norway Maple	<i>Acer platanoides</i>	41	FG	G	FG		6	3	Neighbour	5m	Previously tagged 482, co-dominance at 4m	Remove	3
17	Norway Maple	<i>Acer platanoides</i>	28	PF	FG	FG		3.5	1.8	Neighbour	None	Stem wound (H) from failed stem at 3m, deadwood, asymmetrical crown (M), overhead utility wires in crown	Preserve

18	Siberian Elm	<i>Ulmus pumila</i>	47	F	F	F	20	5	3	Neighbour	5m	Union at 1m with included bark (M), broken branches (M), dead branches (L), epicormic branches (H)	Remove	4
19	Manitoba Maple	<i>Acer negundo</i>	62	P	PF	PF	30	7	4.2	Private	-	Co-dominance at 2m, included fence (L) at base, stem wound (L), deadwood, pruning wounds (M), dead branches (M), sweep (L), lean (L) to west, dead leader, epicormic branches (M)	Remove	5
20	Norway Maple	<i>Acer platanoides</i>	28.5	F	F	FG		3	1.8	Private	-	Lean (L) to south, sweep (L), crook (M), asymmetrical crown (H)	Remove	2
21	Norway Maple	<i>Acer platanoides</i>	28	G	G	G		3.5	1.8	Private	-	Grape vine competition (L)	Remove	2
22	Norway Maple	<i>Acer platanoides</i>	21.5, 21	FG	G	G		3.5	1.8	Private	-	Co-dominance at base, bow (L)	Remove	2
23	Norway Maple	<i>Acer platanoides</i>	18, 14, 11.5	F	G	G		4	1.5	Private	-	Union at base and 0.3m with included bark (M), sweep (M), lean (M)	Remove	2

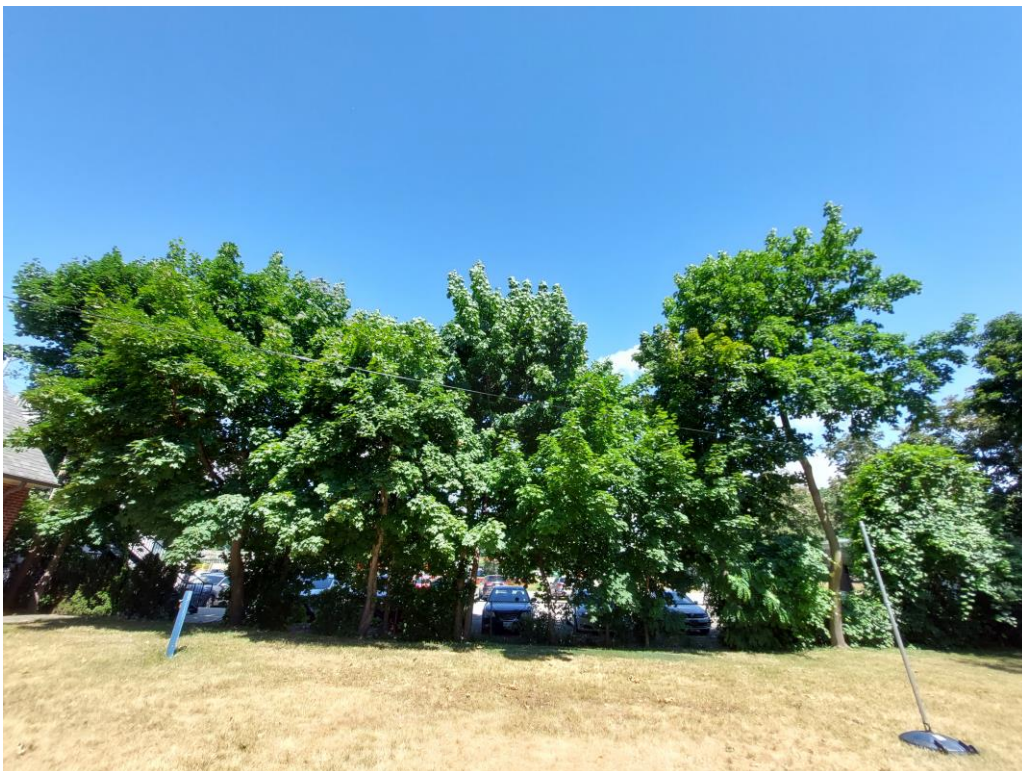
Image 8. Trees 20-25 (from right)

24	Norway Maple	<i>Acer platanoides</i>	18	FG	FG	G		2.5	1.5	Private	-	Crook (M), asymmetrical crown (M)	Remove	2
25	Norway Maple	<i>Acer platanoides</i>	33.5	F	FG	G		3.5	2.4	Private	-	Bow (L) to southwest, co-dominance at 2m with included bark (M), crook (L), asymmetrical crown (M), sweep (L)	Remove	3
26	Norway Maple	<i>Acer platanoides</i>	17.5	G	G	G		3	1.5	Private	-		Remove	2
27	Norway Maple	<i>Acer platanoides</i>	20	G	G	G		3	1.5	Private	-		Remove	2
28	Norway Maple	<i>Acer platanoides</i>	18.5	G	G	G		3	1.5	Private	-		Remove	2
29	Eastern White Cedar	<i>Thuja occidentalis</i>	19	G	P	P	90	1	1.5	Private	-		Remove	2
30	Honey Locust (shademaster)	<i>Gleditsia triacanthos 'inermis'</i>	10	G	G	G		2	1.5	Neighbour	None		Preserve	
31	Blue Spruce	<i>Picea pungens</i>	33	G	F	F	15	1.5	2.4	Private	-		Remove	3
32	Norway Spruce	<i>Picea abies</i>	29	G	F	F	20	2	1.8	Private	-	Asymmetrical crown (M)	Remove	2
33	Blue Spruce	<i>Picea pungens</i>	30	G	P	P	85	1.5	1.8	Private	-		Remove	2

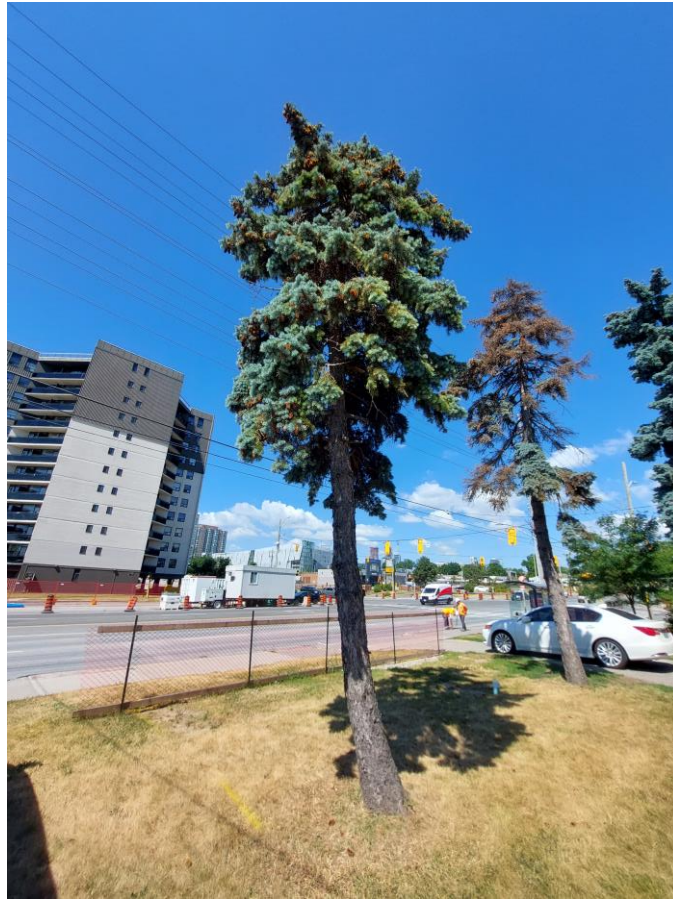
Image 15. Tree 34

34	Blue Spruce	<i>Picea pungens</i>	26	FG	F	PF	35	1.5	1.8	Private	-	Lost leader, sweep (L)	Remove	2
35	Manitoba Maple	<i>Acer negundo</i>	63	PF	PF	PF	20	7	4.2	Private	-	Coppice growth (M) at base, union at base with 3 stems, dead branches (L), sparse leader, epicormic branches (H), lean (M) to south, sweep (L)	Remove	5
36	Eastern Red Cedar (Juniper)	<i>Juniperus virginiana</i>	30	F	F	F		2.5	1.8	Private	-	Frost crack (M), lean (L) to east, asymmetrical crown (M)	Remove	2
													TOTAL	64
