# ARBORIST REPORT

## PROPOSED MIXED-USE DEVELOPMENT CITY OF MISSISSAUGA

***SITE LOCATION:***  
**579-613 LAKESHORE ROAD EAST  
MISSISSAUGA, ONTARIO**

**October 28, 2022 – Issued for Rezoning**

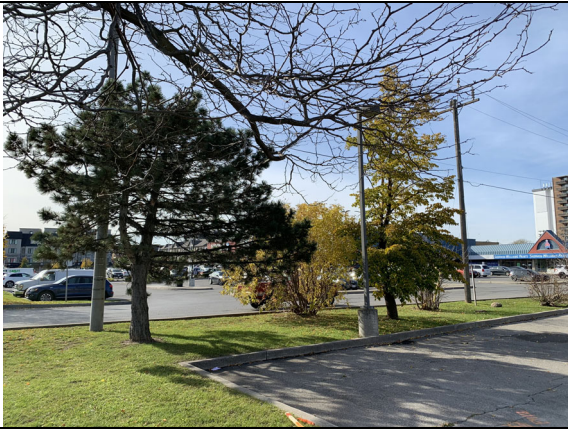
Tree# 1 & 2

<b>EXISTING TREE INVENTORY</b>										
KEY	SPECIES	CALIPER	CROWN	HEALTH	STRUCTURE	COMMENTS	PRESERVATION	OWNERSHIP	MIN. TPZ	KEY
		IN (cm)	IN (m)	G/F/P			DIRECTION			
1	Linden	28.5	5.0	Poor	One sided form	60% dead, declining	REMOVE	PRIVATE	1.8	1
2	Austrian Pine	33.0	7.0	Good	Double leader	Asymmetrical form	REMOVE	PRIVATE	2.4	2
3	Honey locust	37.0	11.0	Fair	Asymmetrical form	Epicormic growth throughout	REMOVE	CITY	2.4	3
4	Honey locust	41.0	14.0	Good	Good form	Some epicormic growth on lower branches	REMOVE	PRIVATE	3.0	4
5	Honey locust	35.0	13.0	Good	One sided form	Elevated crown, east side pruned due to hydro wires	REMOVE	PRIVATE	2.4	5
6	Honey locust	31.5	10.0	Fair	Good form	Minor dieback in crown	REMOVE	PRIVATE	2.4	6
7	Linden	41.0	6.0	Good	Double leader	Significant sucker growth at base	REMOVE	PRIVATE	3.0	7
8	Linden	36.0	9.0	Good	Broad form	Multiple leaders, crowded by adjacent tree	REMOVE	PRIVATE	2.4	8

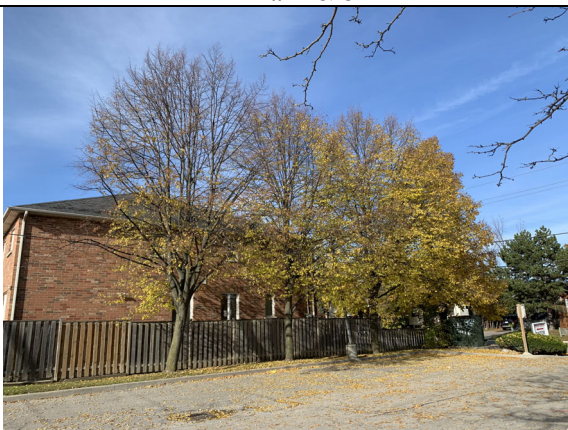
Tree# 7-10

9	Linden	30.0	9.0	Good	Asymmetrical form	Crowded by adjacent tree, elevated crown	REMOVE	PRIVATE	2.4	9
10	Linden	34.0	10.0	Good	Broad form	Minor dieback on lower branches	REMOVE	PRIVATE	2.4	10
11	Linden	35.0	7.0	Fair	Irregular form	Leaning, double leader, one sided form	REMOVE	PRIVATE	2.4	11
12	White Mulberry	20.0	7.0	Good	Pollarded form	Heavily pruned	PRESERVE	NEIGHBOUR	1.8	12
13	Juniper	15-21	7.0	Good	Multi-stemmed	One sided form, crowded by adjacent tree, elevated crown	REMOVE	PRIVATE	1.8	13
14	Juniper	40.0	7.0	Good	Multi-stemmed	Multiple stems fused together, One sided form, crowded by adjacent tree, elevated crown	REMOVE	PRIVATE	2.4	14
15	Juniper	31.0	8.0	Good	One sided form	crowded by adjacent tree, elevated crown	REMOVE	PRIVATE	2.4	15
16	Juniper	23.0	8.0	Good	Multi-stemmed	One sided form, crowded by adjacent tree, elevated crown	REMOVE	PRIVATE	1.8	16
17	Juniper	9-28	7.0	Fair	One sided form	Significant dieback on east side	REMOVE	PRIVATE	1.8	17

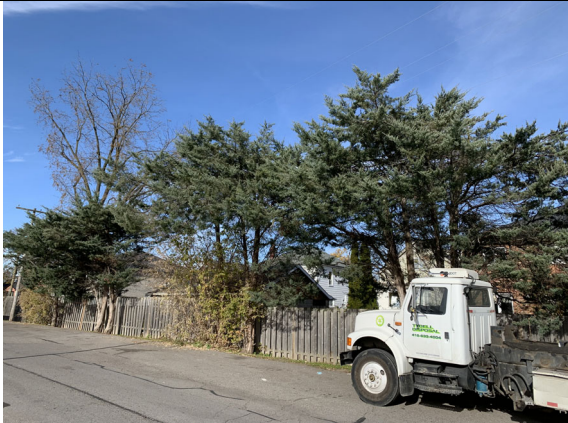
Tree# 13-19

18	Juniper	12-28	10.0	Fair	One sided form	Dieback on lower branches	REMOVE	PRIVATE	1.8	18
19	Juniper	22.5	7.0	Fair	One sided form	Crown subordinated by adjacent tree	REMOVE	PRIVATE	1.8	19
20	Black Walnut	60.0	15.0	Good	One sided form	West side of crown pruned due to overhead wires	PRESERVE	NEIGHBOUR	3.6	20
21	Manitoba Maple	25.0	7.0	Fair	One sided form	Leaning, epicormic growth throughout	PRESERVE	NEIGHBOUR	1.8	21
22	Silver Maple	Approx. 50	16.0	Good	Double stem	Broad form, low branching, minor internal dieback	PRESERVE	NEIGHBOUR	3.6	22
23	Norway Maple	20.0	8.0	Fair	Irregular form	Crossing branches, some sucker growth throughout	REMOVE	PRIVATE	1.8	23
24	Norway Maple	23.0	6.0	Poor	Irregular form	Wound at base, significant dieback in crown	REMOVE	PRIVATE	1.8	24
25	Norway Maple	24.0	8.0	Good	Good form	Minor decay near base, some internal deadwood	REMOVE	PRIVATE	1.8	25
26	Norway Maple	21.0	7.0	Poor	Good form	Girdled stem, basal decay, minor dieback throughout	REMOVE	PRIVATE	1.8	26

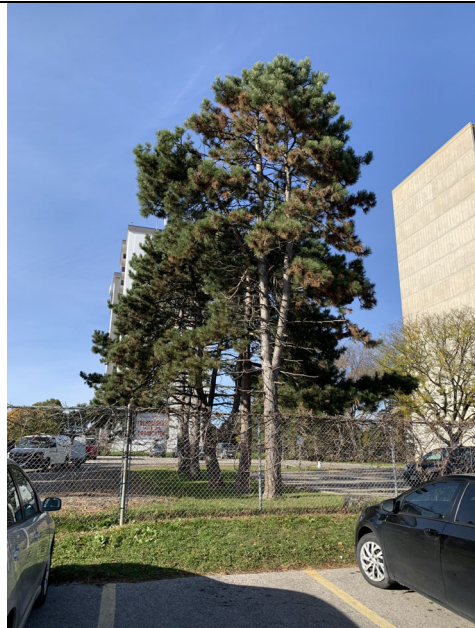
Tree# 27

27	Austrian Pine	Approx. 30	7.0	Fair	Co-dominant leaders	Elevated crown, crowded by adjacent trees, minor dieback in crown	PRESERVE	NEIGHBOUR	2.4	27
28	Austrian Pine	35.0	8.0	Fair	High crown	Dieback on lower branches, dieback in crown	PRESERVE	NEIGHBOUR	2.4	28
29	Austrian Pine	Approx. 35	8.0	Poor	One sided form	Crowded by adjacent tree, dieback on lower branches, no clear leader	PRESERVE	NEIGHBOUR	2.4	29
30	Serviceberry	6.0	2.0	Poor	Good form	Dieback throughout	REMOVE	EXEMPT	1.2	30
31	Linden	11.5	4.0	Good	Asymmetrical form	Girdled roots	REMOVE	EXEMPT	1.8	31
32	Linden	13.0	4.0	Good	Good form	Immature tree	REMOVE	EXEMPT	1.8	32
33	Linden	11.0	3.0	Good	Good form		REMOVE	EXEMPT	1.8	33
34	Linden	22.5	6.0	Good	Irregular form	Multiple leaders, lower limbs pruned, sucker growth at base	REMOVE	PRIVATE	1.8	34
35	Honey locust	10.0	4.0	Good	Good form	Immature tree	REMOVE	EXEMPT	1.2	35
36	Honey locust	9.0	3.0	Good	Good form	Immature tree	REMOVE	EXEMPT	1.2	36

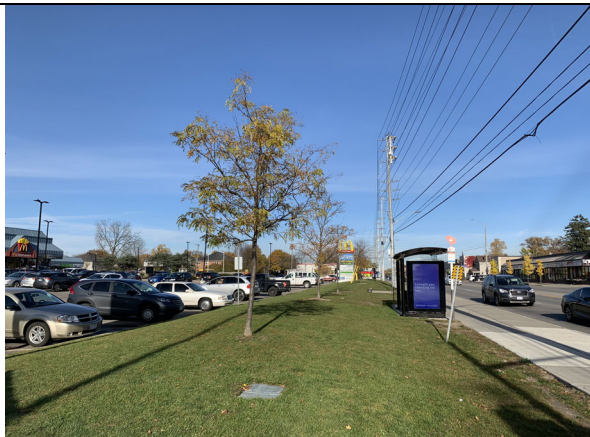
Tree# 35-40

37	Honey locust	9.0	3.0	Good	Good form	Immature tree	REMOVE	EXEMPT	1.2	37
38	Honey locust	6.0	2.0	Poor	Narrow form	Dead leader	REMOVE	EXEMPT	1.2	38
39	Honey locust	7.0	3.0	Poor	Narrow form	95% Dead	REMOVE	EXEMPT	1.2	39
40	Honey locust	6.0	3.0	Poor	Good form	50% of crown dead	REMOVE	EXEMPT	1.2	40
41	Honey locust	7.0	3.0	Fair	Good form	Minor dieback in crown	REMOVE	CITY	1.2	41
42	Honey locust	9.0	5.0	Good	Good form		REMOVE	CITY	1.2	42
43	Linden	19.5	7.0	Good	Good form		REMOVE	CITY	1.8	43
44	Emerald Cedar	Whip-13	2.0	Good	Good form	Minor internal dieback	REMOVE	EXEMPT	1.8	44
45	Emerald Cedar	Whip-13	2.0	Good	Good form	Minor internal dieback	REMOVE	EXEMPT	1.8	45
